# REPORT ON THE 1:10,000 SCALE GEOHAZARDS ASSESSMENT AND MAPPING OF BAYUGAN, AGUSAN DEL SUR

**OCTOBER 2014**

## REPORT ON THE 1:10,000 SCALE GEOHAZARDS (LANDSLIDE AND FLOODING) ASSESSMENT AND MAPPING OF BAYUGAN, AGUSAN DEL SUR

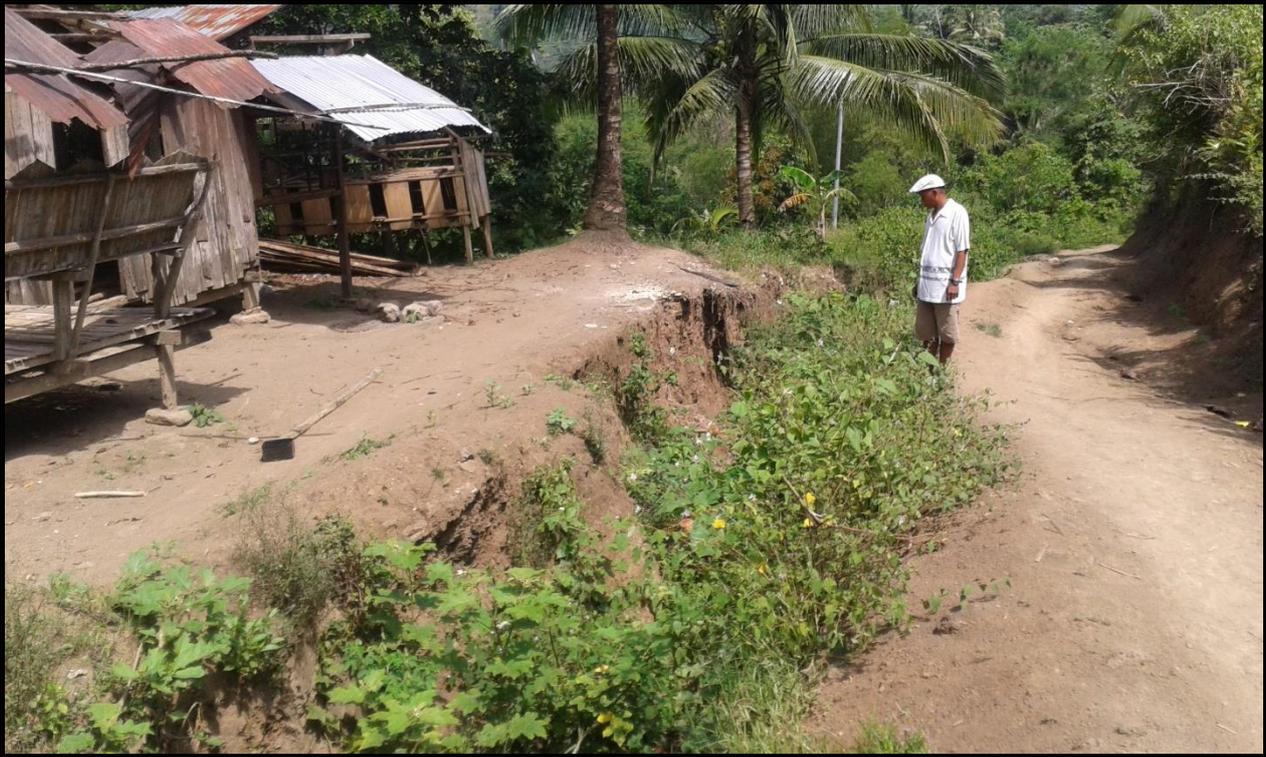
Barangay road, Purok 6. Photo showing gully formation in Purok 6. Note for the abandoned houses. Soil creep was also observed in the area. Minor landslides were observed adjacent to the area indicating unstable slope. GPS Coordinate: 125°8'25.8" E 8°51'6.2" N

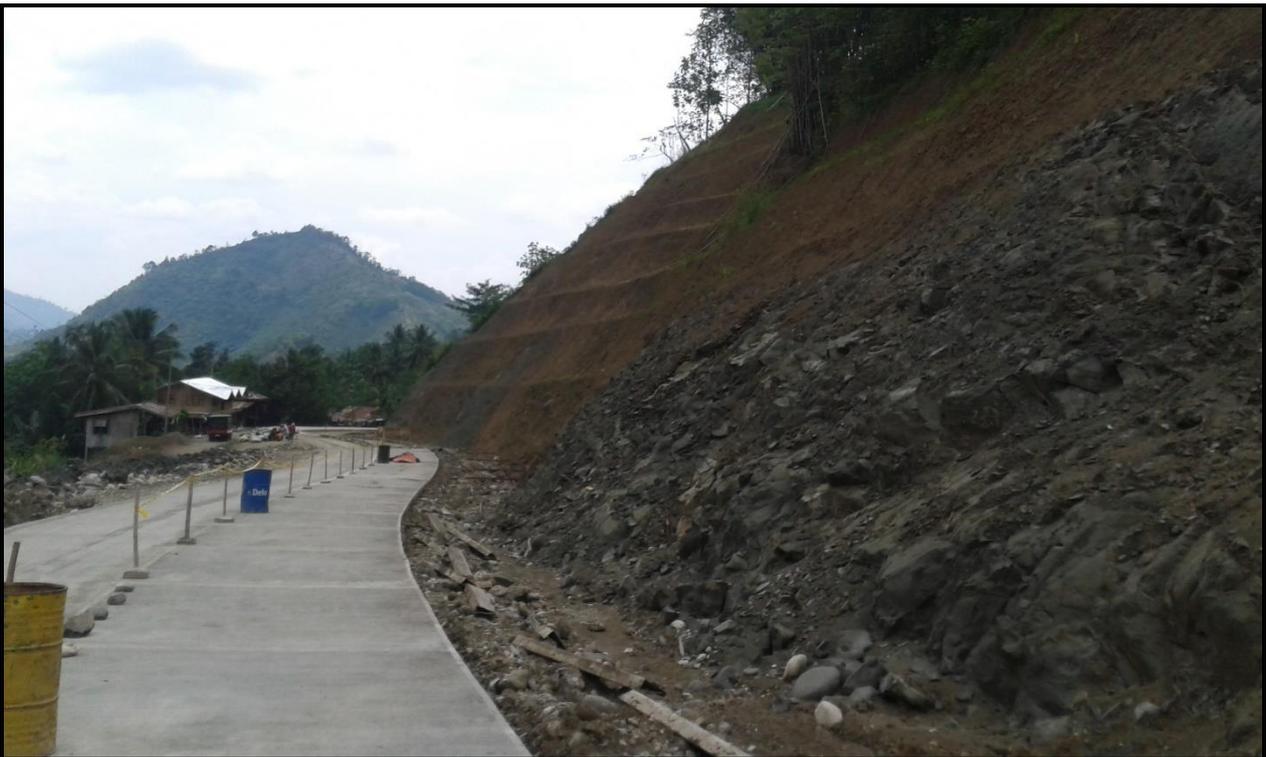
Road cut, Purok 10. Photo showing a mitigated slope in Purok 10. Although benching was applied, few portions of this slope continue to collapse. GPS Coordinates: 125°8'48.8" E 8°49'16.1" N

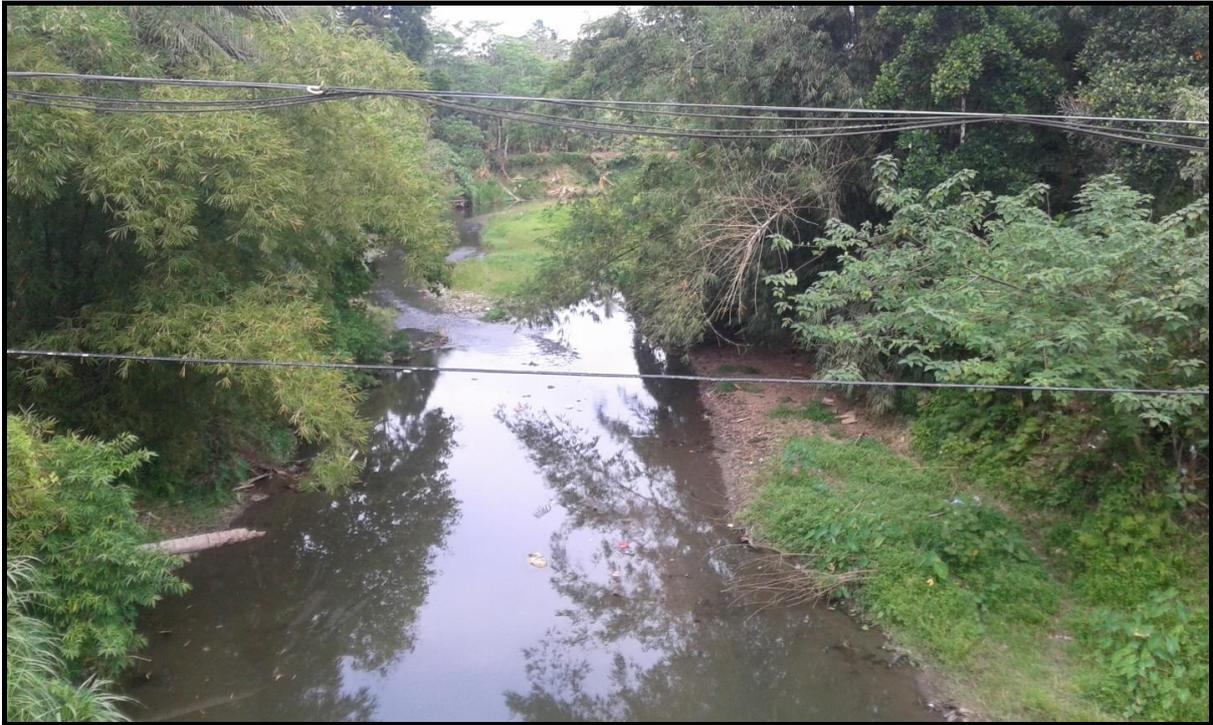
Bayugan River, Purok 1. Very High. Photo showing Bayugan River draining towards Wawa River. Frequently flooded during typhoon season and heavy rainfall. Highest recorded flooding was during Typhoon Agaton where floodwater reached up to 5 meters. Bayugan River serves as boundary between Barangay Poblacion and Barangay Cagbas. View towards downstream of the river. GPS Coordinates: 125°44'21.8" E 8°42'30.9" N

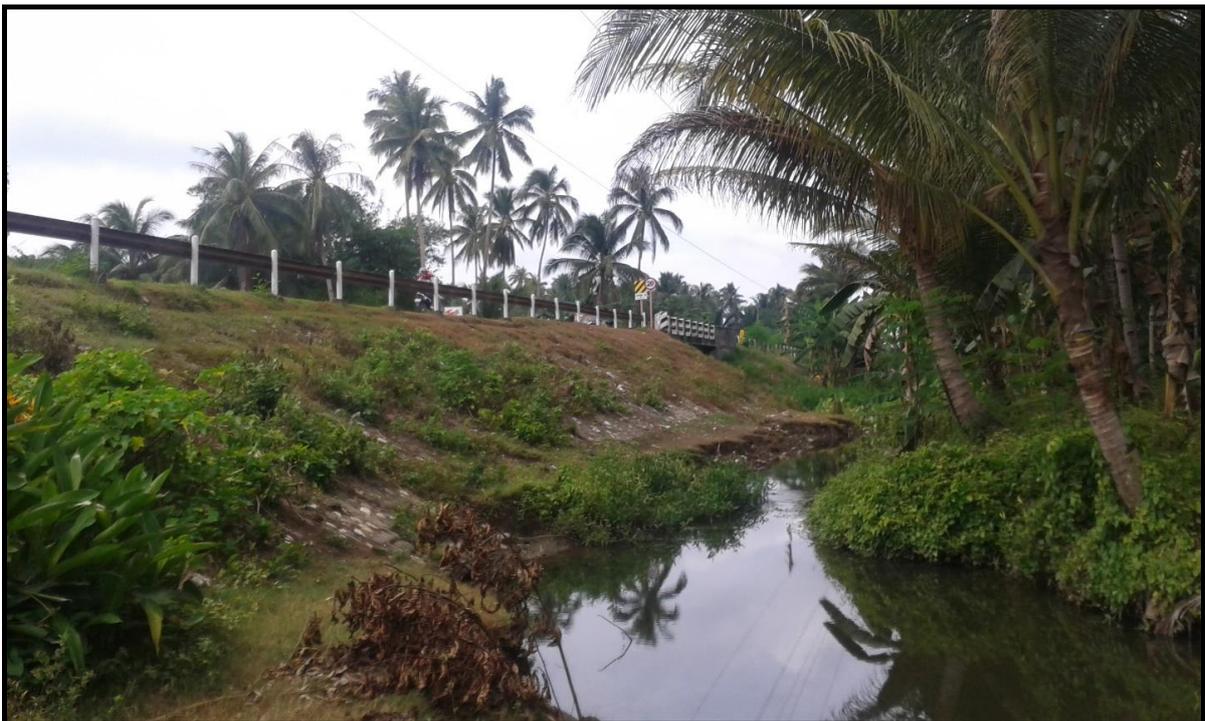
Cagbas Creek, Purok 4-B. High. Photo showing Cagbas Creek that serves as boundary between Barangay Cagbas and Barangay Salvacion. Frequently flooded during typhoon and heavy rainfall. Highest flood recorded was during typhoon Agaton where flood water reached up to 1.8 meters high. GPS Coordinates: 125°43'7.8" E 8°41'33.4" N

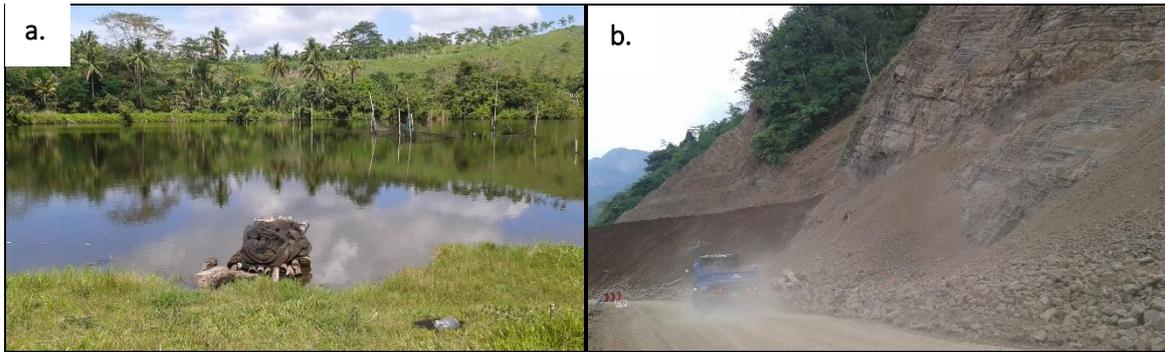
Photo a. Lake along Purok 7 affected by low level flooding during rainy season. b. Active earthmoving works along the provincial road going to Brgy. San Juan. Shown also are steep road cut exposing the tilted sedimentary rocks and talus material generated during excavation.

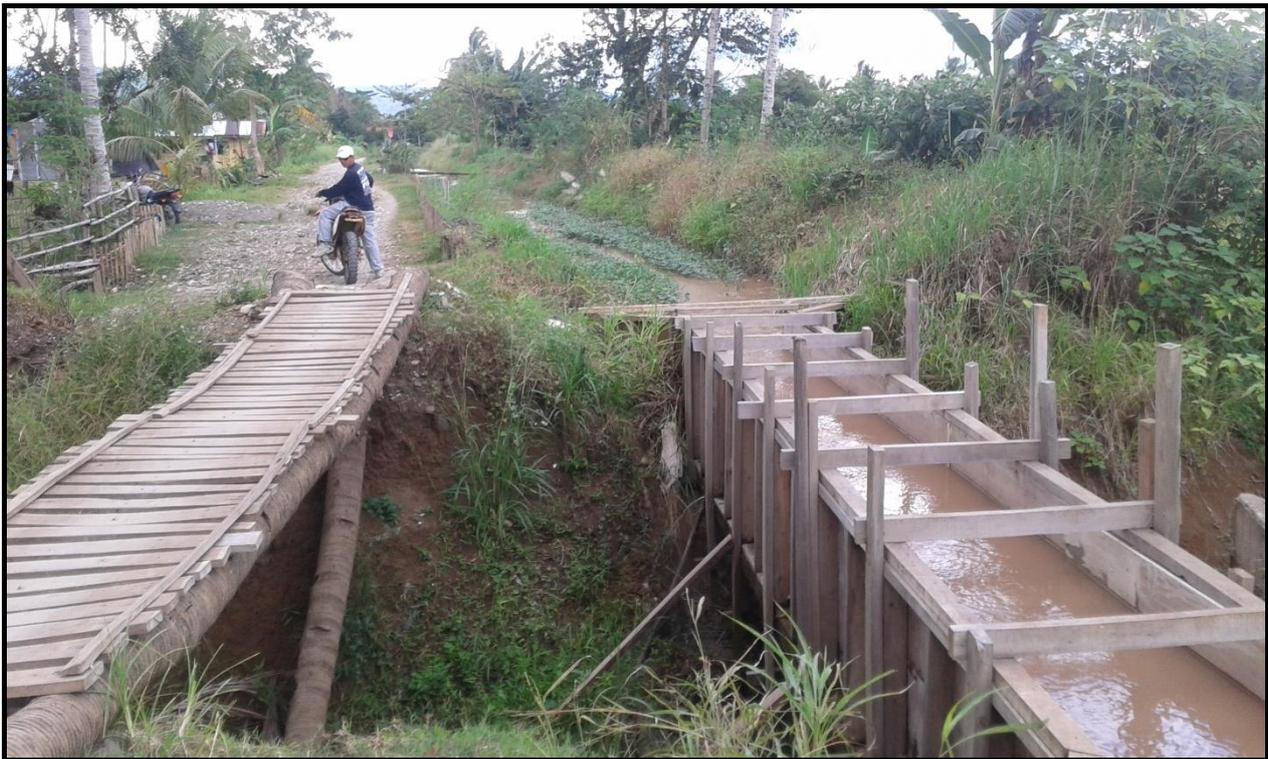
Culvert/Labao Creek, Sitio Azucena. Photo showing a culvert that was destroyed during Typhoon Agaton. Scouring of bank is active. Area is inaccessible during flooding. Flood water reaches up to 2.7 meters. GPS Coordinates: 125°45'29.8" E 8°39'52.8" N

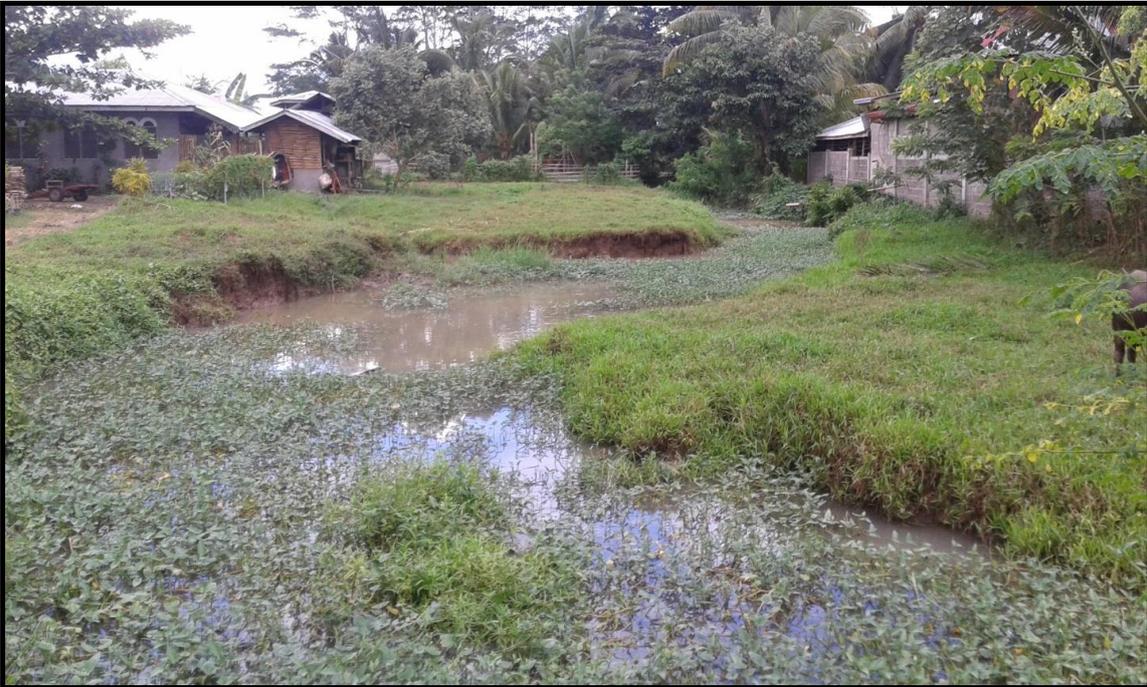
Creek, Purok 2. Photo showing a creek traversing Purok 2 proper. Water from rice paddies/NIA canal is adding water to this creek aggravating flooding hazards during heavy rainfall. Purok 2 experienced 0.8 m flood. GPS Coordinates: 125°45'21.8" E 8°39'33.2" N

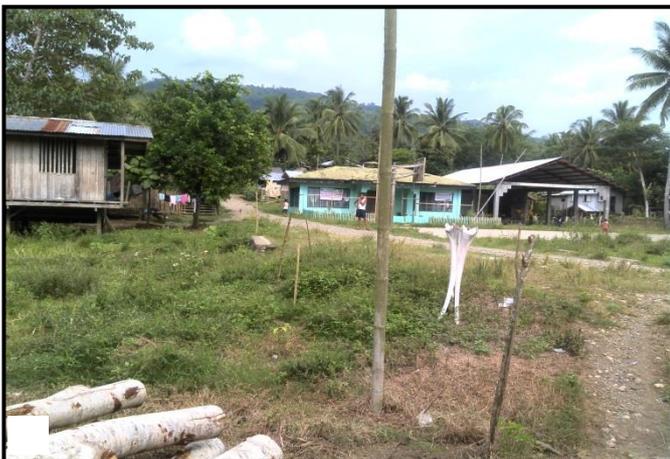
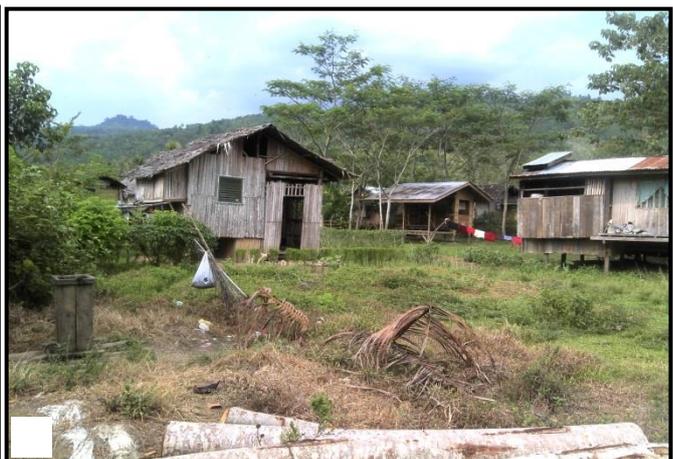
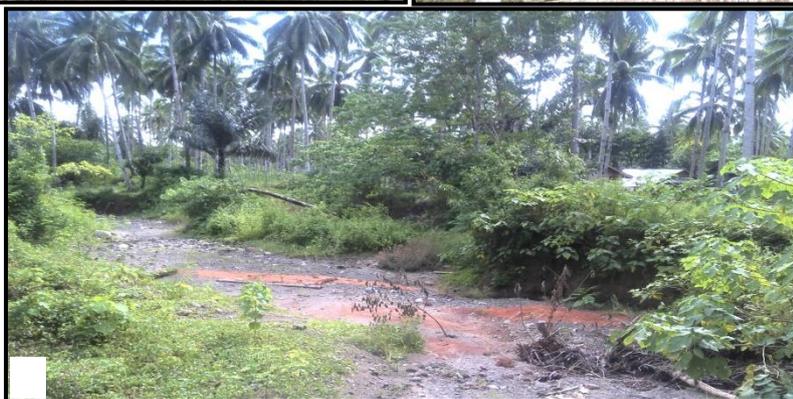
Photo A and B shows settlements in Purok 6 that experiences up to 0.5m depth of flood during intense downpour of rain. Photo C is an intermittent creek in Purok 5 that causes flooding in the area.

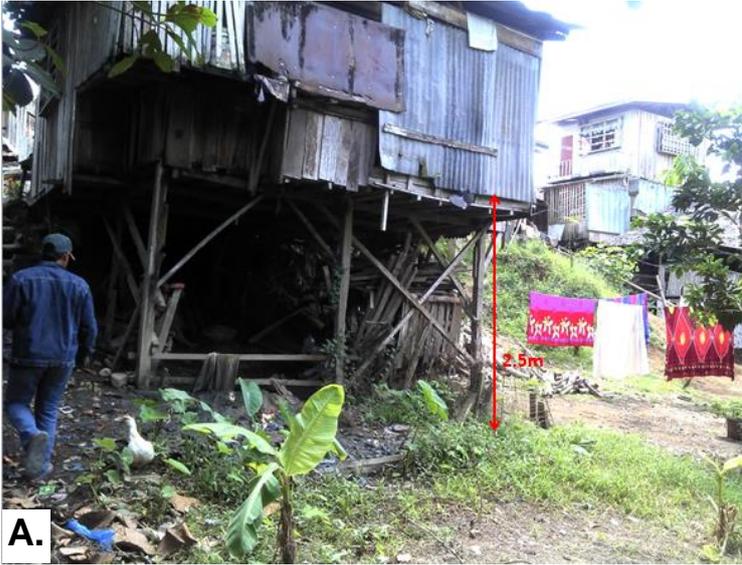
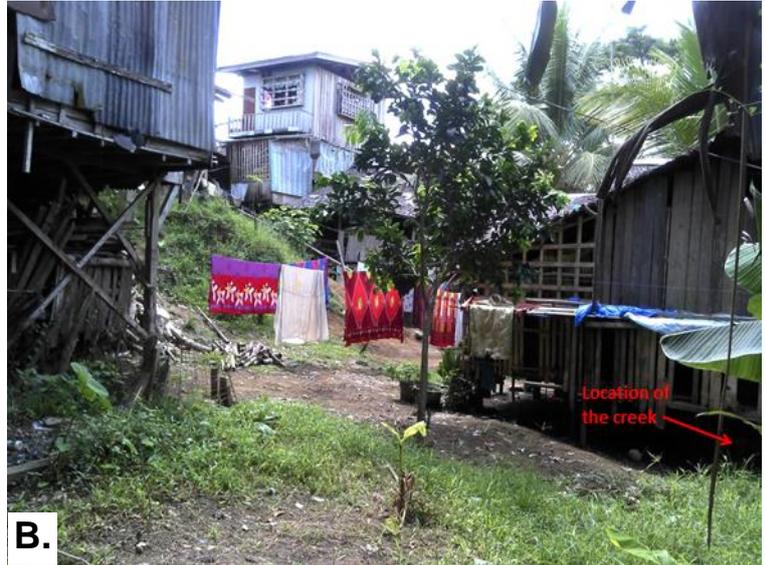
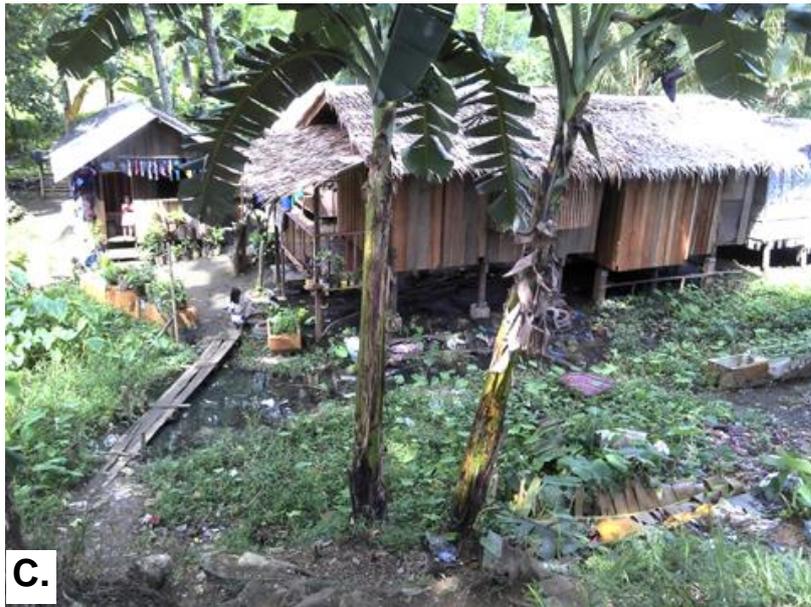
Photos A and B. The area is highly prone to high flooding mainly associated with creek overflowing (a tributary to Andanan River) adjacent to the residential area. Flood depths on this area could reach about 2meters (localized). Photo C. Clogged drainage canal due to improper garbage disposal.

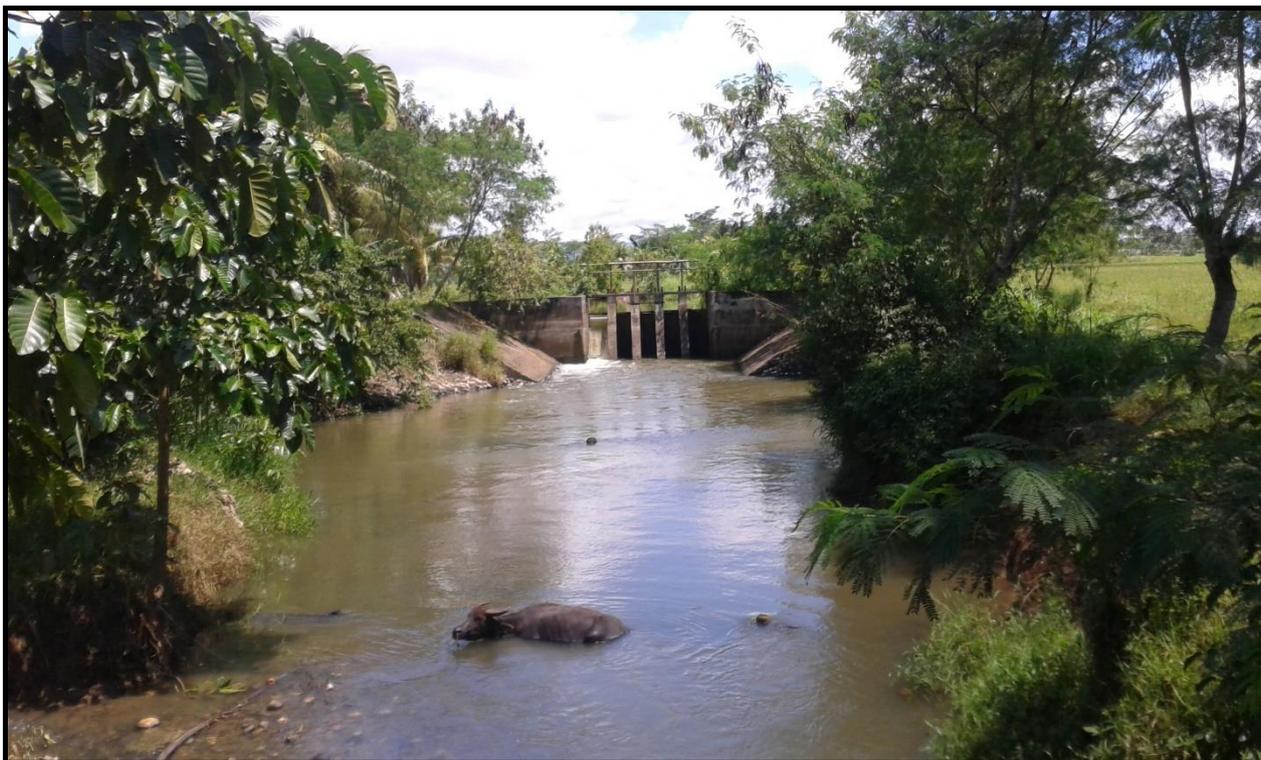
Mahabo Creek, Purok 5. Photo showing Mahabo Creek and NIA dam gate. Frequently flooded during heavy rainfall. Situation is becomes worst when NIA releases water from the dam. GPS Coordinates: 125°43'29.3" E 8°39'14.8" N

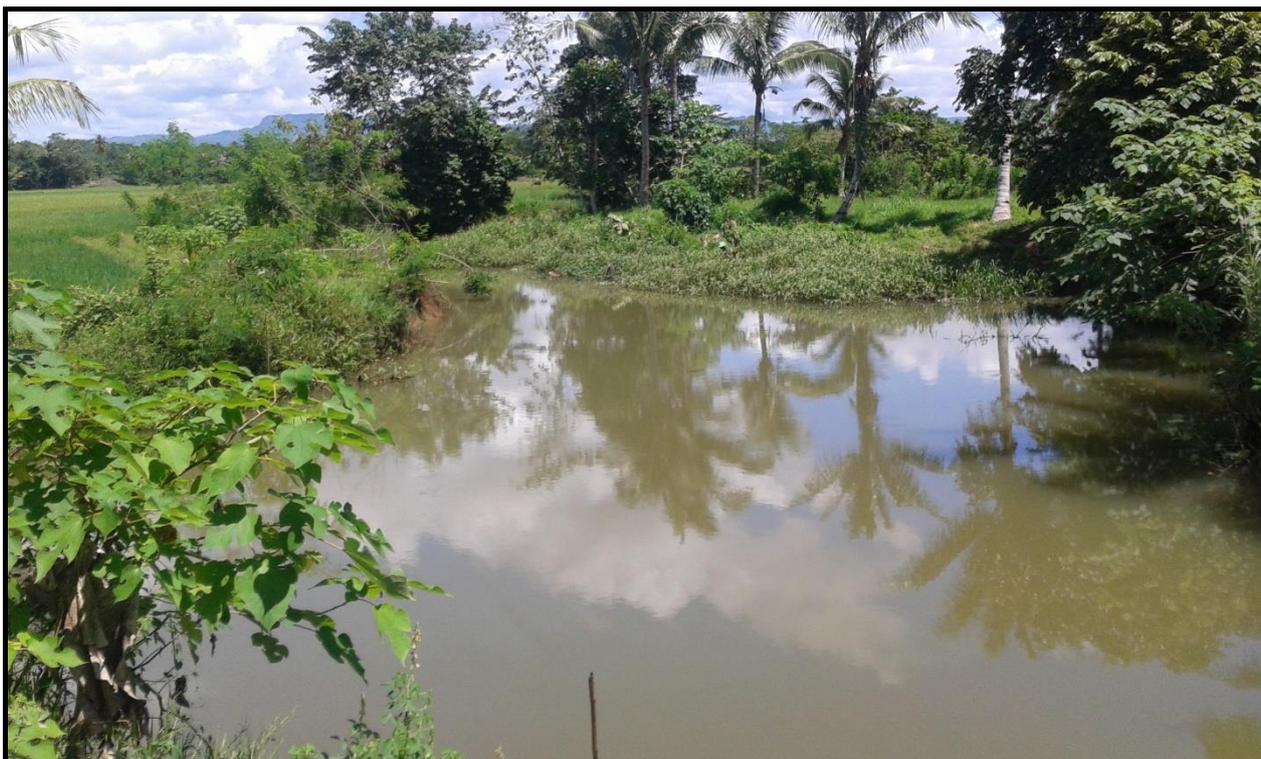
Mahabo Creek, Purok 1. Mahabo Creek is frequently flooded during heavy rainfall aggravated during water release from NIA dam. Photo taken upstream. GPS Coordinates: 125°44'28.5" E 8°39'49.2" N

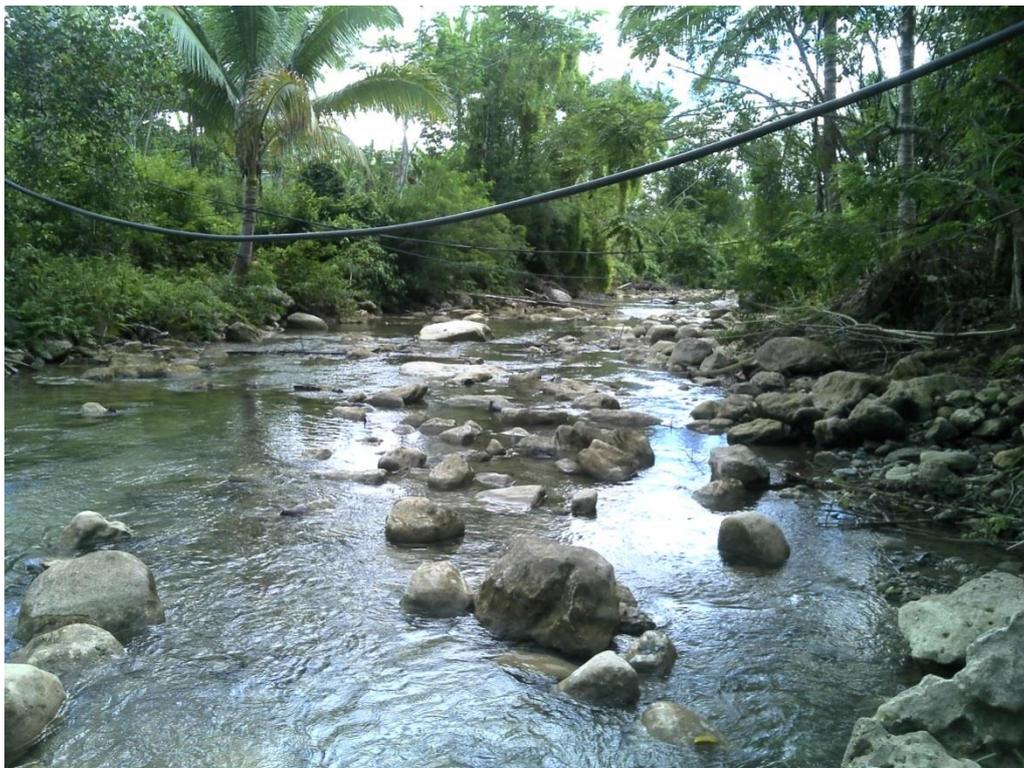
Photo of Sianib River in which flood height reaches as high as 2m. Flooding is restricted along river channel. (Geographic Location: 8° 45' 27.7" N 125° 50' 31.6" E)

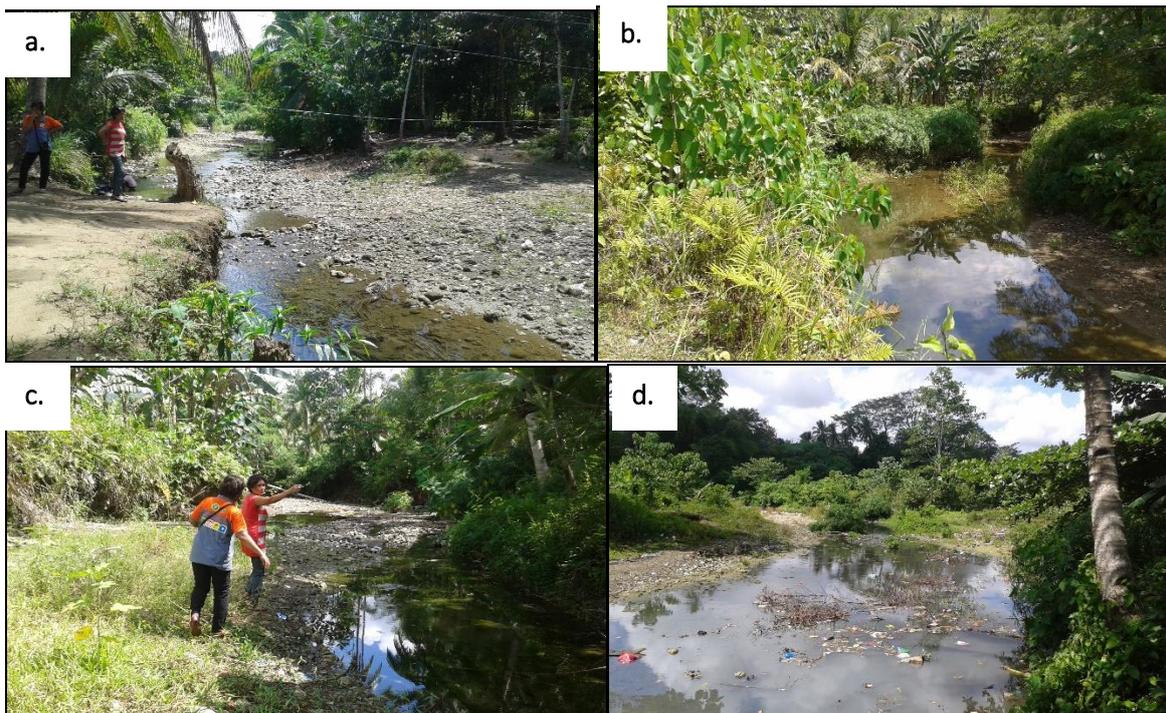
Photos. Flooded segments of Maytibog River in Purok 6 (a.), Purok 4B (b.) and Purok 3 (c.) affected by flooding during rainy season. Junction of Maytibog and Bayugan Rivers both eventually drain to Wawa River (d.).

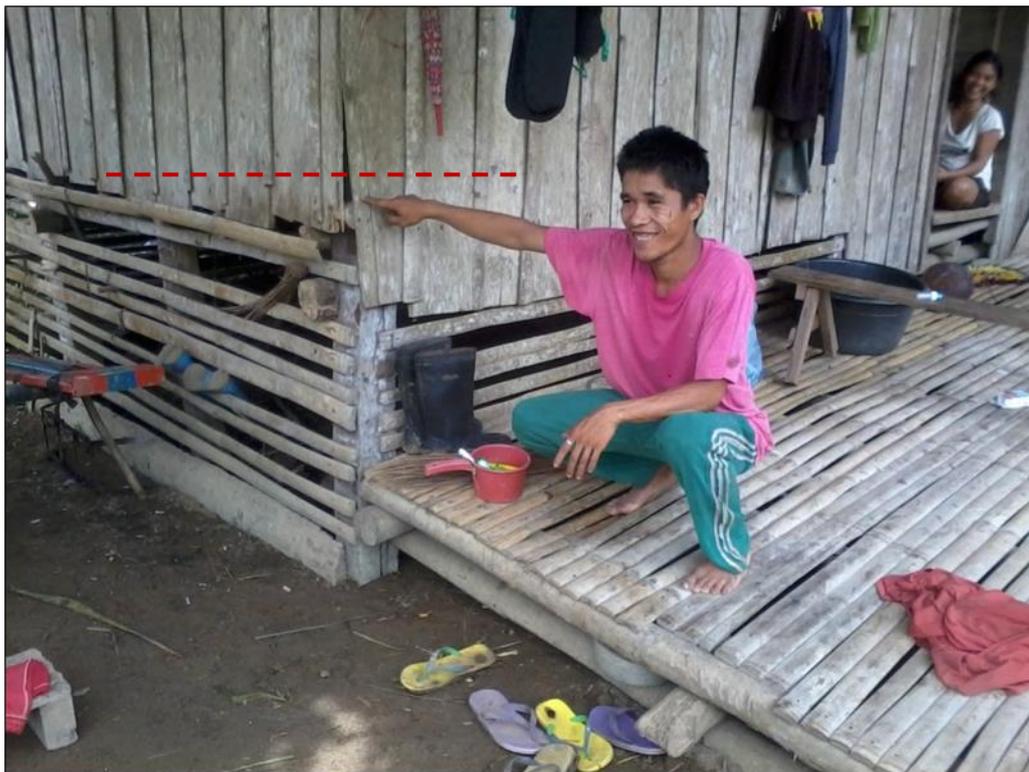
Purok 9 (8° 36' 21.8" N, 125° 48' 43.3"E) Very high. This photo shows a local resident pointing at the approximate flood water level in the area.

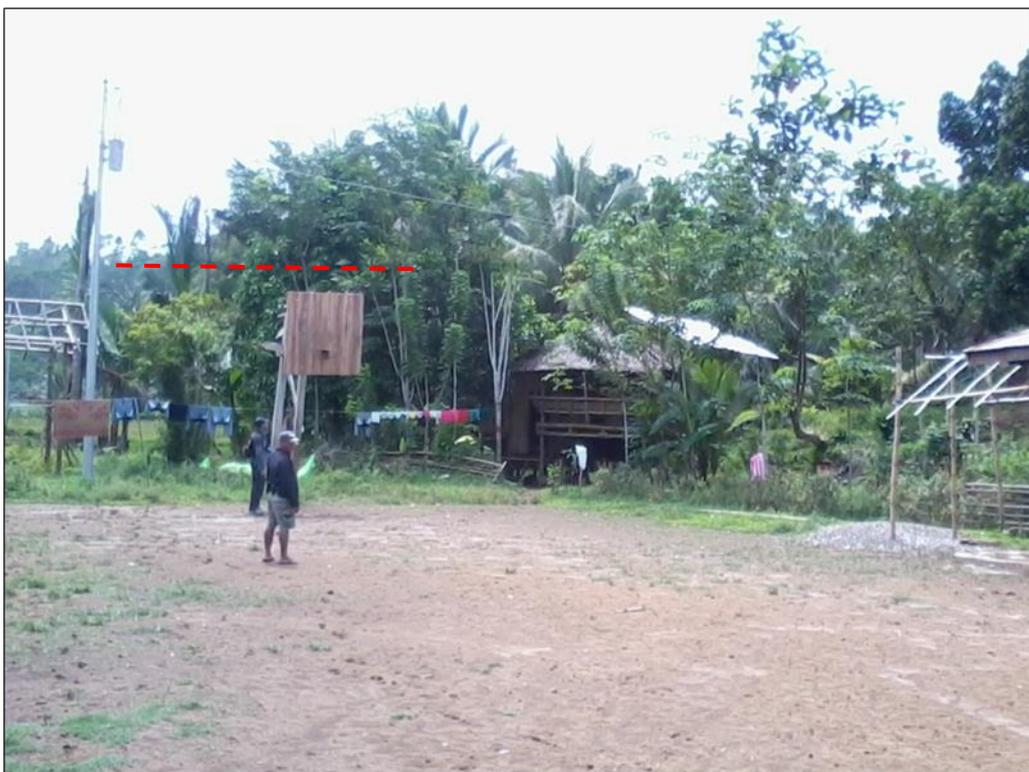
Purok 9 (8° 36' 21.9" N 125° 48' 49.4"E) Photo showing the approximate flood level (red line) reported by the purok residents. Flood height is approximately 2.5 meters.

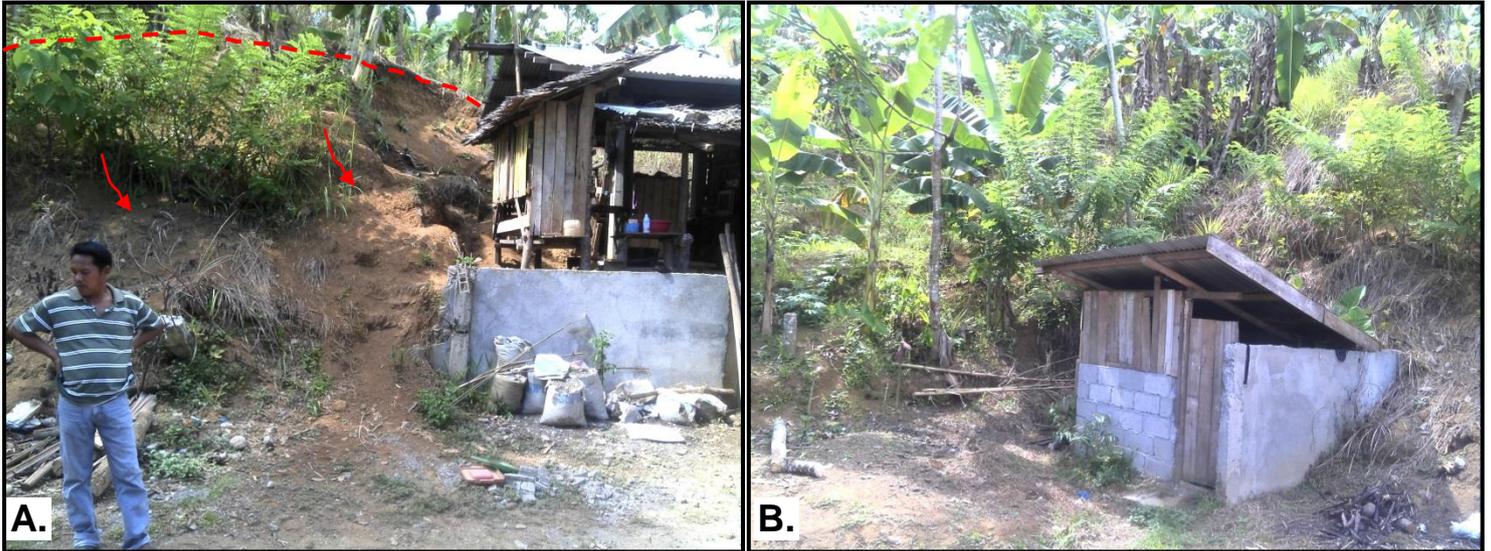
Photo A and B. Localized landslide (20m) in Purok 4 during Bagyong Pablo.

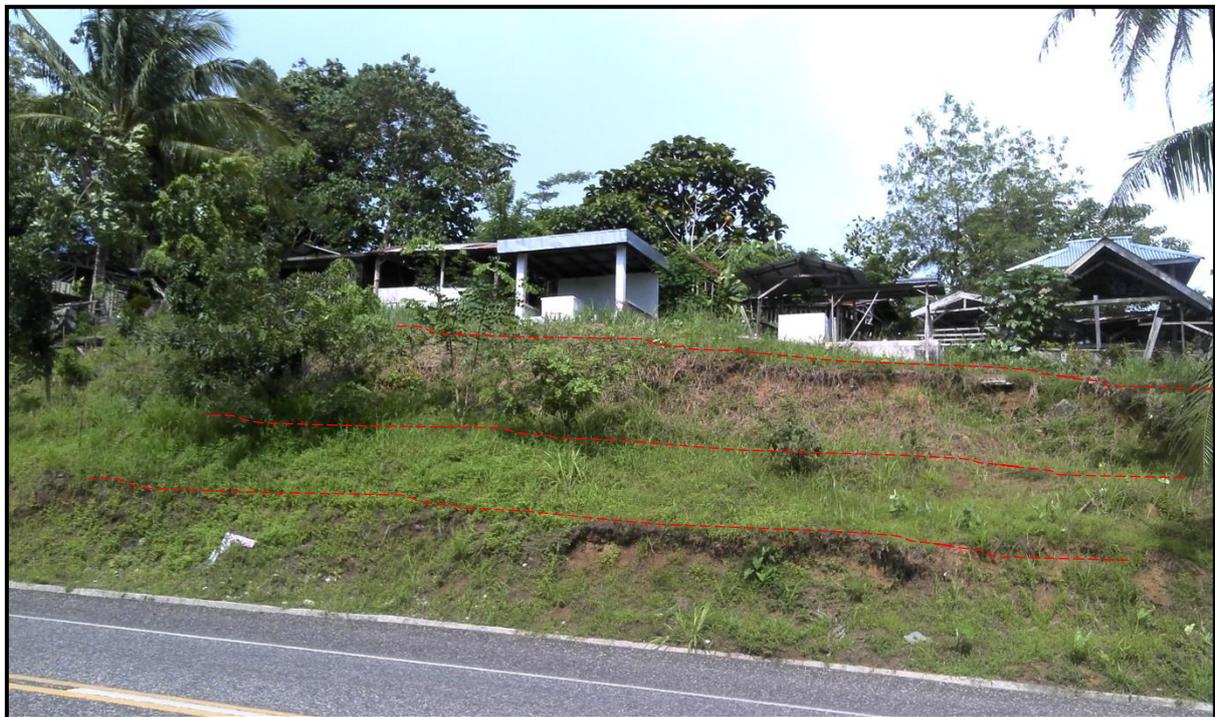
Terracets along the road cut of Purok 4. Mass movement is triggered by ground saturation during intense rain.

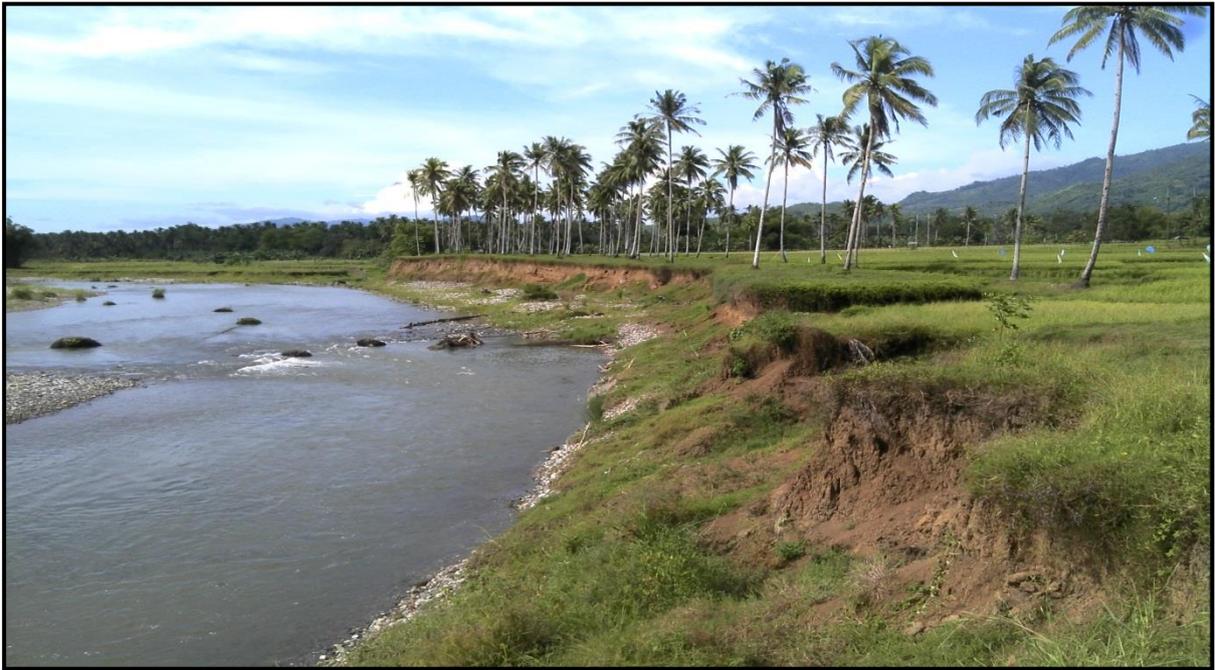
Intense riverbank erosion in Wawa River. This river overflows, caused flooding to portions of the rice paddies.

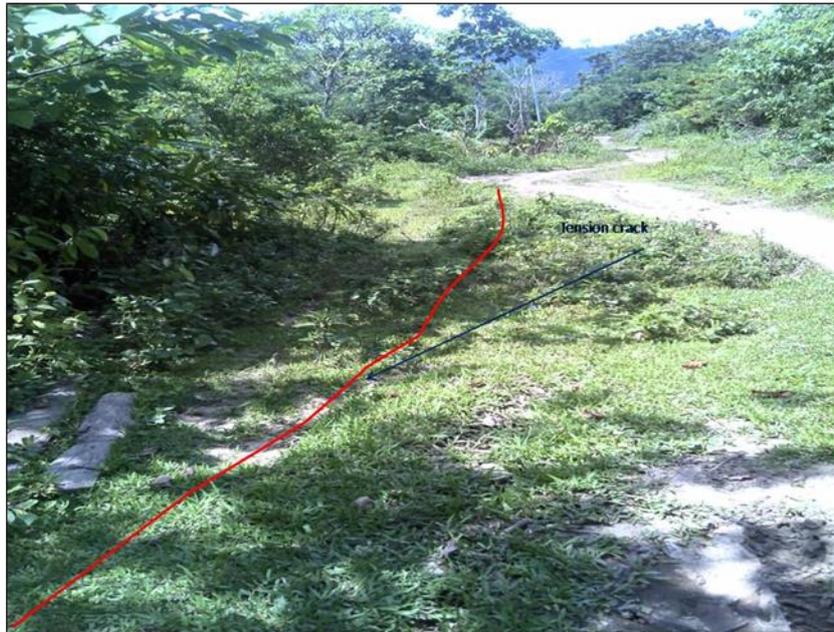
Purok 3 (8° 47' 48.9"N, 125° 45' 10.2"E) Very High. This photo show tension cracks along barangay road in Purok 3, measuring approximately 100m trending SE.

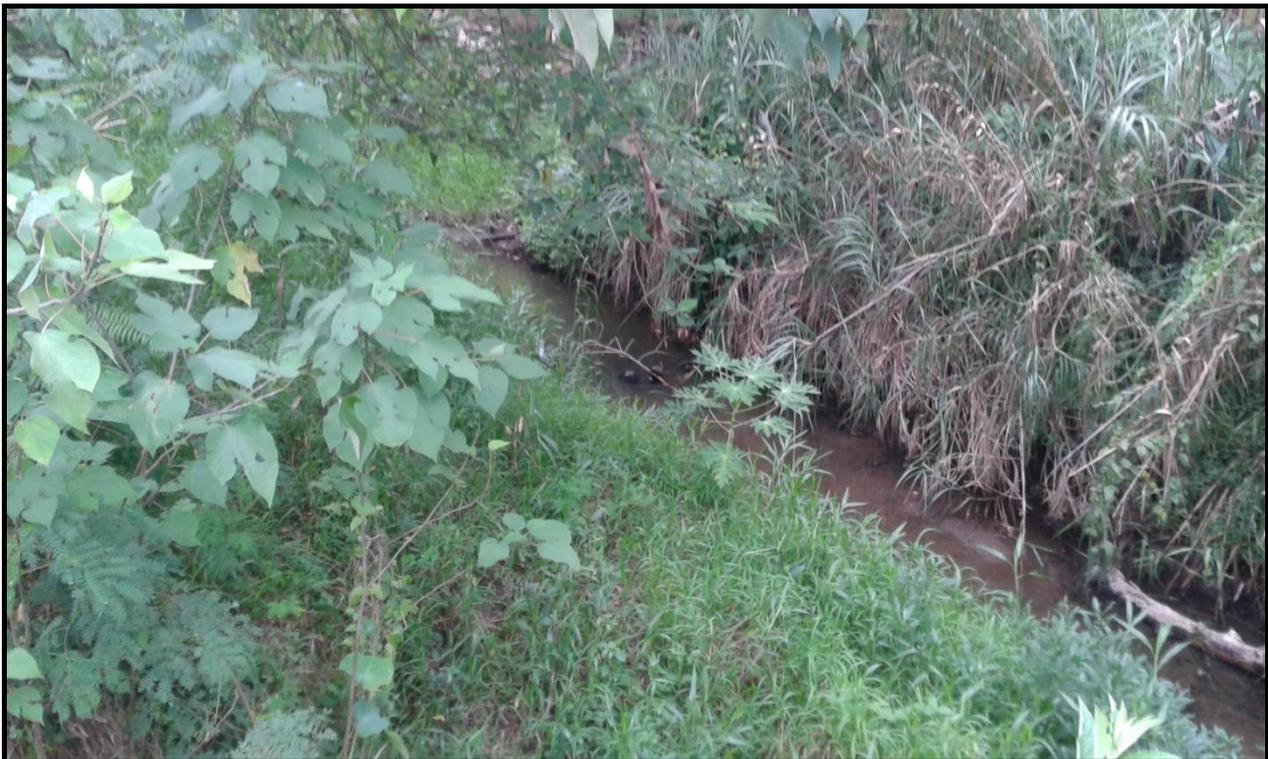
Panaytay Creek, Purok 1. Photo showing Panaytay Creek with normal water level of about 0.3m. During heavy downpour flood water reaches up to 2.0 meter high. Bank erosion is active. GPS Coordinates: 125°46'26.7" E 8°39'37.4" N

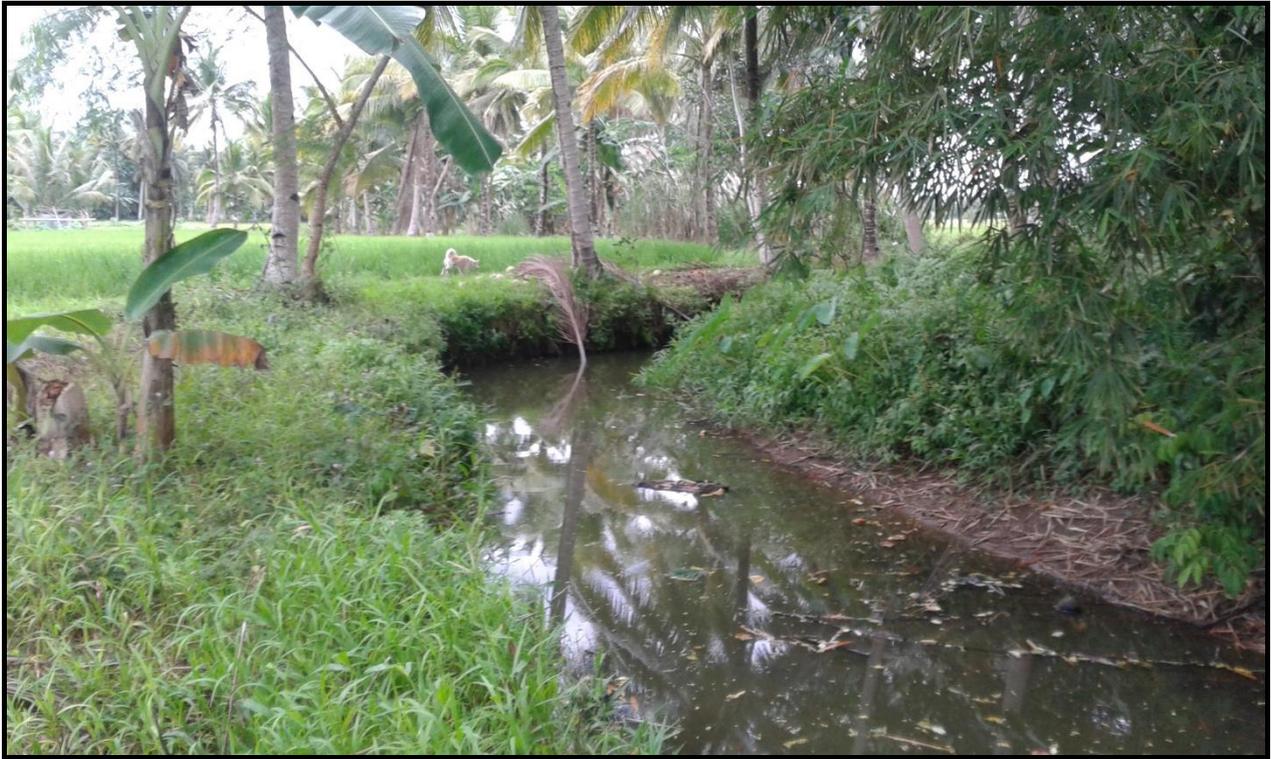
Hagab Creek, Purok 4. Photo showing Hagab Creek near Purok 4 draining to Panaytay Creek. Flood height reaches up to 1.4 meters high. GPS Coordinates: 125°46'7.7" E 8°39'51.6" N

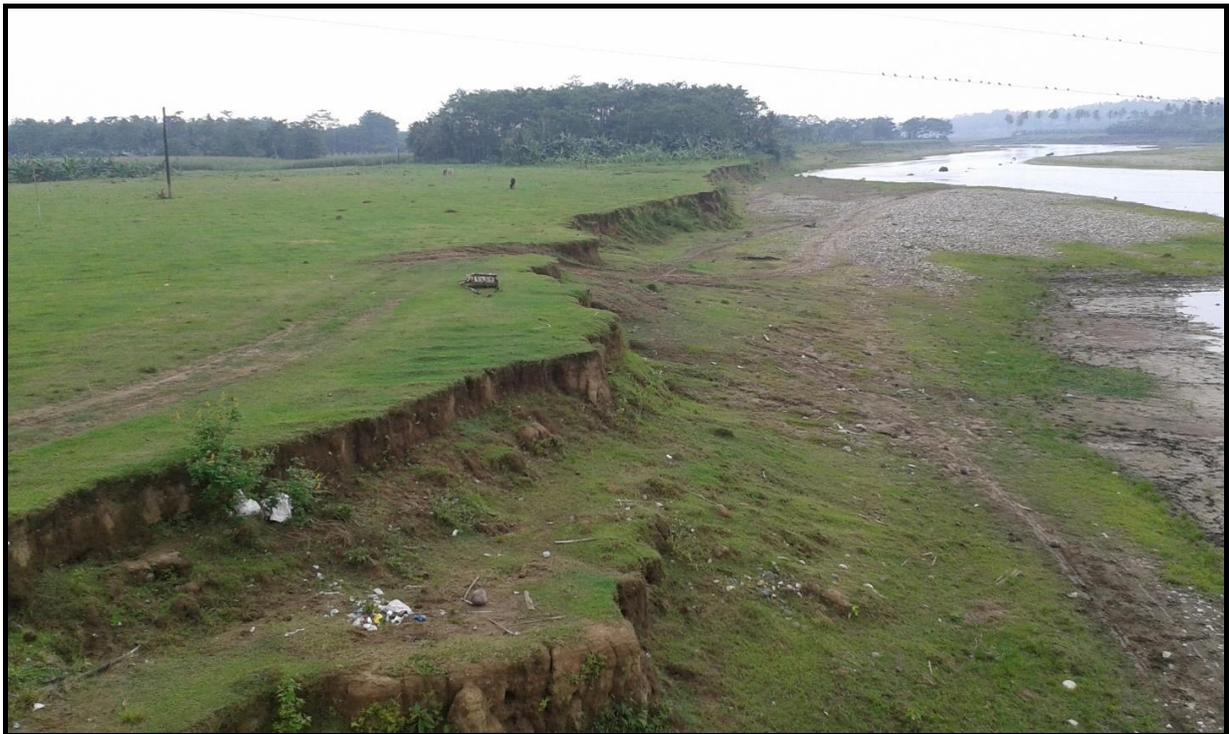
Wawa River, Hanging Bridge. Photo showing lateral spreading caused by bank erosion along Wawa River. Flood water level usually above 5 meters during rainy season (December to February) associated with river water overflow. River channel migration has occurred. GPS Coordinates: 125°42'50.8" E 8°42'39.31" N

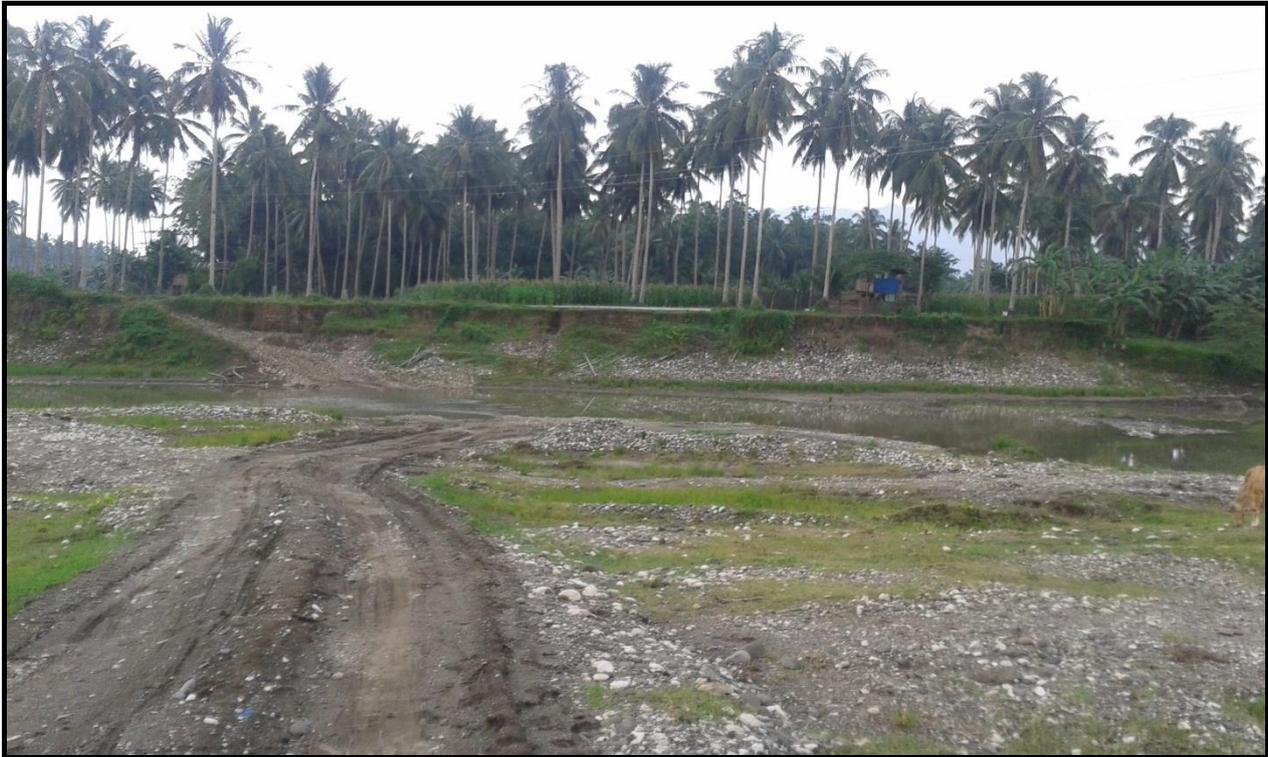
Andanan River, Purok 7. Photo showing Andanan River passing Purok 7. Worst flooding occurred during typhoon Agaton. Flood height reached up to 5 meters. GPS Coordinates: 125°44'2.6" E 8°43'45.7" N

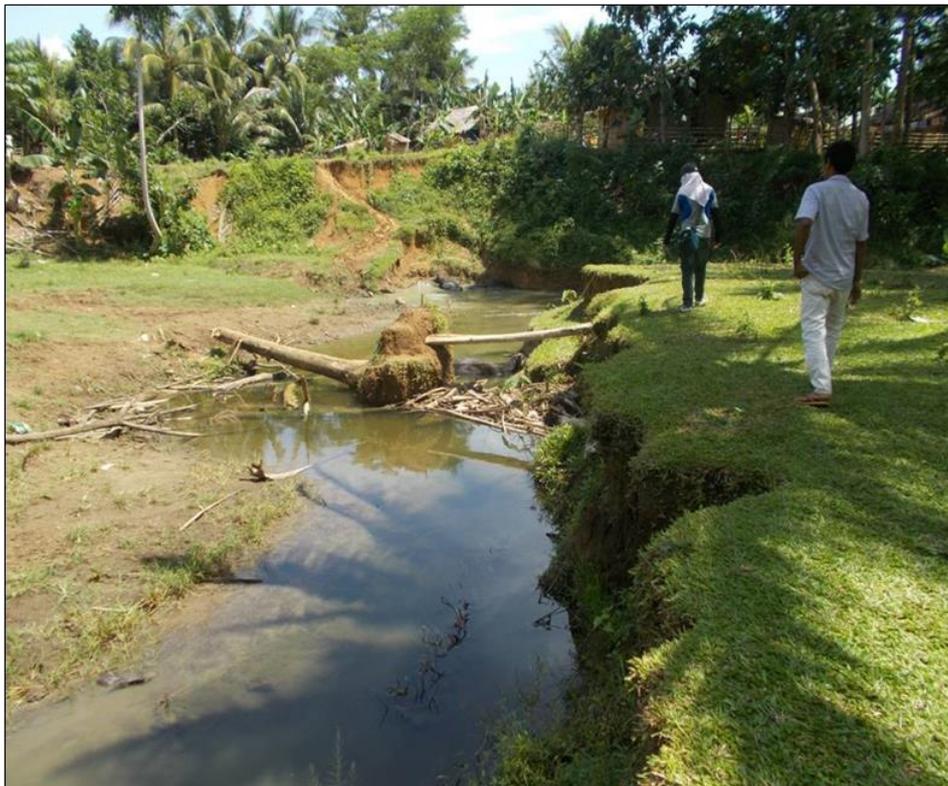
Purok 5 (8° 43' 21" N, 125° 40' 38.3"E) Photo showing segment of Kubo River, where active bank erosion has been mapped. The area is also flooded during rainy season.

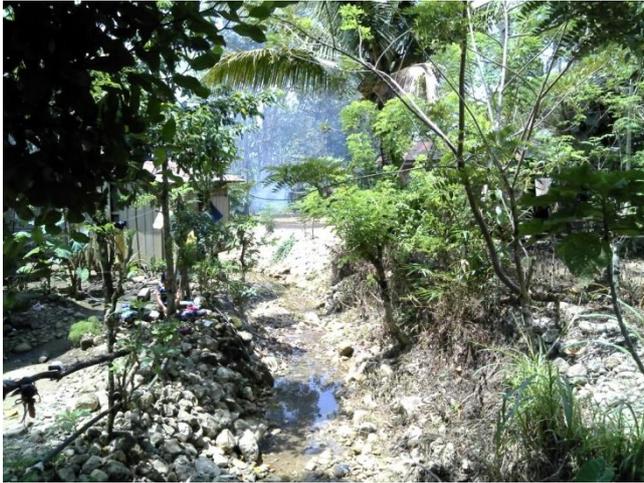
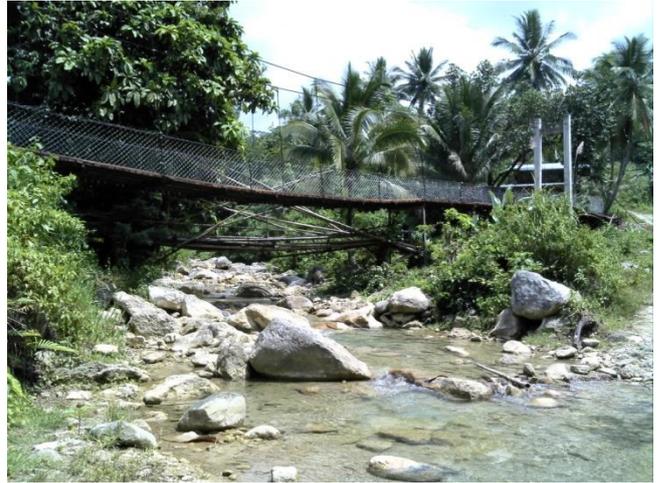
Intermittent creek at Purok 1 which causes sheet flooding in the surrounding area (left) and Minto Creek at Purok 3 Sitio Moriah which overflows to the adjacent residential areas (right).
