# REPORT ON THE 1:10,000 SCALE GEOHAZARDS ASSESSMENT AND MAPPING OF BAYUGAN, AGUSAN DEL SUR

**OCTOBER 2014**

## REPORT ON THE 1:10,000 SCALE GEOHAZARDS (LANDSLIDE AND FLOODING) ASSESSMENT AND MAPPING OF BAYUGAN, AGUSAN DEL SUR

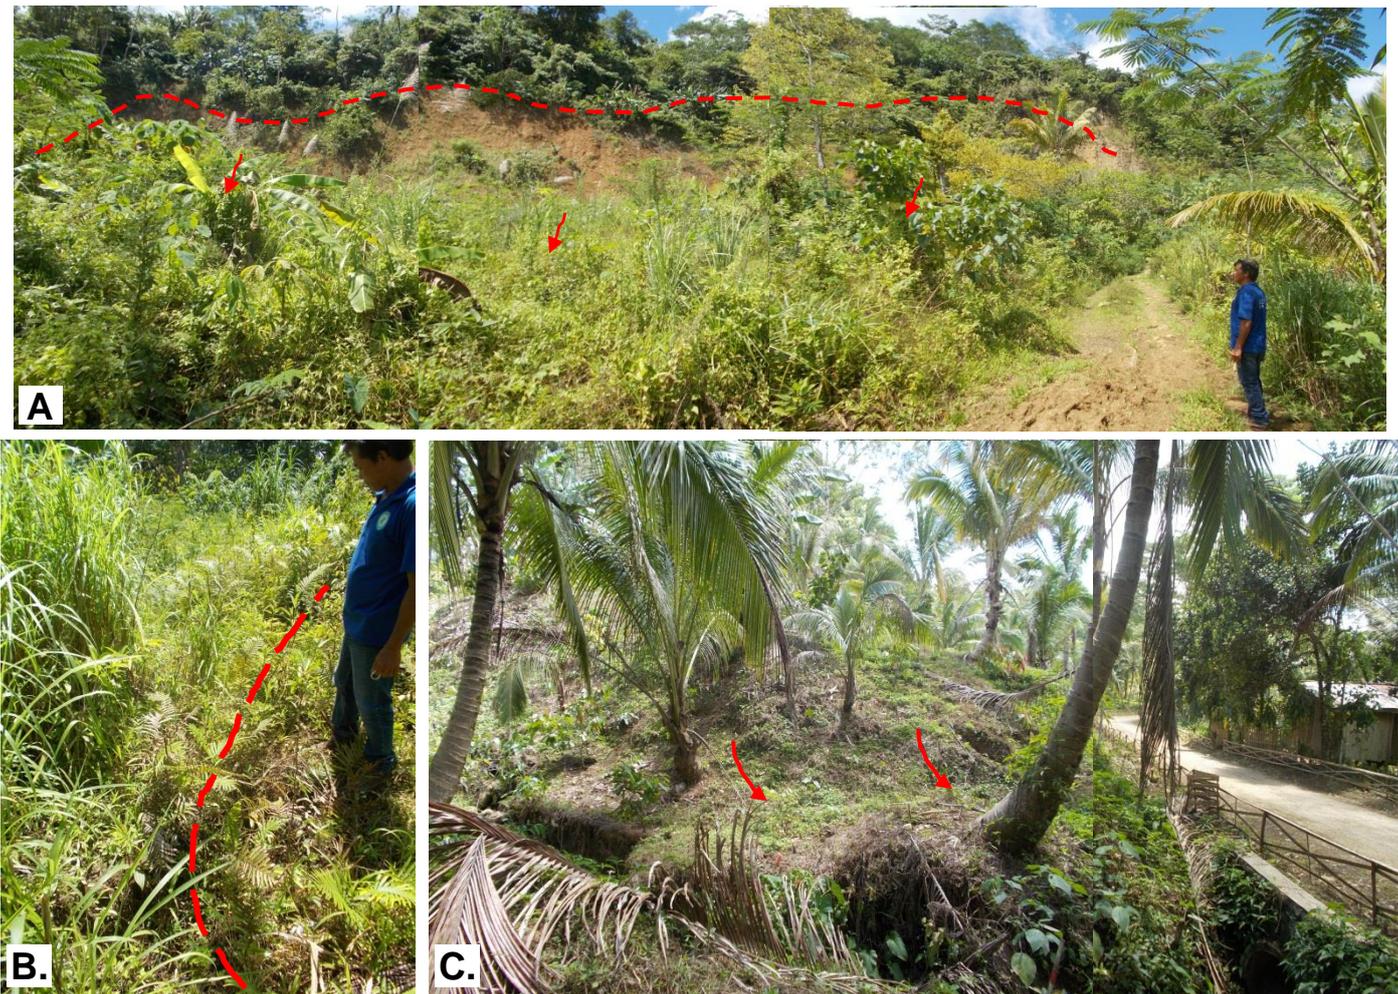
Photo A. Shows a 100-meter landslide in Purok 9 reportedly triggered by the intense rain during Typhoon Pablo. Seepages are present. (B) Tension cracks are present. (C) Soil creep (slow mass movement) is observed indicated by bent vegetation (e.g. coconut trees, etc).

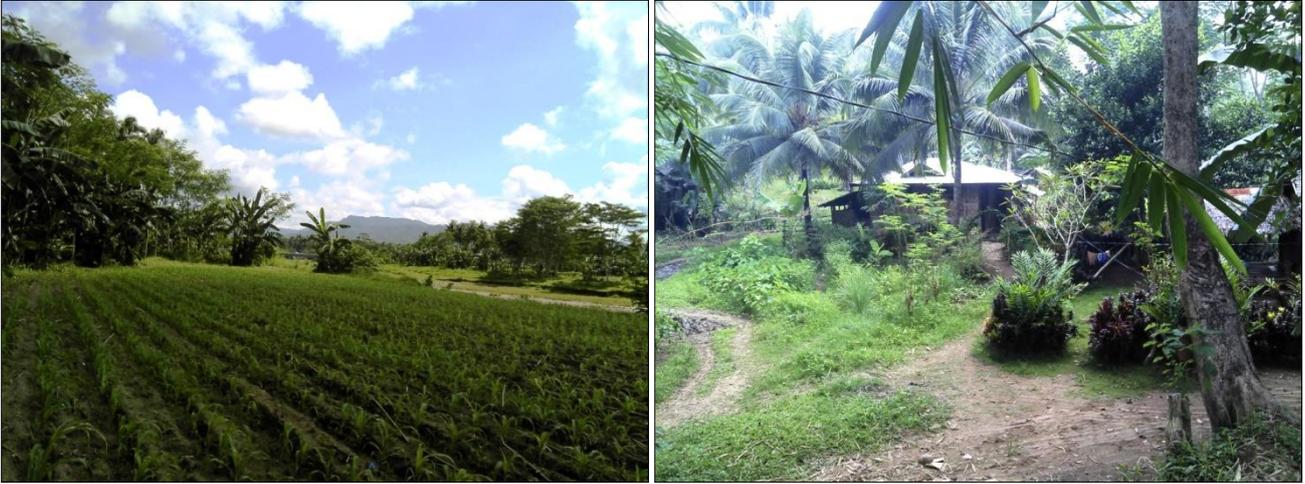
Some of the areas affected with sheet flooding at Purok 7 (left, agricultural area) and Purok 9 (right, residential area).

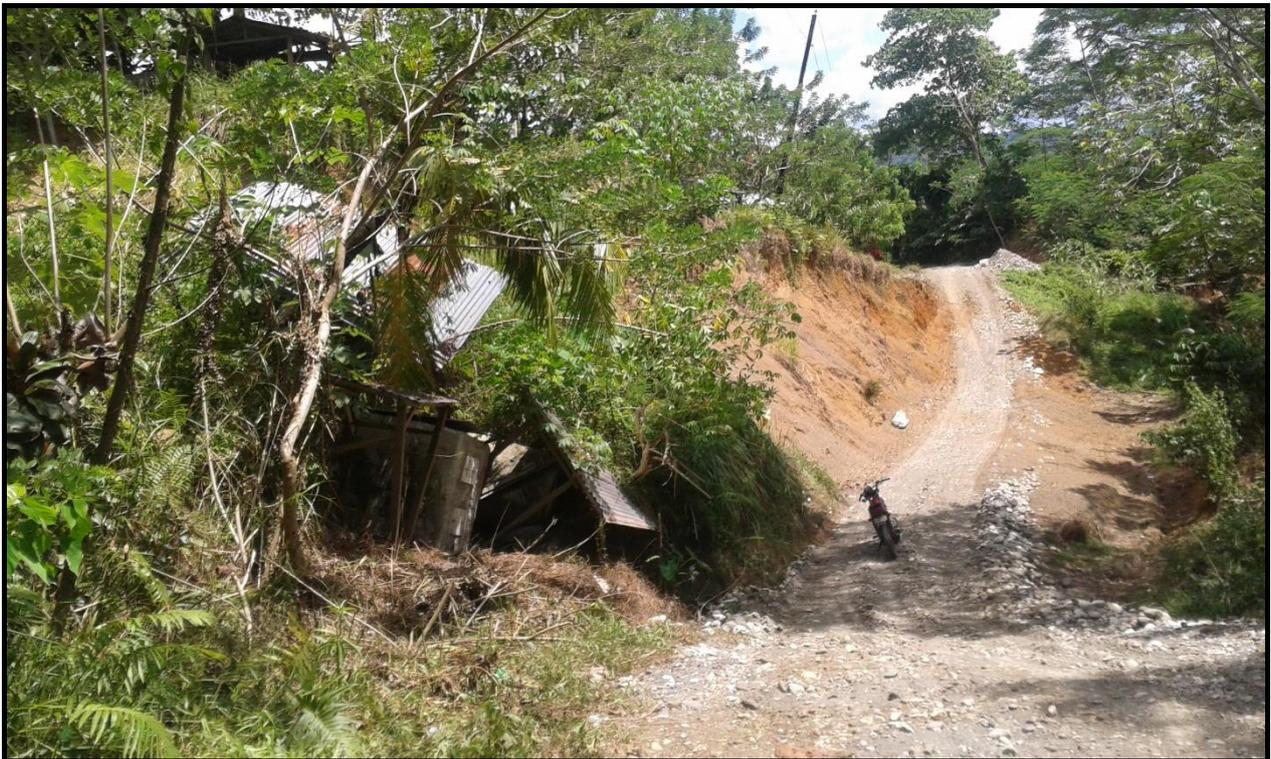
Public Cemetery, Purok 5. Photo showing active landslide near the public cemetery. Approximate length of landslide is 100 meters traversing in WNW direction. Overturned tombstones were observed. GPS Coordinates: 125°49'43.3" E 8°41'33.1" N

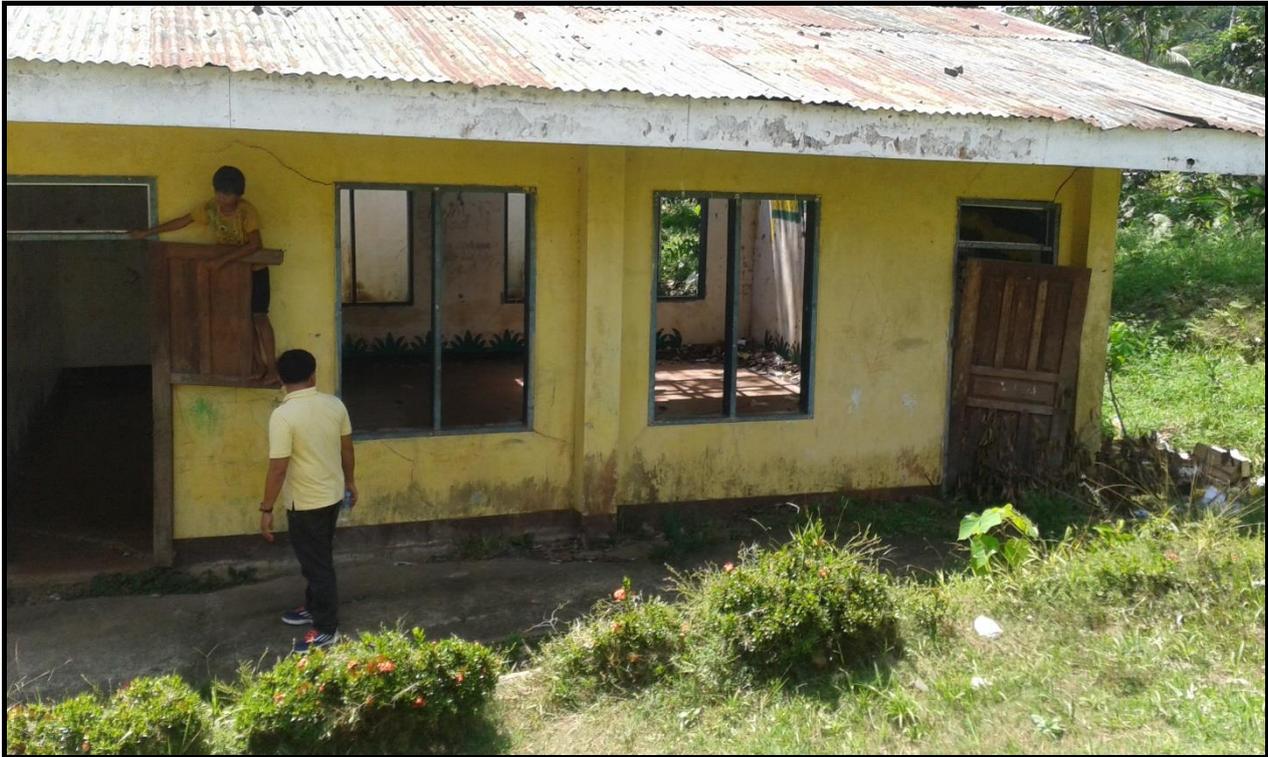
Osmeña Sr. Elementary School. Purok 4. Photo showing abandoned building of Osmeña Sr. Elementary School due to presence of cracks on its walls caused by mass movement probably associated with a fault trending WNW. Direction of collapsed material is ENE. GPS Coordinates: 125°49'16.4" E 8°41'50.2" N

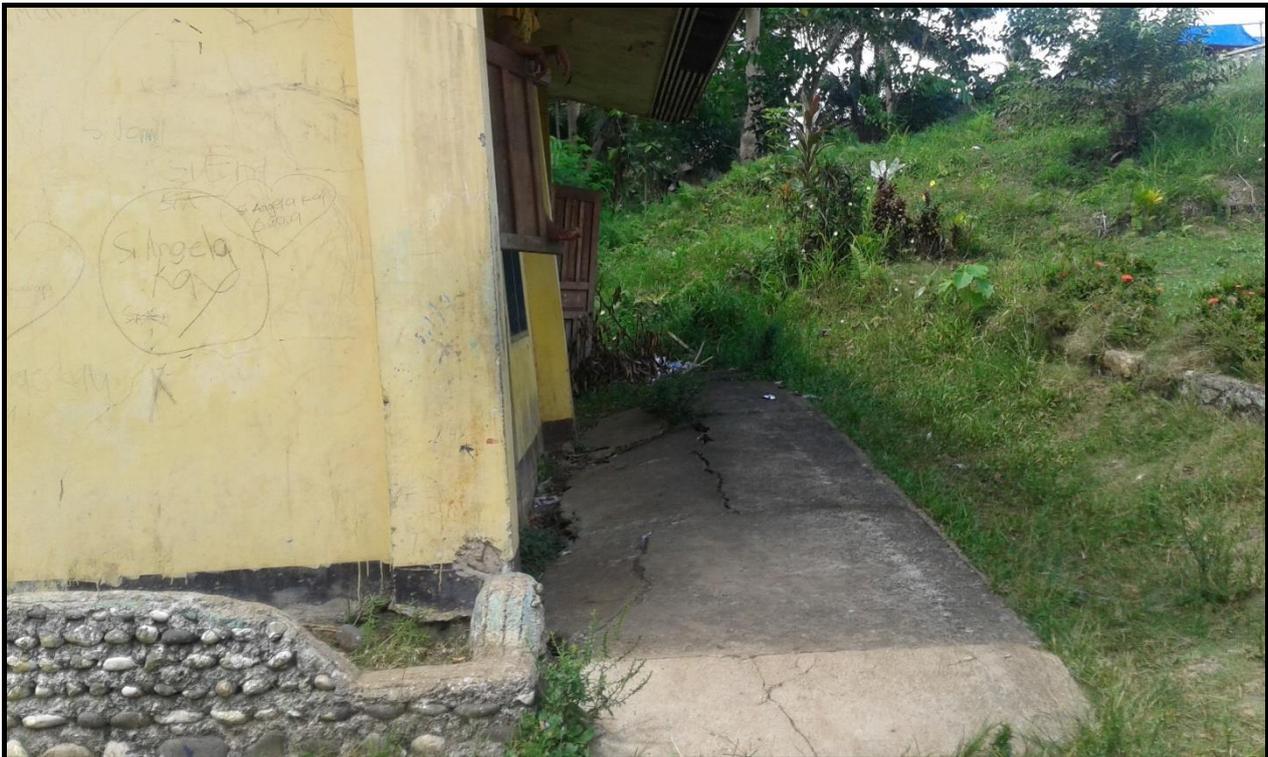
Osmeña Sr. Elementary School, Purok 4. Another photo showing cracks in an abandoned school building caused by ground movement. GPS Coordinates: 125°49'16.4" E 8°41'50.2" N

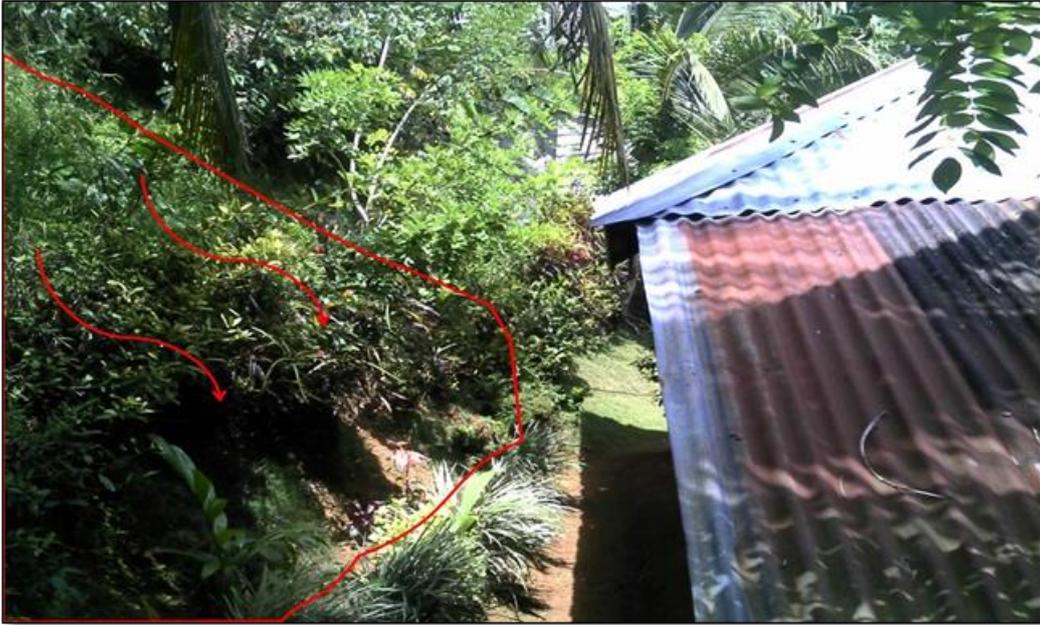
This photo shows a possible soil creep (slow mass movement) indicated by tilted vegetation. Purok 3 ( $8^{\circ} 40' 8.3''$  N,  $125^{\circ} 49' 6.5''$ E).

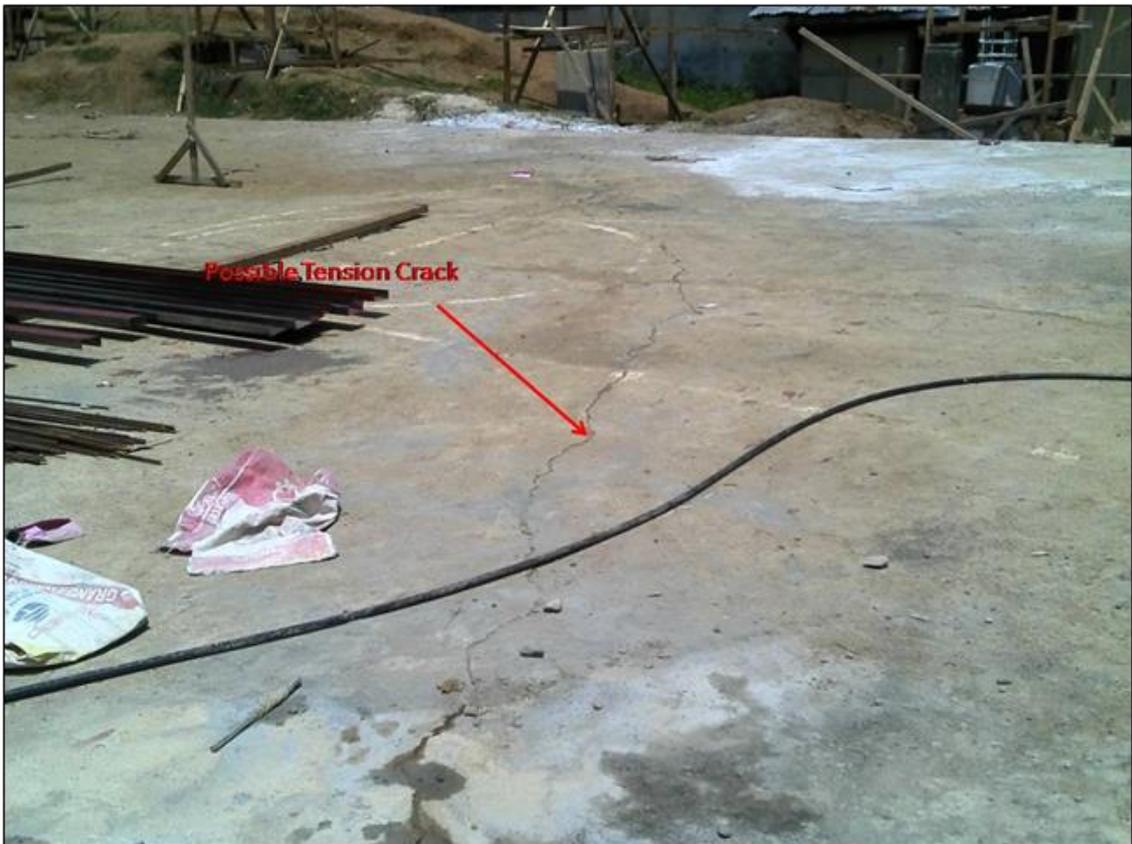
Photo showing a crack at the basketball court probably associated with tension cracks. Purok 3 ( $8^{\circ} 40' 4.5''$  N,  $125^{\circ} 49' 2.3''$ E).

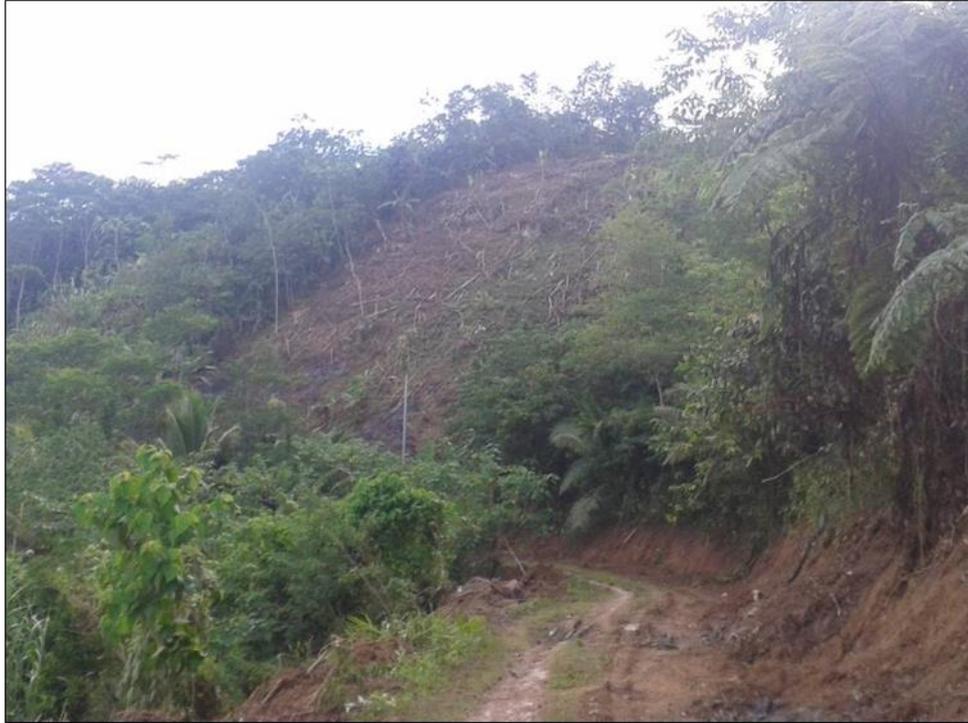
Photograph of a steep road cut along segment of barangay road in Purok 6

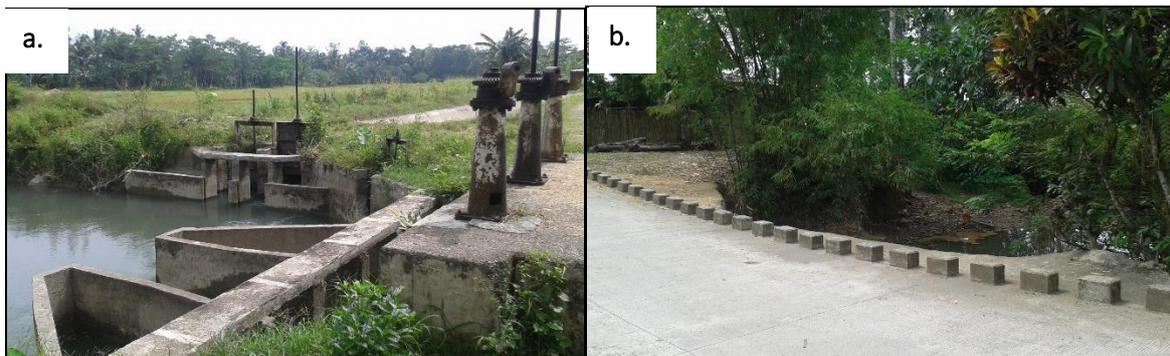
Photos. Irrigation gate at Purok 7 (a) and Santi Creek in Purok 3 (b). These areas are susceptible to flooding.

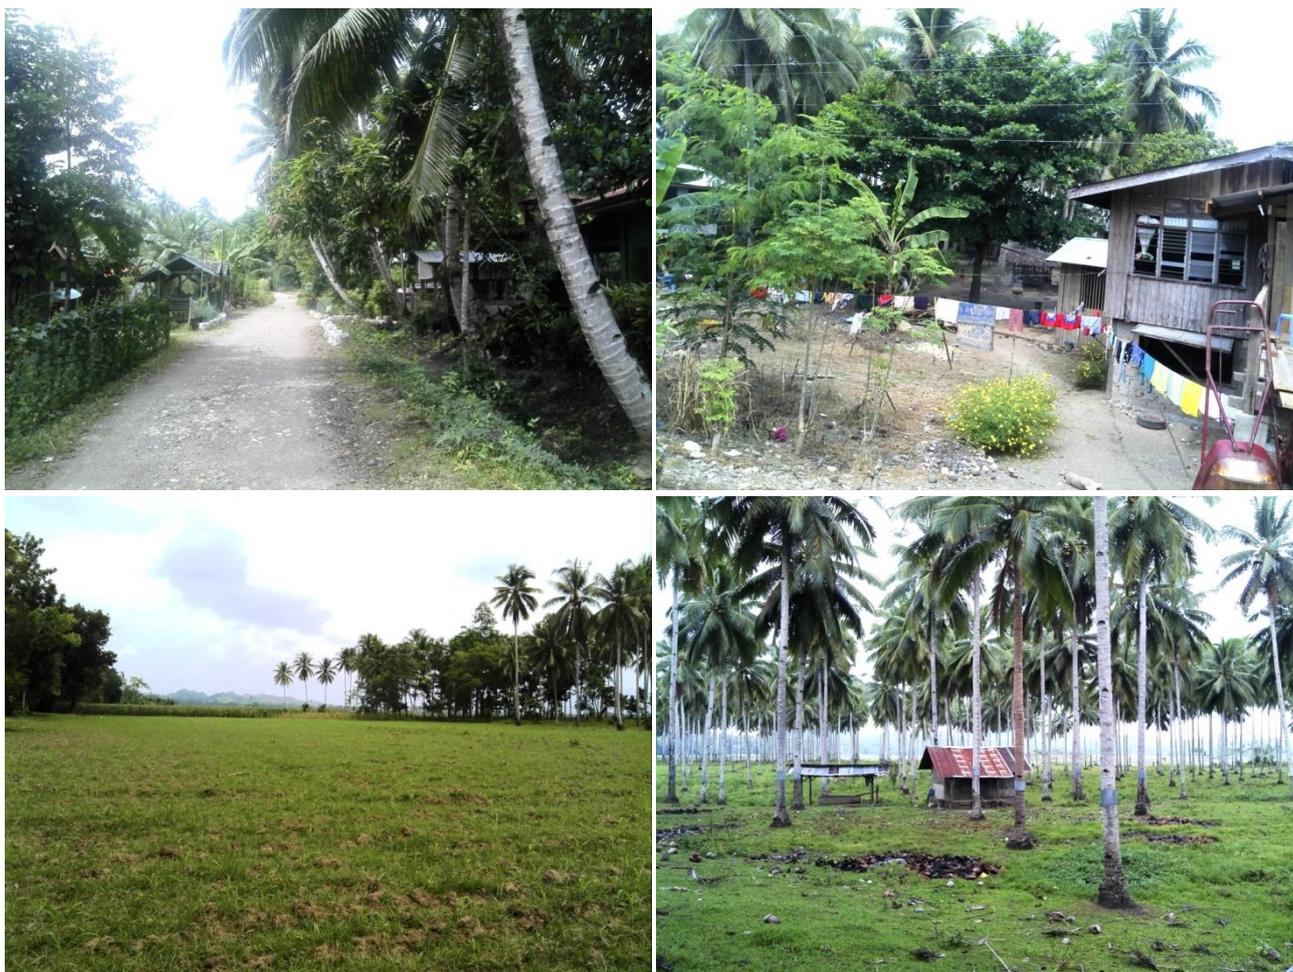
Clockwise: Residential and agricultural areas affected by sheet flooding at Purok 8, Purok 12, Purok 13, and Purok 14.

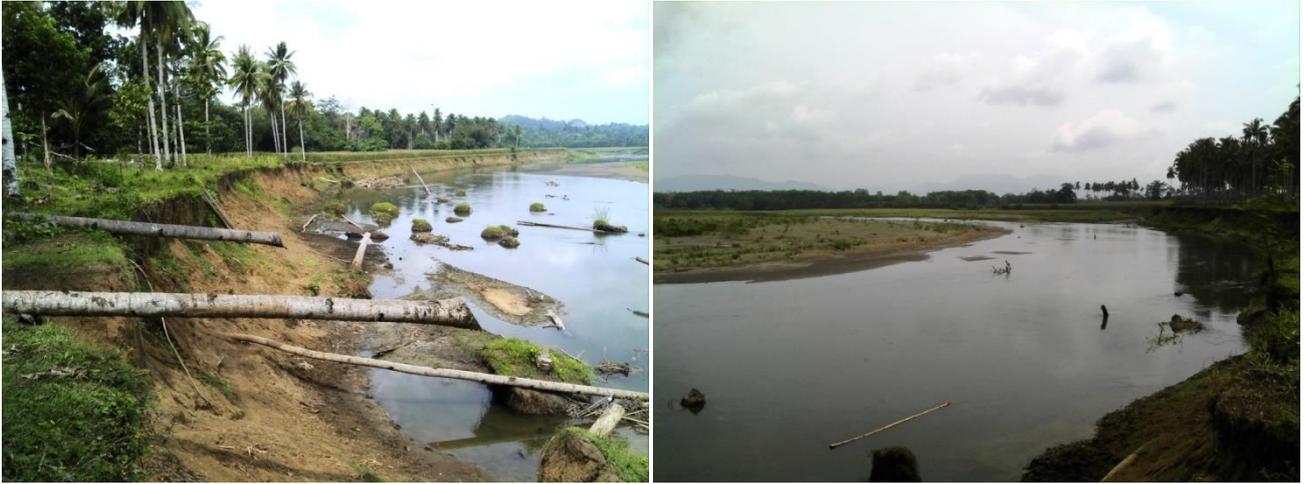
Photographs of Wawa River taken at Purok 13 (left) with notable bank erosion towards the agricultural area. Wawa River is the main source of sheet flooding in the area.

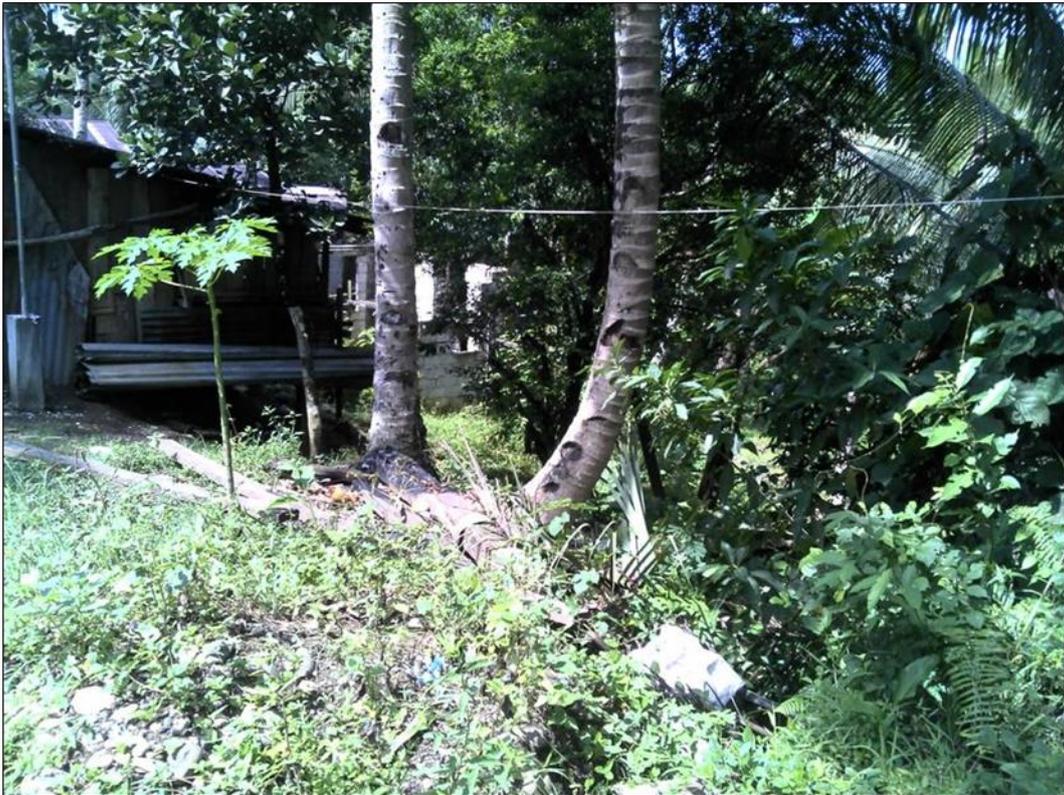
This photo shows a settlement area adjacent to a moderate-steep slopes in Purok 5 where previous landslide has occurred. Purok 5 (8° 45' 31.2" N, 125° 40' 52.2"E)

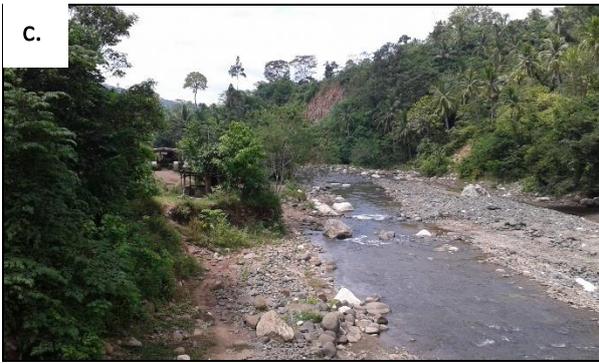
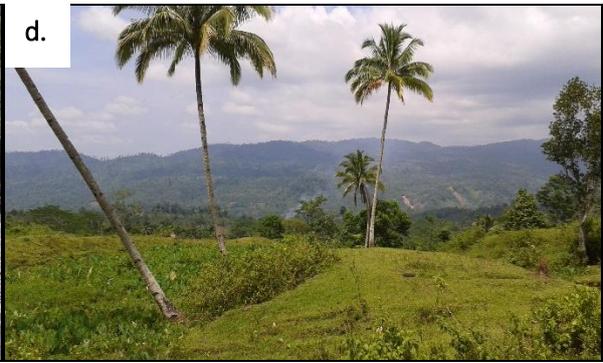
View of Andanan River (c) taken from the bridge showing portion of the residential area (left side of the Photo c). Tilted coconut trees indicating mass movement/ground instability observed in Purok 1A (d).

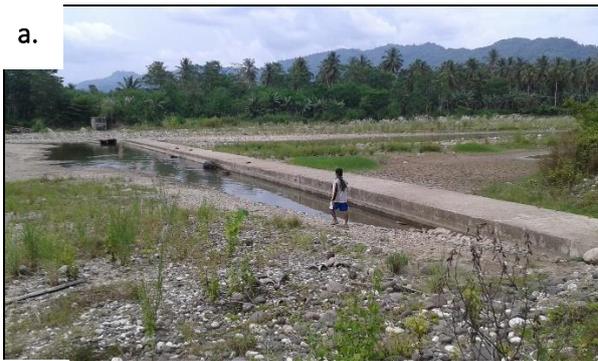
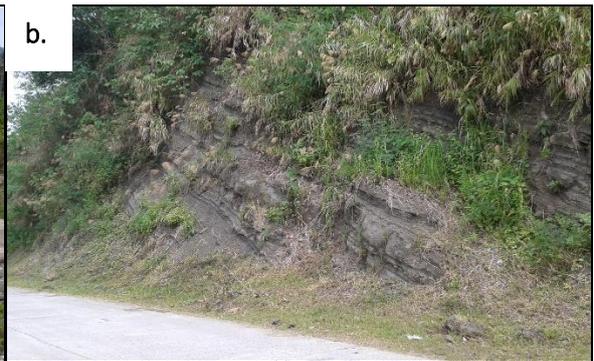
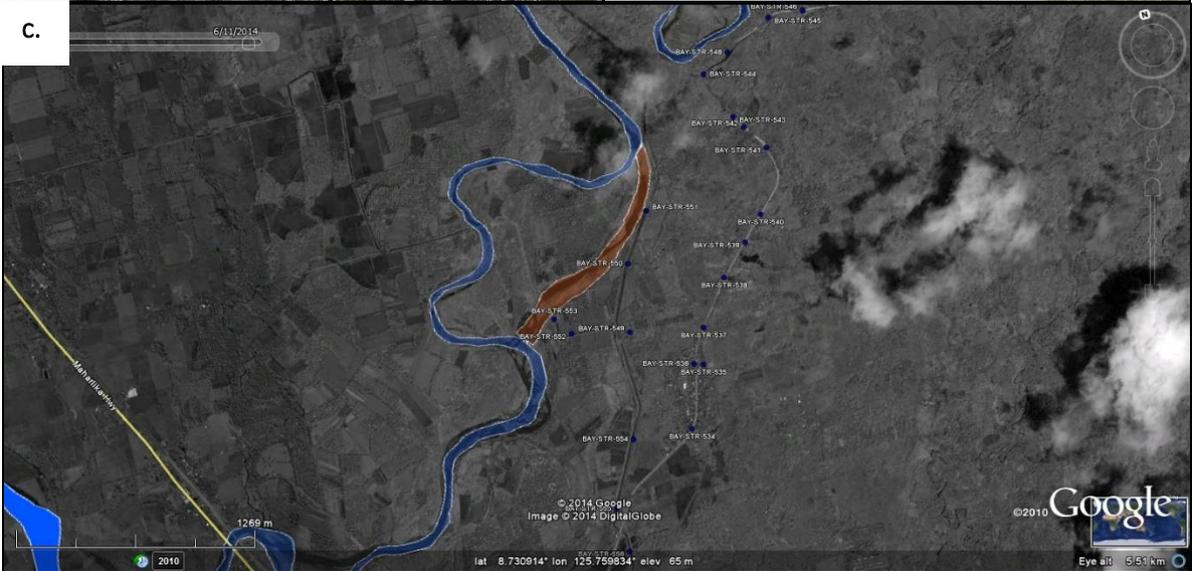
Irrigation line destroyed by flood water along Andanan River (a). Tilted sedimentary rocks exposed along provincial highway going to Barangay San Juan (b). Stream migration observed in google generated image, red polygon is the current river channel which diverted from the previous course (c.).

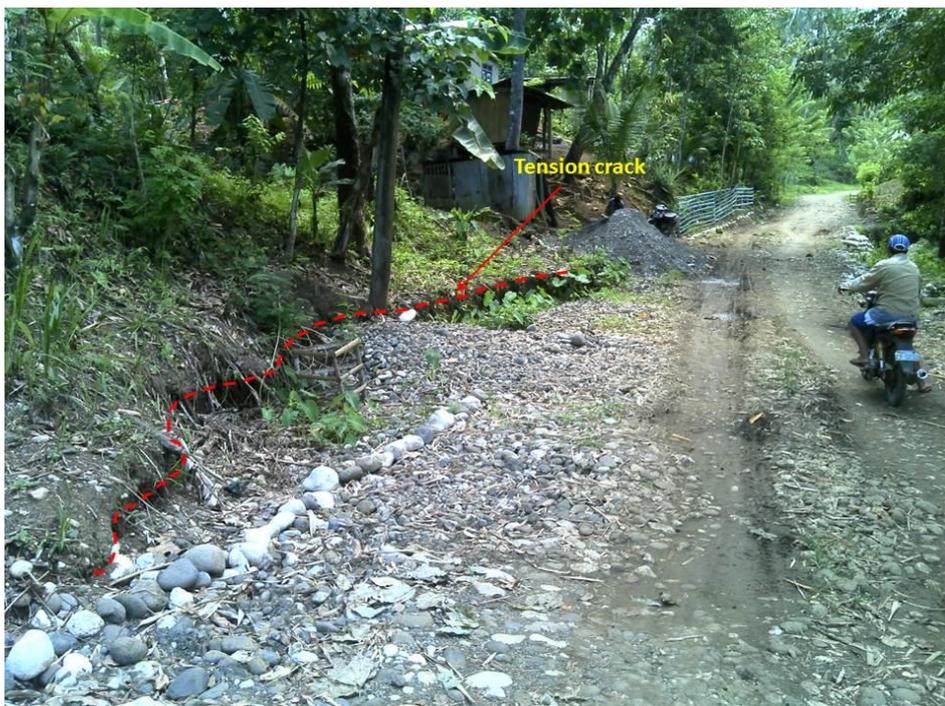
This photo shows a 20-meter long tension crack and has a vertical displacement of 0.5 to 1.5 meters. Reportedly associated with the prolonged heavy rains during typhoon Agaton. (Geographical Location: 8° 42' 3.9" N 125° 47' 11.9" E)

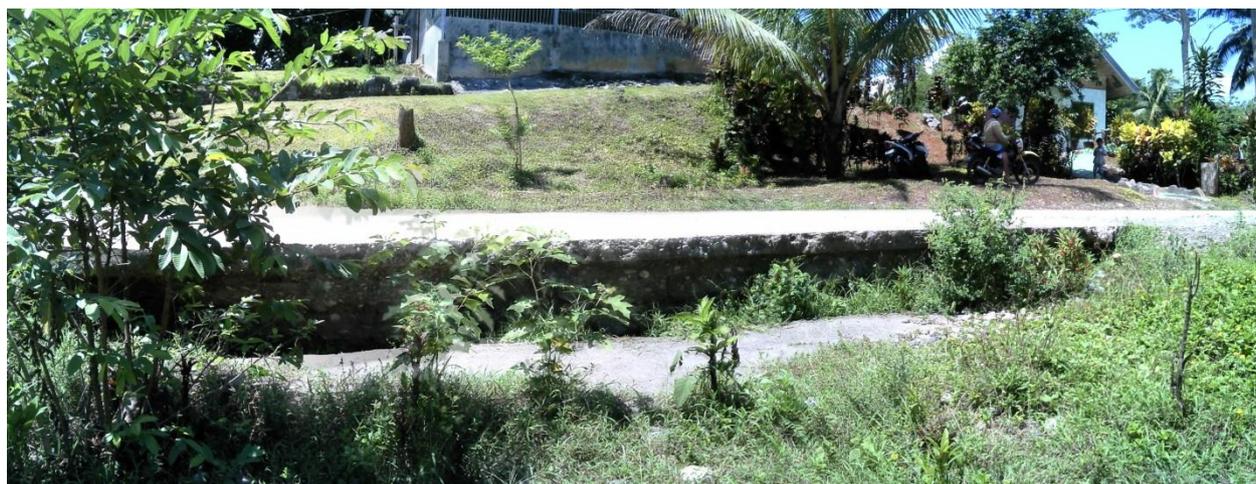
Panoramic view of a 20-meter long tension crack with vertical displacement of 1 to 1.5 meters observed along the road. (Geographical Location: 8° 42' 47.8" N 125° 46' 52.8" E)

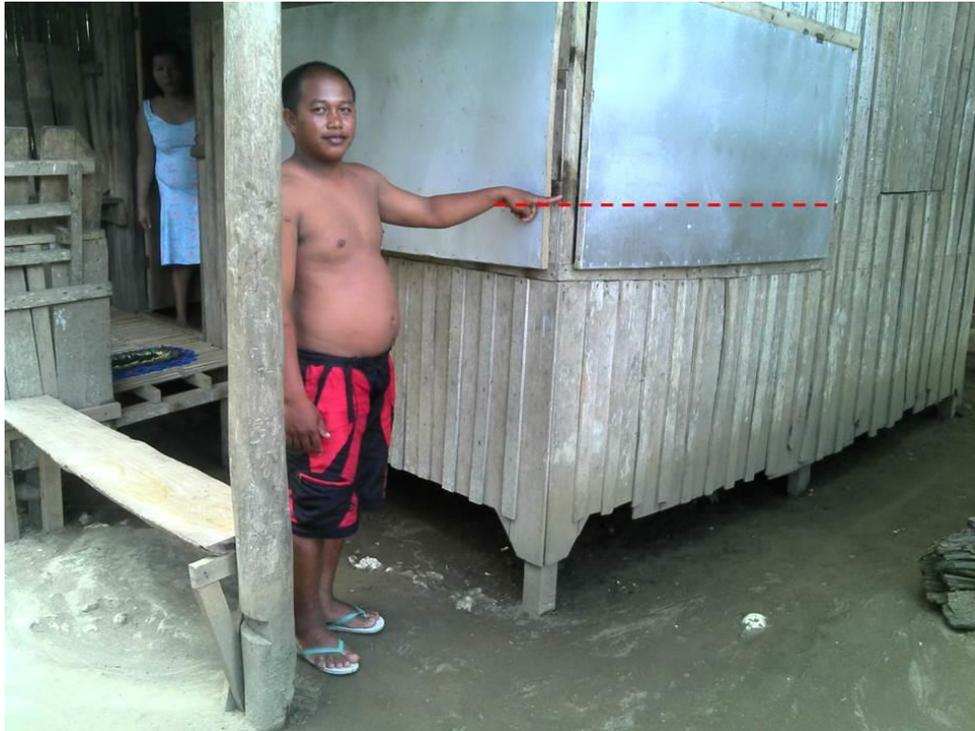
A resident of Purok 6 shows the approximate flood height of about 1 meter in his house. Residential areas near Bayugan River usually experienced flooding in the months of December to February. (Geographical Location: 8° 42' 25.2" N 125° 46' 52.7" E)

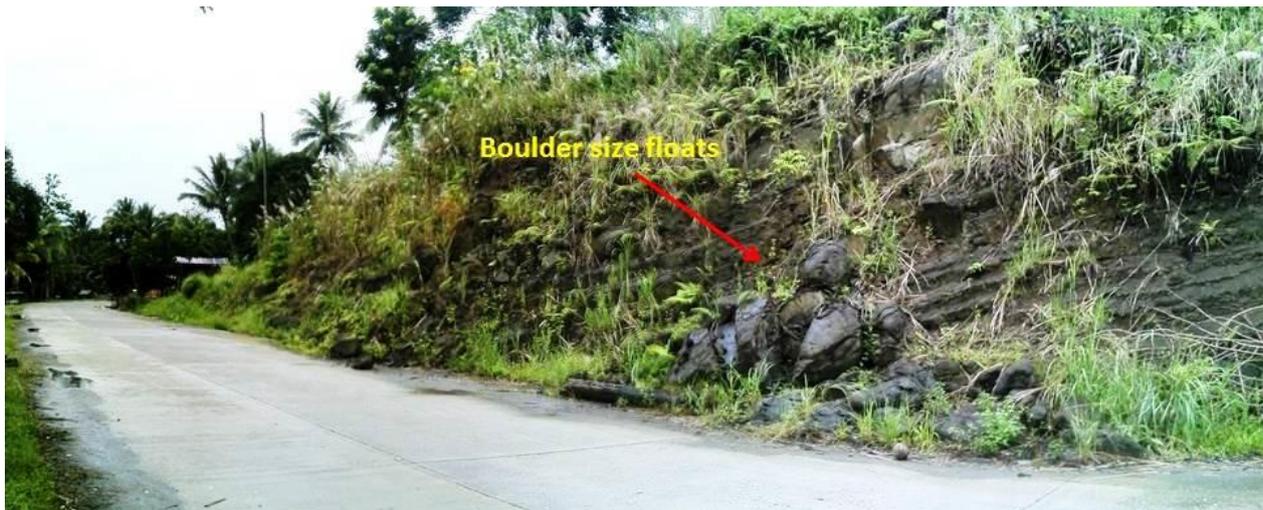
Panoramic view of the road cut along the barangay road in Purok 9. Boulder size fragments found at the base of the slope indicating slope instability. (Geographical Location: 8° 47' 47.1" N 125° 47' 31.6" E)

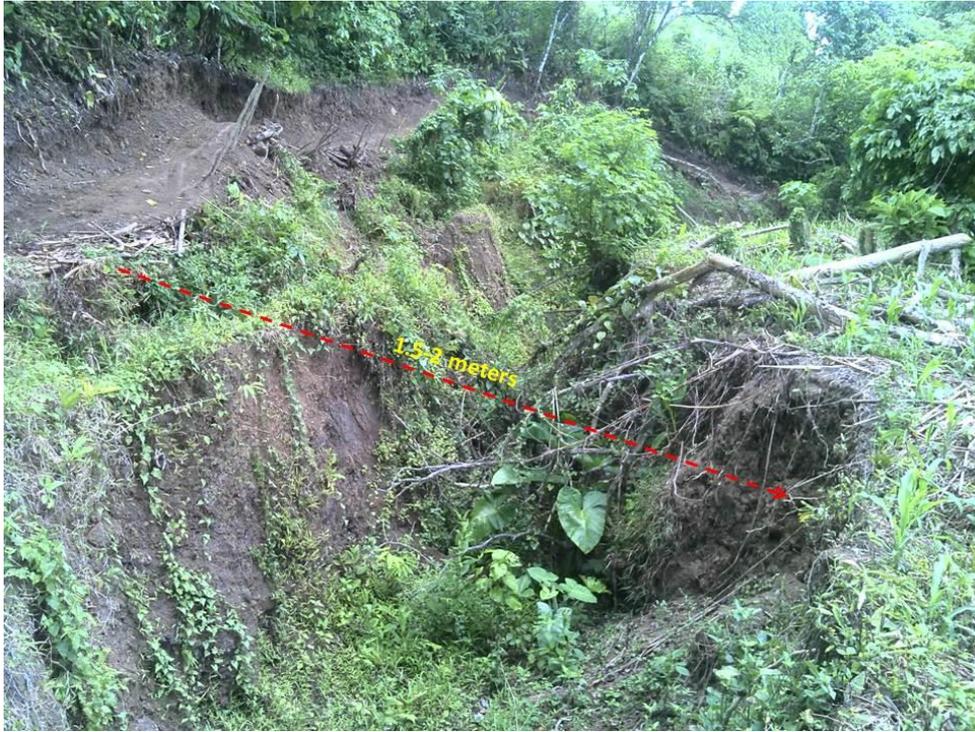
Photo of 100-meter long tension crack with horizontal displacement of 1.5 to 2 meters that dips towards the southwest. (Geographical Location: 8° 49' 56.1" N 125° 45' 50.1" E)

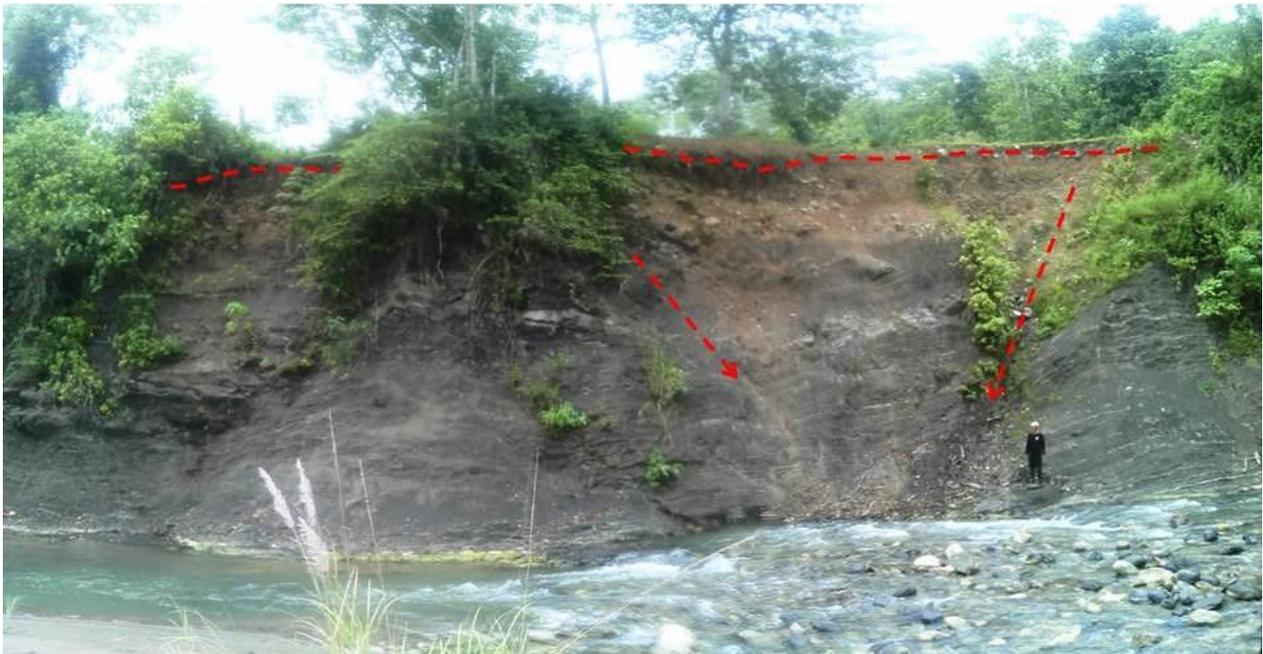
Photo of 30-meters high bank erosion along the riverbank of Andanan River underlain mainly by bedded sandstone and siltstone. (Geographical Location: 8° 49' 3.4" N 125° 46' 39.8" E)

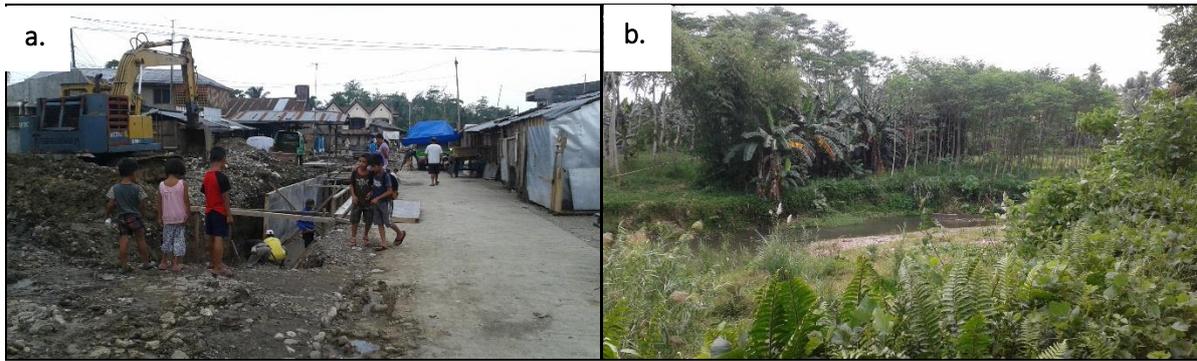
Active drainage construction along the market/commercial area (a). Segment of Bayugan River along Purok 2C where localized river bank erosion has been mapped (b).

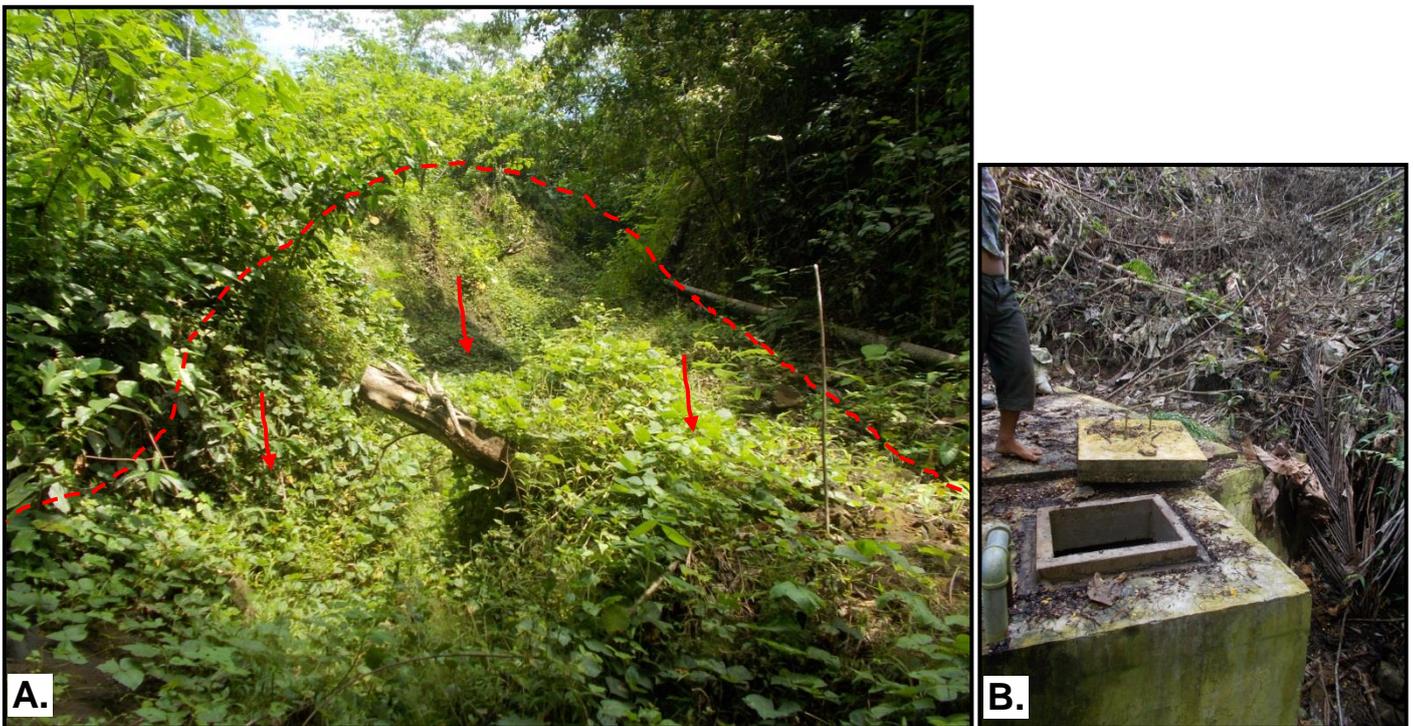
Photo A and B shows Localized landslide in Purok 1 covering the pipeline from the Barangay's water source.

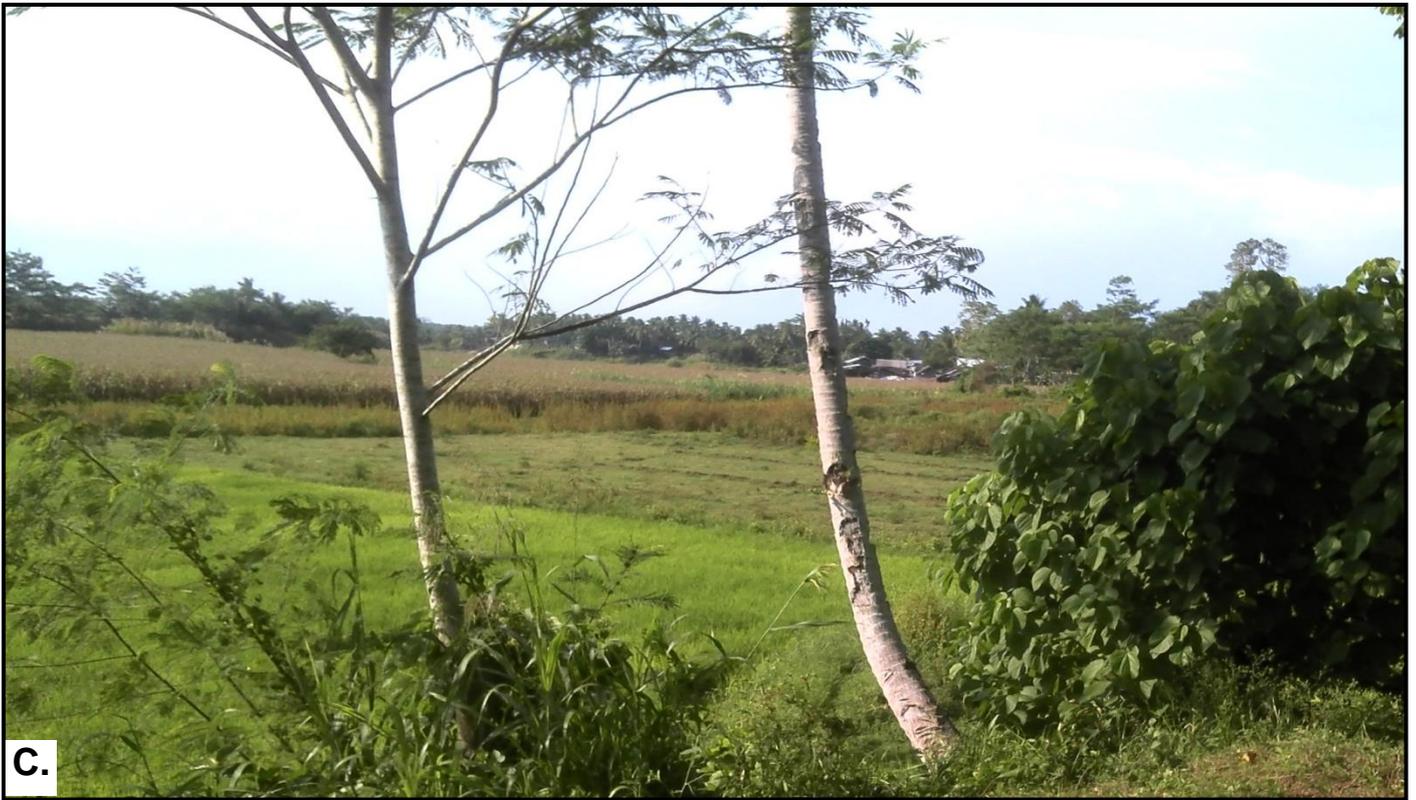
Photo C shows an agricultural area in Purok 3 that is affected by sheet flooding with depths of up to 1meter.

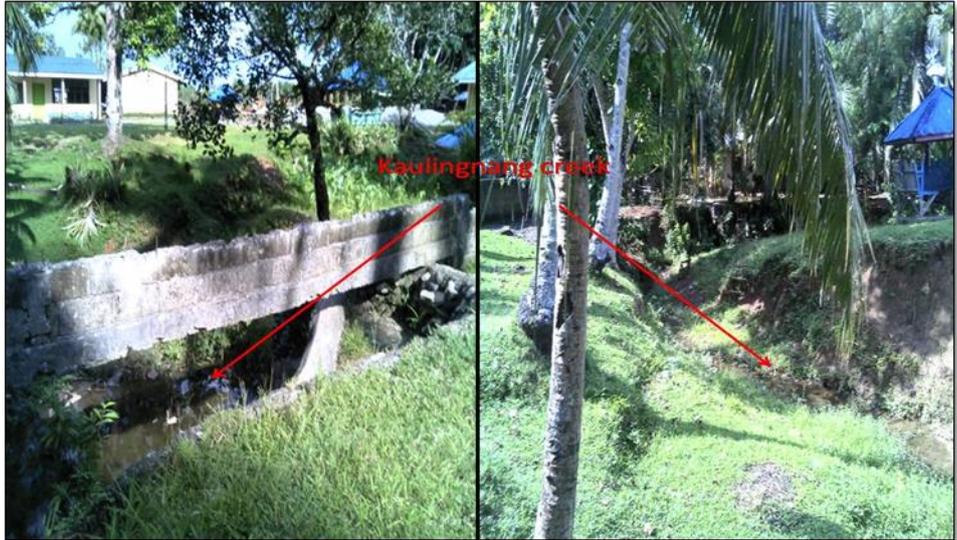
This two photo shows Kaulingnang Creek within the premises of Verdu Elementary School. Note the destroyed concrete fence associated with flood water action (left). Purok 1 (8° 43' 28.3" N, 125° 42' 16"E)

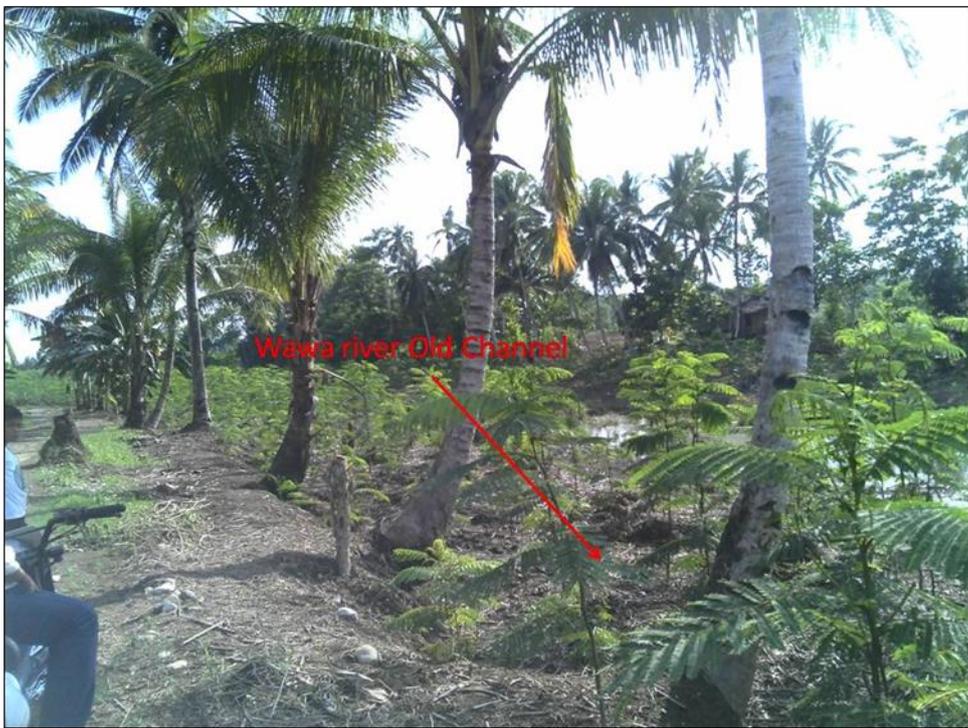
This photo shows the old channel of Wawa River which caused flooding in Puroks 4, 5, 6 and 7 including the adjacent agricultural areas.

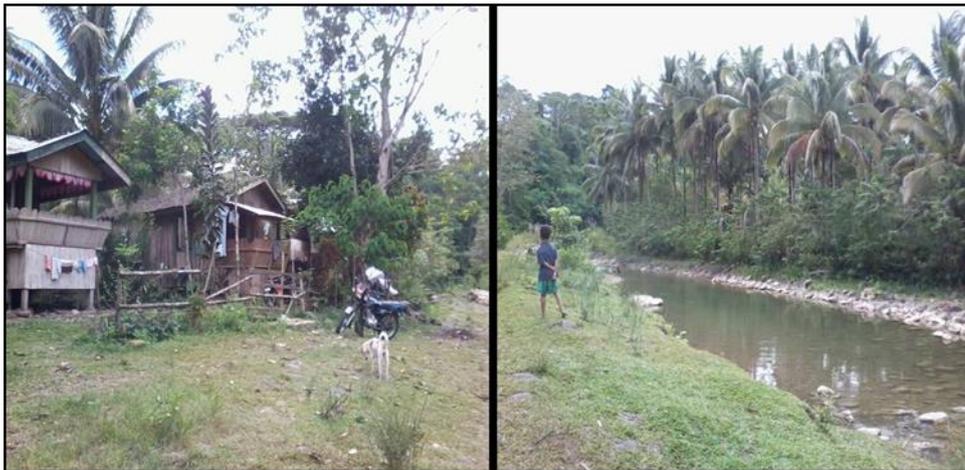
Photograph of the residential area in Purok Wakay-Wakay (left) and Sianib River (right) located near the where flooding is associated. Purok Wakay Wakay (8° 43' 48.5" N, 125° 51' 25.4"E).

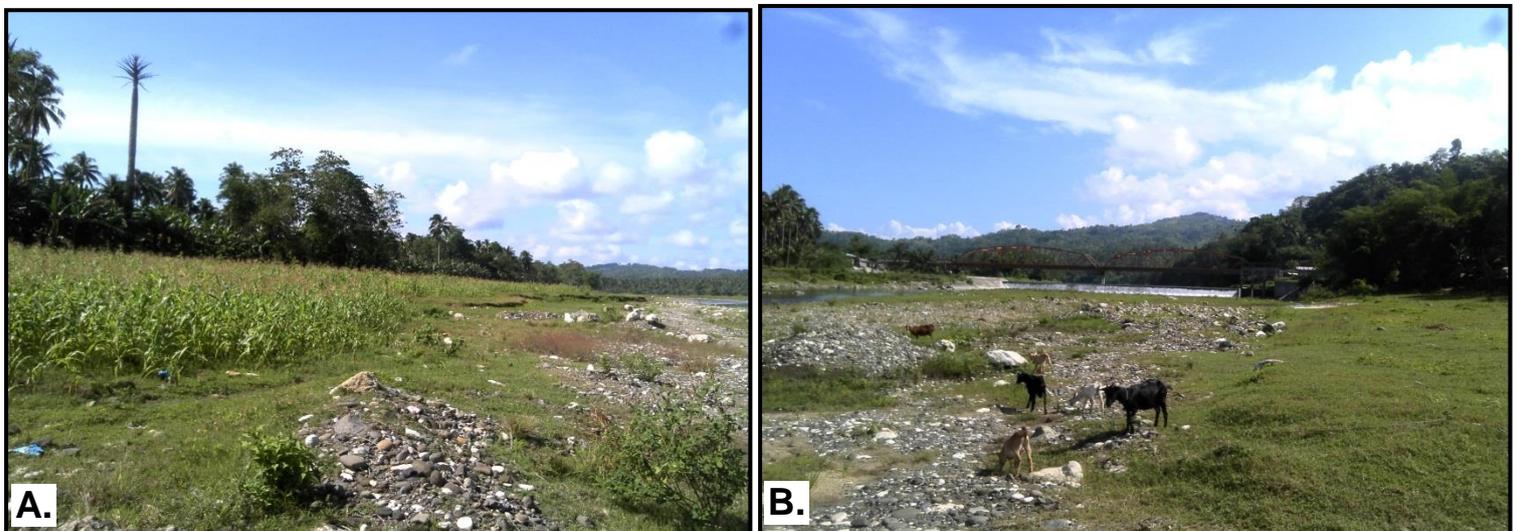
Photo (A and B) Shows the floodplain of Wawa River.
