REPORT ON THE 1:10,000 SCALE GEOHAZARDS ASSESSMENT AND MAPPING OF ESPERANZA, AGUSAN DEL SUR

OCTOBER 2014

REPORT ON THE 1:10,000 SCALE GEOHAZARDS (LANDSLIDE AND FLOODING) ASSESSMENT AND MAPPING OF ESPERANZA, AGUSAN DEL SUR

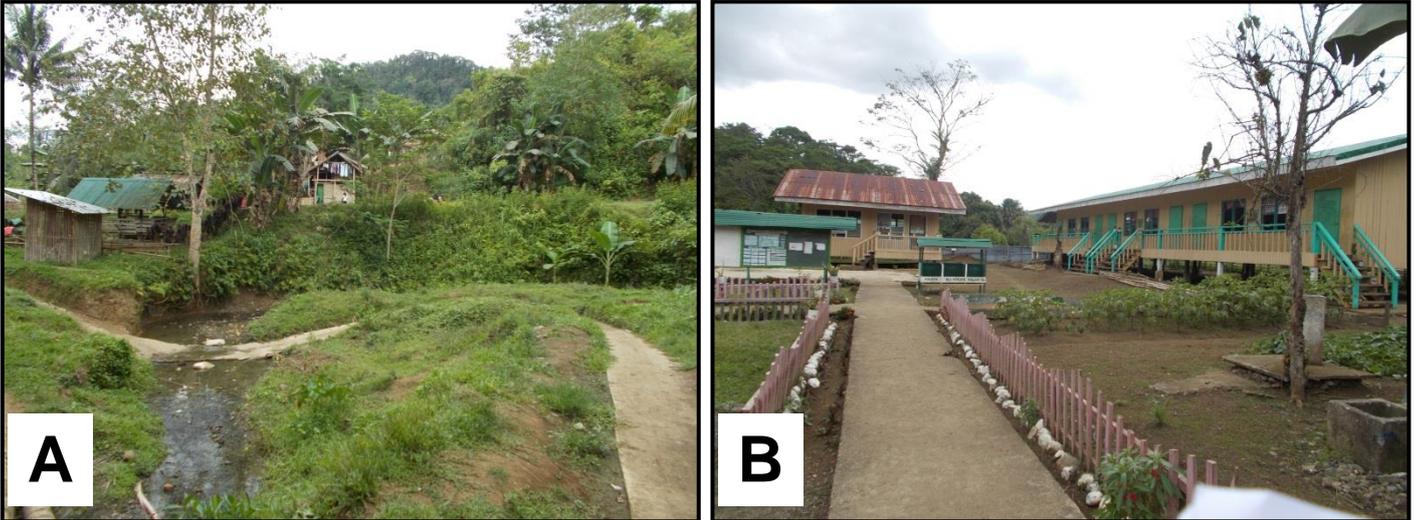
(A) Afga creek inundates the area during persistent rain. (B) Aqsabu Elementary School is relatively on a higher elevation thus flooding in the area is minimal. Most of the flooding in the barangay is situated near Aqsabu River and Afga Creek.

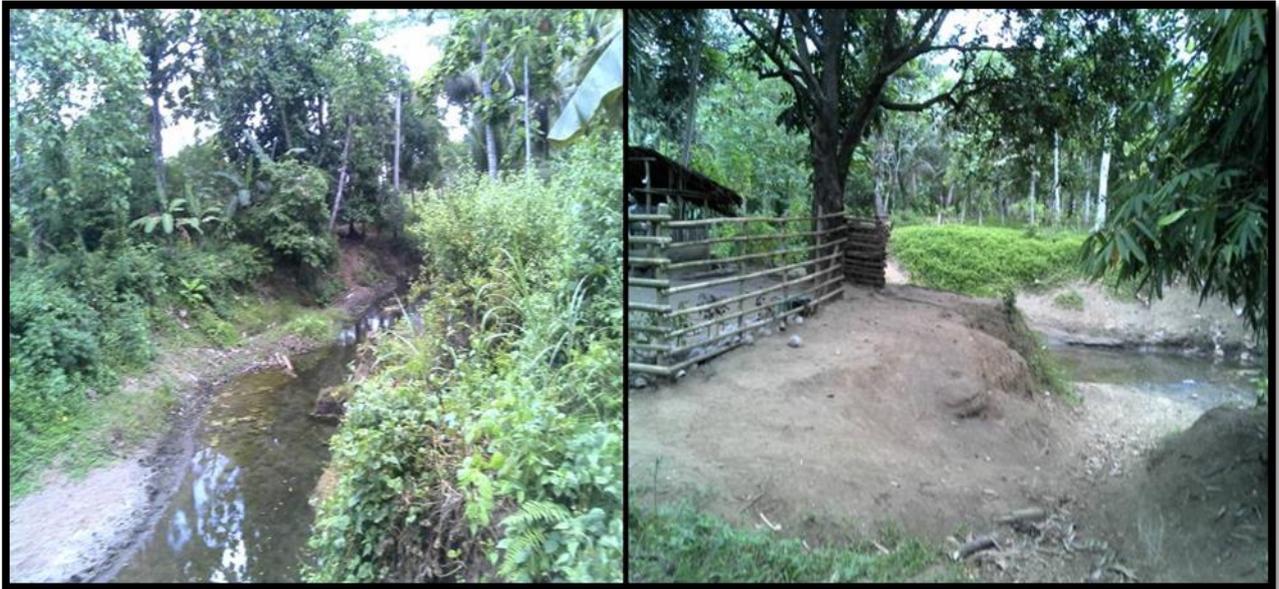
Purok 2 (8° 37' 34.4" N, 125° 44' 4.8" E) A photos of Maasin River where most of the flooding in Purok 1, Purok 2 and the Agriland of Barangay Aguinaldo is associated.

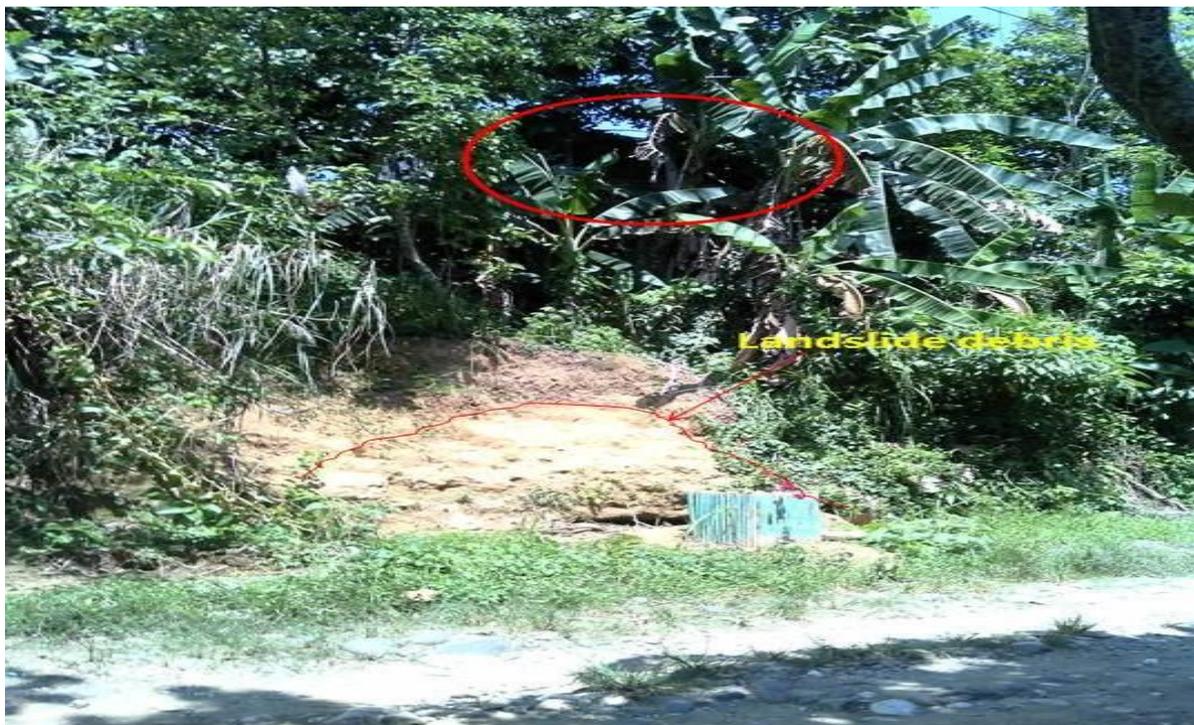
Photo on top, is a house situated on a steep slope. Shallow debris slide is also observed at the base of the slope. (Geographical Location: 8° 36' 46.7" N 125° 46' 21.2" E)

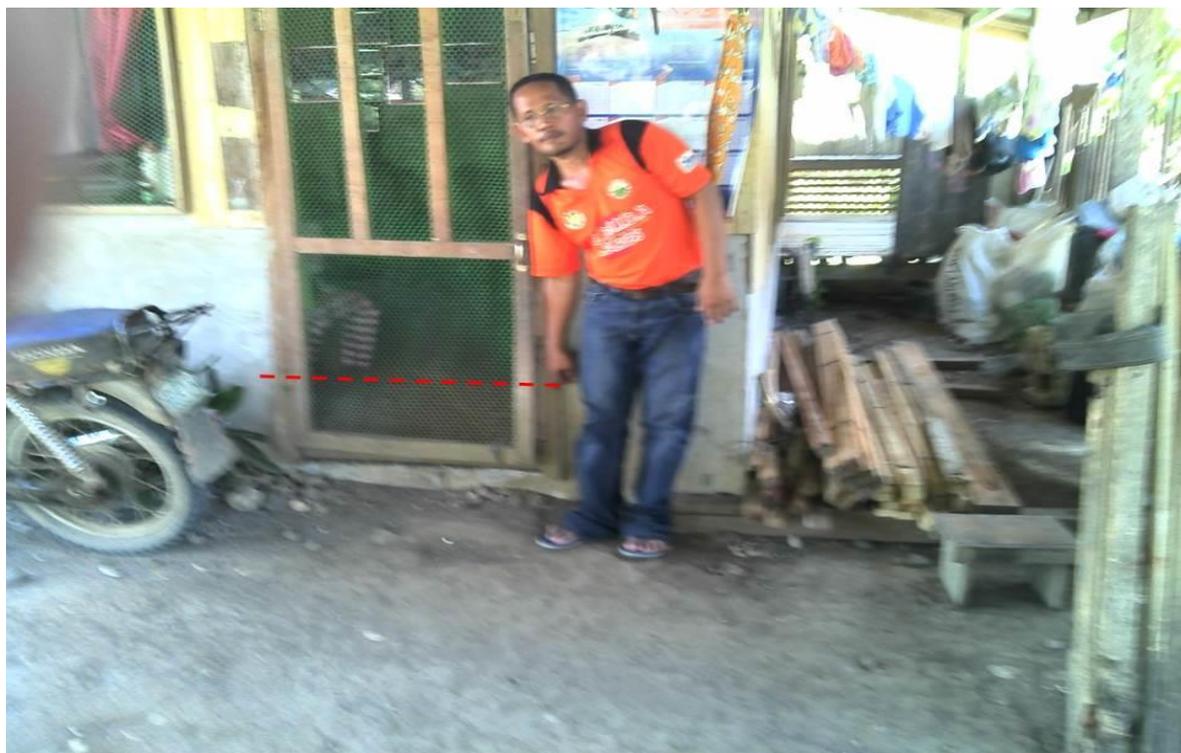
A barangay official shows the flood height of approximately 0.5 meter which lasted for almost a week during typhoon Agaton. (Geographical Location: 8° 36' 52" N 125° 46' 32.5" E)

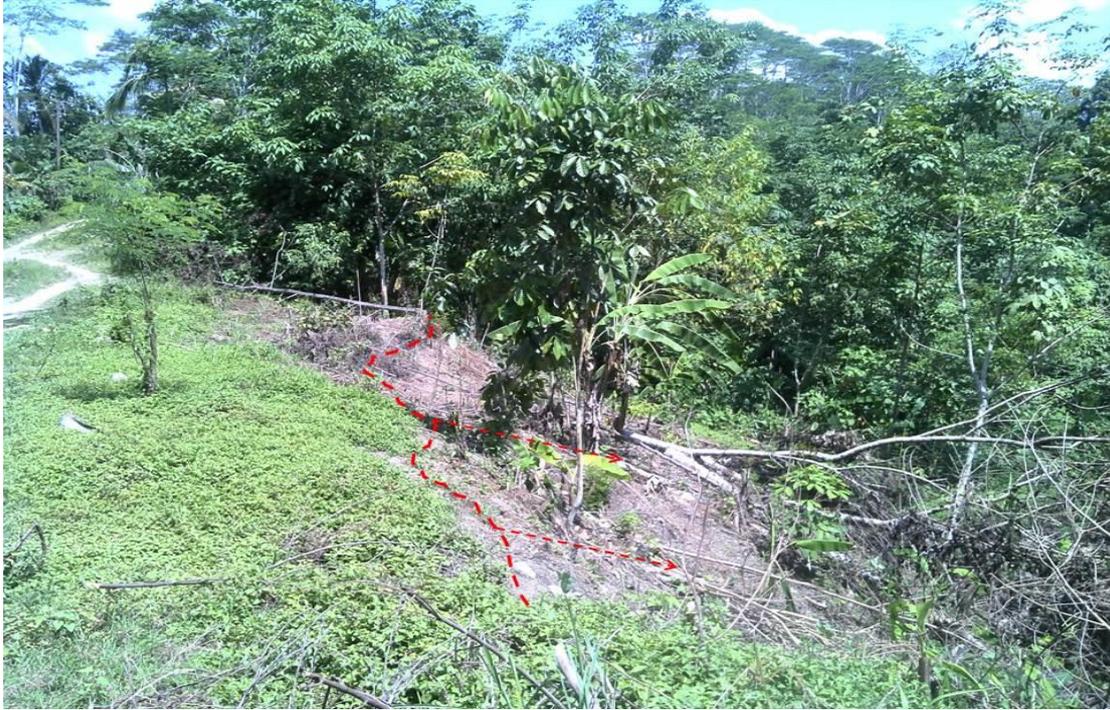
An active landslide along the barangay road in Purok 6 associated with the prolonged heavy rains during typhoon Agaton. (Geographical Location: 8° 35' 28.8" N 125° 46' 30" E)

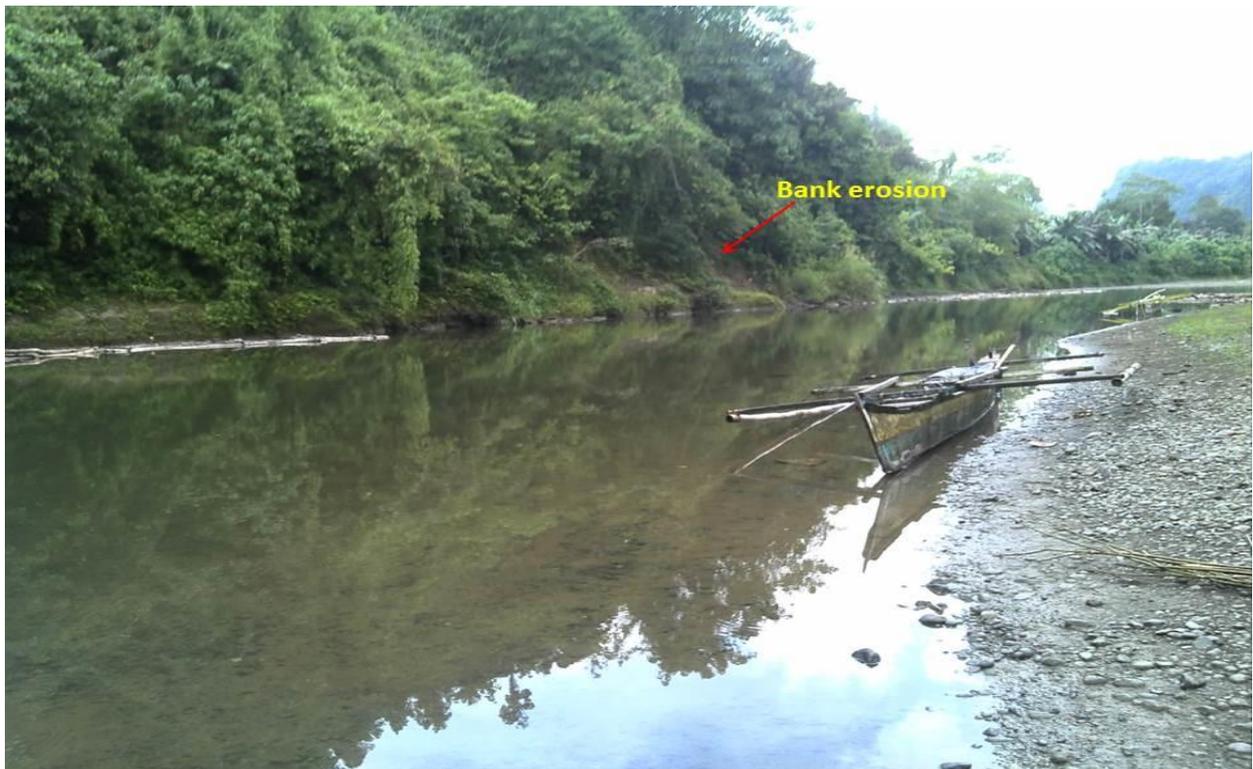
View of Ujot River which serves as their main access to Barangay Bakingking. Active bank erosion is also observed in the outer bend of the meander. (Geographical Location: 8° 40' 52.3" N 125° 31' 27.7" E)

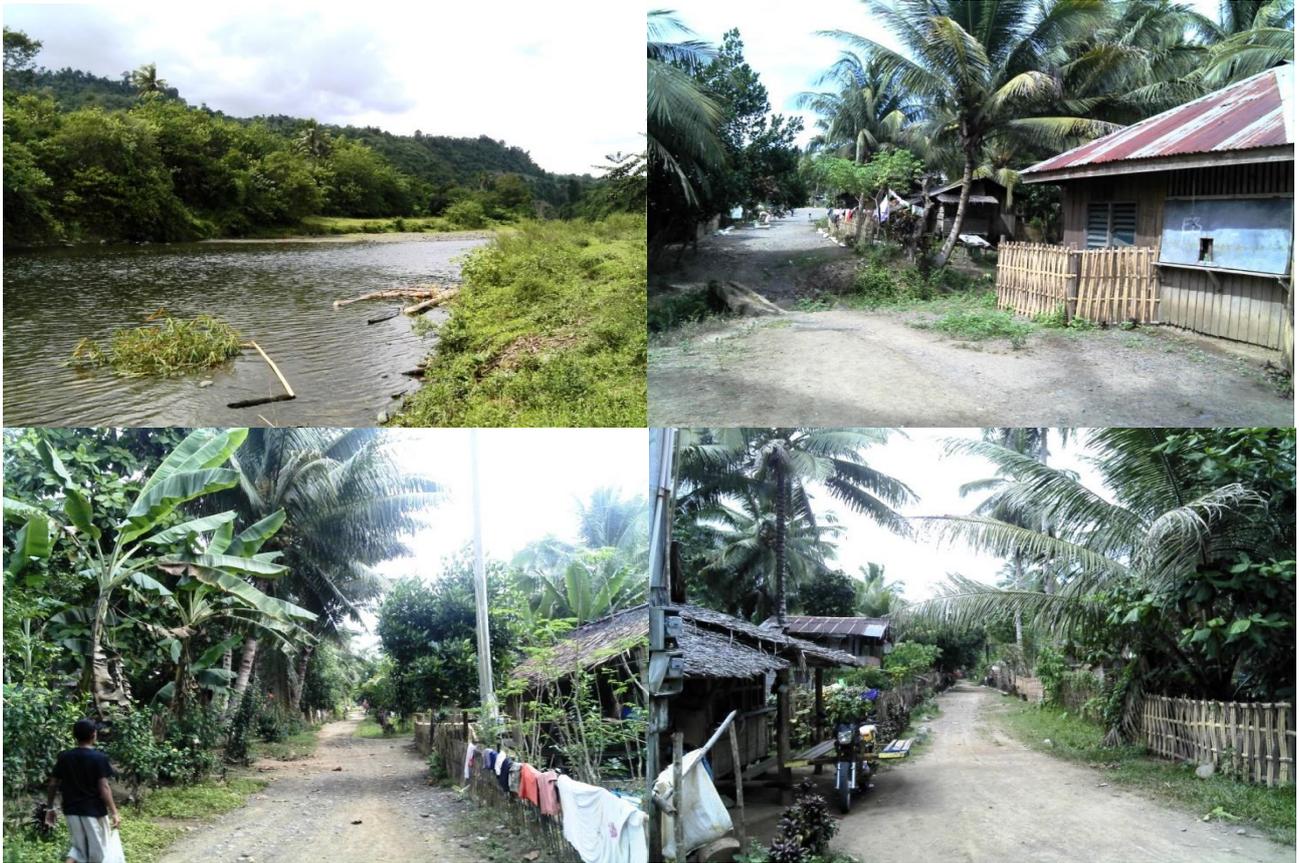
Clockwise: View of Ohot River taken from Purok 1. River overflow caused sheet flooding at Purok 1, Purok 2 and Purok 3.

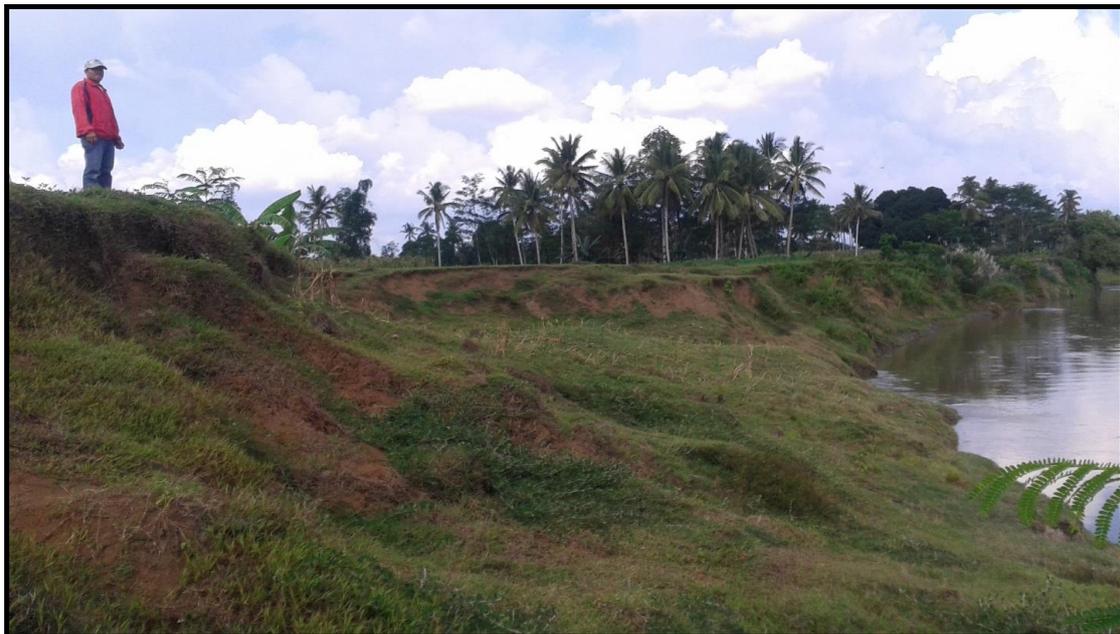
Wawa River, Purok 2. Very High. Photo showing upstream of Wawa River. Point taken along the meander bend of the River. Flood reaches up to 2.1 meters during Typhoon Agaton. Bank erosion is active. GPS Coordinates: 125° 40' 43.3"E 8° 41' 1" N

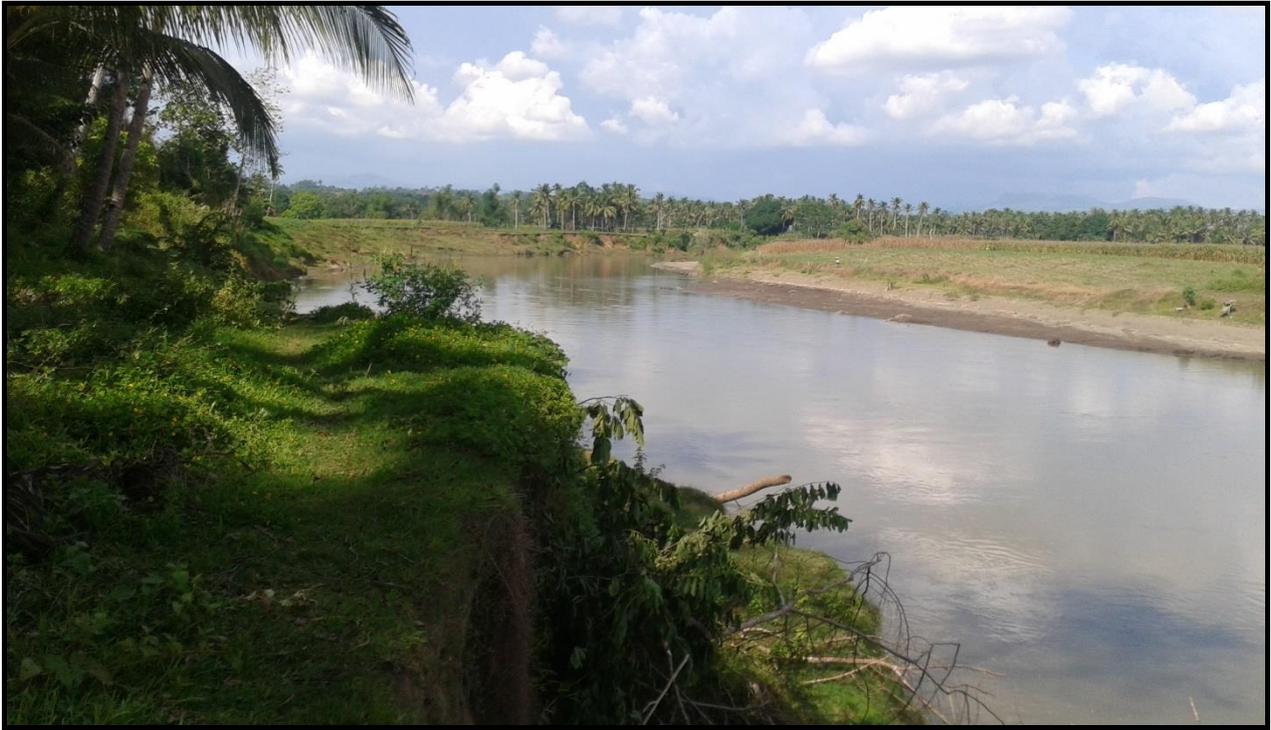
Wawa River, Purok 1-B. Photo showing Wawa River. This river is frequently flooded and Typhoon Agaton registered the highest flood water. Wawa River is approximately 40 meters wide with a bank height of about 8 meters high. It was reported that the river channel migrates once every 3 years. GPS Coordinates: 125° 40' 38.8"E 8° 40' 51.8" N

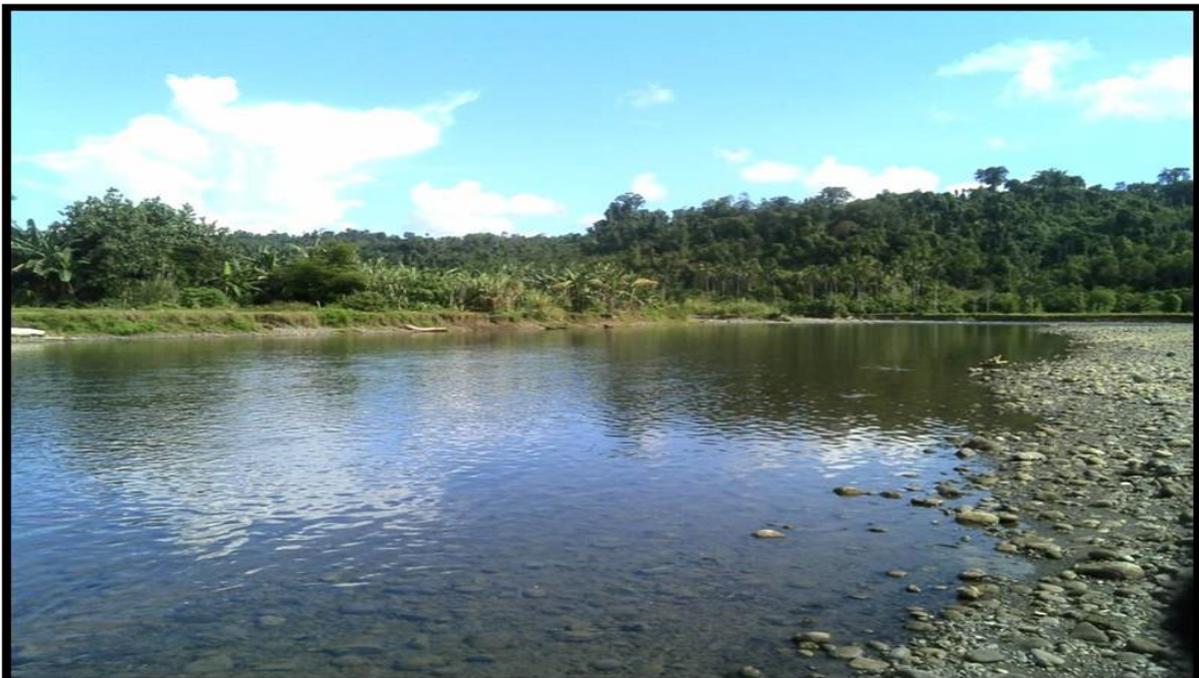
Purok 2 (8° 36' 51.1" N 125° 28' 39" E) The photo above is the Posilaw River showing the portion with active bank erosion.

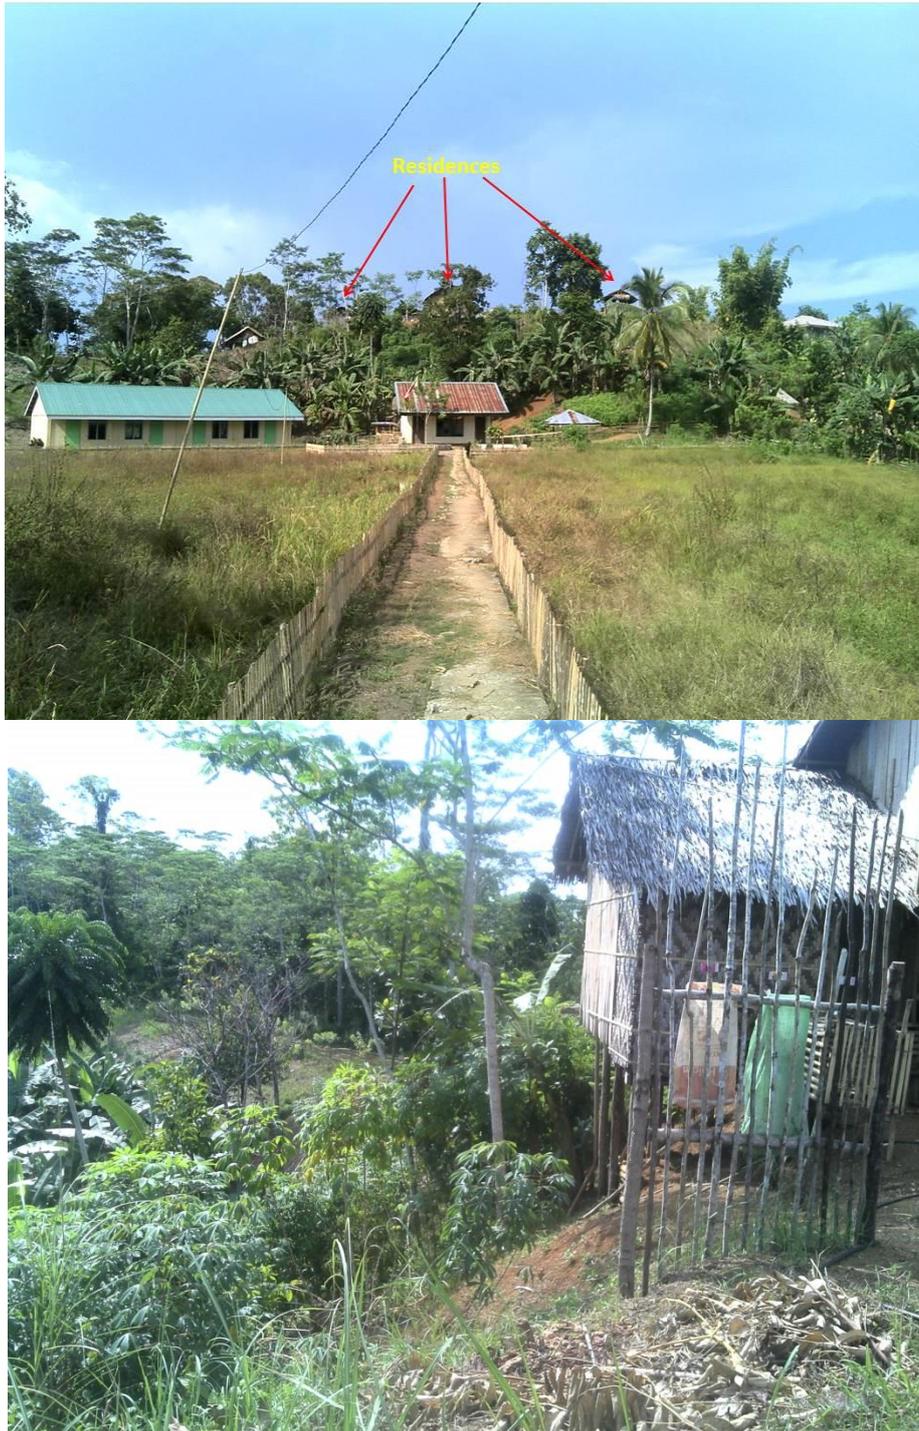
Photo on top is a distal view of the residential area that are situated on top of a 15-meter steep slope. Below is a close-up view of one of the houses. (Geographical Location: 8° 37' 48.4" N 125° 45' 42.2" E)

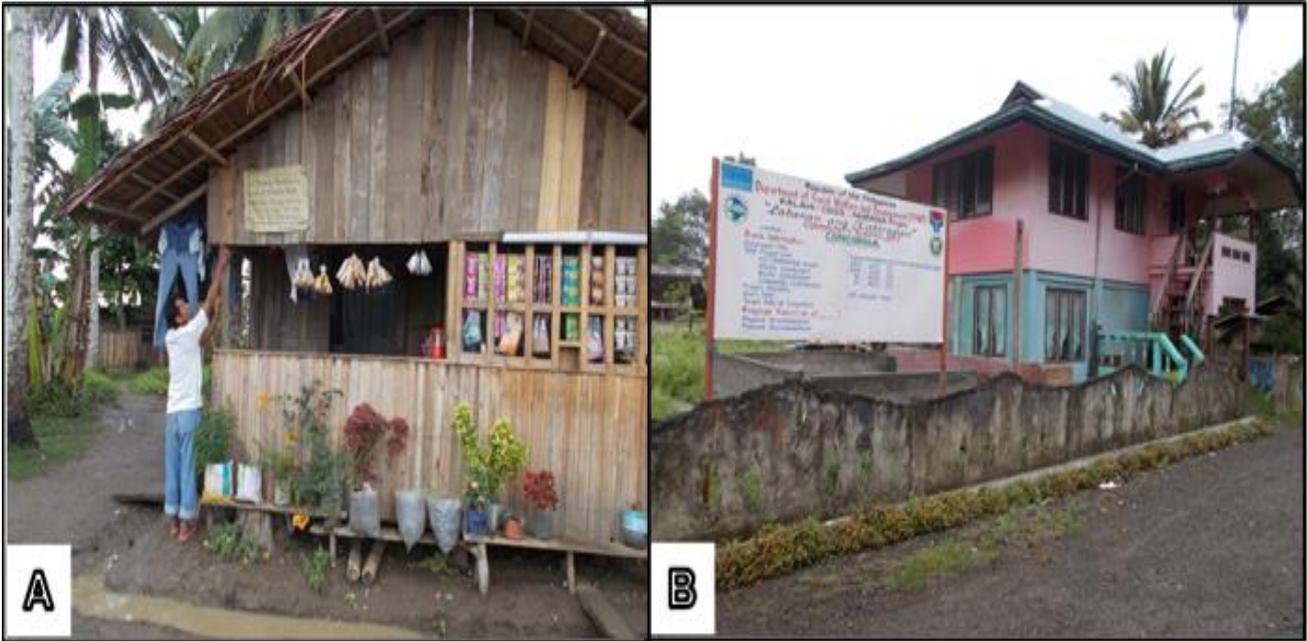
Photo (A) A resident showing the flood depth in his house during one of the recorded overflows of the Agusan River. (B) The worst recorded flooding near the Barangay office was on 1982. Flood depth reached up to 1.0m in the area.

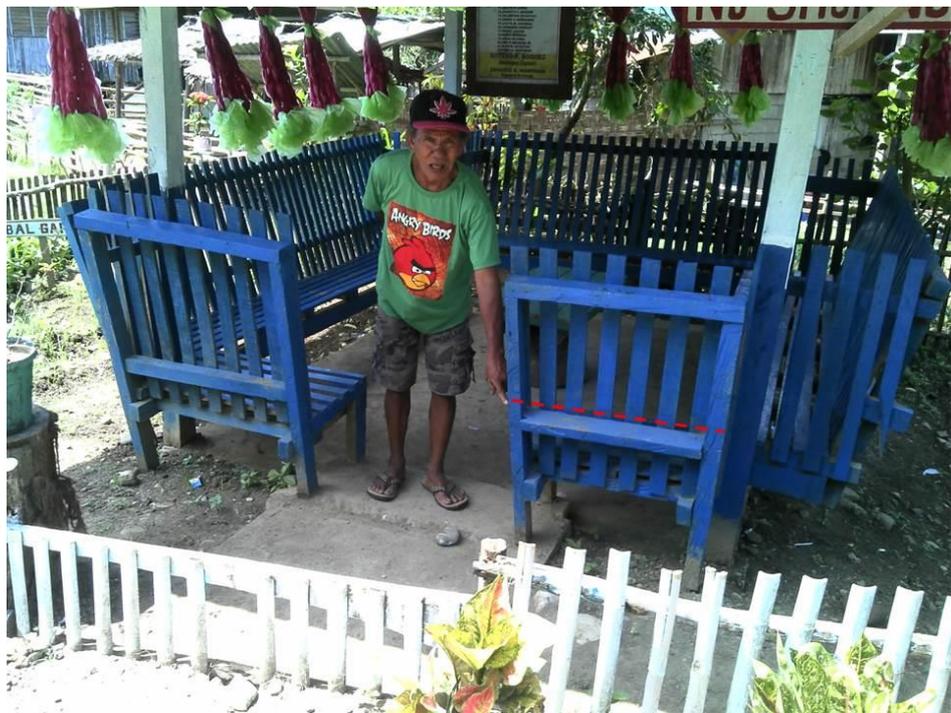
A barangay official points at the approximate flood height of 0.6 meters in Purok 4 waiting shed which lasts for 9 days. (Geographical Location: 8° 41' 38" N 125° 39' 3.9" E)

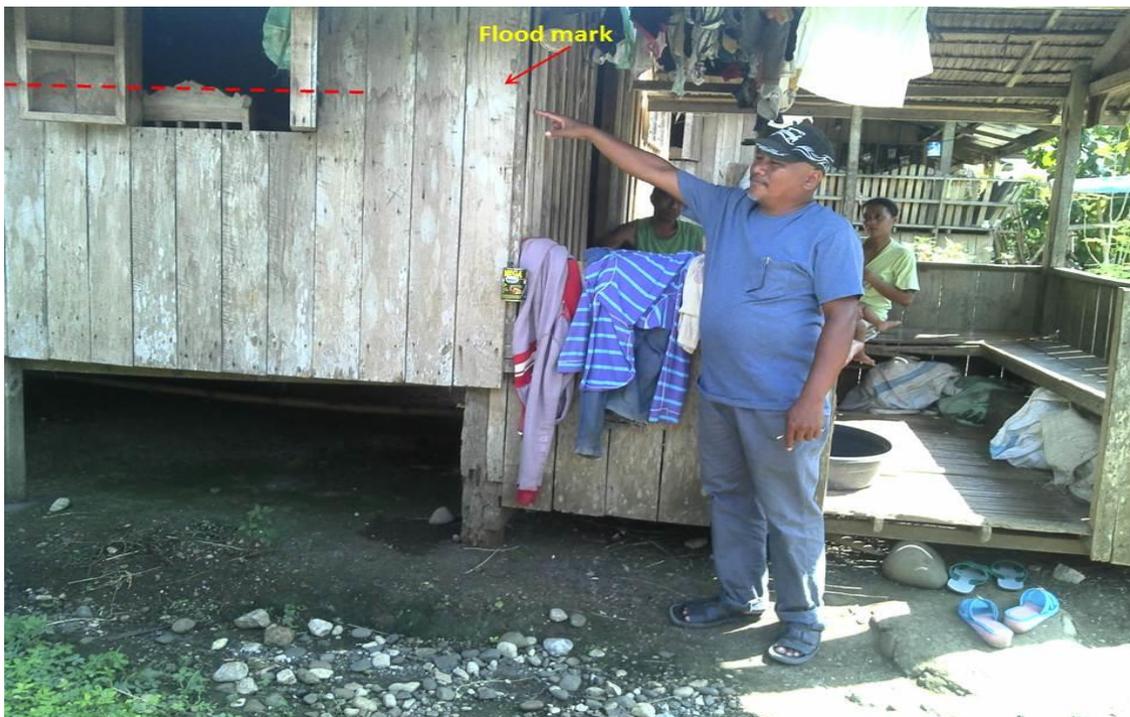
A barangay official shows the flood height of 1.7 meters which lasted for two weeks during typhoon Agaton.
(Geographical Location: 8° 38' 35.7" N 125° 41' 7.6" E)

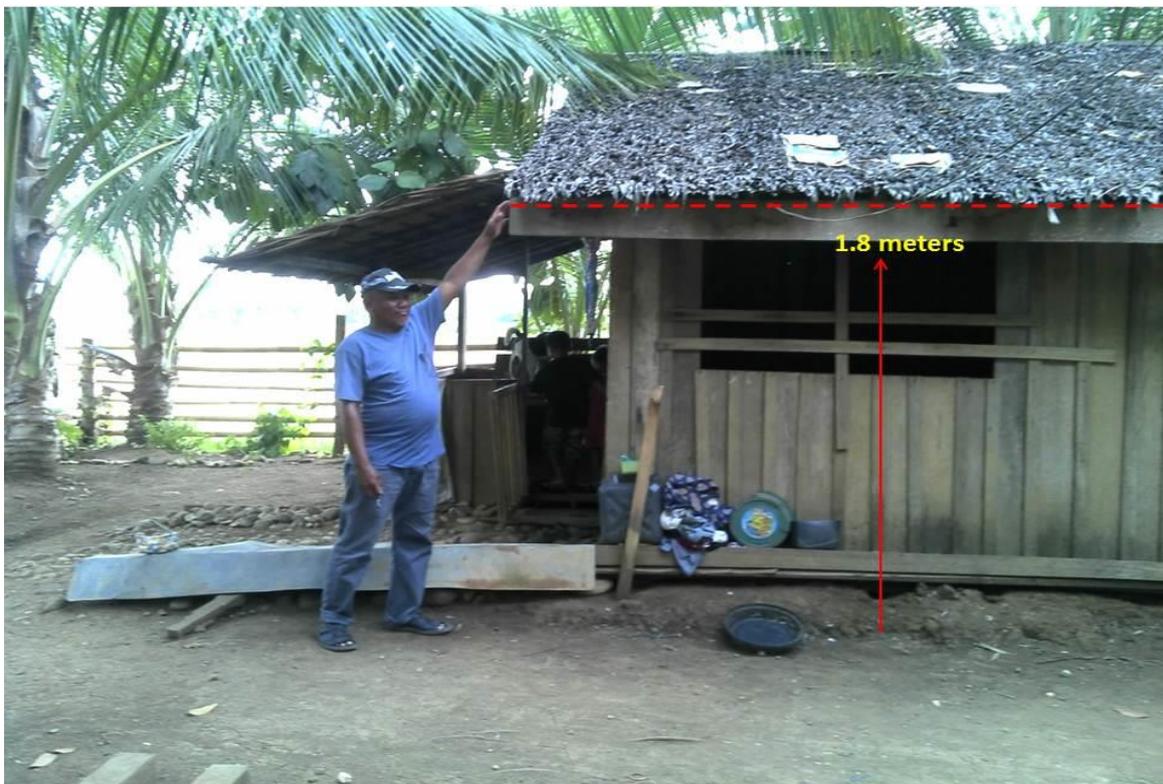
A barangay official shows the flood height of 1.8 meters which lasted for two weeks during typhoon Agaton.
(Geographical Location: 8° 38' 47.7" N 125° 40' 23.8" E)

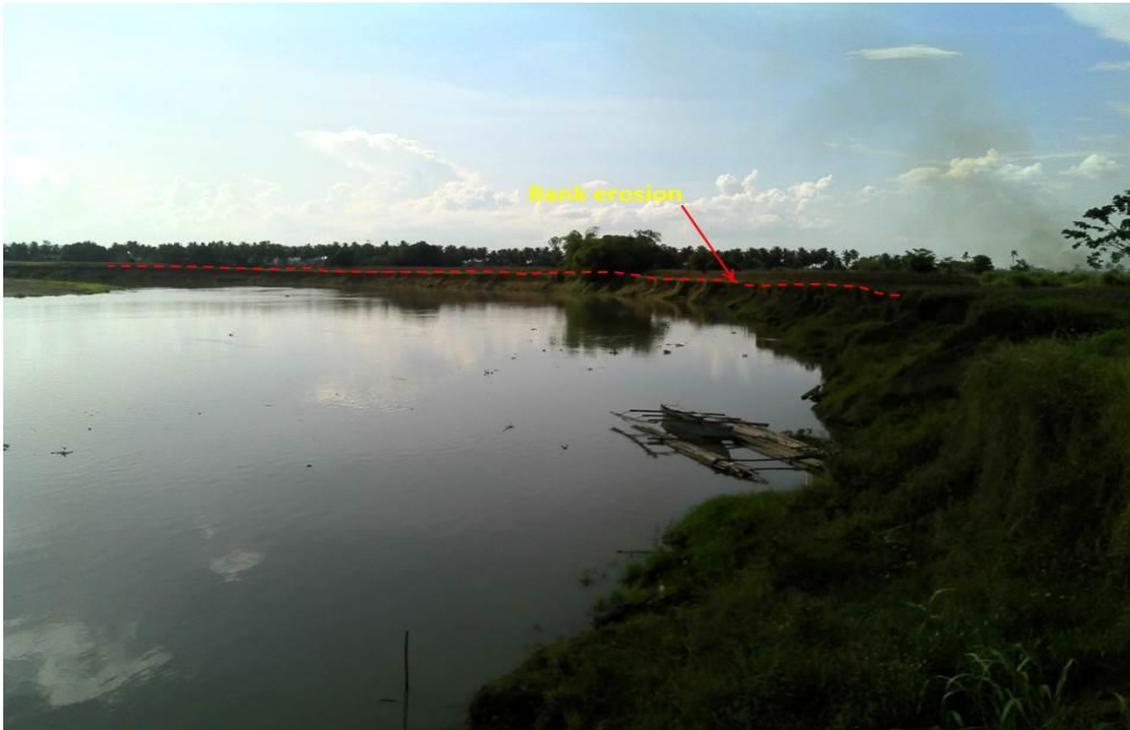
This picture shows severe bank erosion along Agusan River bank. (Geographical Location: 8° 38' 47.1" N 125° 40' 23.8" E)

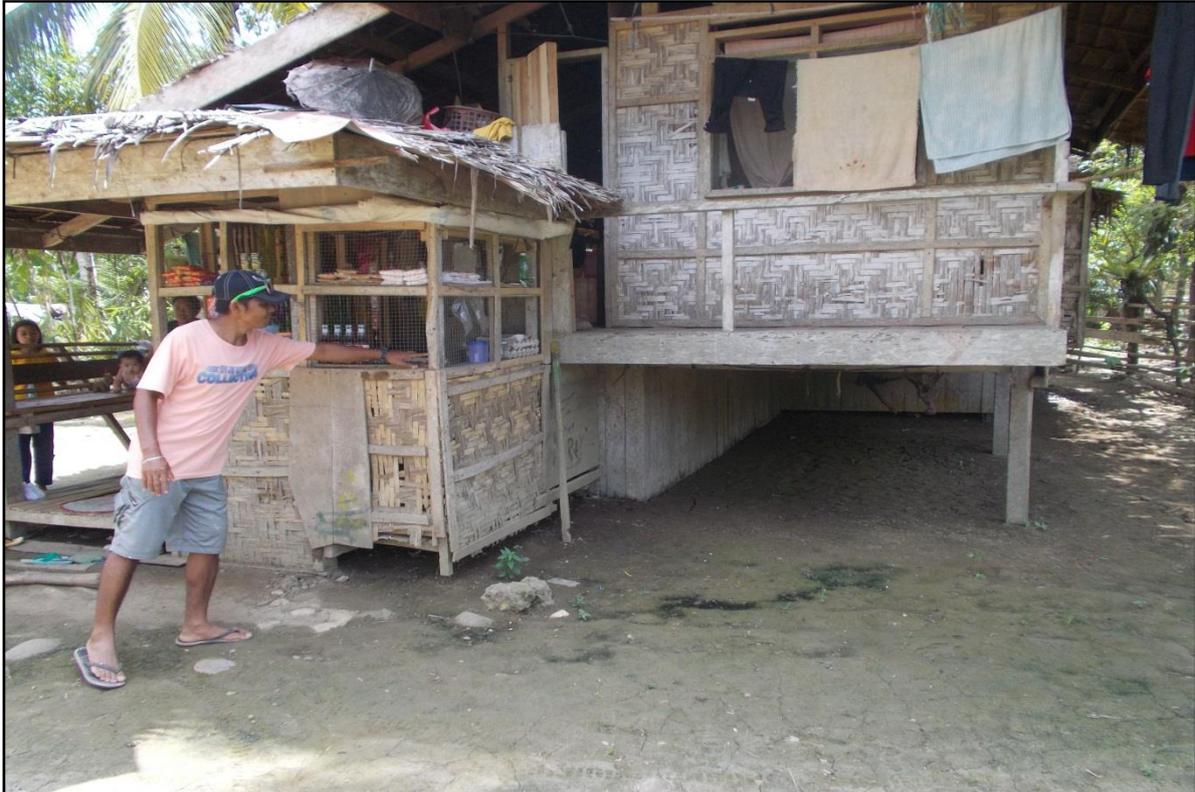
Barangay Kagawad pointing to the approximate flood depth during intense rain at Purok 7.

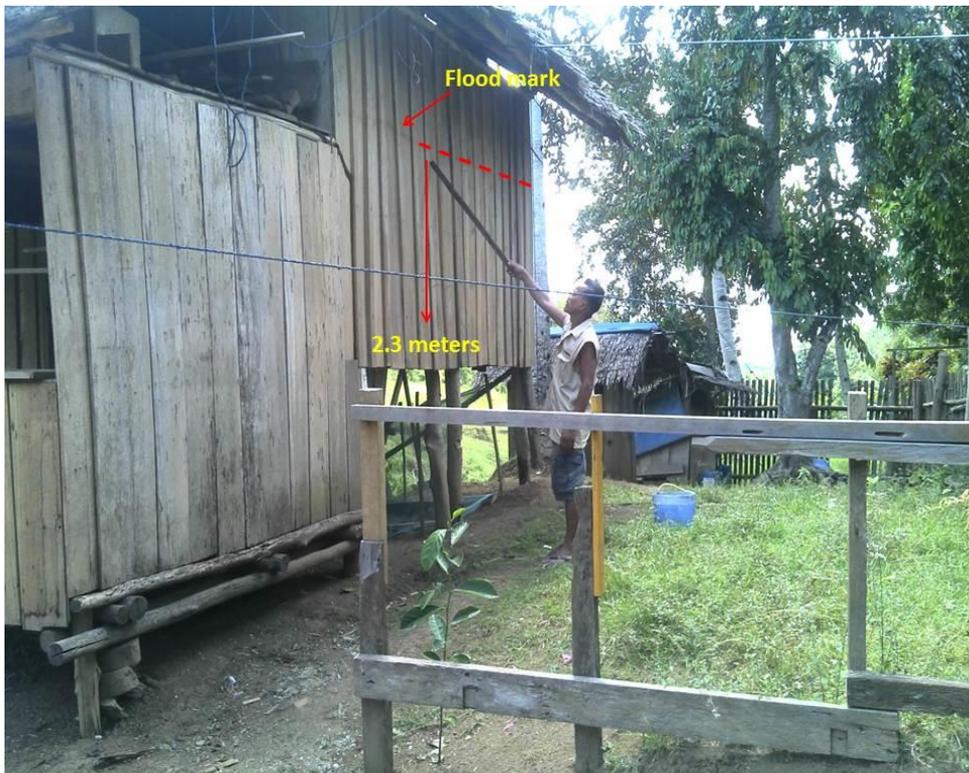
A barangay official points the approximate flood height of about 2.3 meters in one of the residences in Purok 3. (Geographical Location: 8° 40' 18.8" N 125° 38' 14" E)

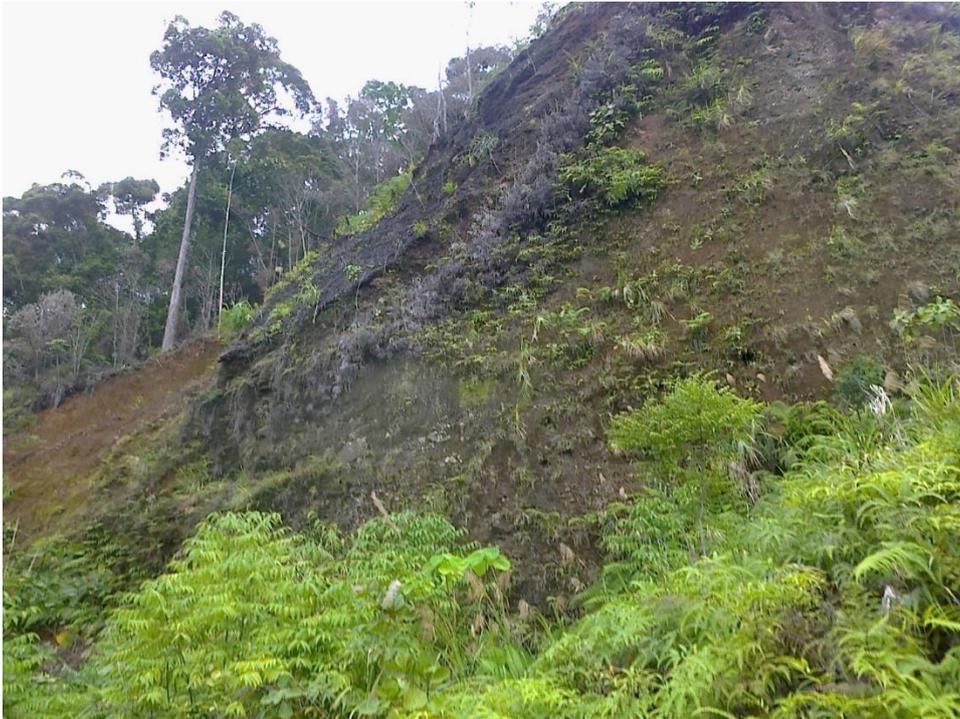
Both sides are bounded by very steep slopes approximately 80M high. A thick layer of loose soil materials was observed along with several indications of mass movement such as tilted trees and soil creep. At Purok 2 with GPS location: 8° 36' 51.9" N/125° 21' 5.1" E.

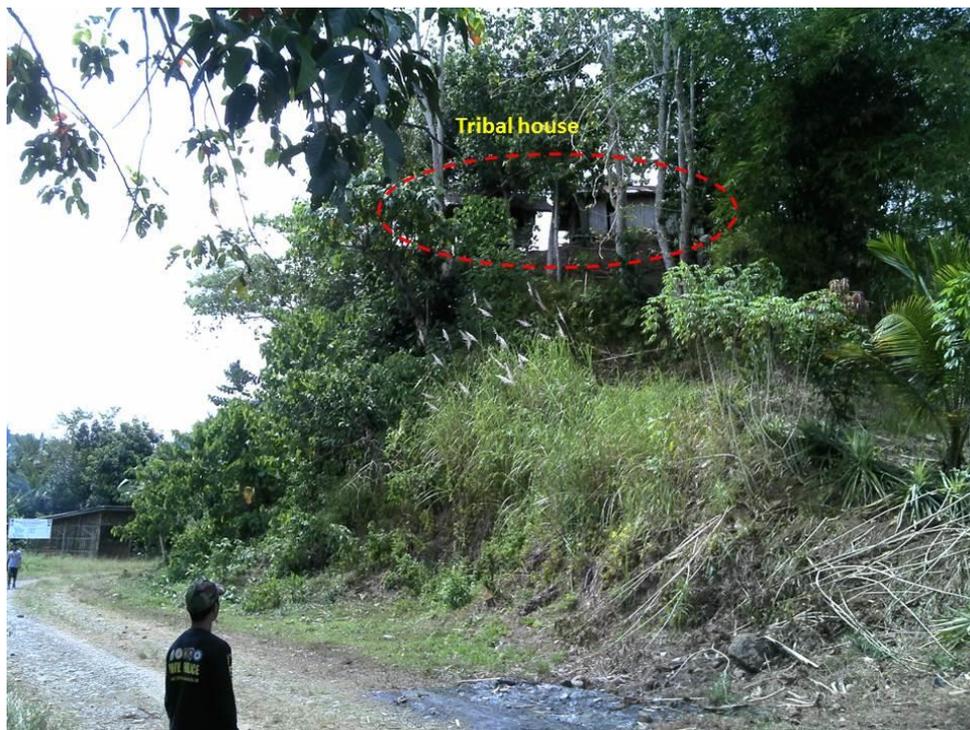
125°21'54.7" E		
Barangay Kinamaybay		
ESP-KNM-1393 Tribal House in Purok 3 8°44'10.6" N 125°24'51.9" E	High	The tribal house is situated on top of a steep slope composed of highly weathered sandstone. Shallow seated debris slides were also observed at the base of the slope. Recommendation: Observe for and/or monitor for presence of mass movement (e.g., landslides, tension cracks), saturated ground or seeps and sunken or displaced road surfaces and report to MGB/municipal authorities.
ESP-KNM-1390 Kinamaybay Barangay Hall 8°44'9.7" N 125°24'55.9" E	Low	No landslide component mapped.
ESP-KNM-1391 Kinamaybay Health Center 8°44'9.5" N 125°24'55.5" E	Low	
ESP-KNM-1392 Kinamaybay Day Care Center 8°44'10.1" N 125°24'53.3" E	Low	
ESP-KNM-1394 Near Ujot River in Purok 3 8°44'9.3" N 125°24'45.1" E	Low	
ESP-KNM-1395 Near Ujot River in Purok 3 8°44'9.1" N 125°24'45" E	Low	
ESP-KNM-1396 Near Ujot River in Purok 3 8°44'8.8" N 125°24'44.7" E	Low

This photo shows a tribal house situated on top of a 15m steep slope composed of weathered sandstone. This house is used for occasional tribal meetings. (Geographical Location: 8° 44' 10.6" N 125° 24' 51.9" E)

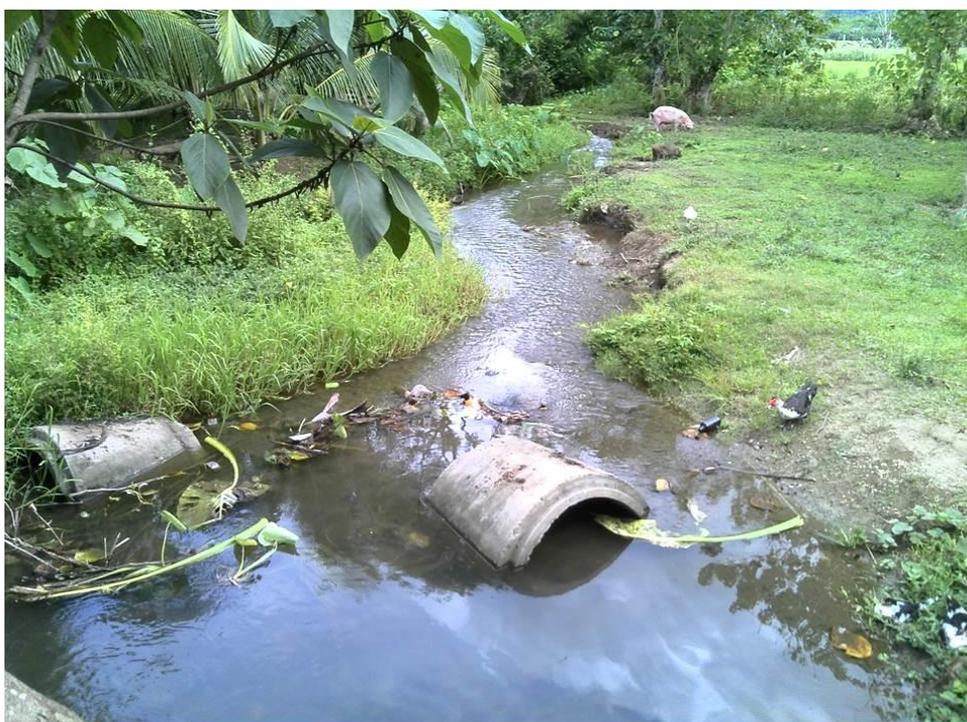
A photo showing a reinforced concrete pipe (RCP) which was destroyed during typhoon Pablo due to prolonged heavy rains. (Geographical Location: 8° 44' 15.4" N 125° 25' 11.3" E)

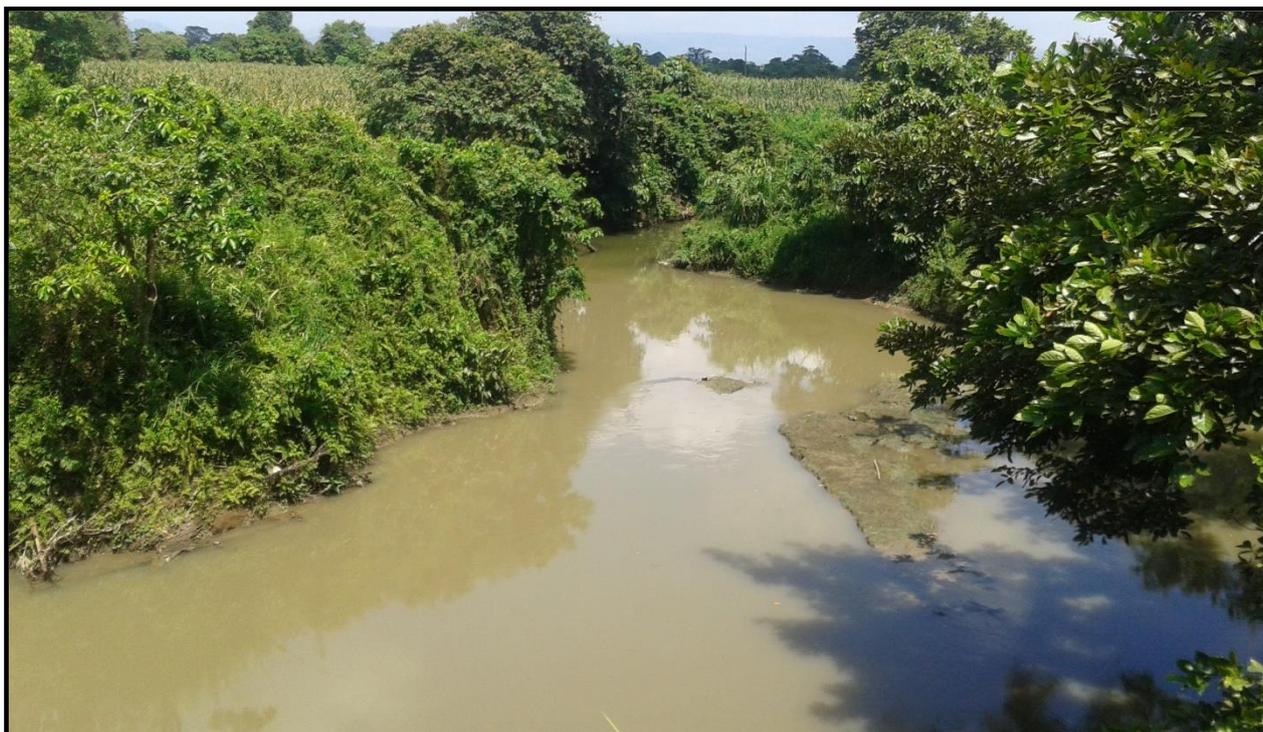
Labao Bridge, Purok 2. Very High. Photo showing Labao Creek in Purok 1. Labao Creek frequently overflow during heavy rainfall especially during Amihan (December-February) Flood water usually reaches the top of the bridge 8 meters above the channel. GPS Coordinates: 125° 42' 45.7"E 8° 37' 45.5" N

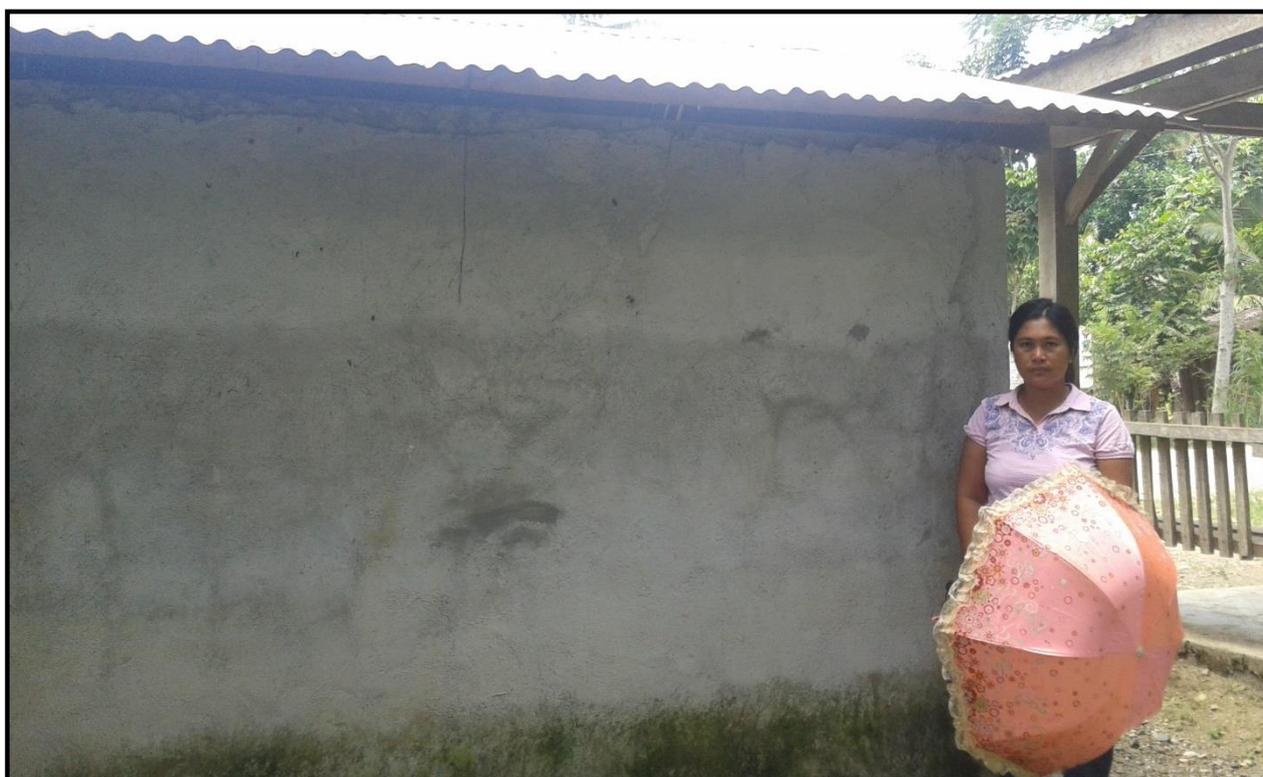
Near Minaslat Creek, Purok 3. Very High. Photo showing flood marks indicating the height of flooding in Purok 3. Point taken adjacent to Minaslat Creek. Worst flooding was during Typhoon Agaton. GPS Coordinates: 125° 42' 48"E 8° 37' 44" N

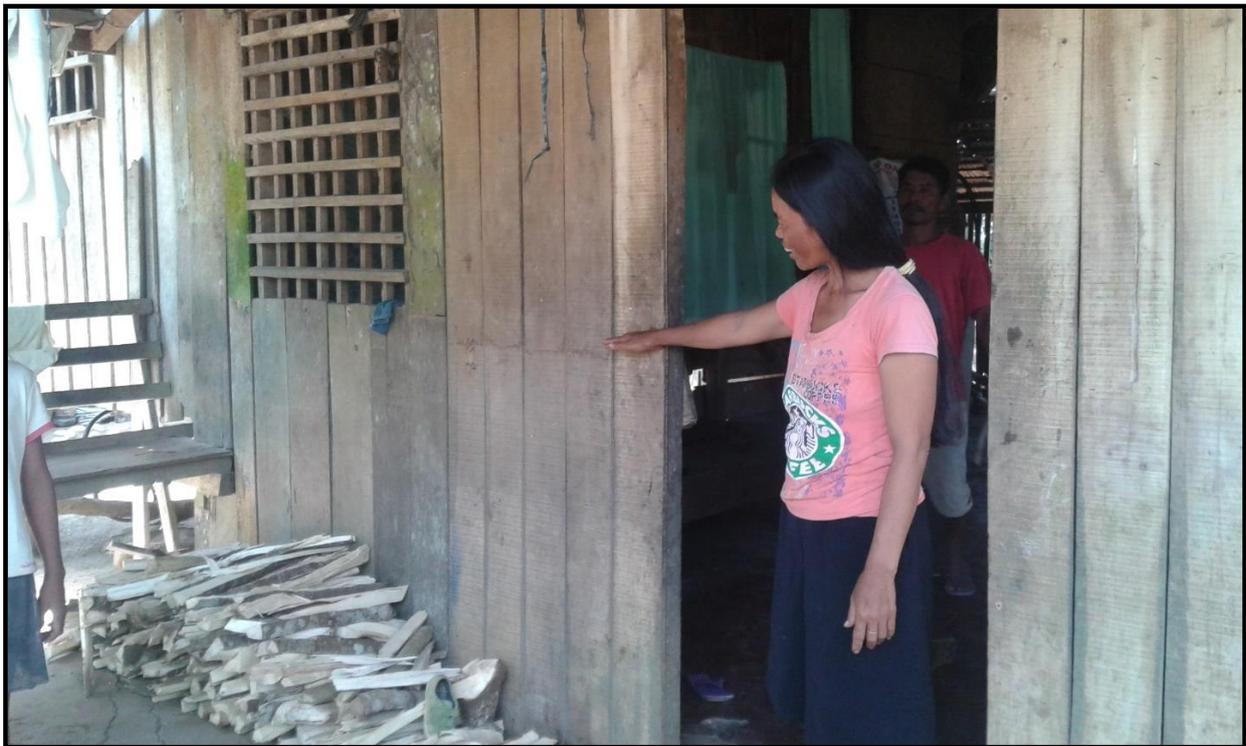
Purok proper, Purok 2. Photo showing a resident of Purok 1 pointing at the approximate height of flooding during Typhoon Agaton. Station point was taken on top of Labao riverbank approximately 8 to 10 meters high from base of the channel. GPS Coordinates: 125° 42' 44"E 8° 37' 44.5" N

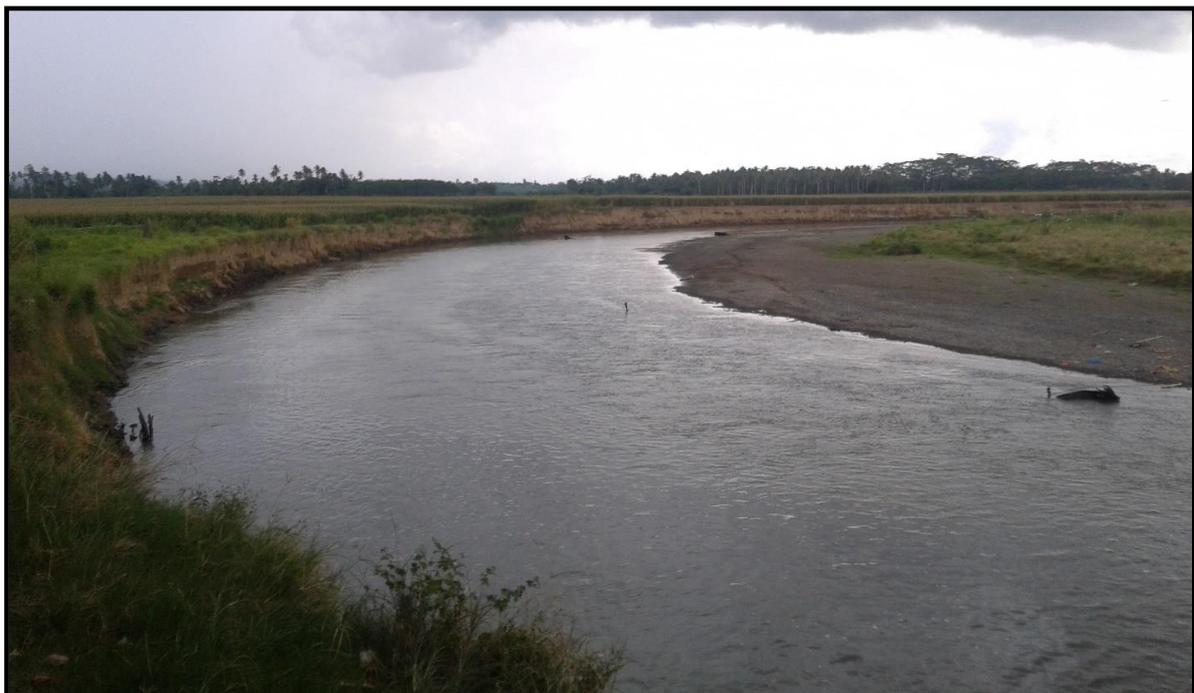
Ohot River, Purok 1. Photo taken near meander bend of Ohot River. Ohot River frequently takes a short cut and passes through this area during flooding carving a new river channel. Highest flood recorded was during Typhoon Agaton which reached up to 2.3 meters above river bank. GPS Coordinates: 125° 38' 24.5"E 8° 41' 18.8" N
