REPORT ON THE 1:10,000 SCALE GEOHAZARDS ASSESSMENT AND MAPPING OF ESPERANZA, AGUSAN DEL SUR

OCTOBER 2014

REPORT ON THE 1:10,000 SCALE GEOHAZARDS (LANDSLIDE AND FLOODING) ASSESSMENT AND MAPPING OF ESPERANZA, AGUSAN DEL SUR

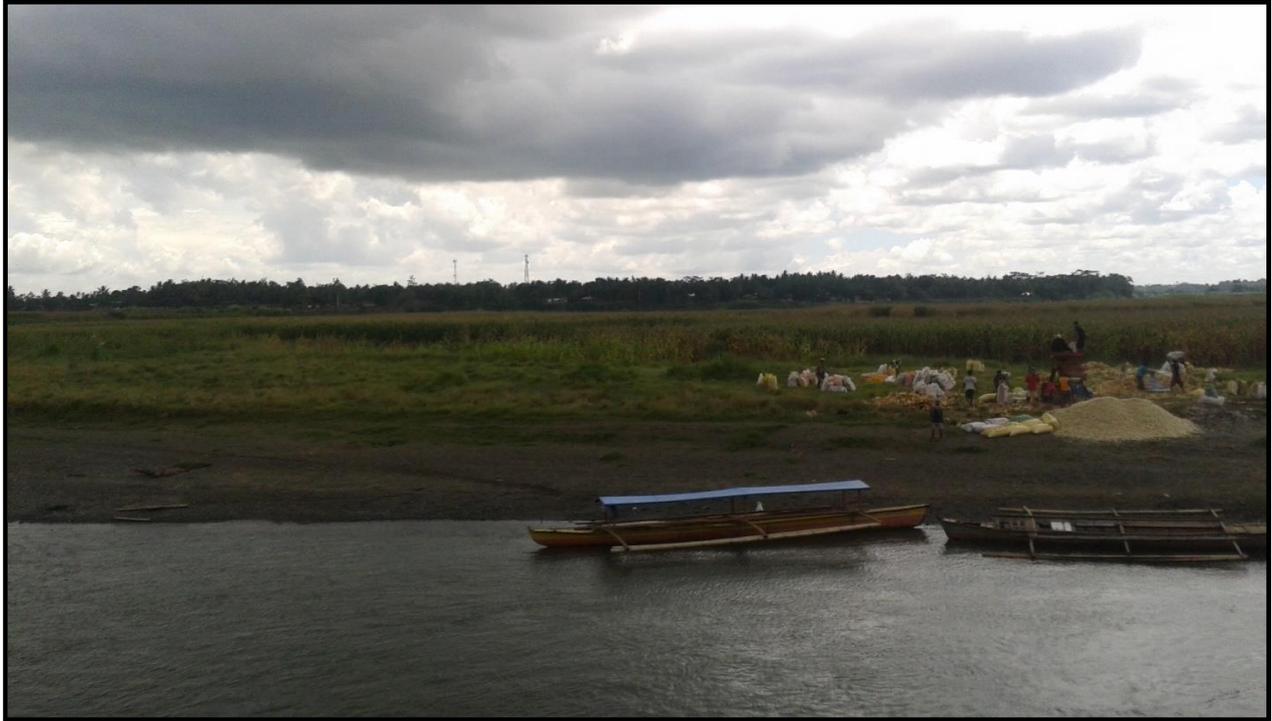
Ohot River, Purok 1. Very High. Photo showing agricultural area of Ezperanza near the flood plain of Ohot and Agusan River(same station point from previous photo). See distal view of Poblacion, Ezperanza. GPS Coordinates: 125° 38' 24.5"E 8° 41' 18.8" N

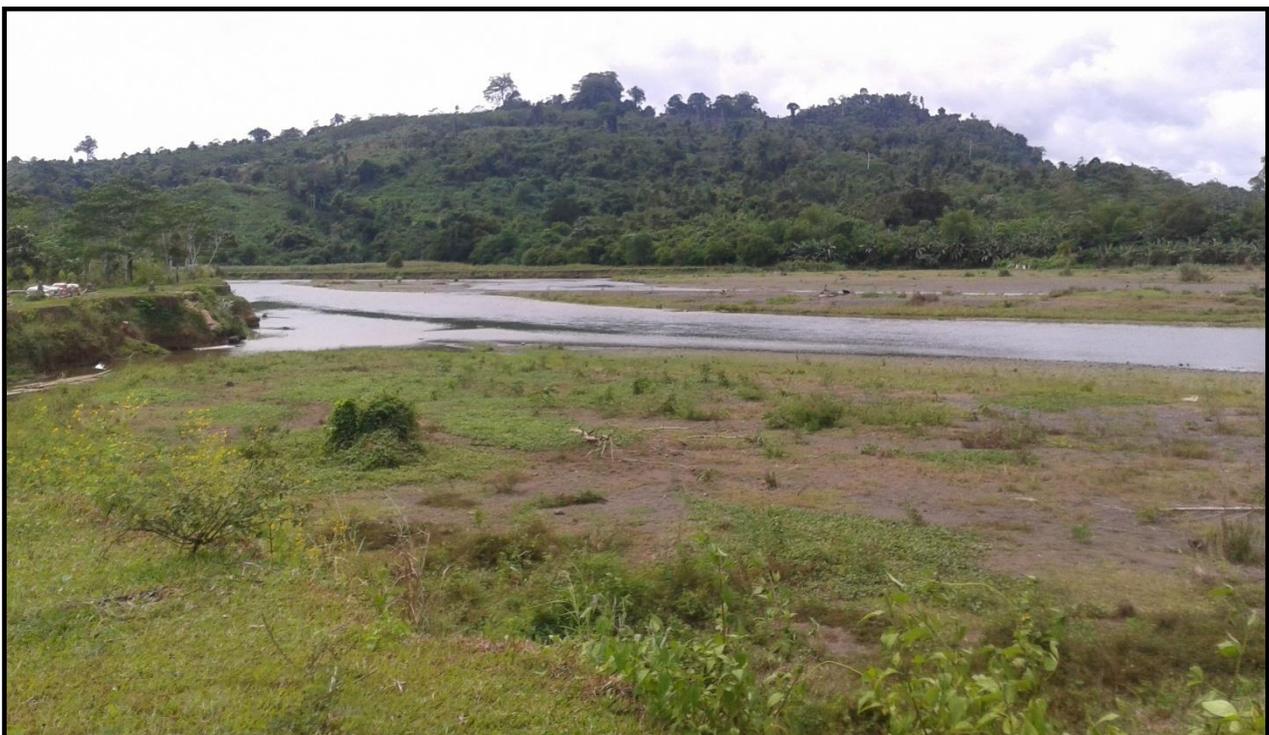
Ohot and Agsabo River Confluence, Purok 2. Photo showing Ohot and Agsabo River confluence. Point taken on top of River bank. Flooding is frequent especially during heavy rainfall. Bank erosion is active. Highest flood height was recorded during typhoon Pablo. Channelized flooding only. GPS Coordinates: 125° 28' 29.6"E 8° 40' 55.8" N

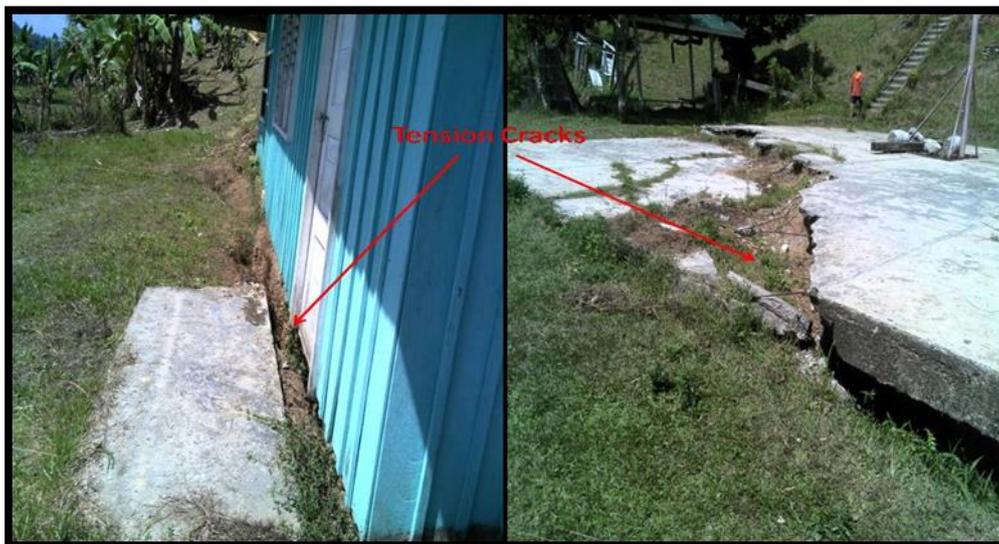
ESP-MCR-280 Purok 1 Community area 8°35'7.4" N 125°44'26" E	Very High	<p>Identified at least 5 tension cracks in the whole barangay area trending SSW with a length of 25 to 30 meters that occurred in the past two years.</p> <p>Recommendations: Develop an early warning system (e.g., signage). Advise for pre-emptive evacuation during inclement weather condition and occasions of heavy and prolonged rains. Relocate houses and other structures to safer areas and away from landslide and flood-prone areas especially if tension cracks become larger and soil movement/landslide continues. Identify/finalize relocation site area to be assessed later by MGB personnel. Discourage future habitation and construction of government structures in known/identified landslide and flood-prone areas (steep slopes, mid-slopes and foot slopes of mountains and hills, along rivers and creeks). Observe for and/or monitor for presence of mass movement (e.g., landslides, tension cracks), saturated ground or seeps and sunken or displaced road surfaces and report to MGB/municipal authorities.</p>

Purok 1(8° 35' 10" N, 125° 44' 27.6"E) Photo above show the mapped tension cracks in the basketball area near the Baranggay hall and Datu Mankumbate Elementary School. Several tension cracks were also identified that requires detailed mapping.

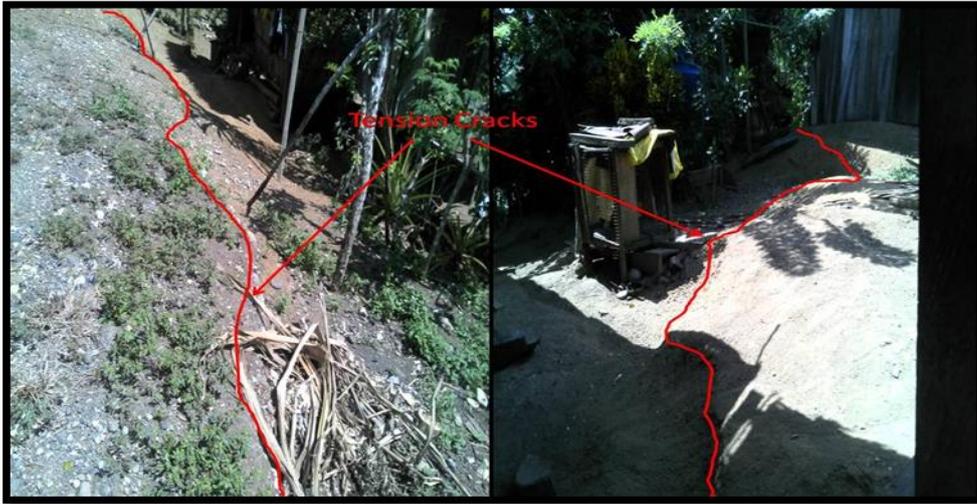
Purok 3 (8° 35' 5" N 125° 44' 25.9"E) Photos above show the mapped tension cracks in Purok 1 with traceto the residential area in Purok 3.

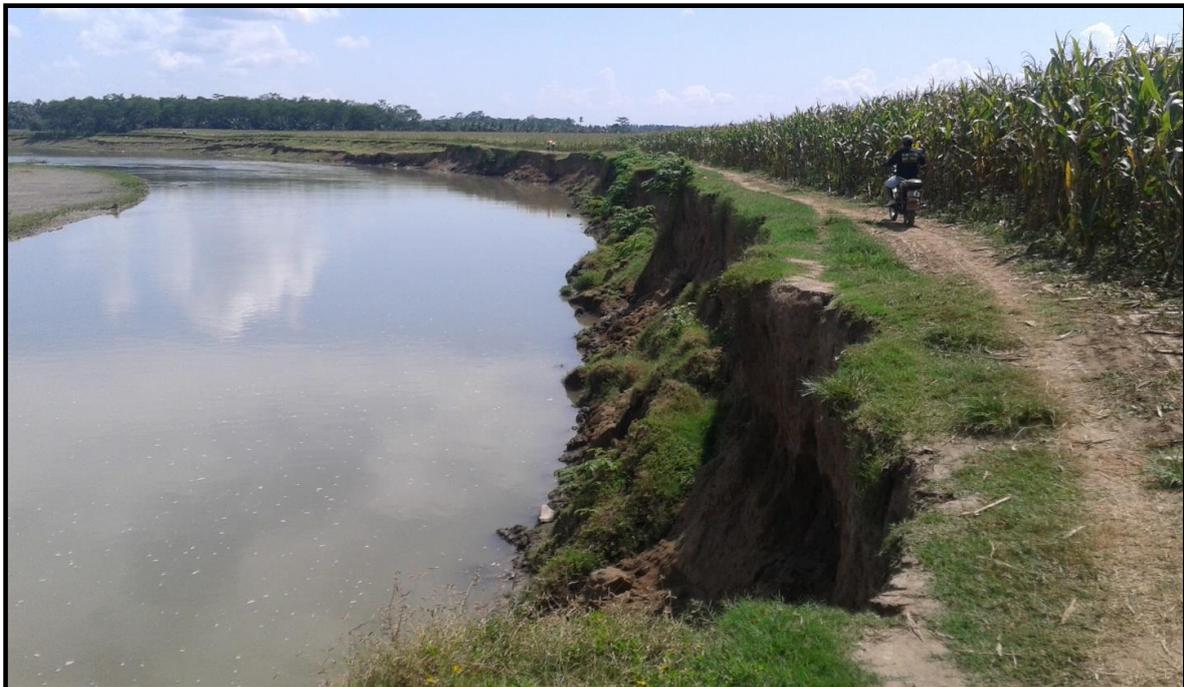
Wawa River, Purok 8. Photo showing an agricultural area near Wawa River. Area frequently inundated during heavy rainfall. Massive bank erosion takes place every flooding. Wawa River is approximately 100 meters wide. Bank height where point was taken is about 6 meters. Highest recorded flooding was during Typhoon Agaton. GPS Coordinates: 125° 41' 53"E 8° 41' 49.7" N

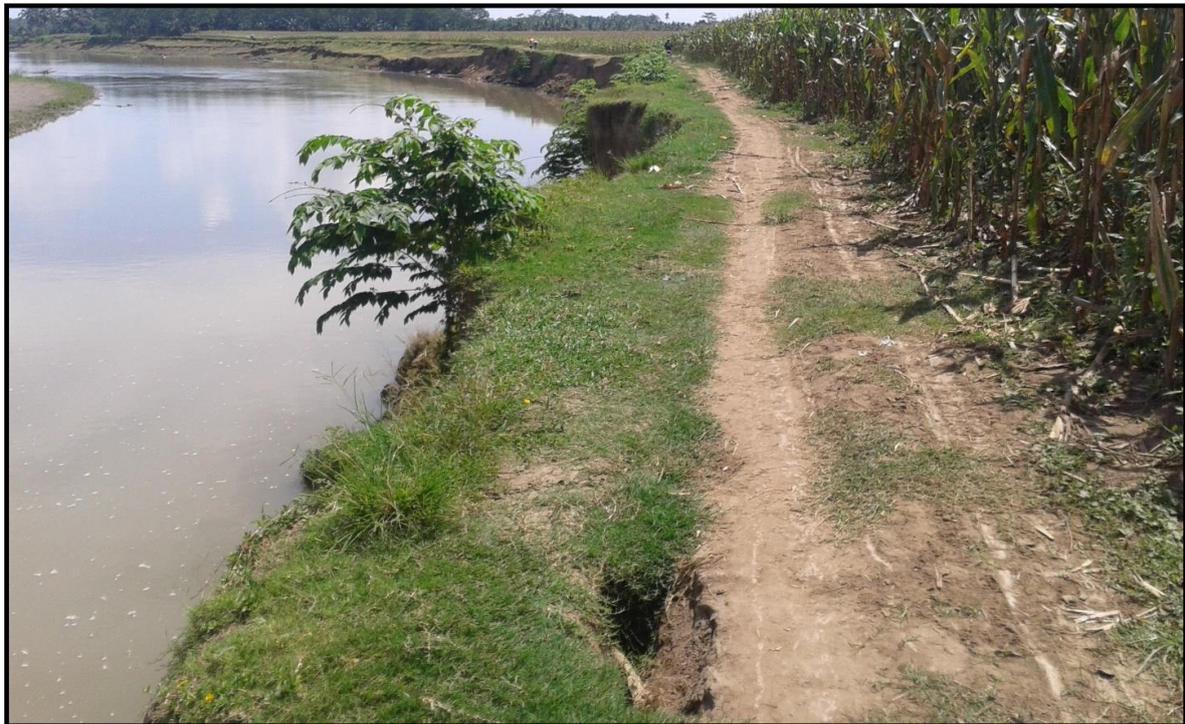
Wawa River, Purok 8. Another photo showing cracks running adjacent to river bank of Wawa River indicating inward bank erosion. GPS Coordinates: 125° 41' 50.6"E 8° 41' 42.6" N

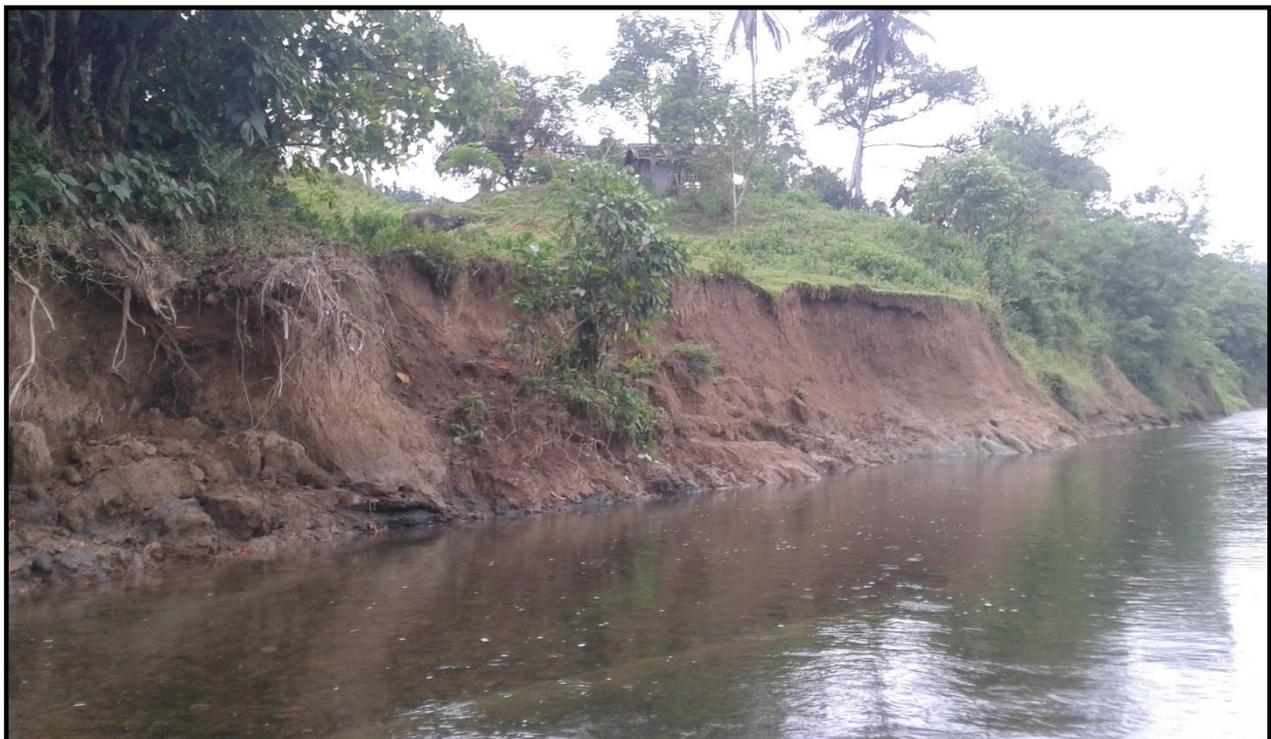
Libang River, Purok 2. Libang River approximately 20-25 meters wide. Highest recorded flooding was during Typhoon Pablo which reached up to 3 meters. Bank erosion is active. GPS Coordinates: 125° 31' 47.4"E 8° 31' 52.5" N

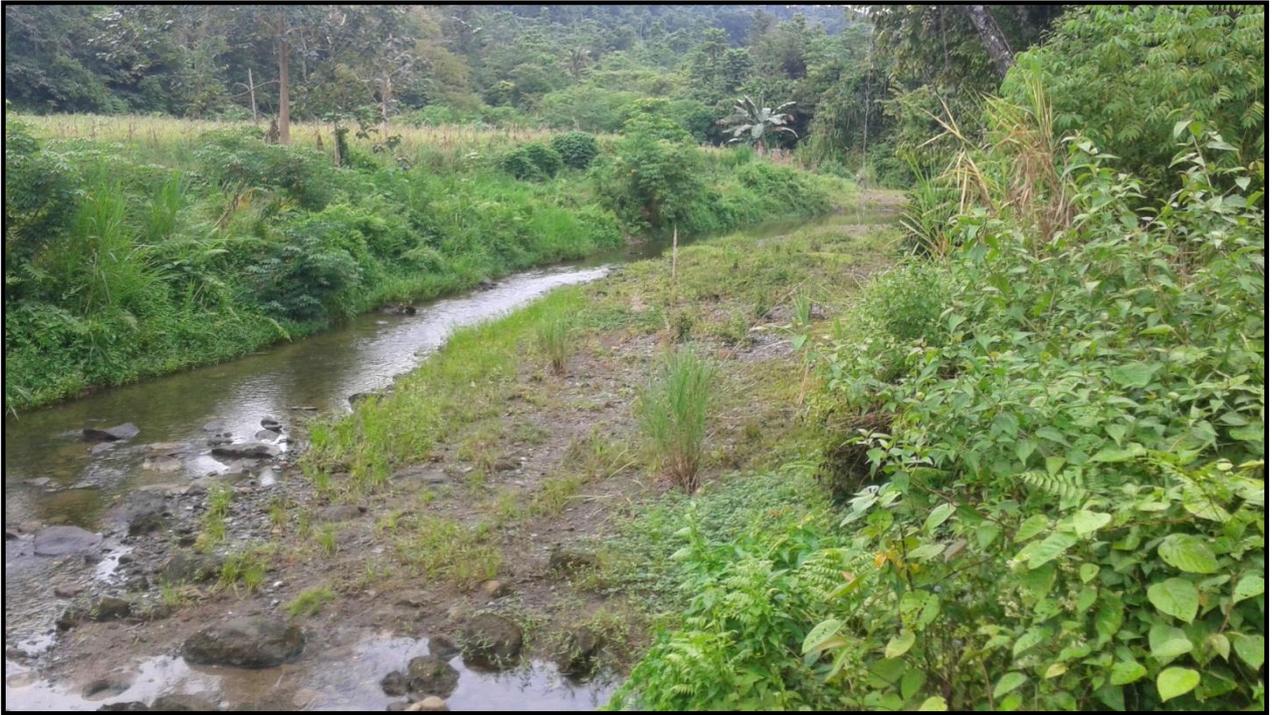
Creek, Purok 1. Creek approximately 5 meters wide draining towards Libang River. Frequently flooded during heavy rainfall. Flood height reached up to 1.5 meters during Typhoon Pablo. Channelized flooding only. GPS Coordinates: 125° 31' 35.7"E 8° 32' 25.9" N

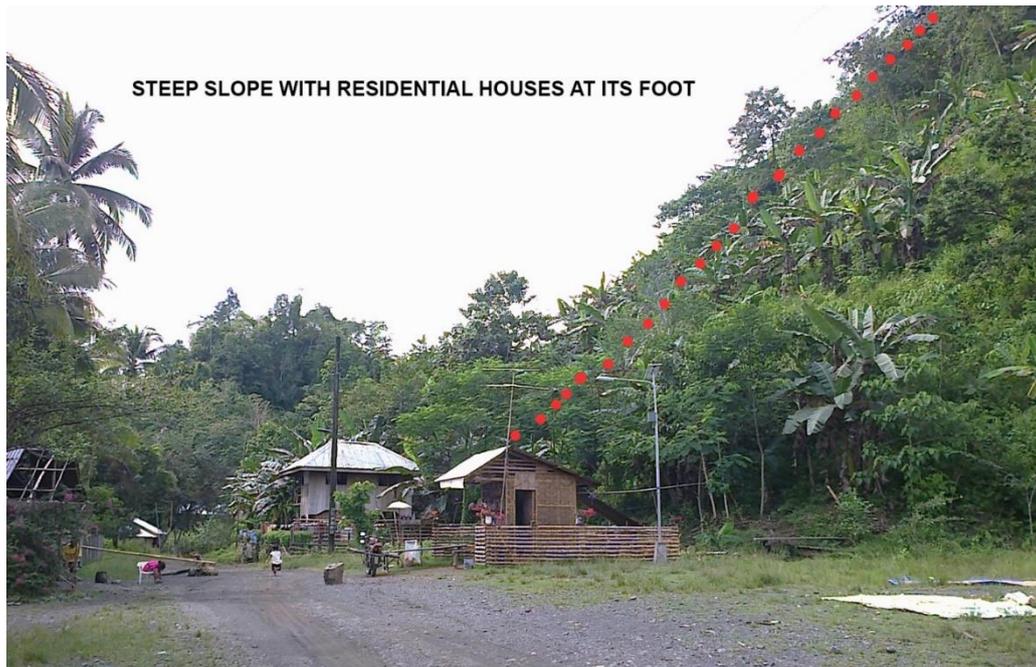
A very steep slope approximately 50 meters high was observed along the road. Six houses were identified to lie just a few meters at the foot of the slope. Relocation is highly advised for the residents. At Purok 3 with GPS location 8° 38' 2.6" N/125° 34' 48.2" E

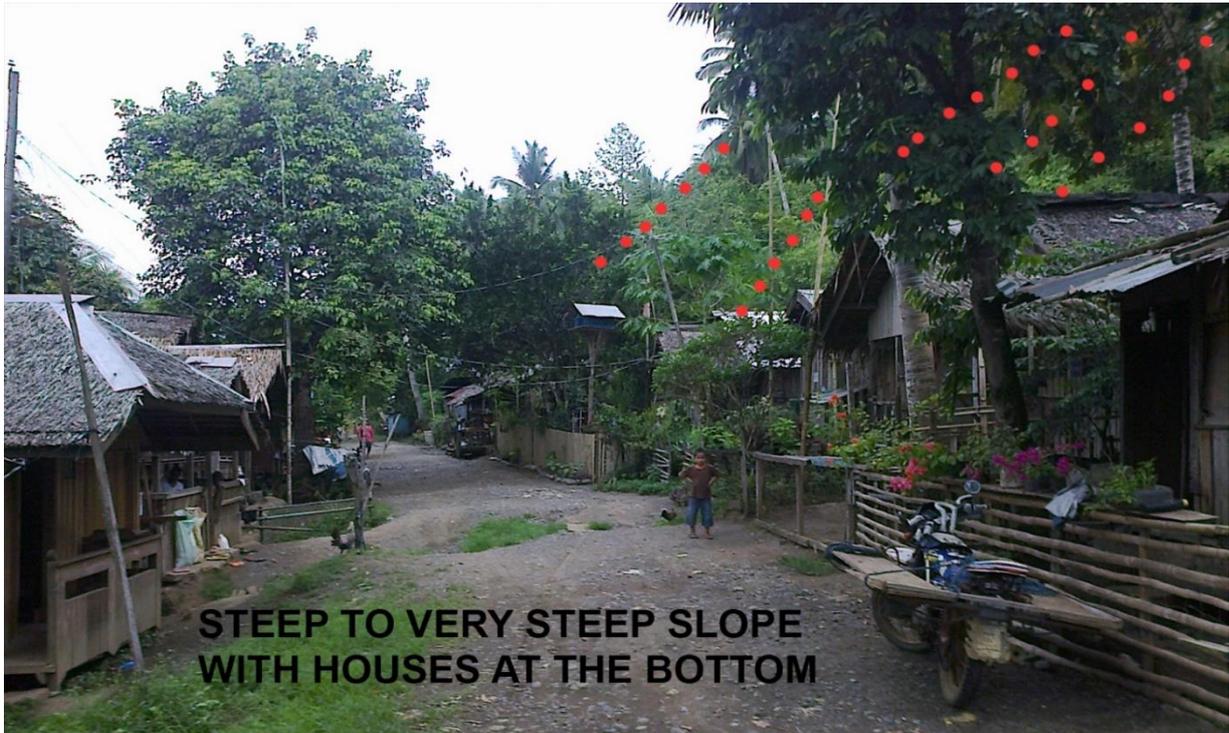
A very steep slope approximately 15M high was observed along the road. A number of houses are located at the foot of the slope. Signs of mass movement such as soil creep, and tilted trees were observed. At Purok 4 with GPS location: 8° 38' 54.9" N/125° 38' 32.2" E.

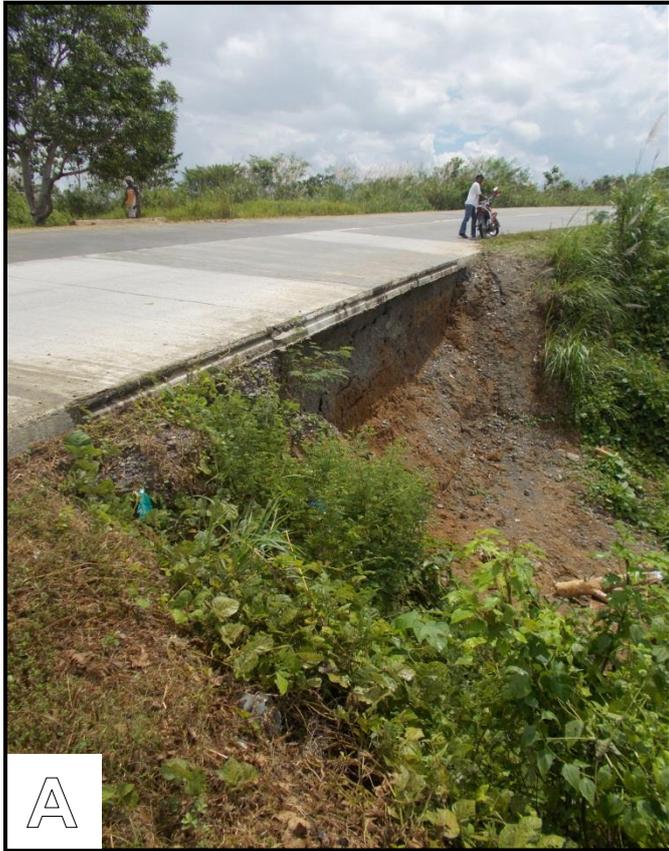
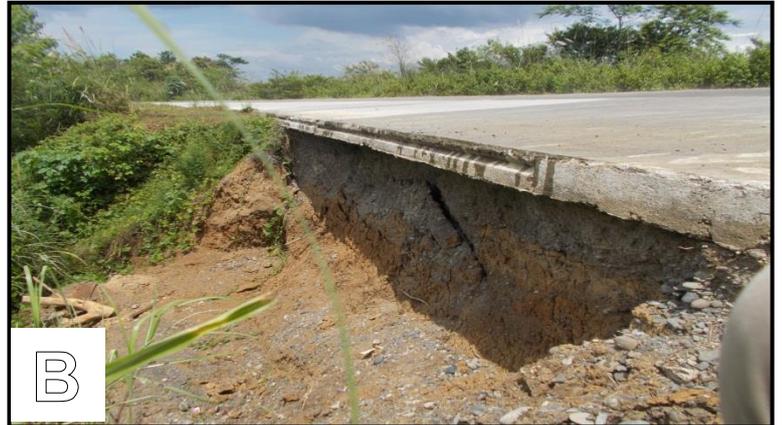
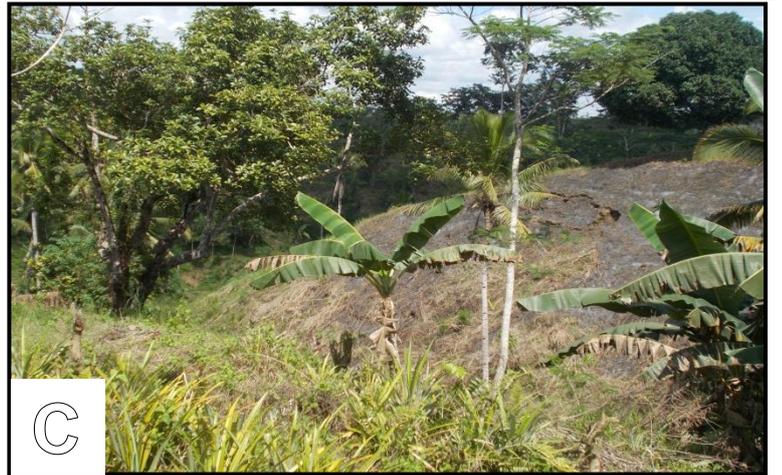
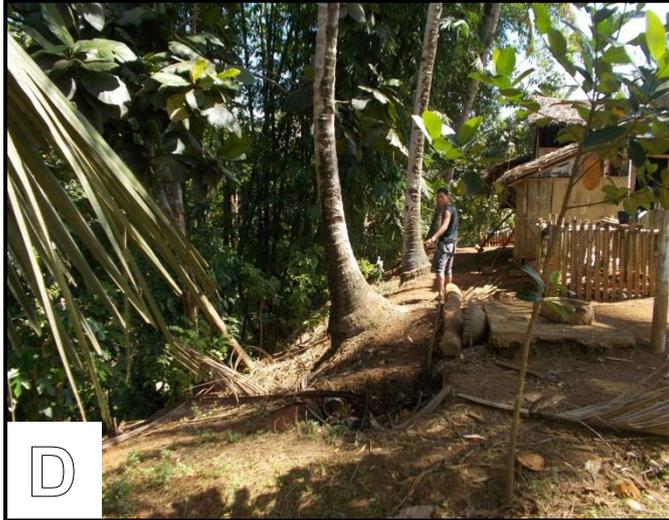
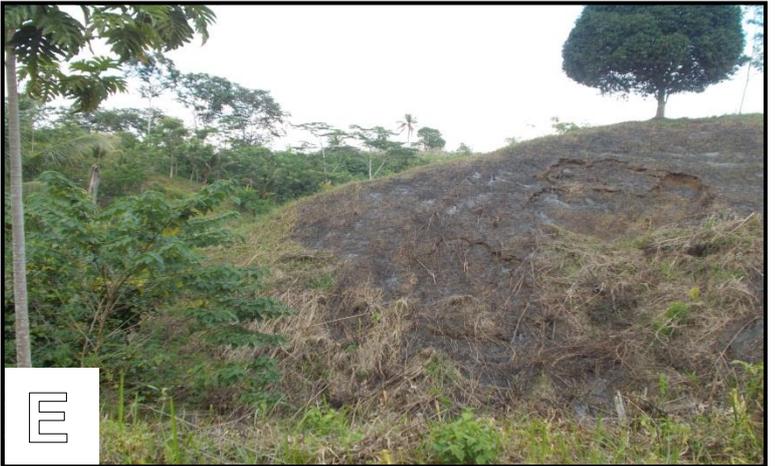
Photos (A) (B) A localized landslide at the side of a road. The height of the slide is ~5-8m. Tension cracks were observed in the road. (C) (E) A localized landslide in an agricultural area in Purok 1. (D) Tilted coconut trees indicate soil movement/soil creep in the area that may develop into a mass movement.

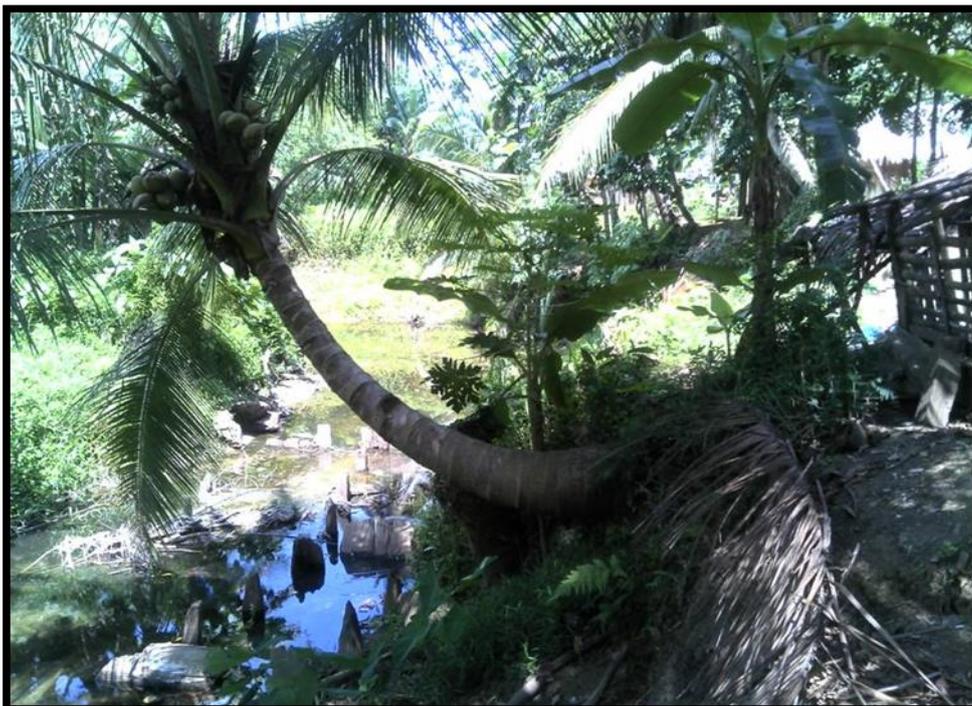
Purok 1 (8° 36' 57.9" N, 125° 45' 7.7"E). This Photo shows the Odiong River where bank erosion is active. The river is also usually flooded affecting the nearby communities.

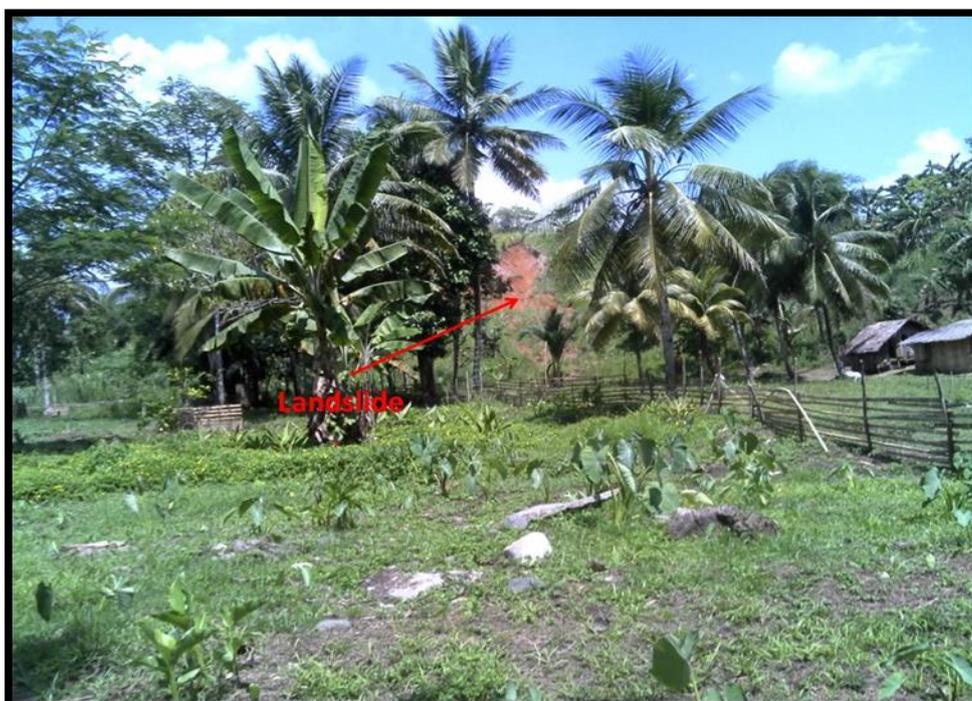
Purok 1(8° 36' 59.7" N, 125° 45' 9.9"E). This photo shows a landslide approximately 200 meters located at the back of the school area in Purok 1.

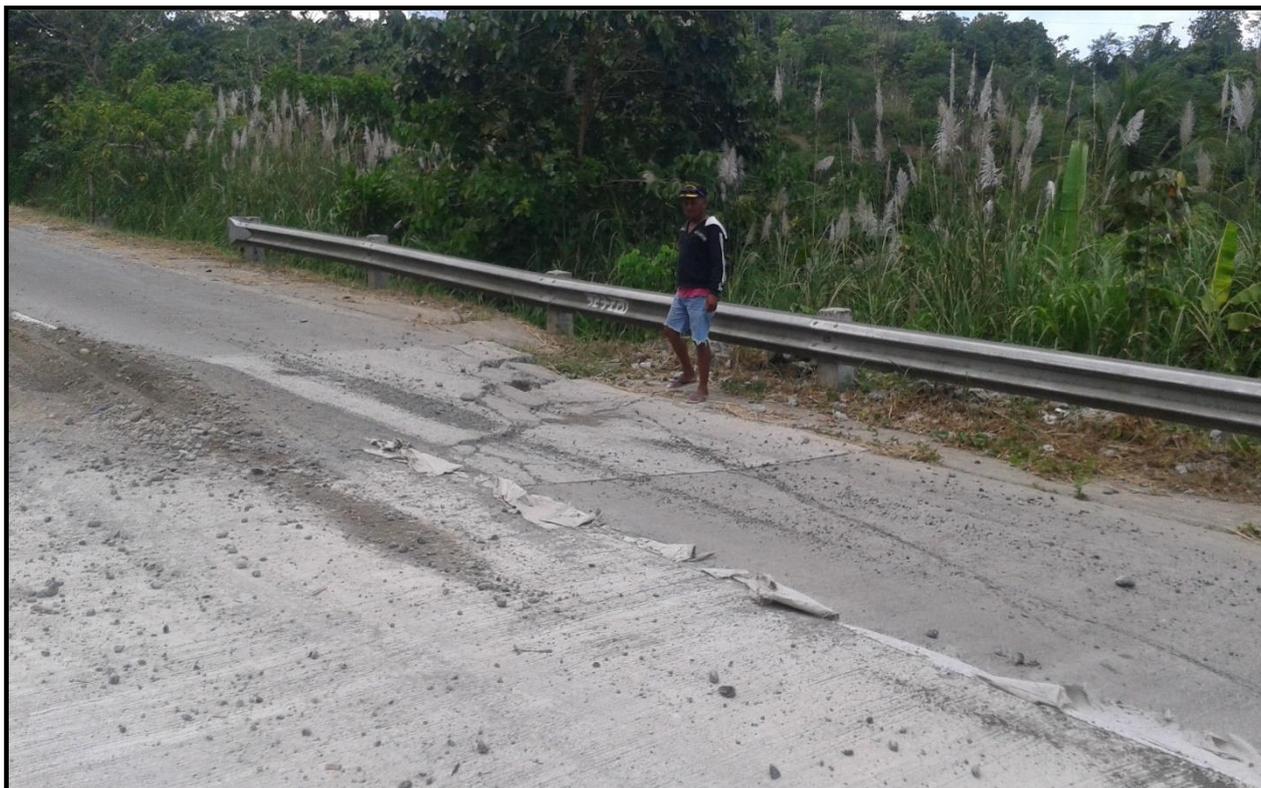
Barangay road, Purok 8. Photo showing cracks along Barangay road in Purok 8. Slope height is about 20 meters deep. GPS Coordinates: 125° 35' 56"E 8° 40' 17.5" N

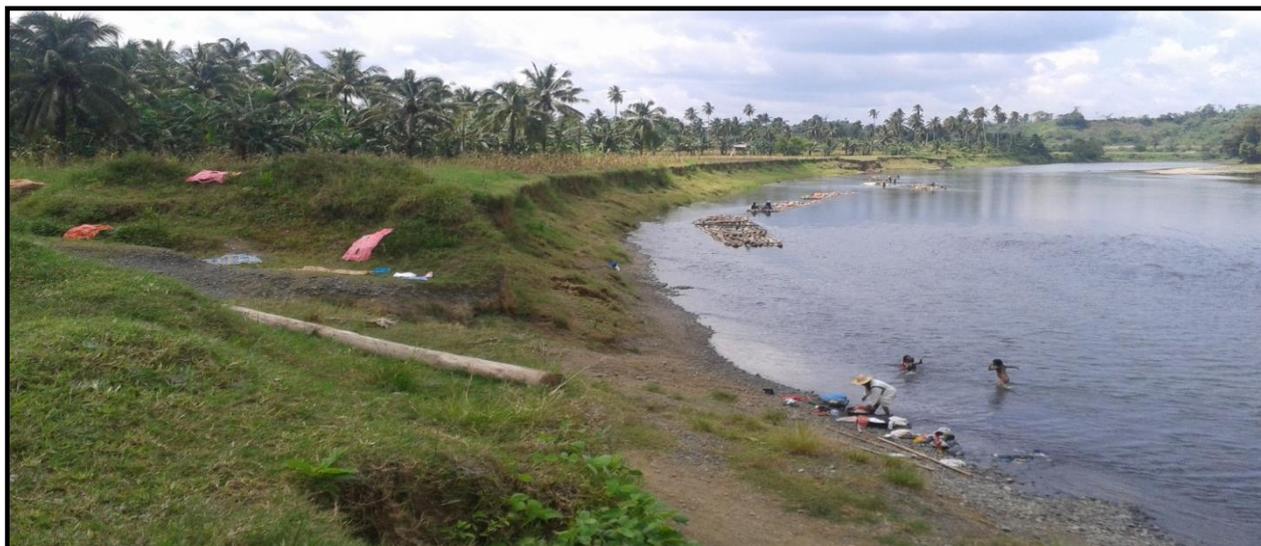
Ohot River, Purok 5. Photo showing portion of Ohot River. Ohot River frequently flooded up to 2.5 meters during heavy rainfall and Amihan (December-February). River is approximately 50 meters wide and bank height is about 5 meters. GPS Coordinates: 125° 36' 39.8"E 8° 40' 28.2" N

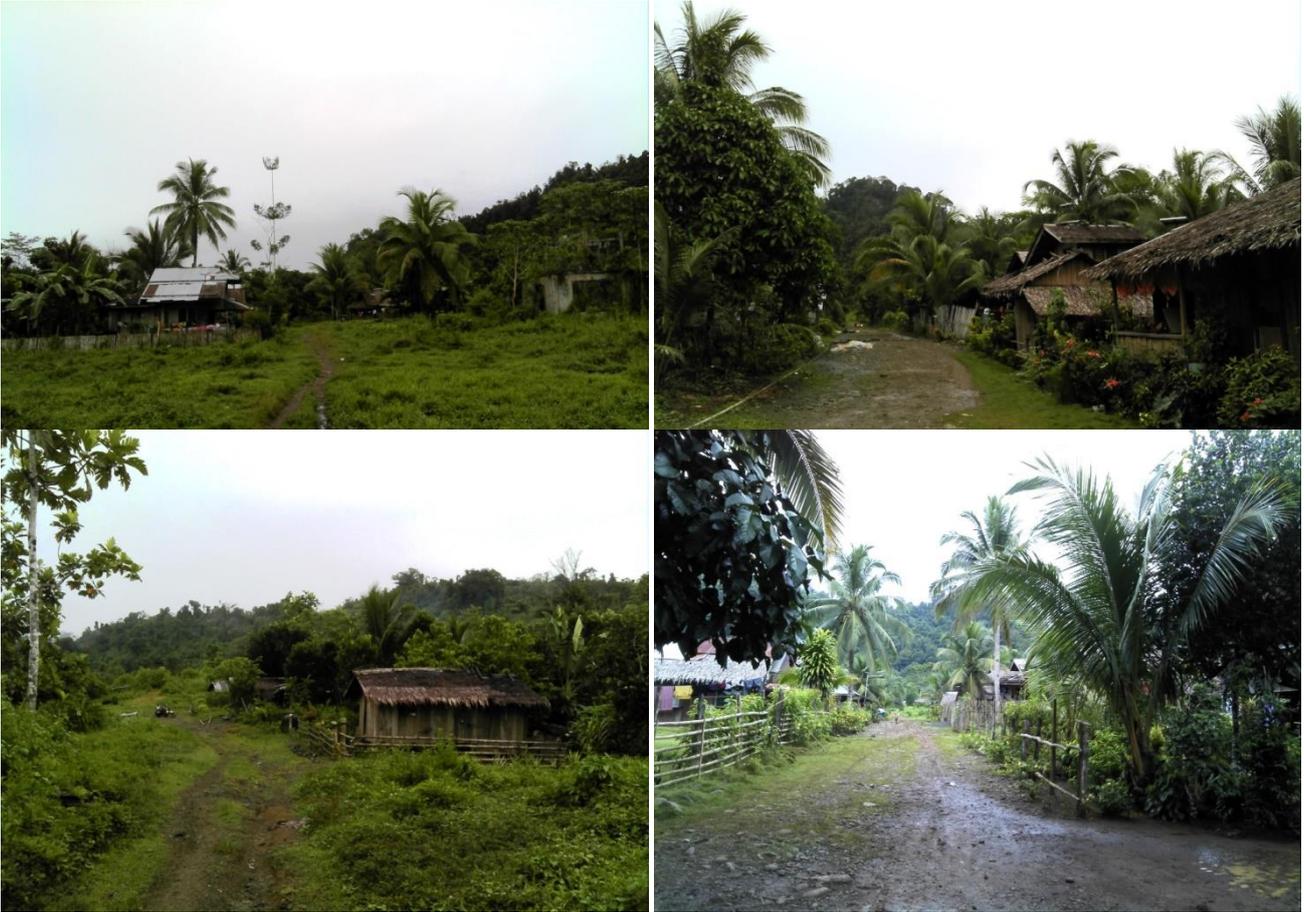
Clockwise: Residential area near the base of a steep sloping terrain at Purok 2, Purok 3, Purok 6 and few houses at Purok 5 situated along moderately sloping ground.

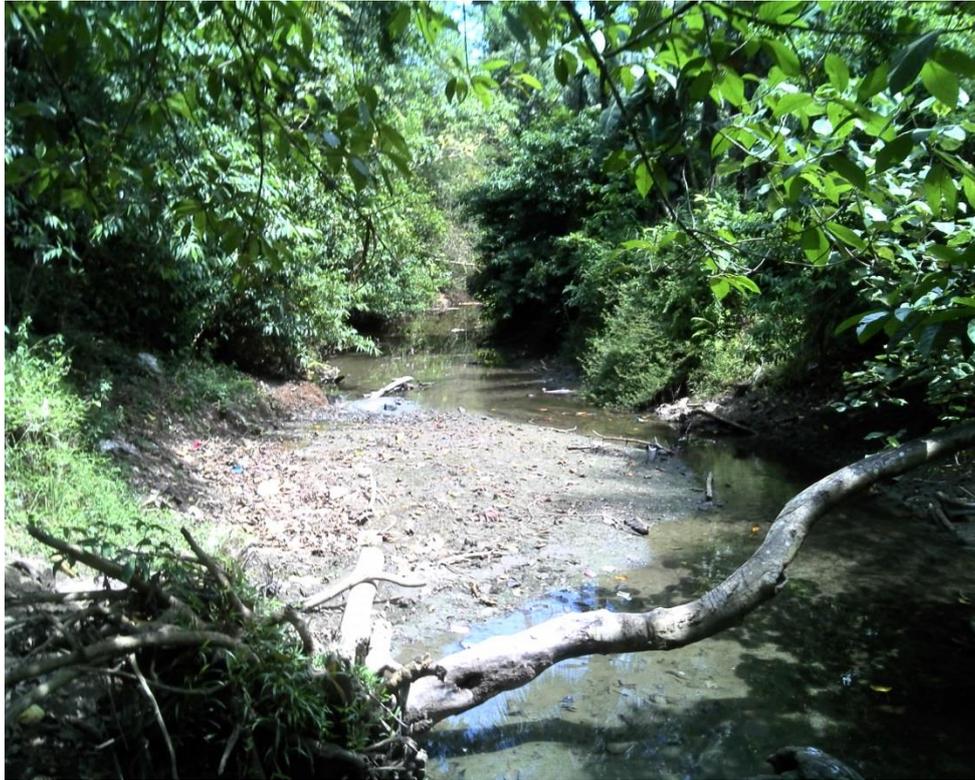
Photo of Kubo Creek whose flood height reaches as high as 8.5 meters which lasted for >3 hours during typhoon Agaton. (Geographical Location: 8° 41' 59.2" N 125° 40' 15.1" E)

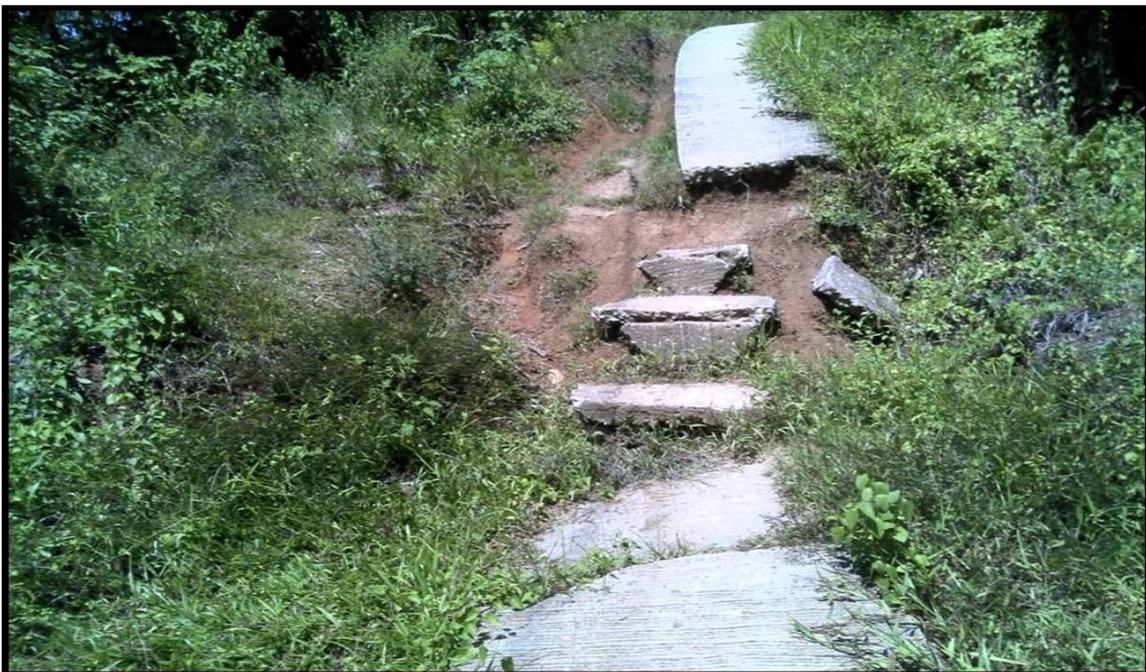
Purok 3 (8° 35' 41.7" N 125° 45' 0.4"E) A photo showing a destroyed path way leading to the barangay center affected by minor mass movement.

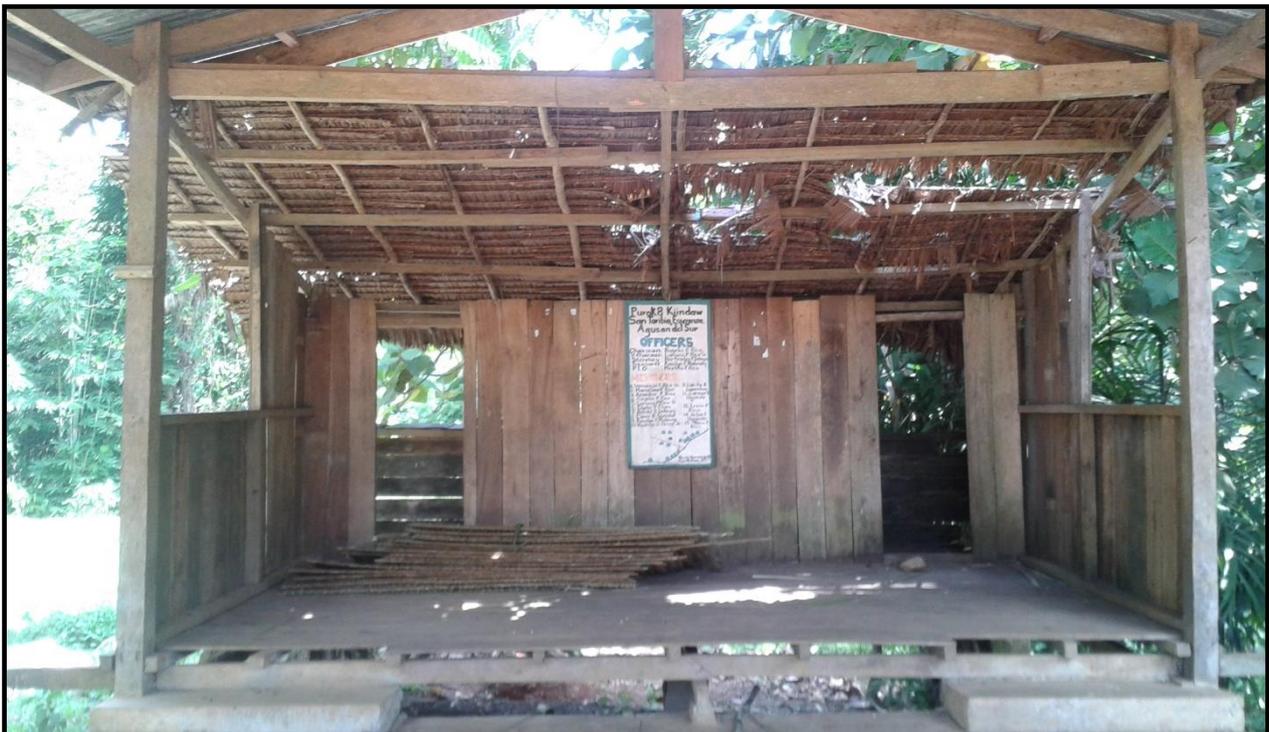
Purok Center, Purok 8. Photo showing Purok center of Purok 8. This structure was built on top of a slope approximately 20 meters high. Tension cracks were observed adjacent to this structure. Soil creep was also observed in this area indicating active mass movement. GPS Coordinates: 125° 45' 32.4"E 8° 37' 58.8" N

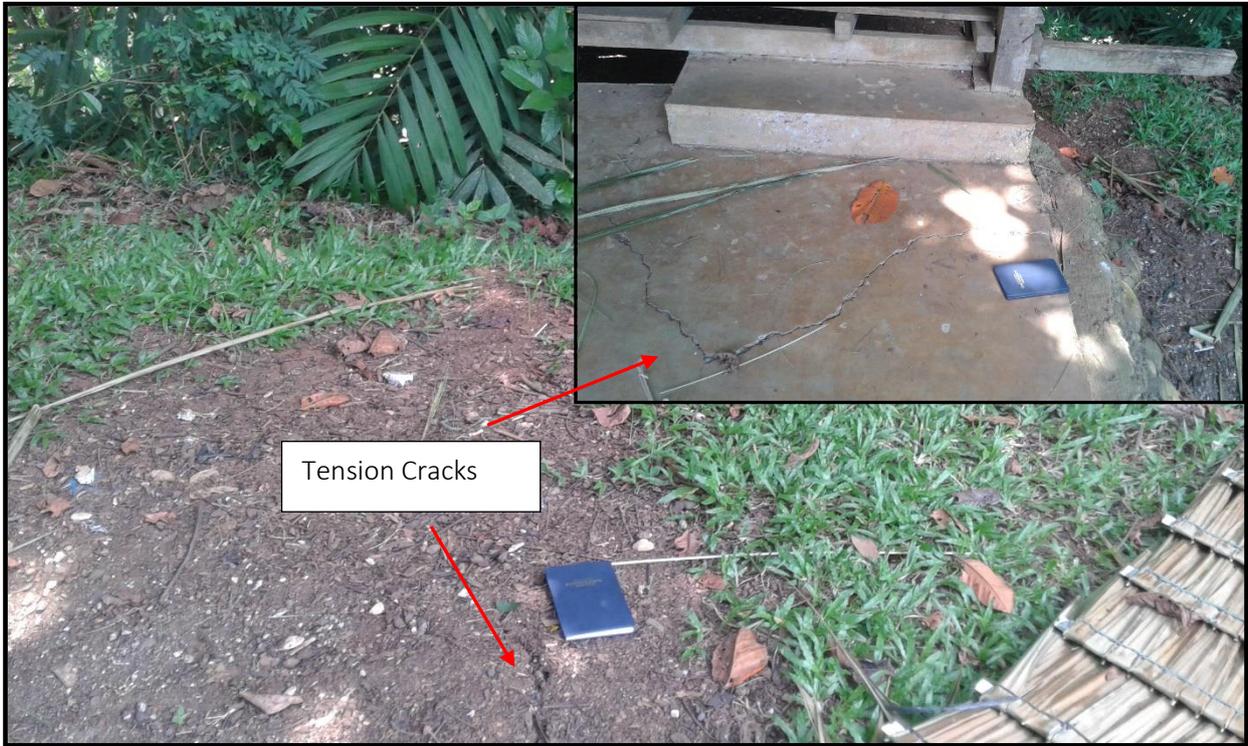
Purok Center, Purok 8. Photo showing tension cracks in Purok Center, Purok 8. GPS Coordinates: 125° 45' 32.4"E 8° 37' 58.8" N

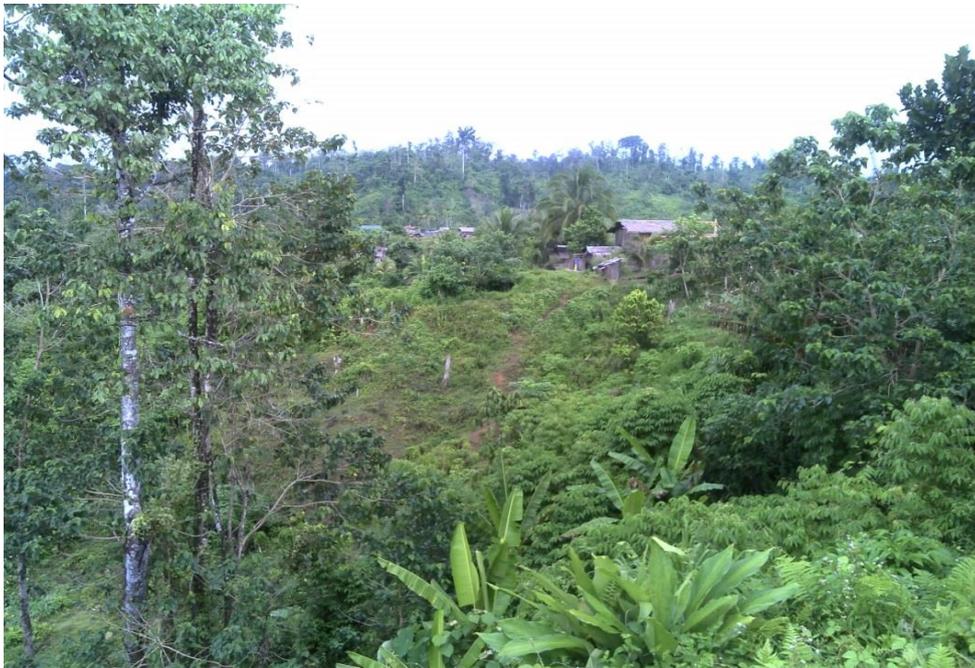
Photo of a 20m long tension and has a vertical displacement of 0.2-0.7 meters high is observed near San Vicente Primary School. (Geographical Location: 8° 29' 25.1" N 125° 24' 17.4" E)

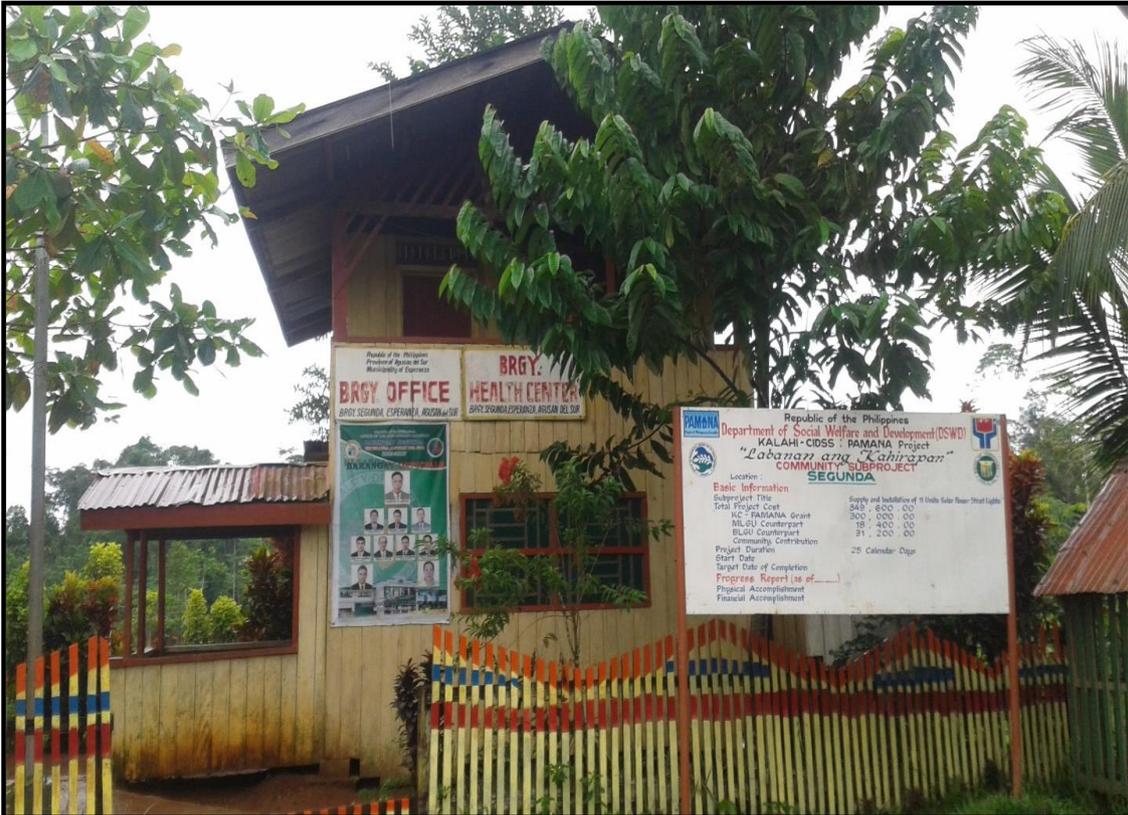
Barangay Hall, Purok 2. Moderate. Photo showing Barangay Hall of Segunda. Barangay Hall of Segunda is situated on a moderate steep slope. Rill erosion is active. GPS Coordinates: 125° 31' 29.4"E 8° 33' 10.9" N

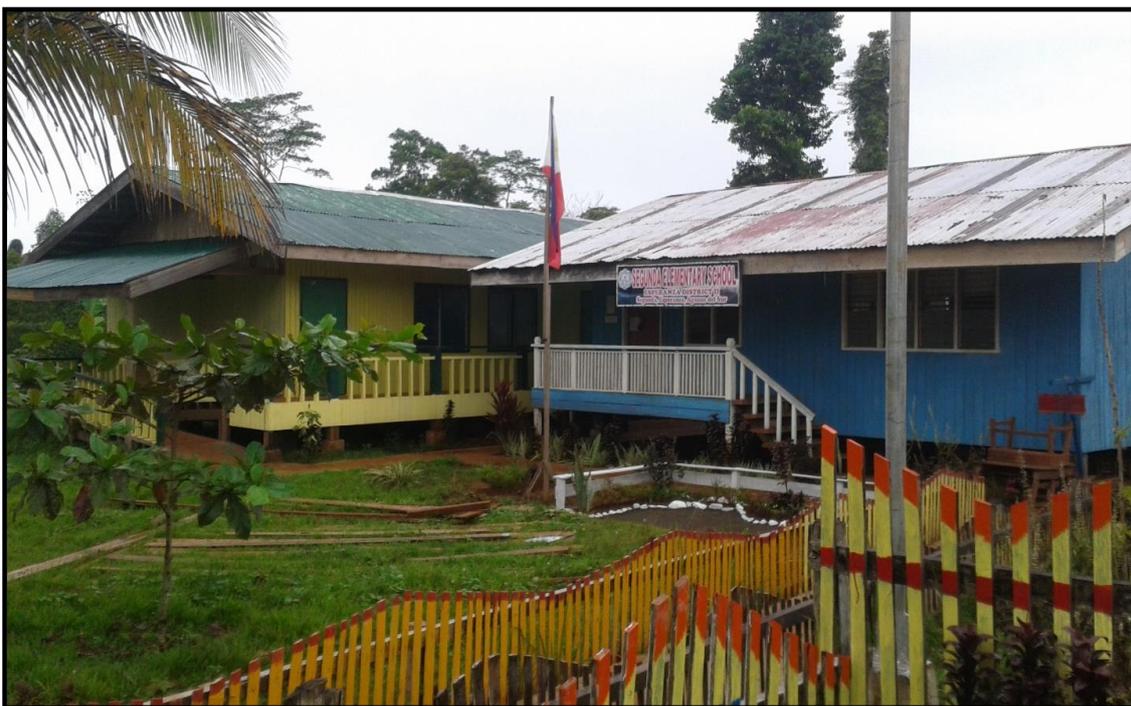
Segunda Elementary School, Purok 2. Photo showing Segunda Elementary School. The school is adjacent to the Barangay Hall. It is situated on a moderate to locally steep slope. Active rill erosion was observed. Soil creep is also observed. GPS Coordinates: 125° 31' 30.1"E 8° 33' 11.5" N

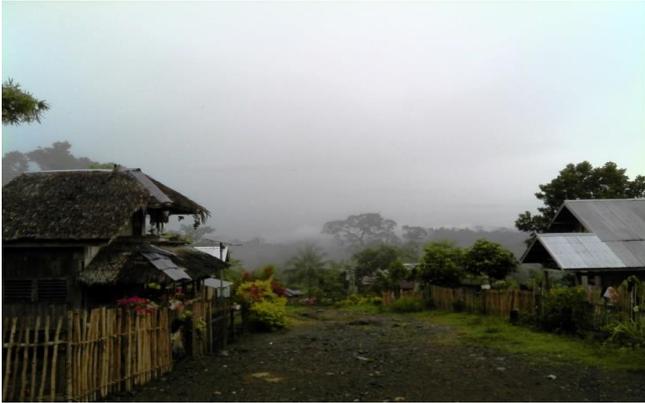
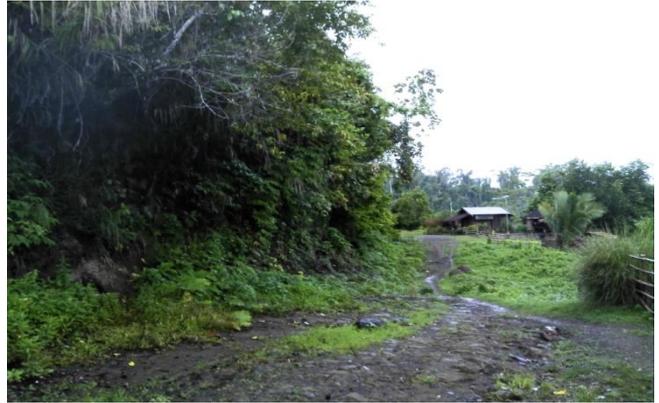
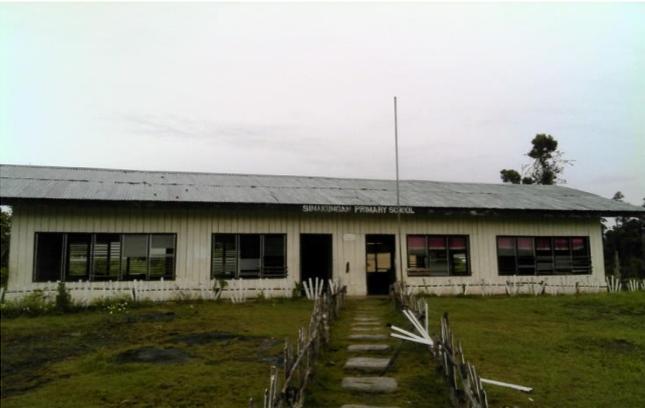
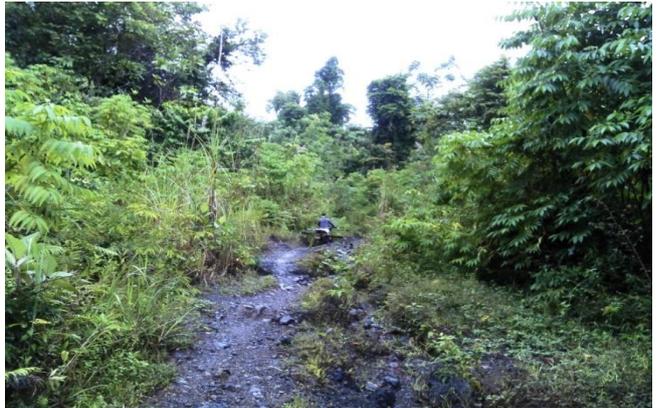
Clockwise: Residential area along steep sloping ground, very steep road cut, road located atop of steep sloping terrain, and Sinakungan Primary School situated near a steep sloping ground.
