REPORT ON THE 1:10,000 SCALE GEOHAZARDS ASSESSMENT AND MAPPING OF ESPERANZA, AGUSAN DEL SUR

OCTOBER 2014

REPORT ON THE 1:10,000 SCALE GEOHAZARDS (LANDSLIDE AND FLOODING) ASSESSMENT AND MAPPING OF ESPERANZA, AGUSAN DEL SUR

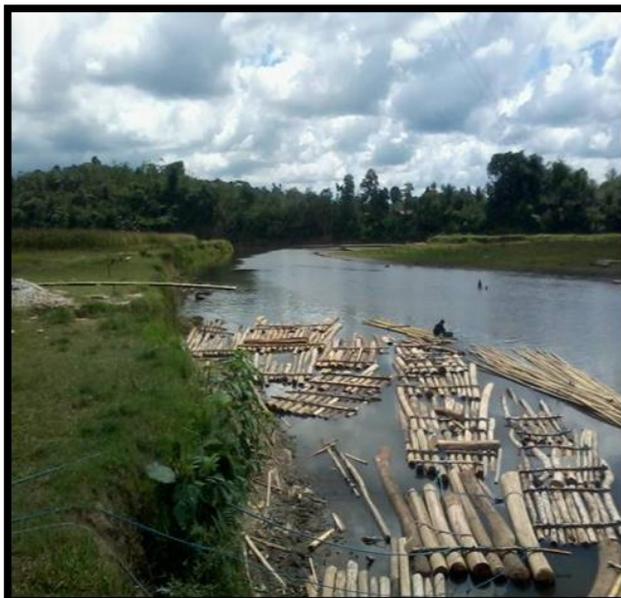
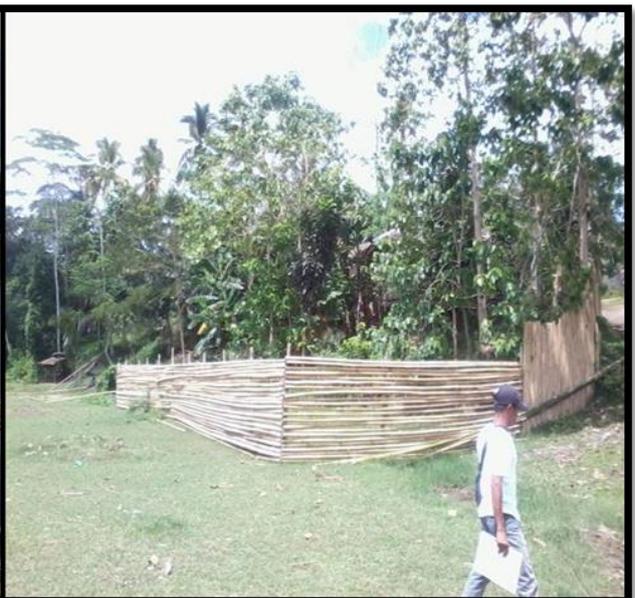
Purok 1(8° 39' 51.4" N, 125° 35' 4.5"E) A photo showing the Ohot River (left) where active bank erosion is present. No river overflow has been reported but residents adjacent to the river banks (right) are still advised to regularly monitor the river water level during bad weather condition.

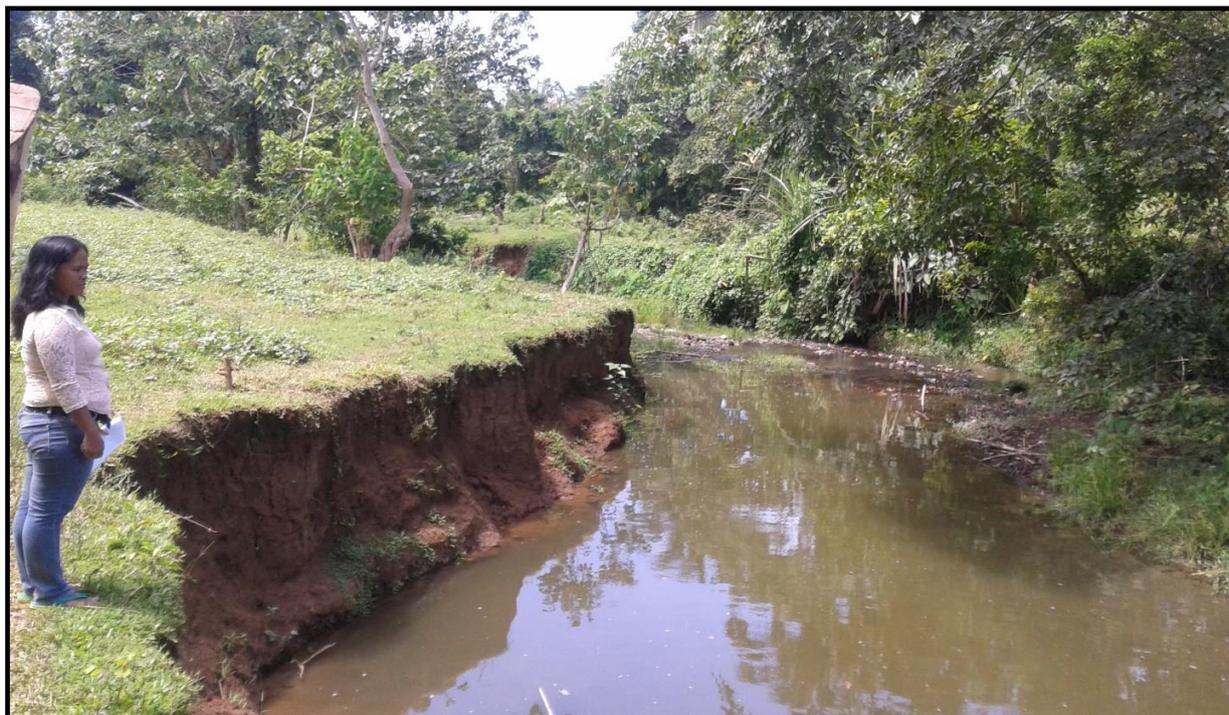
River Confluence, Purok 1. River confluence between Cubo River and Lahi Creek. Flooding reaches up to 1.6 meters. Bank erosion is active in the area. GPS Coordinates: 125° 40' 39.5"E 8° 43' 0.8" N

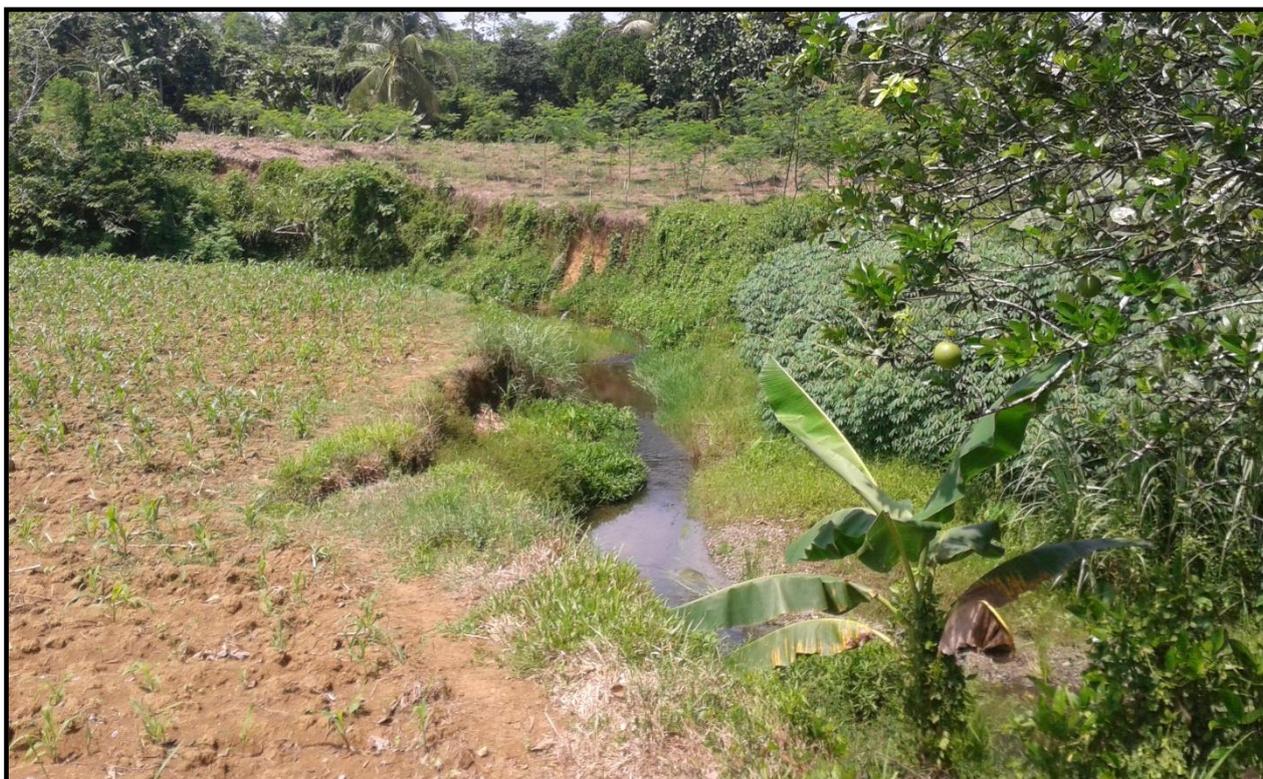
Cubo River, Purok 2. Photo showing Cubo River. Area frequently flooded up to 1.8 meters during heavy rainfall. Stream width is about 6 meters wide. Bank height is approximately 1.5 meters. Agricultural land frequently inundated by flooding. GPS Coordinates: 125° 40' 36.3"E 8° 42' 35.2" N

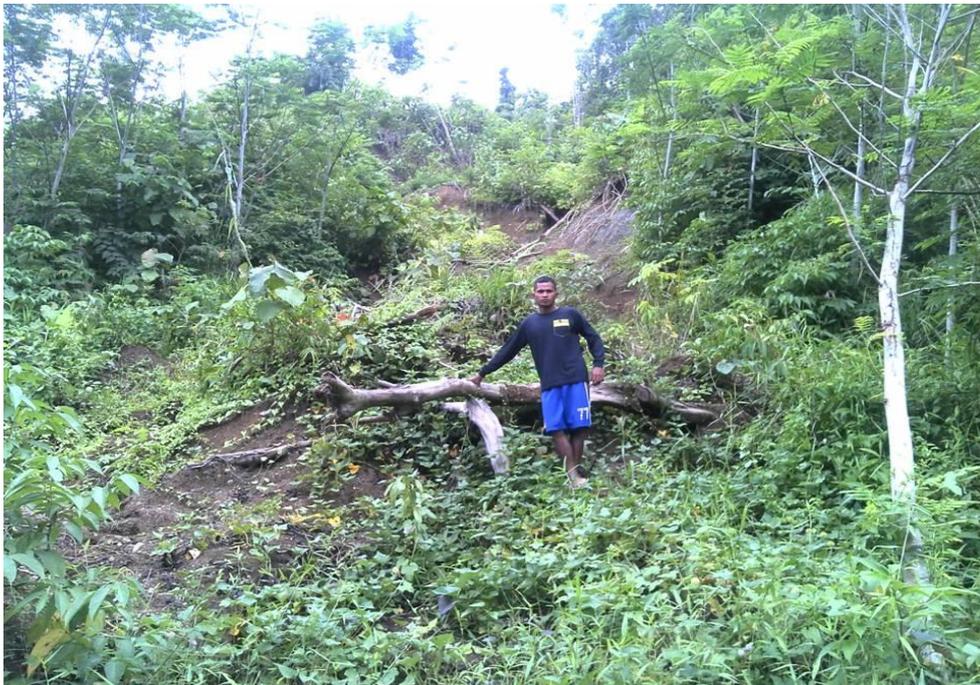
Photo of a 20meter high landslide that was triggered during typhoon Agaton associated to the prolonged heavy rains. (Geographical Location: 8° 32' 35.5" N 125° 26' 17.1" E)
