REPORT ON THE 1:10,000 SCALE GEOHAZARDS ASSESSMENT AND MAPPING OF SIBAGAT, AGUSAN DEL SUR

SRDP Consulting Inc.
Units 119, 420 & 421 SJB Condominium
130-B Panay Ave, South Triangle
Quezon City, Philippines

OCTOBER 2014

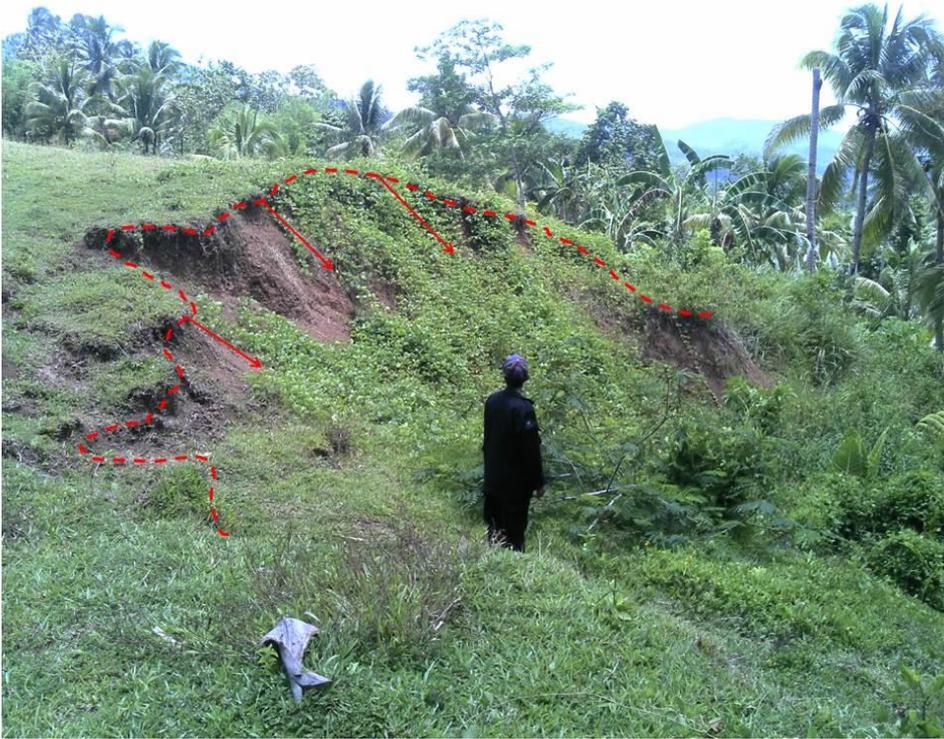
Photo showing the escarpment with vertical displacement of 0.5 to 1.5 meters and about 30 meters long found in the proposed relocation site for the residents affected by the road widening. (Geographical Location: 8° 52' 41" N 125° 39' 23.3" E)

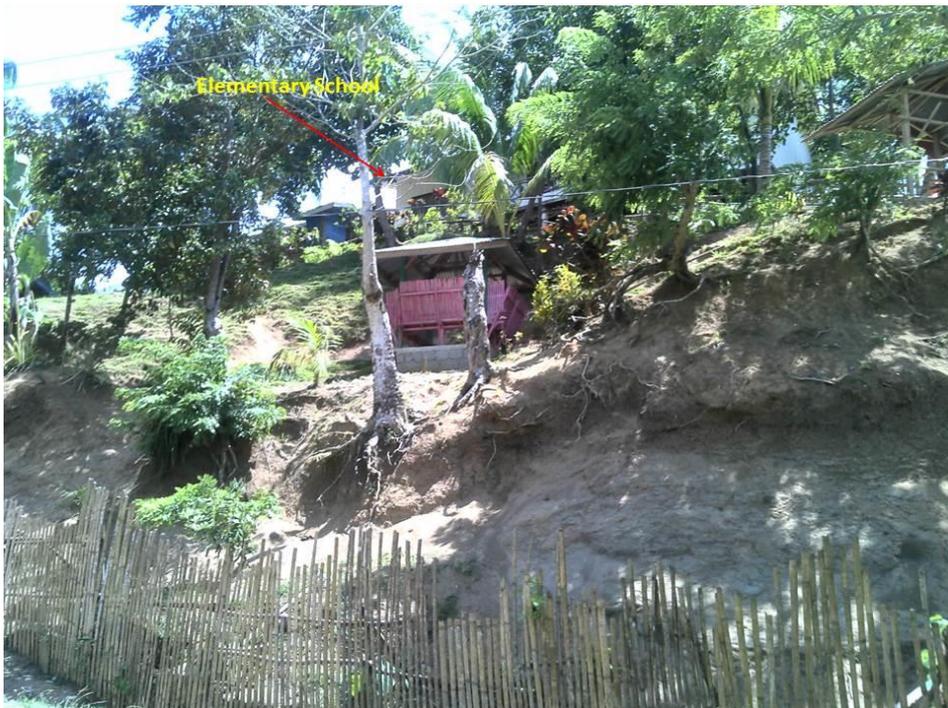
Above is a photo of San Isidro Elementary School located on top of 20-meter steep slope. Shallow landslides found at the base of the slope. (Geographical Location: 8° 52' 22.8" N 125° 38' 33.1" E)

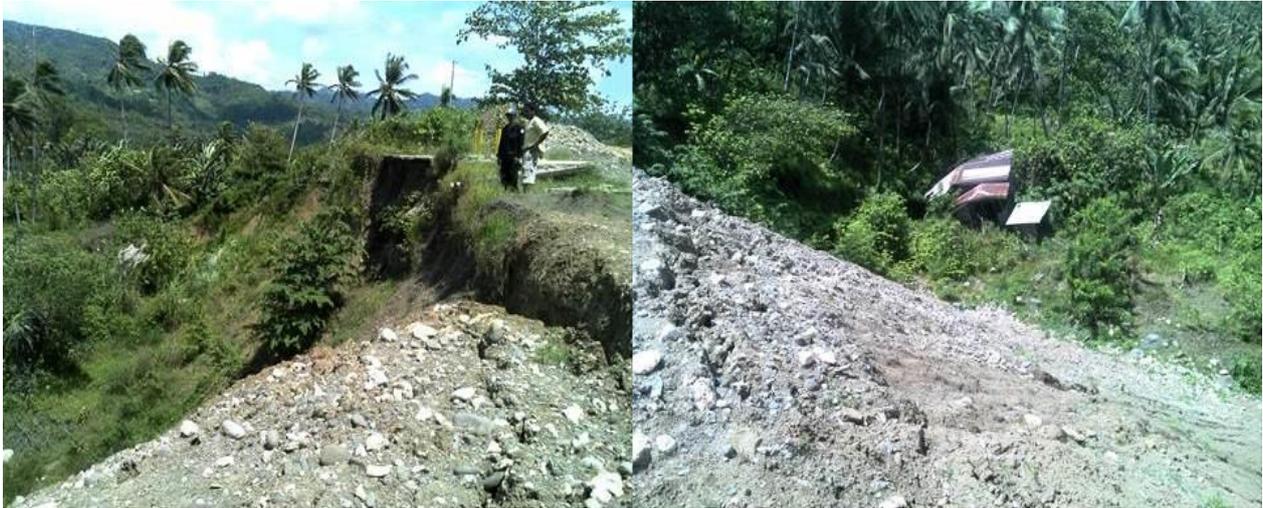
Left photo is a landslide along segment of Maharlika Highway with a length of approximately 15 meters. To the right is a photo of a house affected by the landslide. (Geographical Location: 8° 52' 6.3" N 125° 39' 38.1" E)

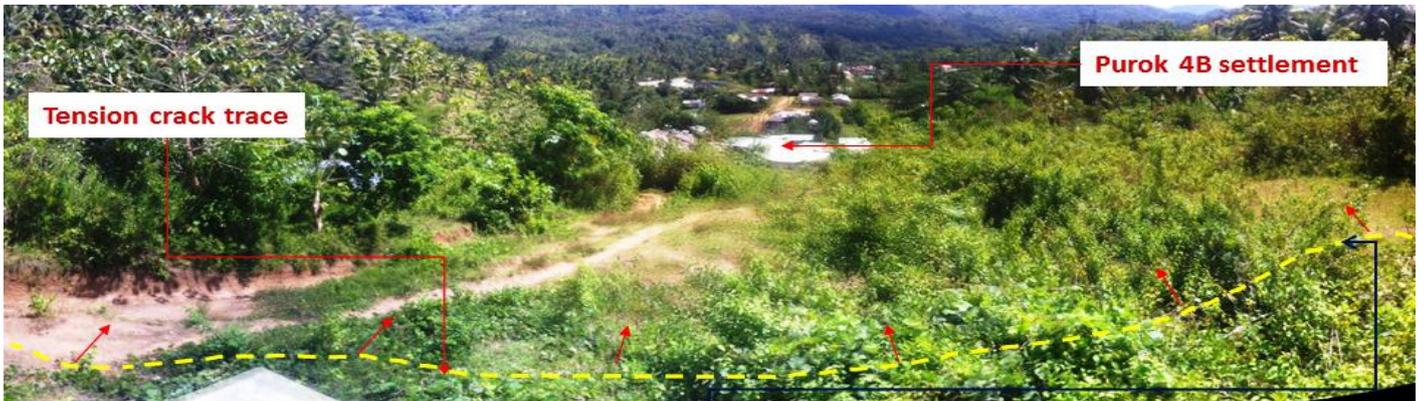
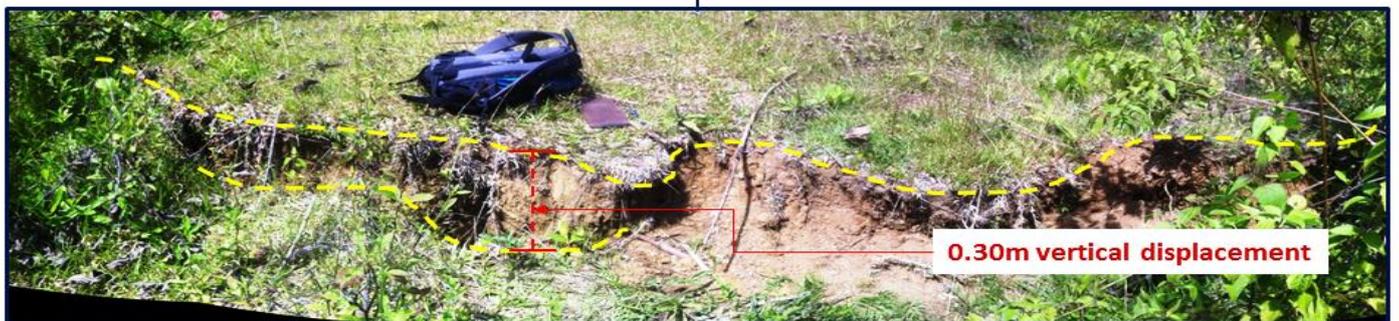
Developing tension cracks located at the upper slopes of Purok 4B.

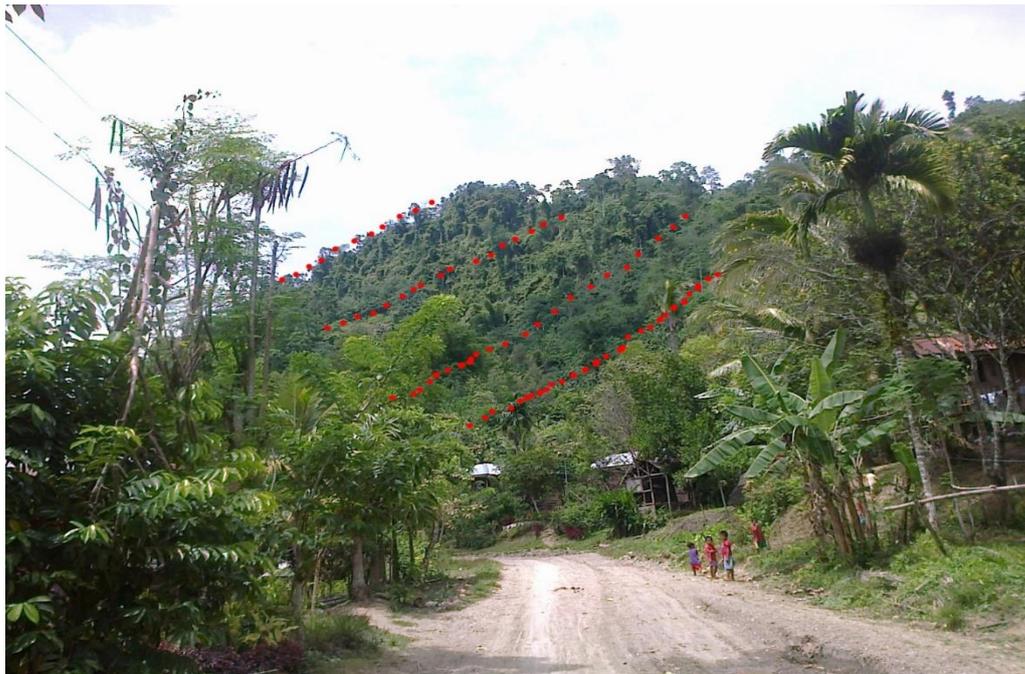
The area is located on a steep to very steep, relatively elevated slope, approximately 500 meters high. The slope is composed entirely of weathered sedimentary materials making it highly susceptible to landslide. Presence of mass movement is observed due to soil creep and subtle disintegration of overlying sedimentary units. (At Purok 4 with GPS location: 8° 58' 59.9" N 125° 43' 19.2" E)

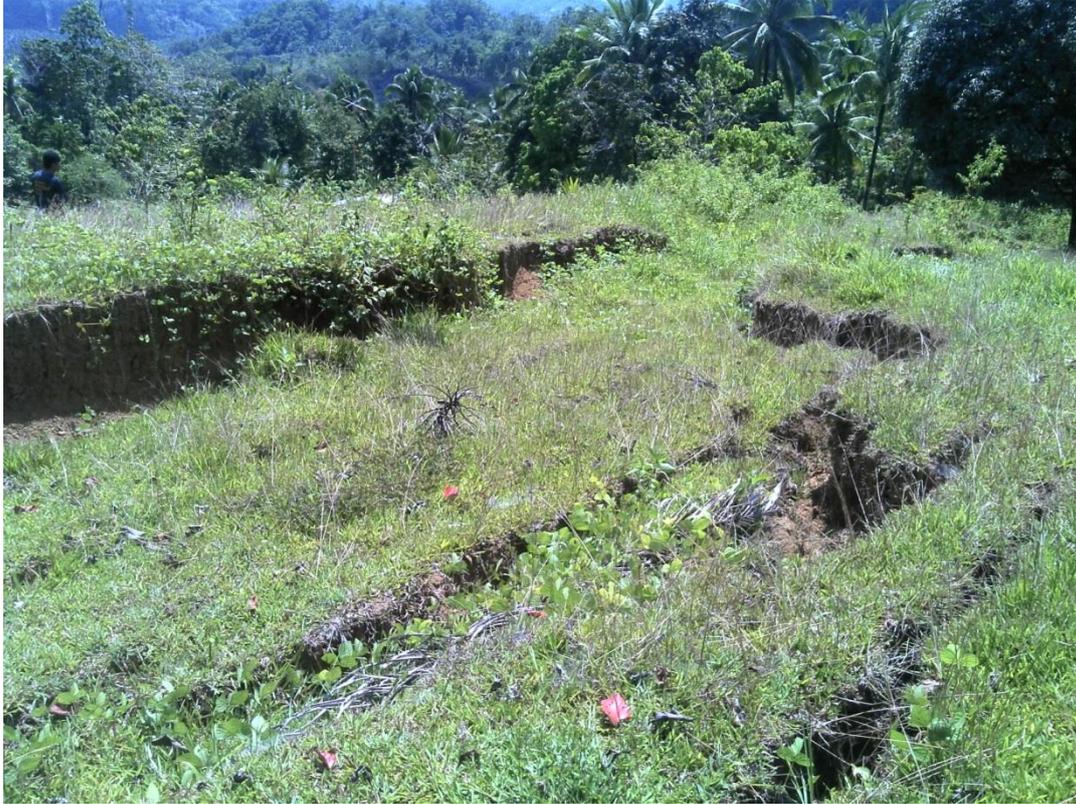
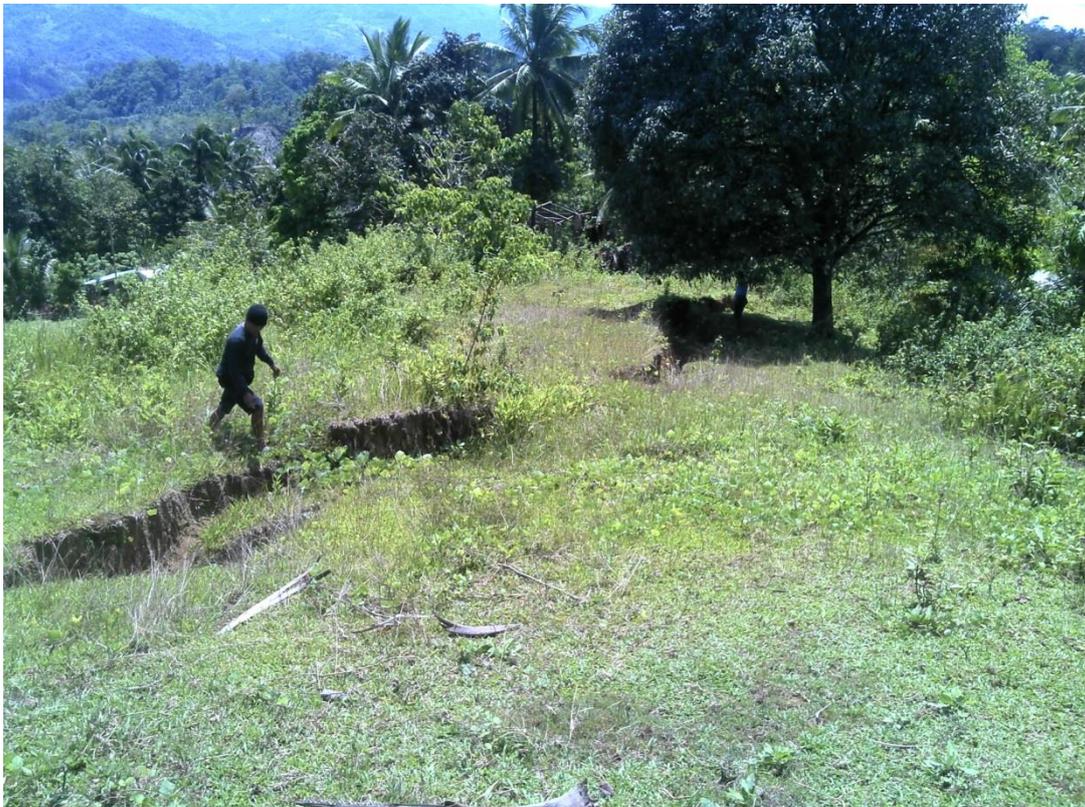
These photos shows series of tension cracks about 300-meter long with a vertical displacement of 0.5 to 1 meter found in Purok 6 are possibly associated by regional tectonism. (Geographical Location: 8° 50' 35.5" N 125° 40' 29.4" E)

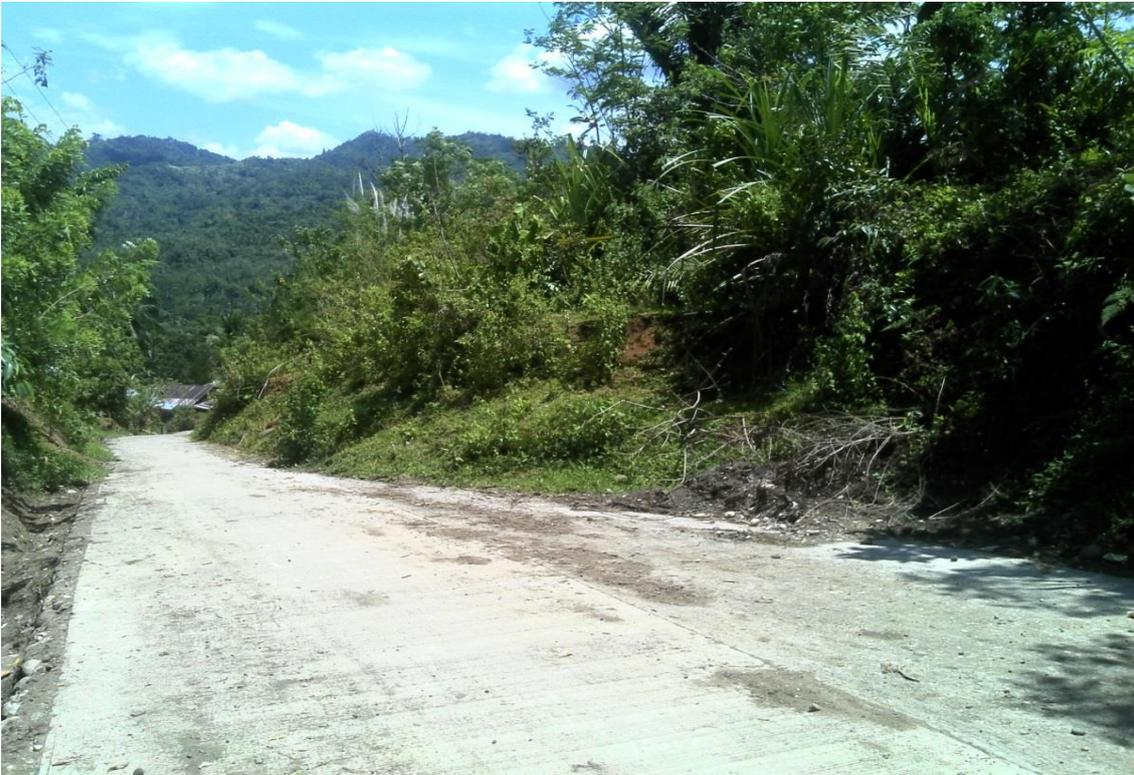
This photo shows shallow landslide found along the barangay road going to Purok 6 which is possibly associated with regional tectonism (Geographical Location: 8° 50' 43.8" N 125° 40' 42.6" E)

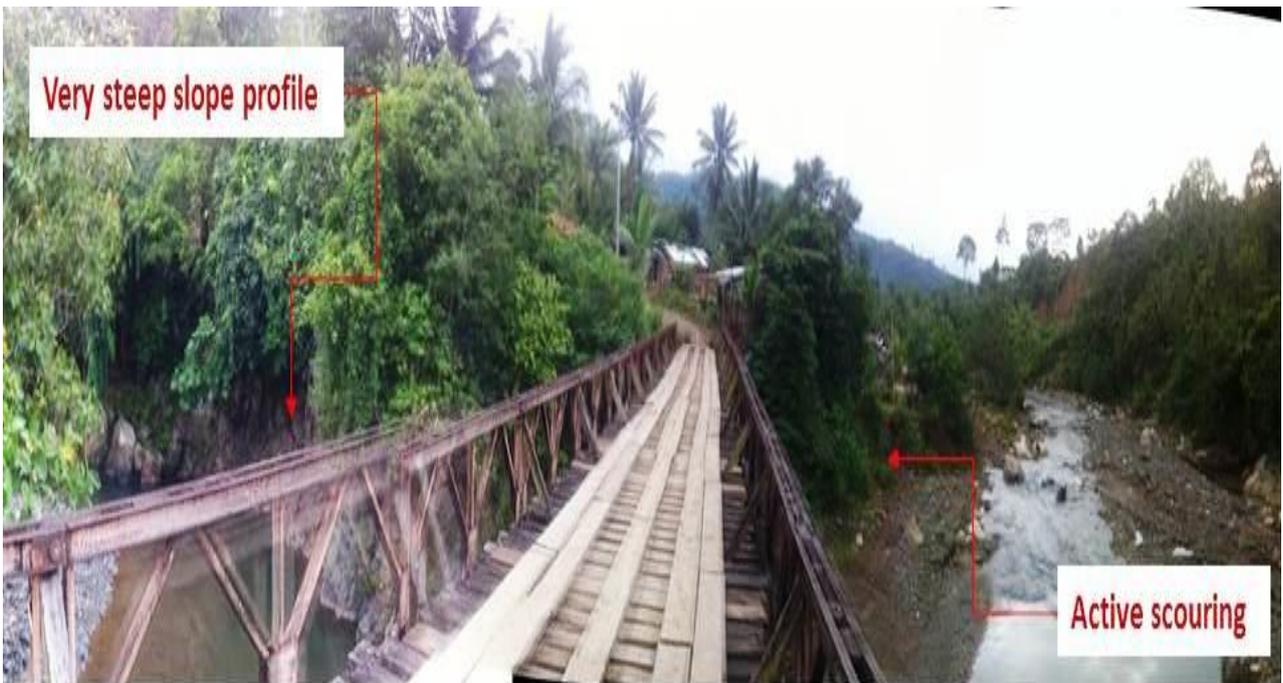
Old steel and wooden bridge along Andanan River showing river banks with active scouring.

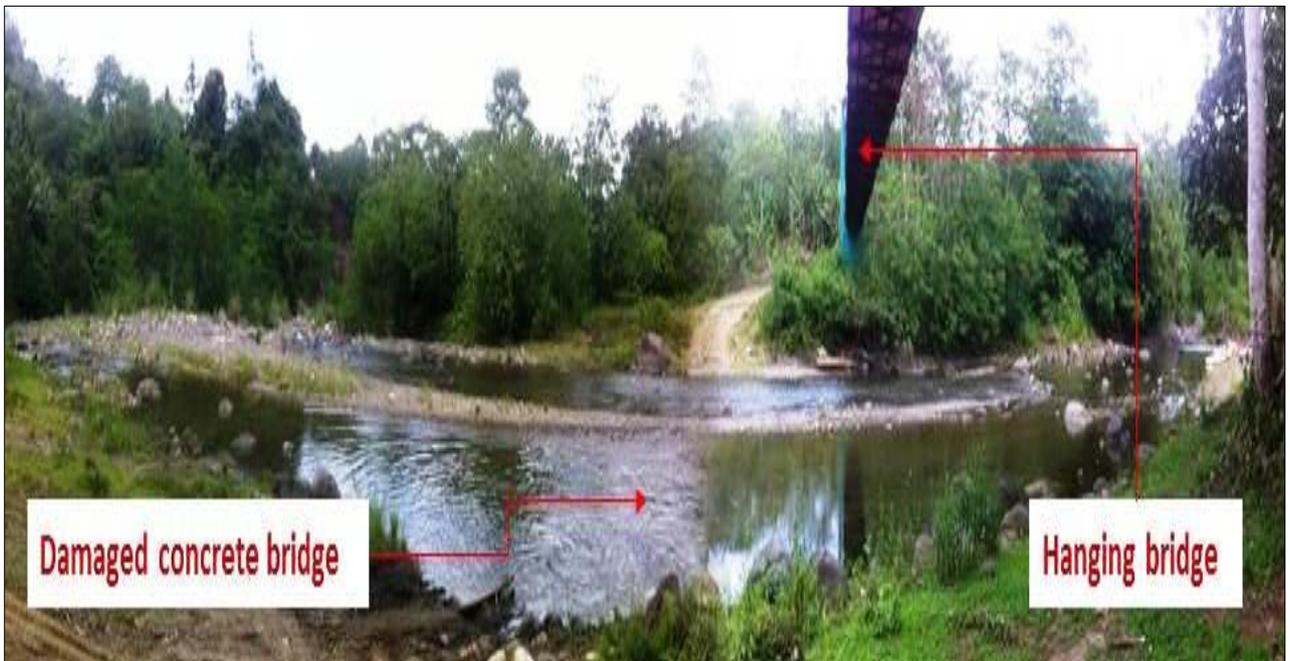
Segment of Pariay River showing the location of the damaged concrete bridge.

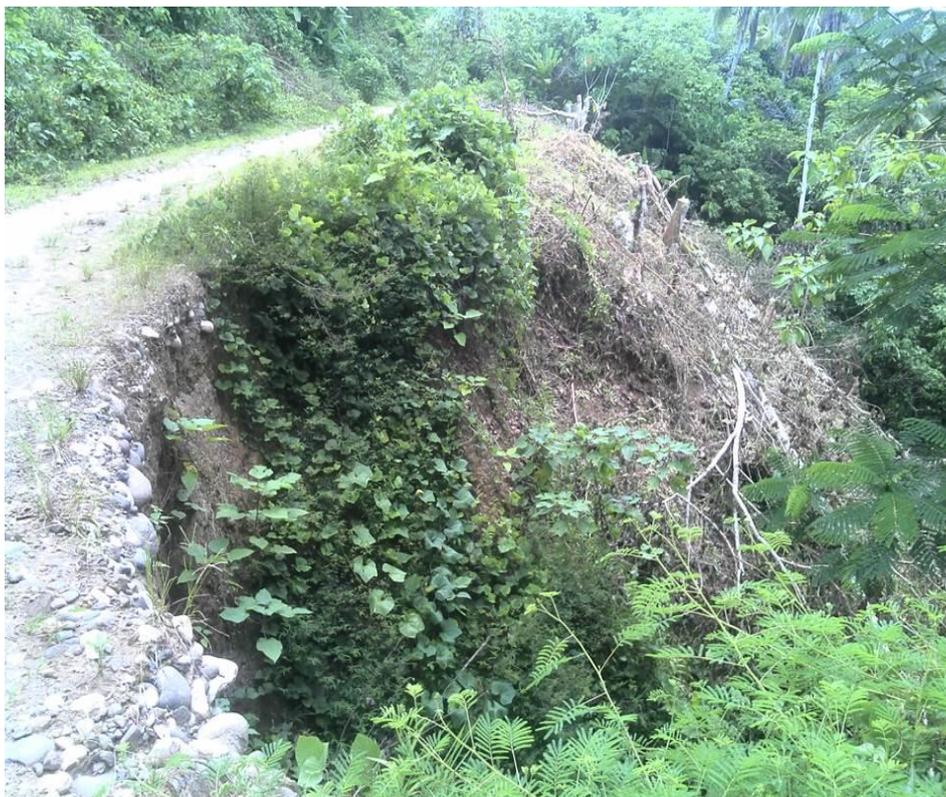
This is a photo of a 50 meters long and 6 meters deep landslide along the trail going to Purok 15. Several landslides are also found in the area which is possibly associated by the movement of the Philippine Fault. (Geographical Location: 8° 49' 58" N 125° 42' 3.4" E)

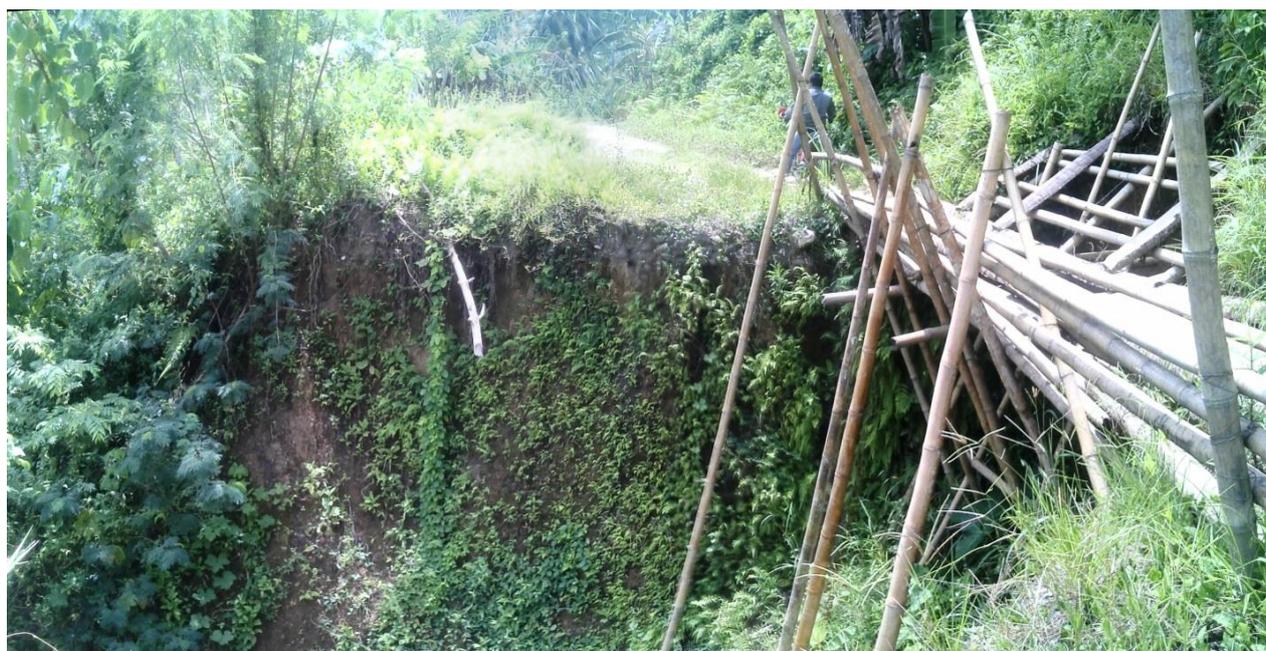
This is a photo of 8 meters deep landslide which occurs during typhoon Agaton and destroyed the road in Purok 15. These landslides that are found in the area are possibly associated by the Philippine Fault. (Geographical Location: 8° 50' 3.1" N 125° 42' 30.9" E)

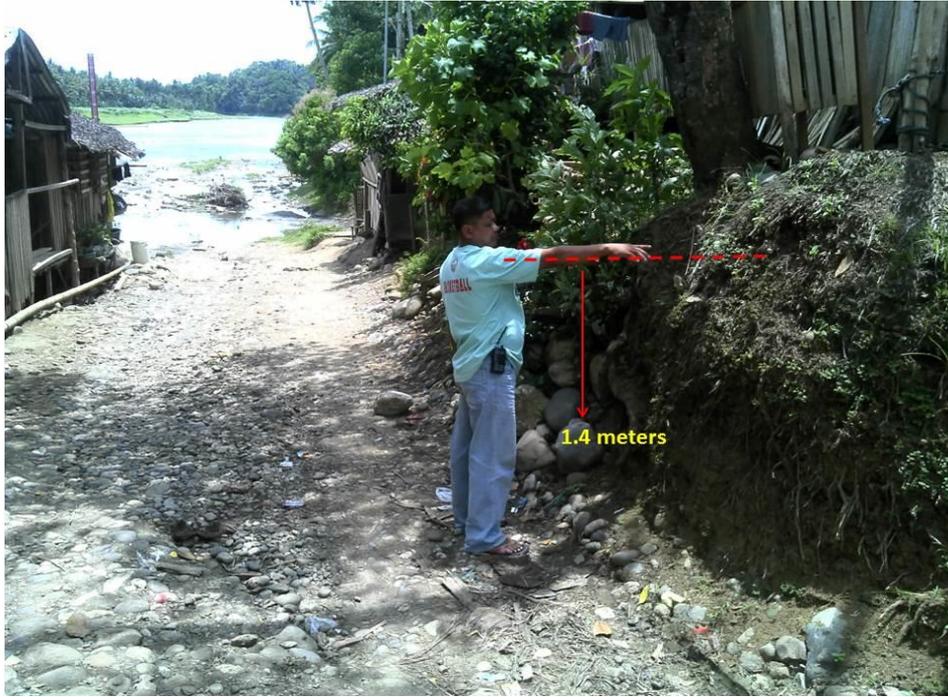
A barangay official of Poblacion shows the flood height of 1.4 meters during typhoon Agaton which lasts for two to three days. (Geographical Location: 8° 49' 17.8" N 125° 41' 43.4" E)

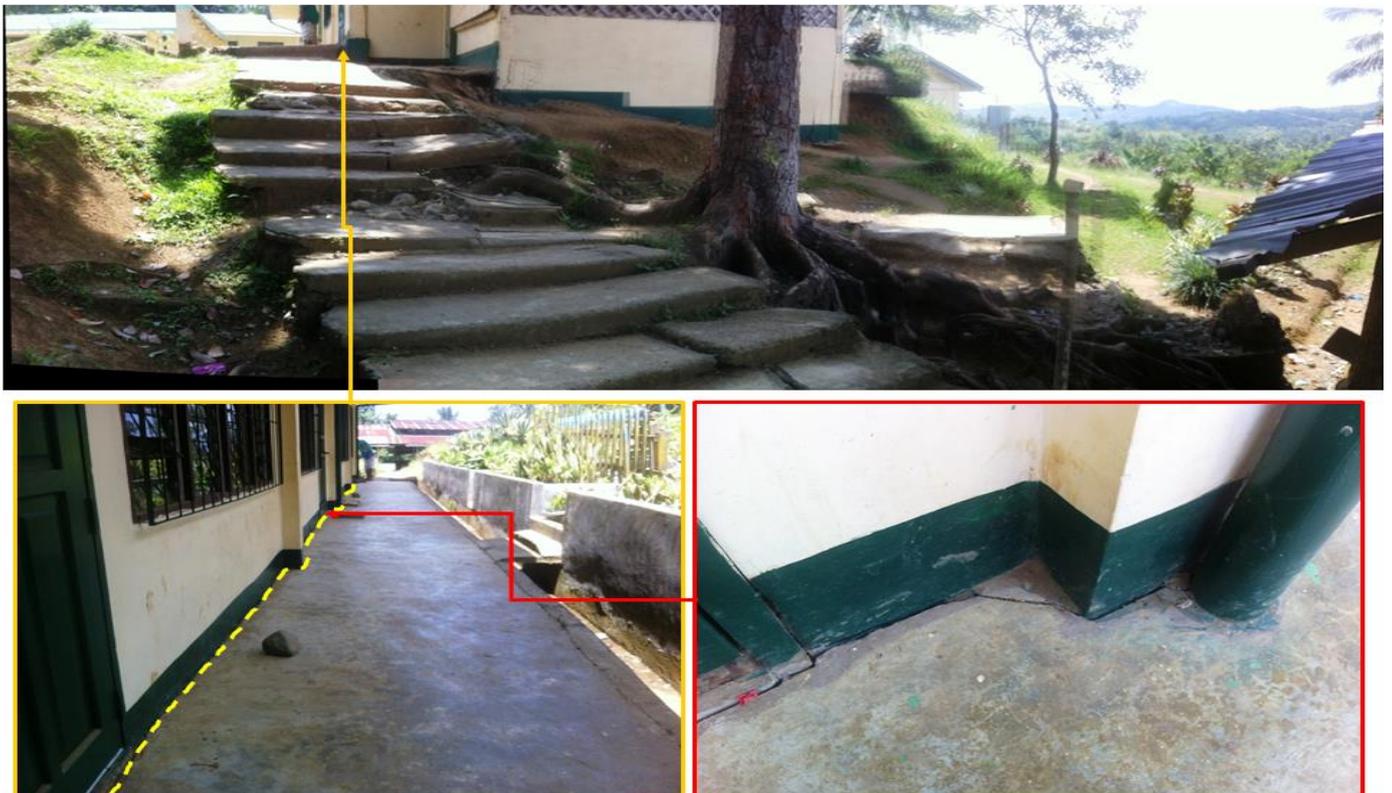
Damages to school building caused by tension cracks and ground movement.

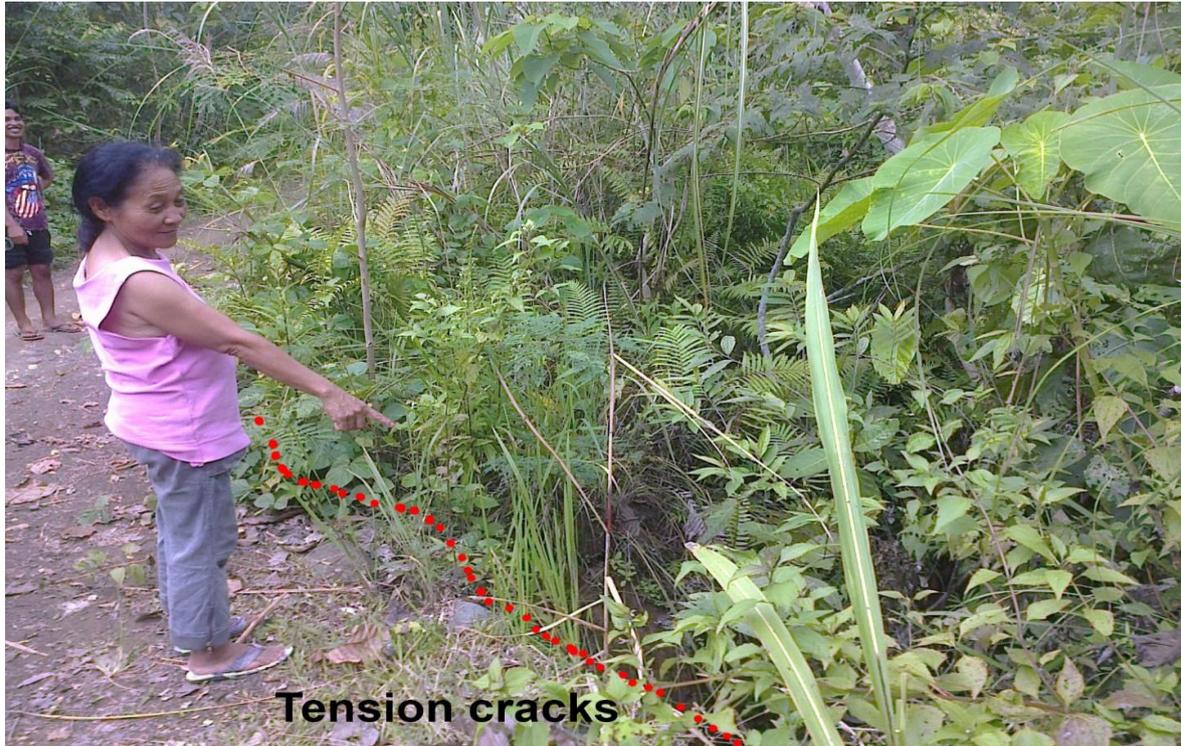
The chairman of Barangay Tag-Oyango pointing on a tension crack extending 100M along the barangay road in Purok 8. (With a GPS location $8^{\circ} 49' 21.8'' N/125^{\circ} 42' 39.4'' E$)

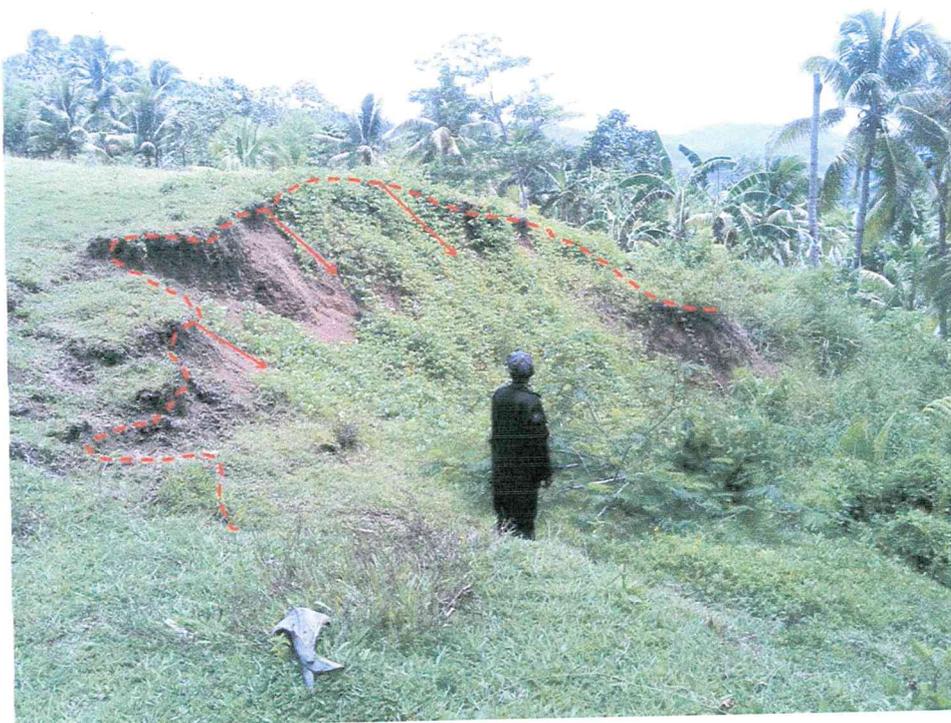
Photo showing the escarpment with vertical displacement of 0.5 to 1.5 meters and about 30 meters long found in the proposed relocation site for the residents affected by the road widening. **(Geographical Location: 8° 52' 41" N 125° 39' 23.3" E)**

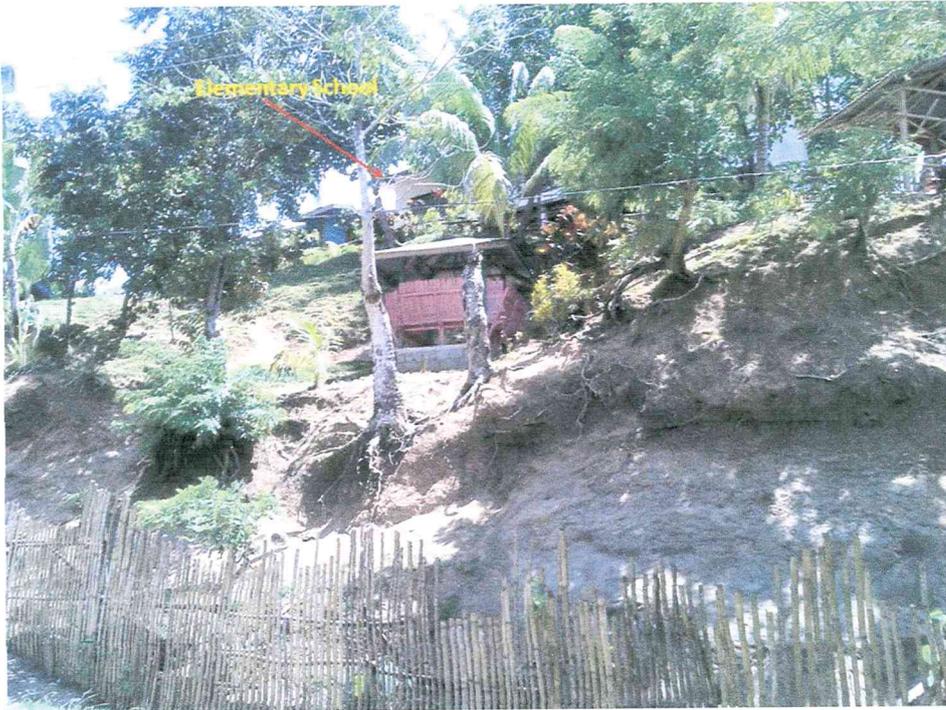
Above is a photo of San Isidro Elementary School located on top of 20-meter steep slope. Shallow landslides found at the base of the slope. **(Geographical Location: 8° 52' 22.8" N 125° 38' 33.1" E)**

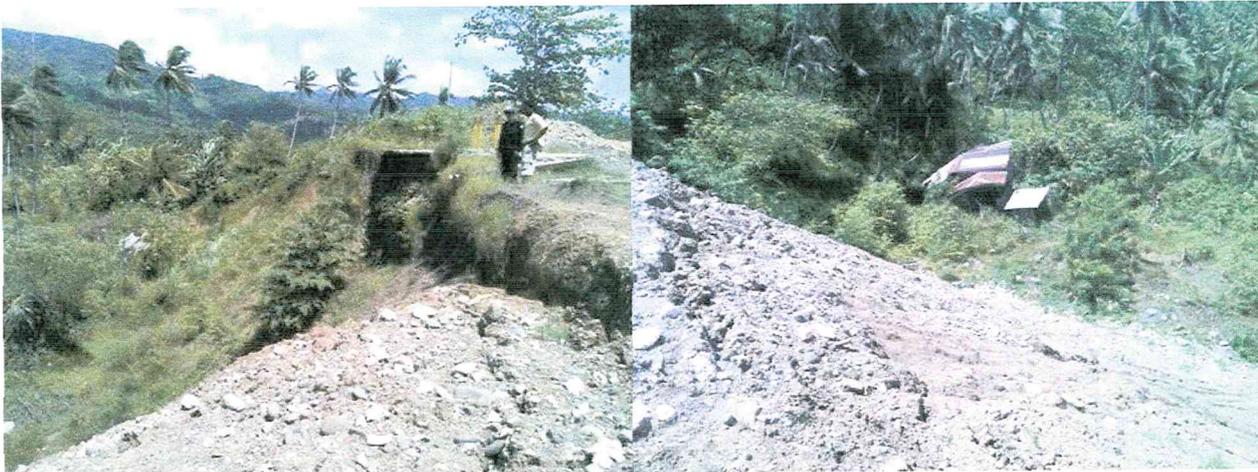
<p>Along Maharlika Highway, Purok 8 8° 52' 6.3" N 125° 39' 38.1" E</p>	<p>High</p>	<p>Very steep landslide along the eastern side of Maharlika Highway where one house fell during the said event.</p> <p>Recommendations: Discourage future habitation and construction of government building that might add additional load to the steep slope. Organize disaster preparedness and rescue training for barangay officials and residents of the barangay.</p>
<p>Purok 8 waiting shed 8° 52' 6.3" N 125° 39' 35.6" E</p>	<p>High</p>	<p>Residences near Purok8 waiting shed that are situated on the eastern side of Maharlika Highway are very prone to landslide due to the instability of the slope.</p> <p>Recommendations: Discourage future habitation and construction of government building that might add additional load to the steep slope. Organize disaster preparedness and rescue training for barangay officials and residents of the barangay.</p>

Left photo is a landslide along segment of Maharlika Highway with a length of approximately 15 meters. To the right is a photo of a house affected by the landslide. **(Geographical Location: 8° 52' 6.3" N 125° 39' 38.1" E)**

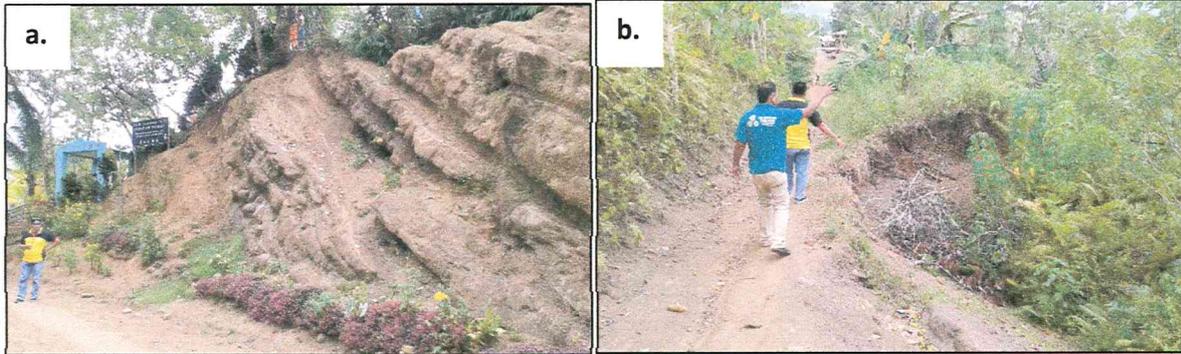
Photos. Tilted bedded sedimentary rocks exposed along the road cut in Anahawan Elementary School (a) and minor landslide along the access road to Purok 5 (b).

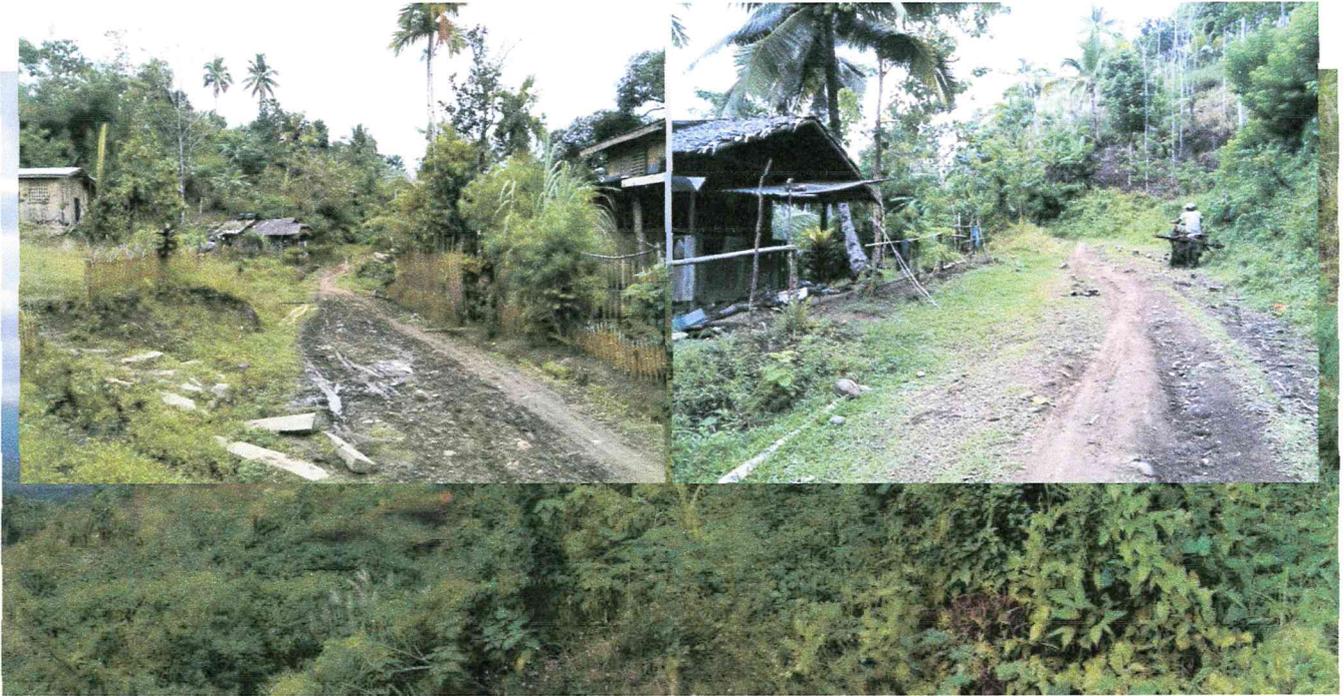
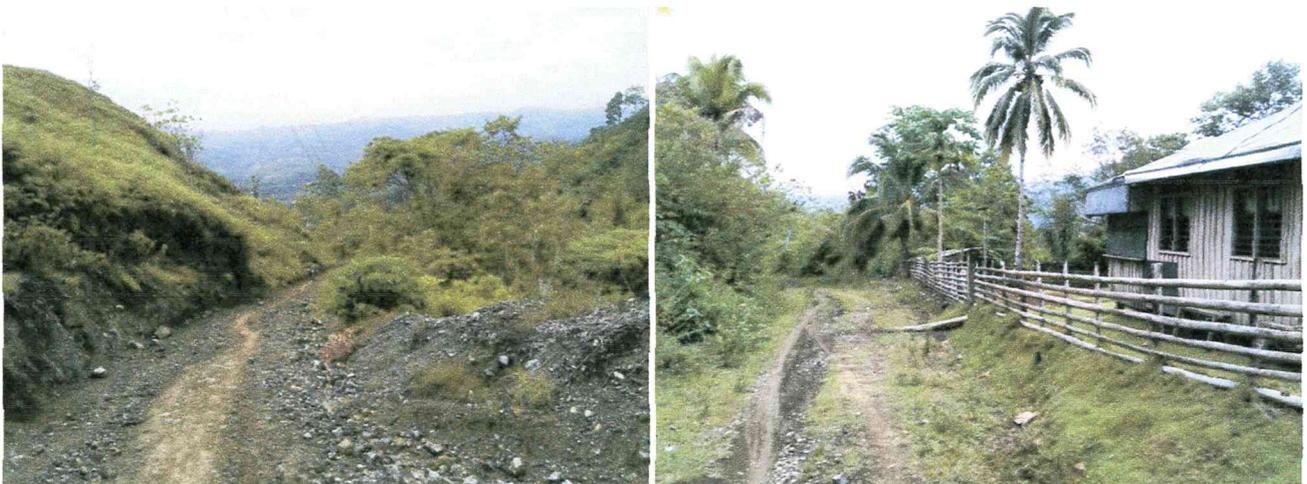
An approximately 200 meter wide landslide area at Purok 3 was mapped affecting the barangay access road. The event took place during Typhoon Agaton.

Clockwise: Residential area situated along a rugged terrain; Purok 1B, Purok 3, Purok 5, and access road within a steep terrain along Purok 2

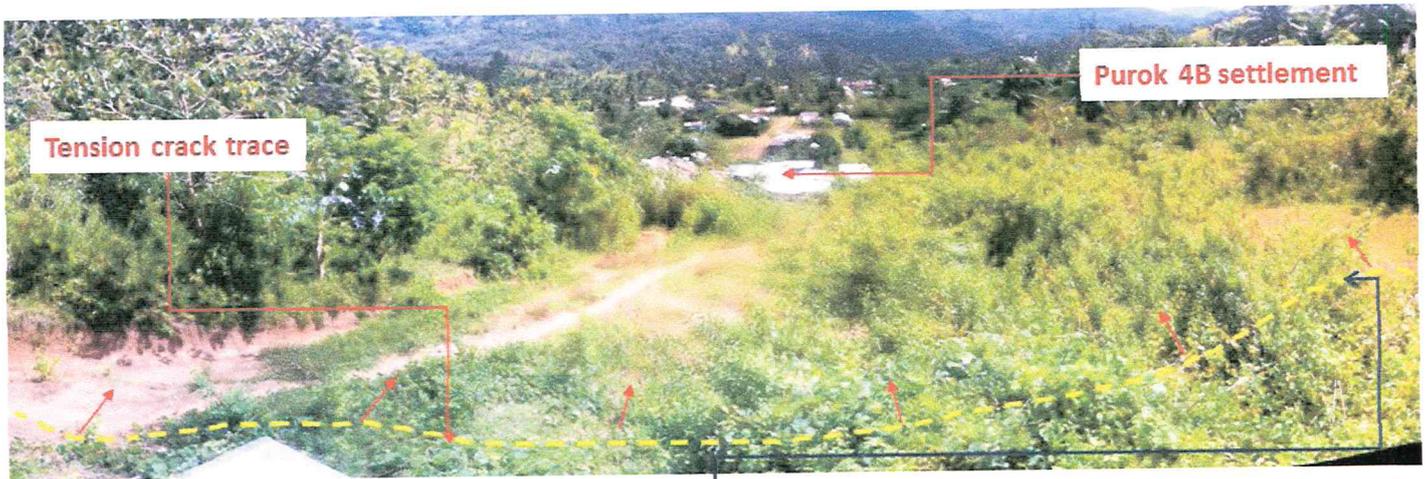
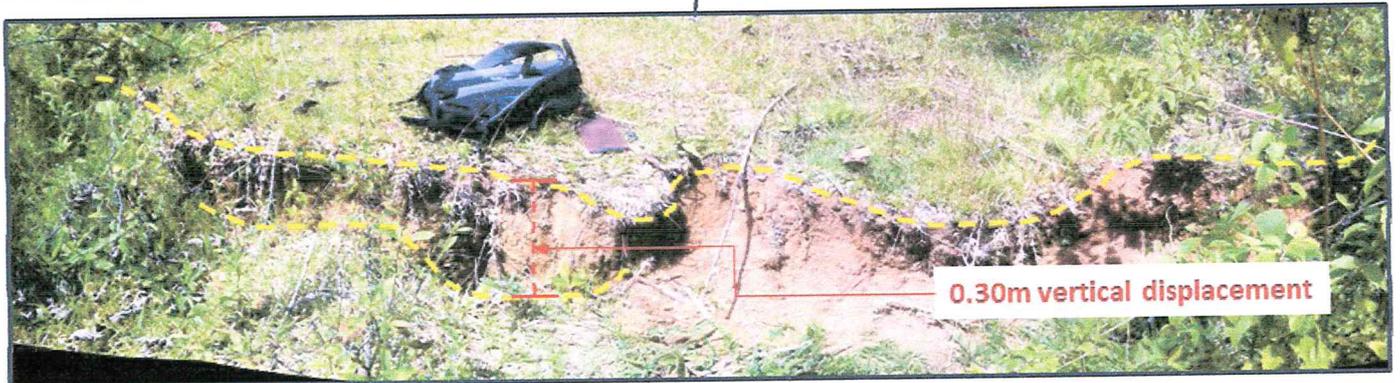
Developing tension cracks located at the upper slopes of Purok 4B.

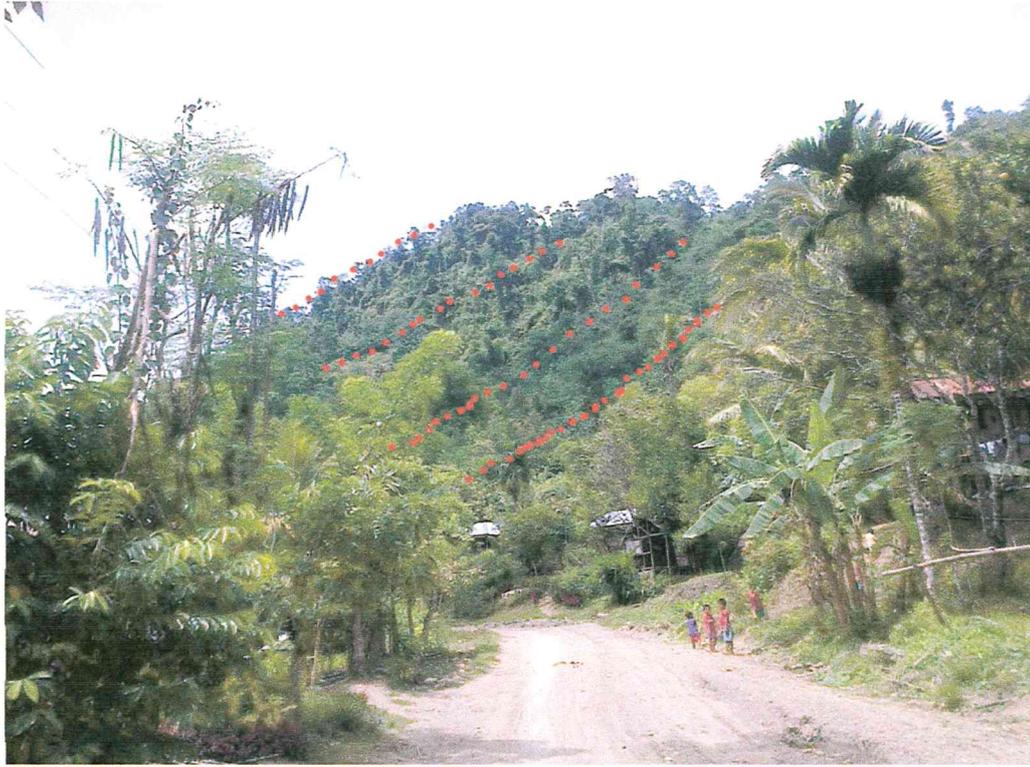
The area is located on a steep to very steep, relatively elevated slope, approximately 500 meters high. The slope is composed entirely of weathered sedimentary materials making it highly susceptible to landslide. Presence of mass movement is observed due to soil creep and subtle disintegration of overlying sedimentary units. (At Purok 4 with GPS location: 8° 58' 59.9" N 125° 43' 19.2" E)

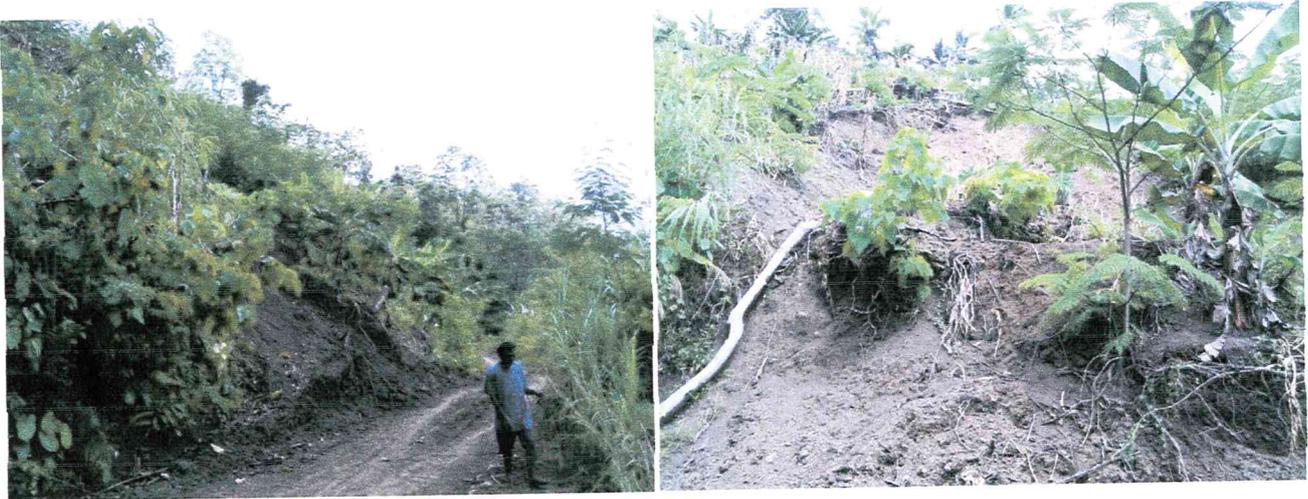
Photographs of minor landslide area mapped along the road in Purok 1.

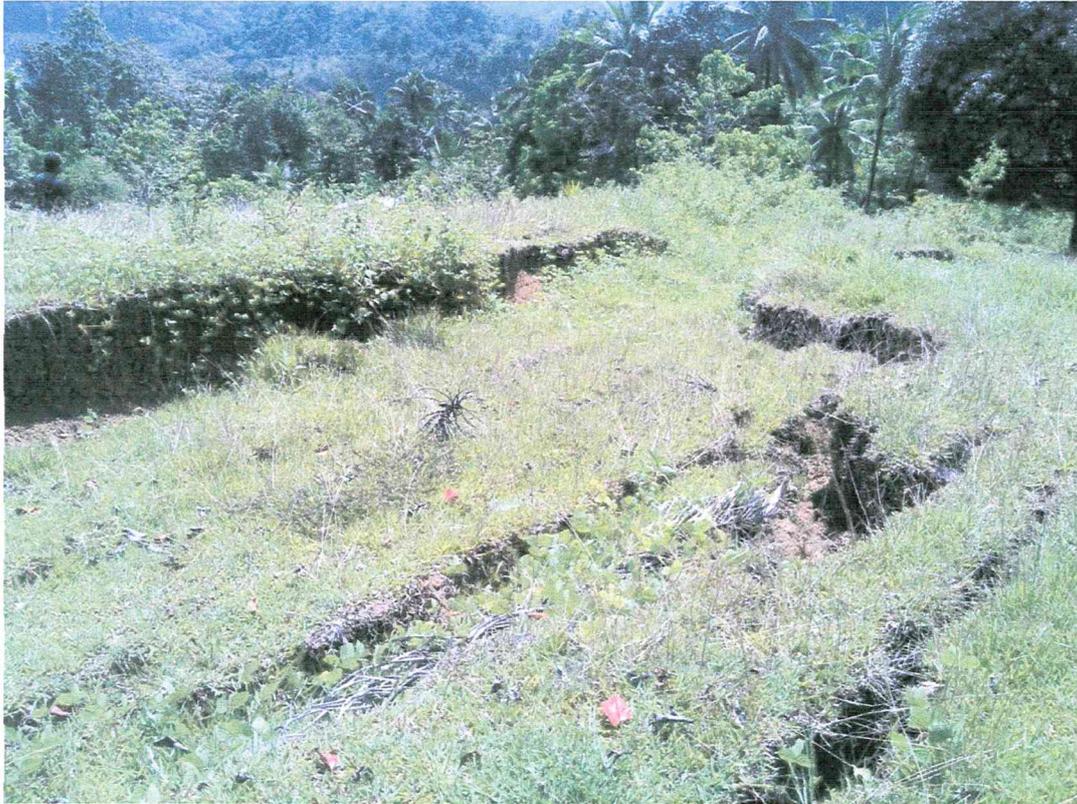
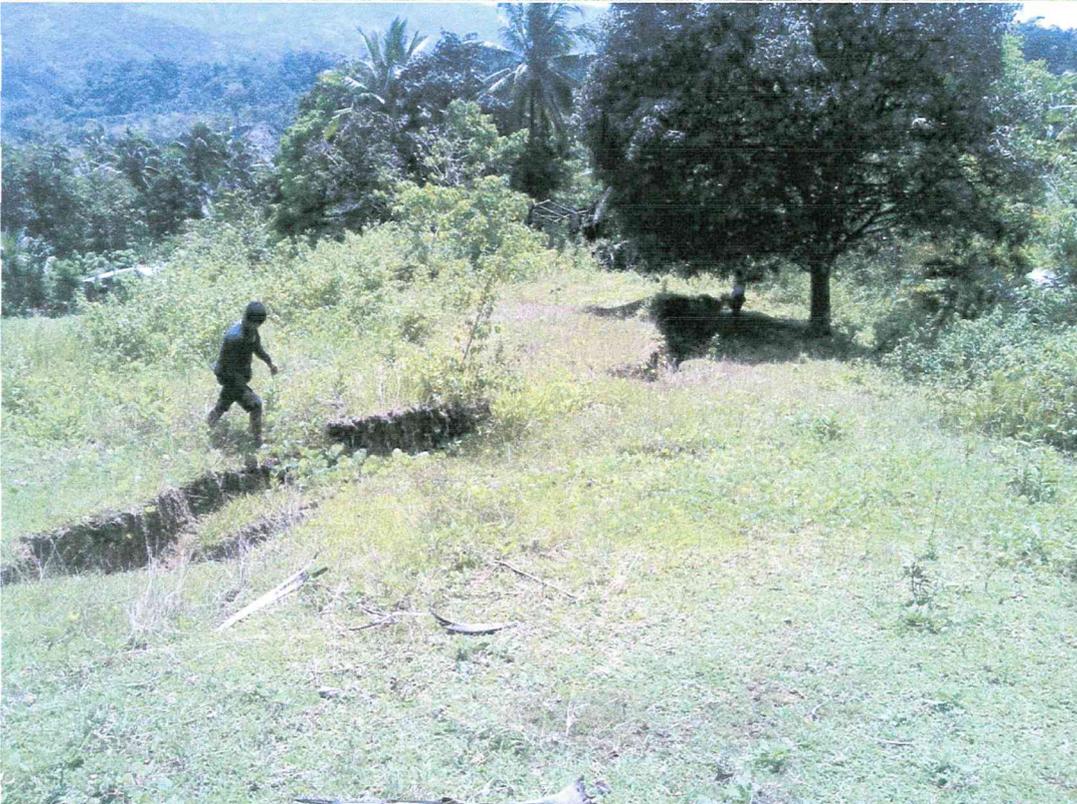
These photos shows series of tension cracks about 300-meter long with a vertical displacement of 0.5 to 1 meter found in Purok 6 are possibly associated by regional tectonism. (Geographical Location: 8° 50' 35.5" N 125° 40' 29.4" E)

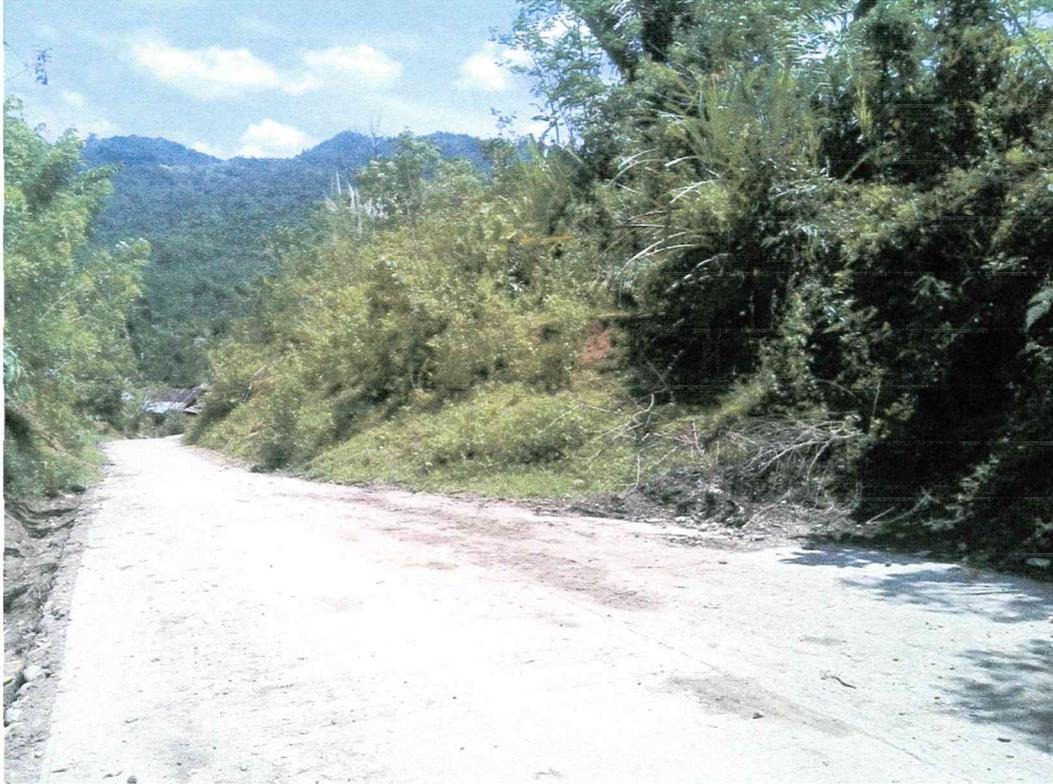
This photo shows shallow landslide found along the barangay road going to Purok 6 which is possibly associated with regional tectonism (**Geographical Location: 8° 50' 43.8" N 125° 40' 42.6" E**)
