REPORT ON THE 1:10,000 SCALE GEOHAZARDS ASSESSMENT AND MAPPING OF SIBAGAT, AGUSAN DEL SUR

SRDP Consulting Inc.
Units 119, 420 & 421 SJB Condominium
130-B Panay Ave, South Triangle
Quezon City, Philippines

OCTOBER 2014

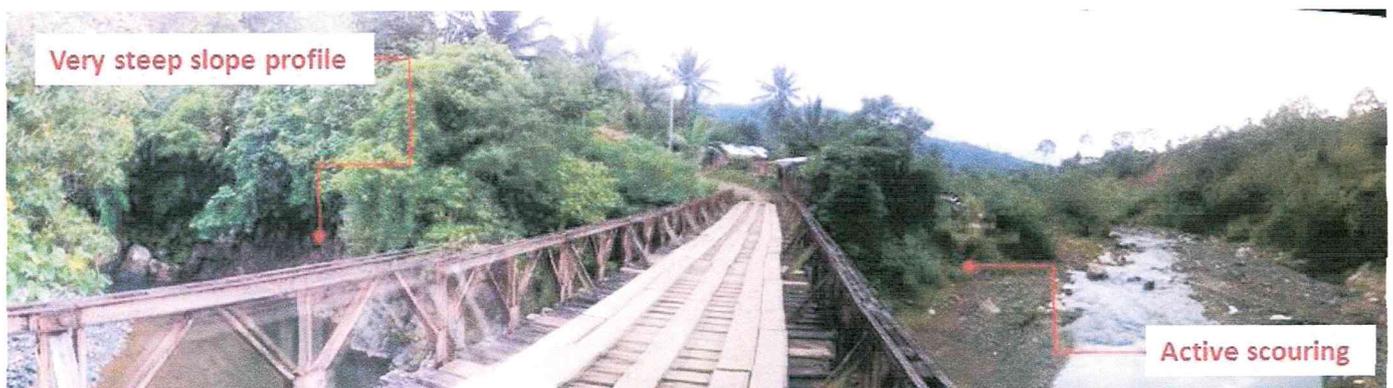
Old steel and wooden bridge along Andanan River showing river banks with active scouring.

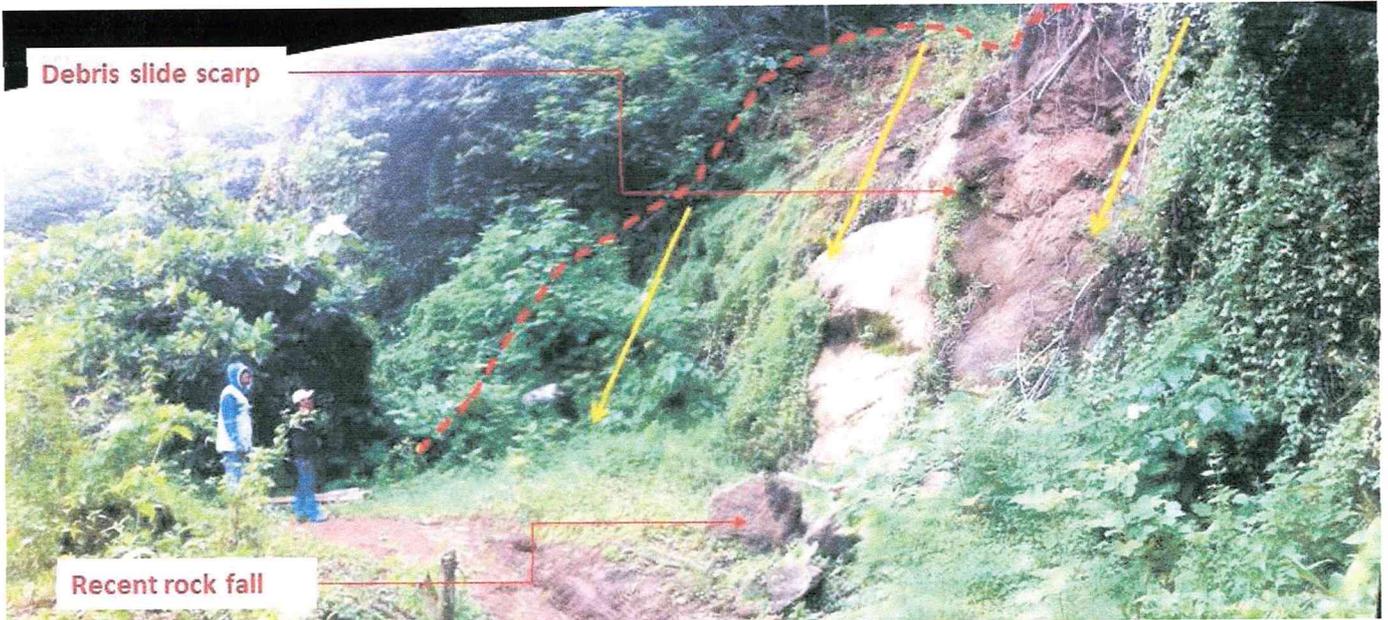
Debris slide with rock fall at Purok 2. These mass movements are common on ridge areas characterized by very steep slope profile.

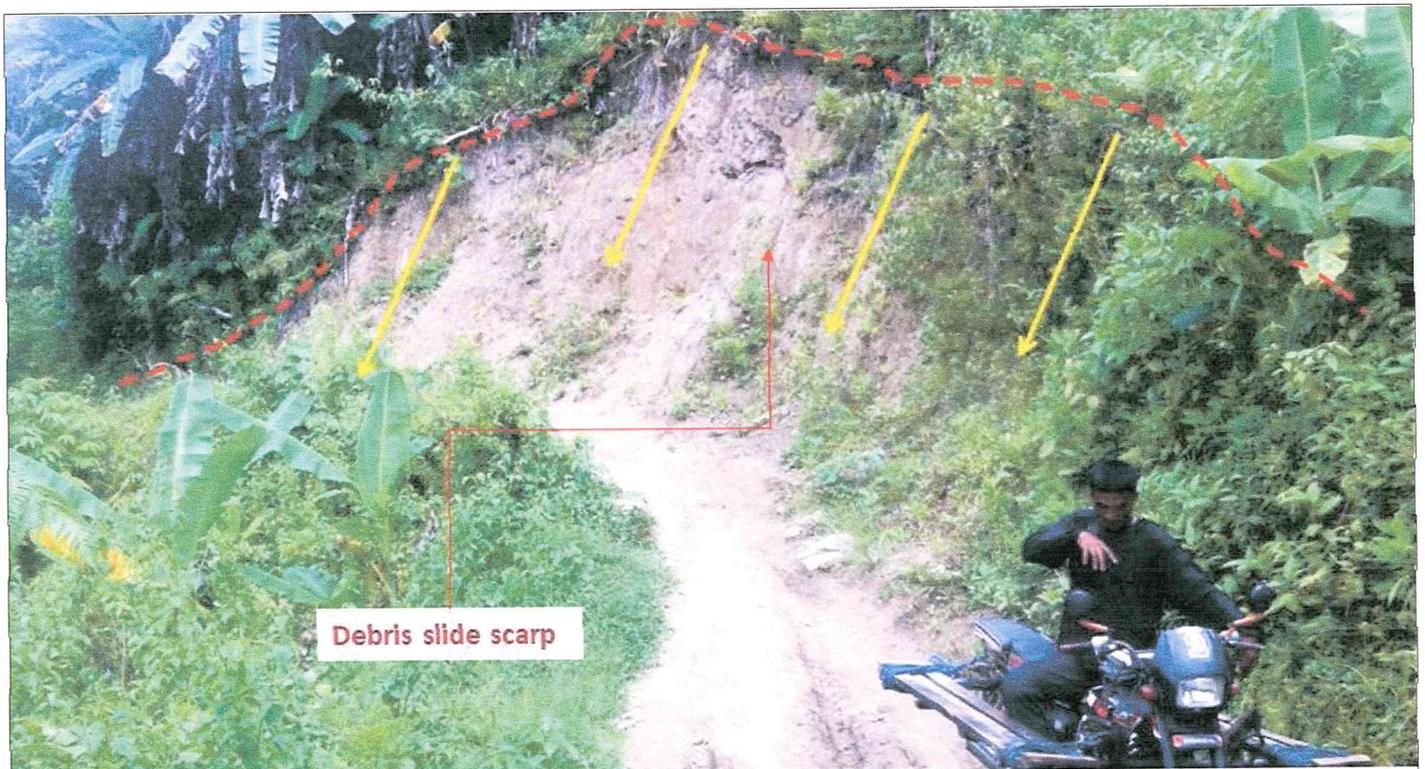
Segment of an all-weather road where landslide has occurred associated with unmitigated road cut slope.

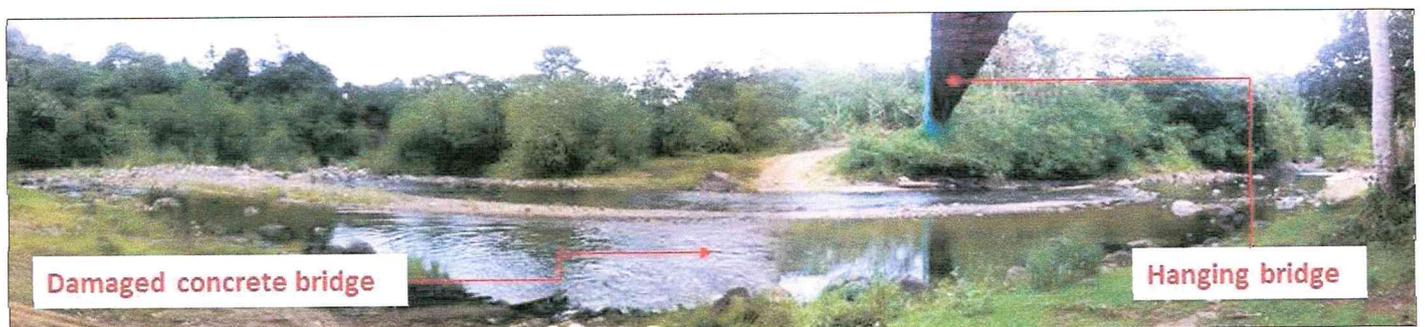
Segment of Pariay River showing the location of the damaged concrete bridge.

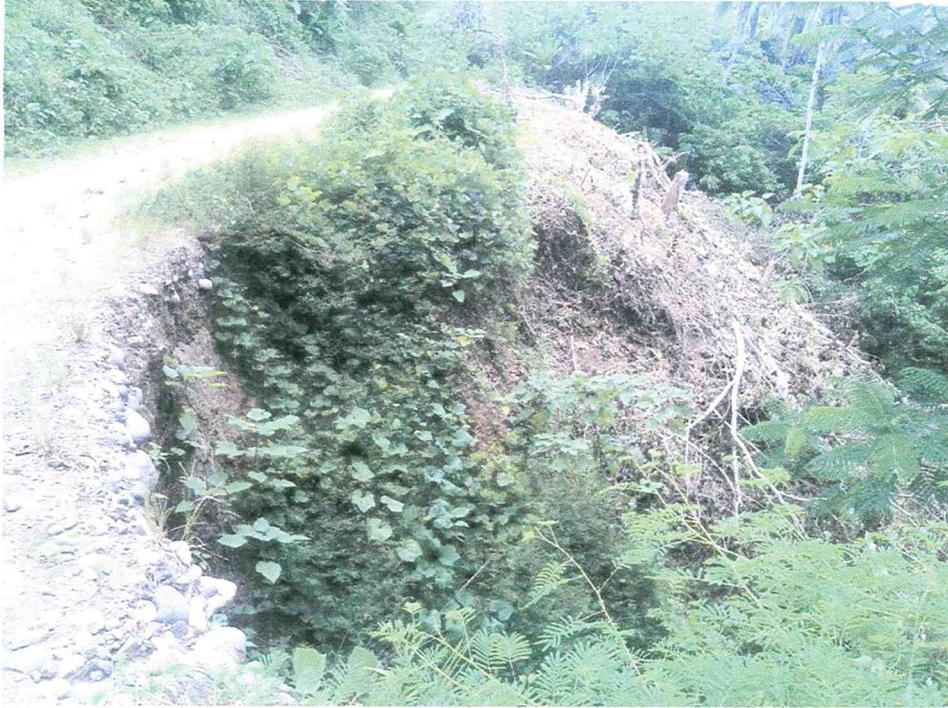
This is a photo of a 50 meters long and 6 meters deep landslide along the trail going to Purok 15. Several landslides are also found in the area which is possibly associated by the movement of the Philippine Fault. **(Geographical Location: 8° 49' 58" N 125° 42' 3.4" E)**

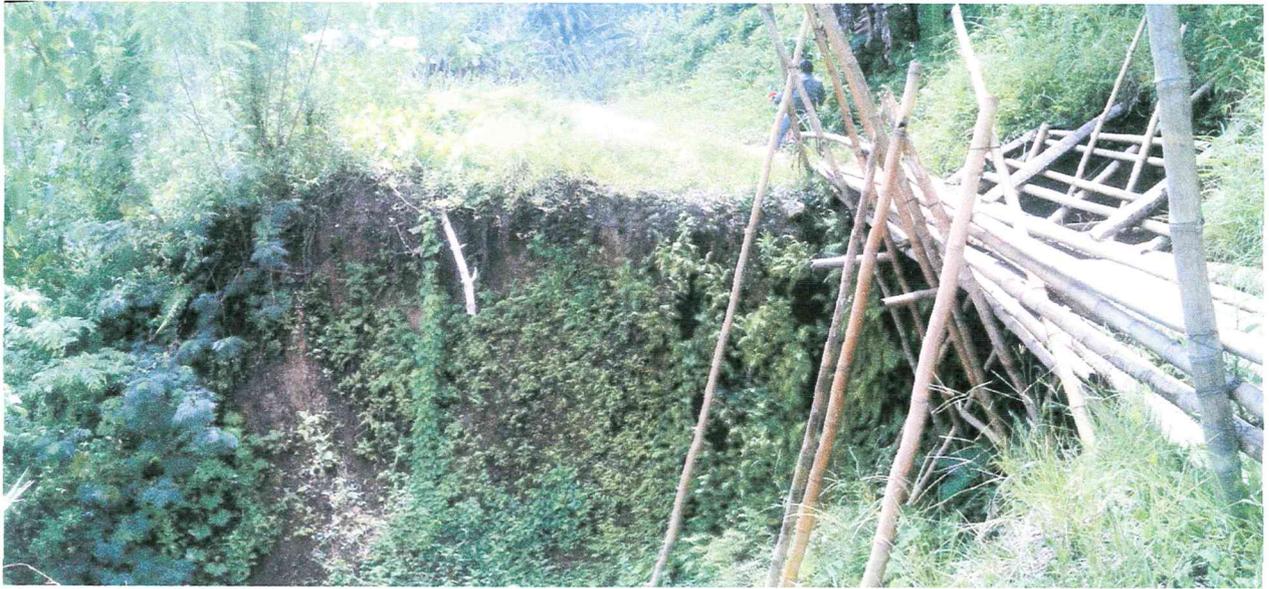
This is a photo of 8 meters deep landslide which occurs during typhoon Agaton and destroyed the road in Purok 15. These landslides that are found in the area are possibly associated by the Philippine Fault. (Geographical Location: 8° 50' 3.1" N 125° 42' 30.9" E)

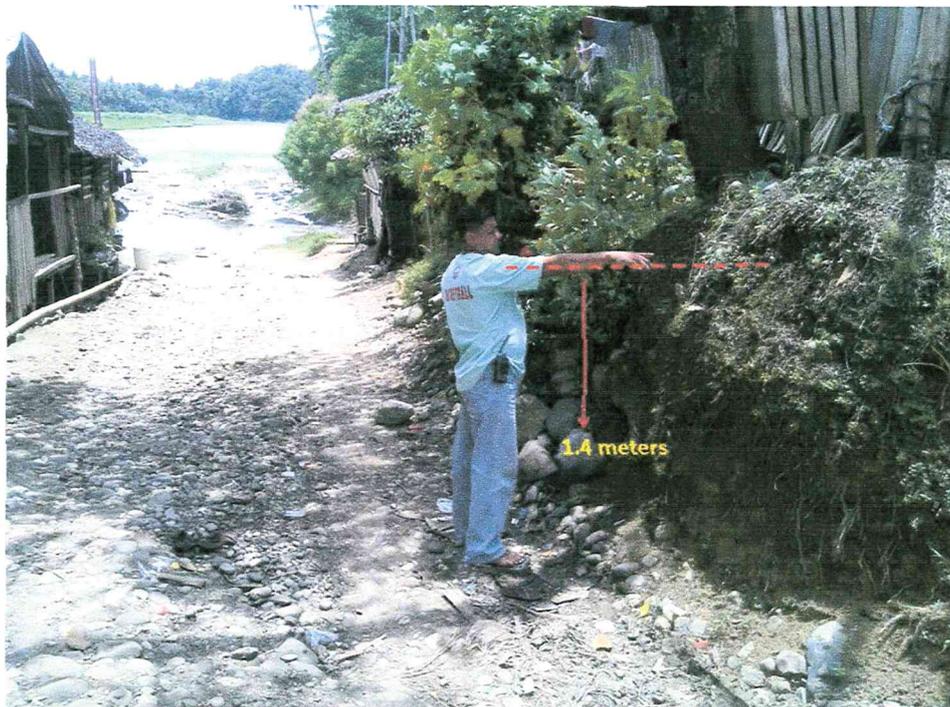
A barangay official of Poblacion shows the flood height of 1.4 meters during typhoon Agaton which lasts for two to three days. (Geographical Location: 8° 49' 17.8" N 125° 41' 43.4" E)

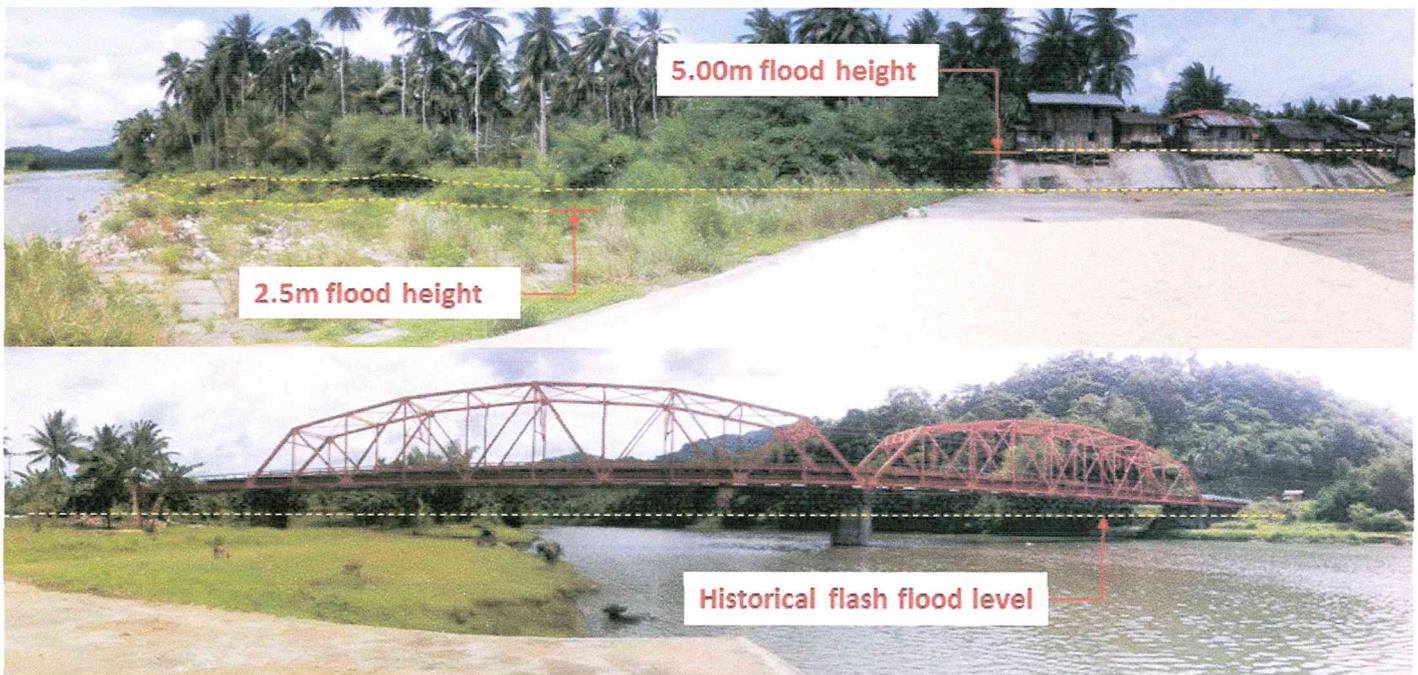
Wawa River along Barangay San Vicente. Yellow dashed line indicates previous flash flood level.

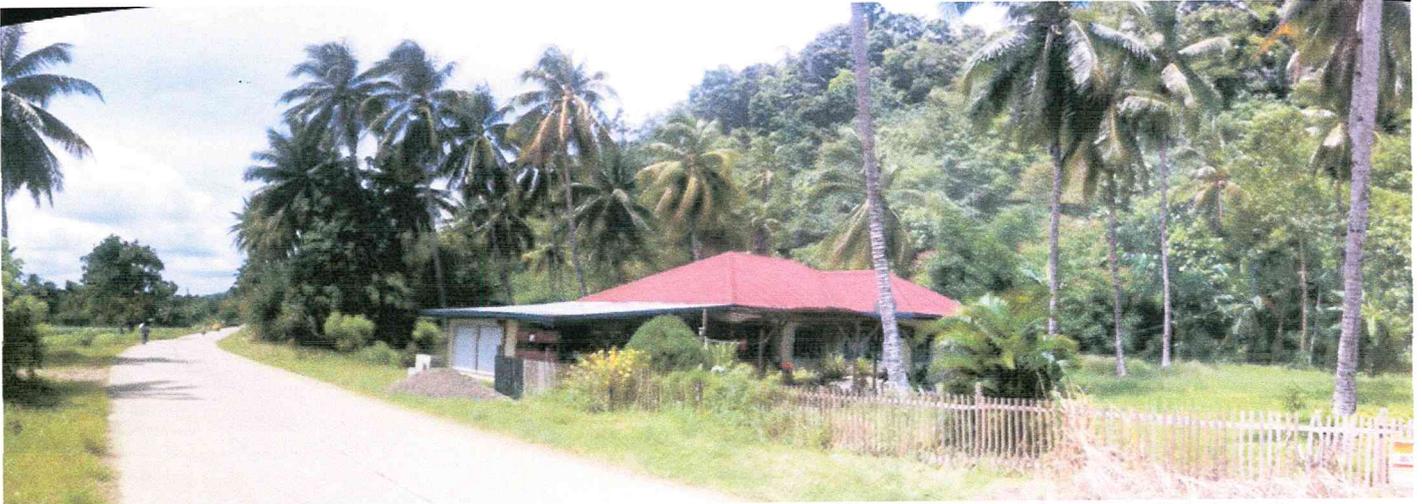
Looking southwest along section of concrete road going to Barangay Ilihan. This area is susceptible to soil creep and localized debris slides.

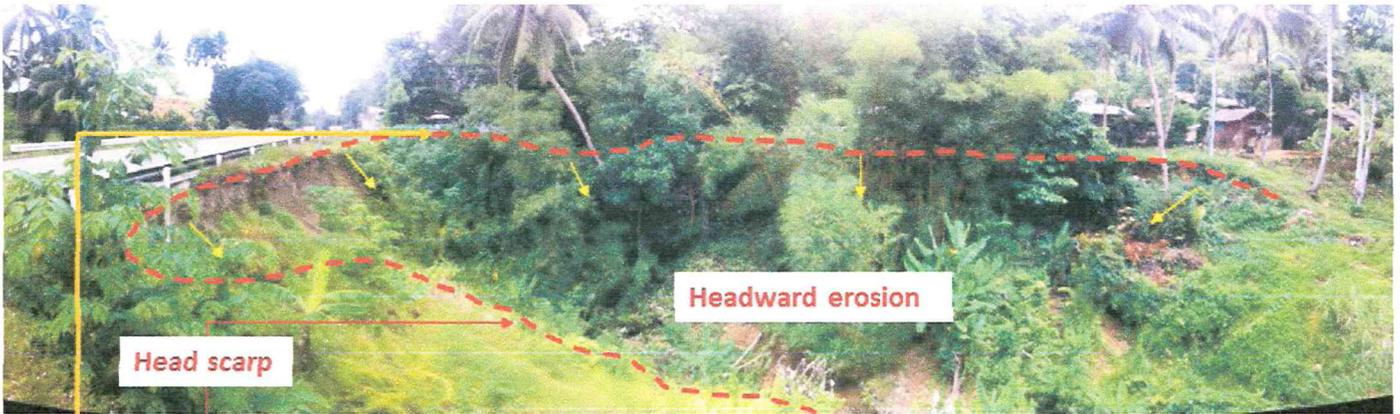
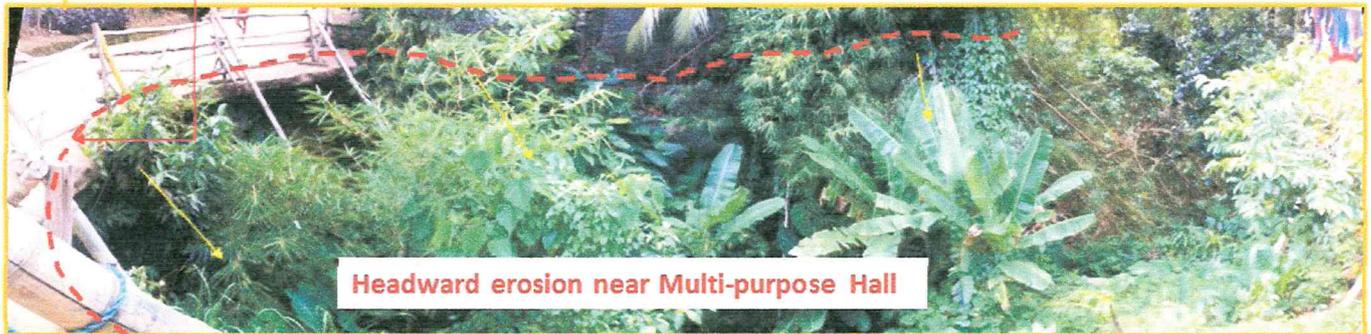
Headward erosion located near Barangay Tabontabon proper.

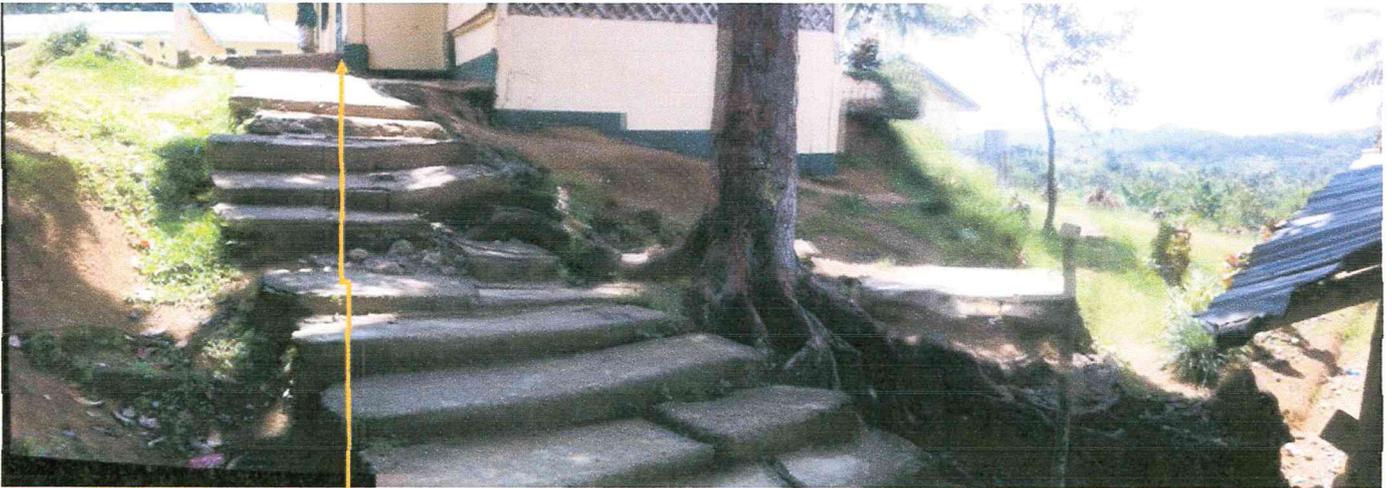
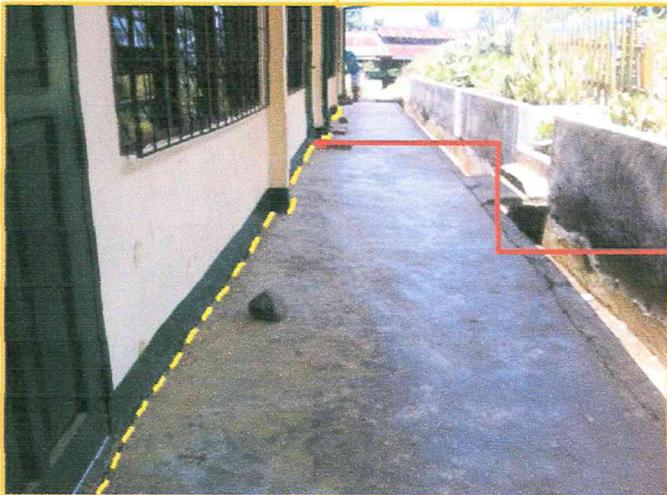
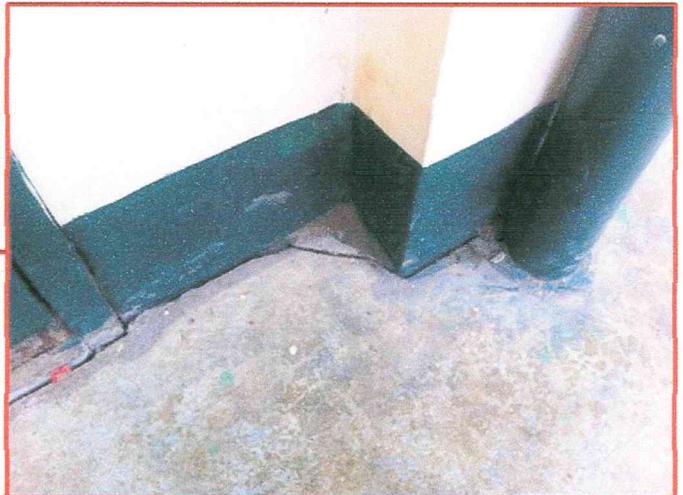
Damages to school building caused by tension cracks and ground movement.

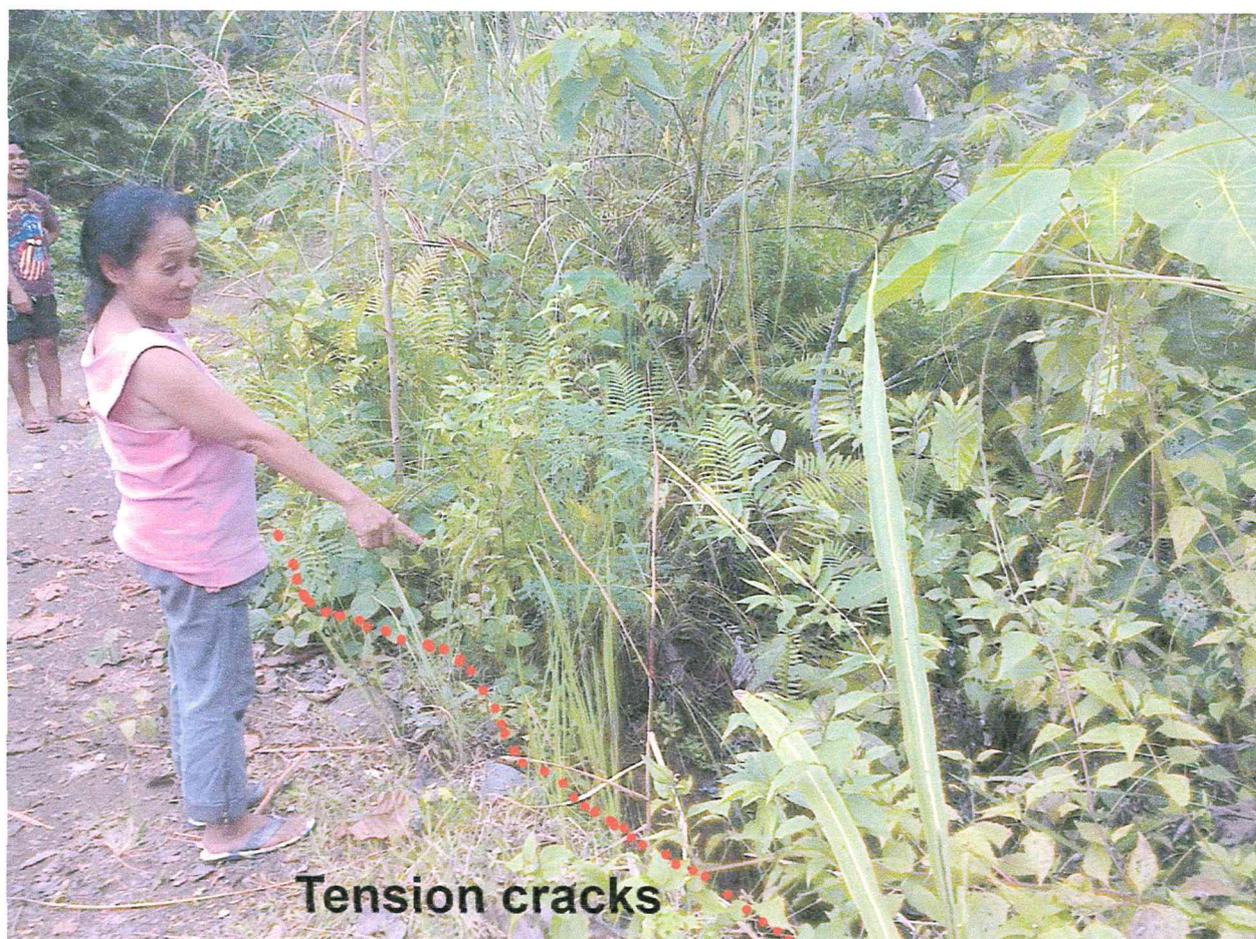
The chairman of Barangay Tag-Oyango pointing on a tension crack extending 100M along the barangay road in Purok 8. (With a GPS location 8° 49' 21.8" N/125° 42' 39.4" E)

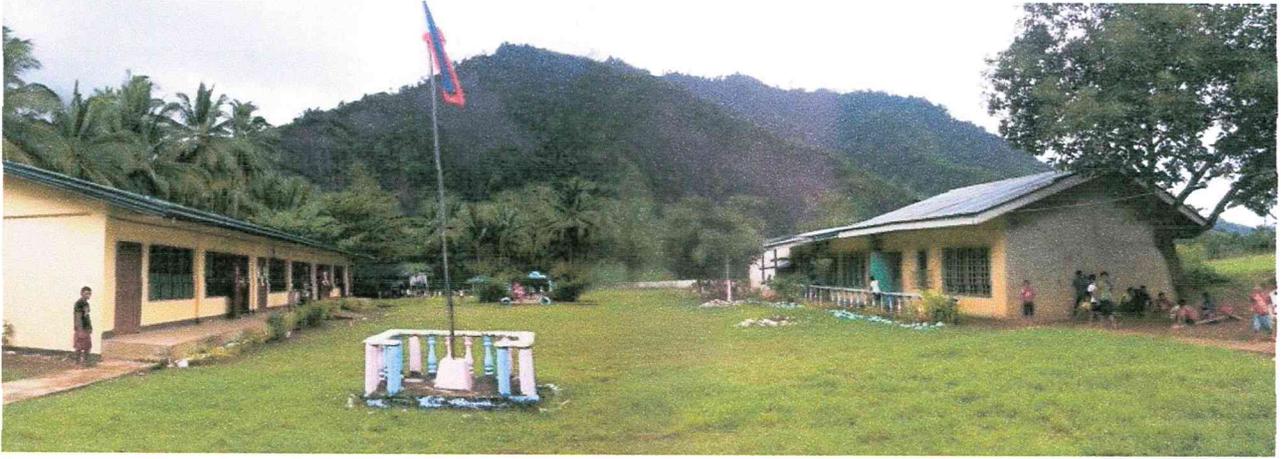
Villangit Elementary School at Purok 1 is situated near the base of a very steep slope.
