Republic of the Philippines  
Department of Environment and Natural Resources  
**MINES AND GEOSCIENCES BUREAU**  
Regional Office No. XIII

Respectfully furnishing your end the document entitled "Results of the MGB Landslide and Flood Assessment and Mapping (1:10,000 scale) of the Municipality of Sta. Josefa Agusan del Sur". The assessment is in line with the government's effort aimed at reducing, if not totally mitigating the destructive effects and impacts of natural hazards to the populace.

## RESULTS OF THE MGB LANDSLIDE AND FLOOD ASSESSMENT AND MAPPING (1:10,000 SCALE) OF THE MUNICIPALITY OF STA. JOSEFA, PROVINCE OF AGUSAN DEL SUR

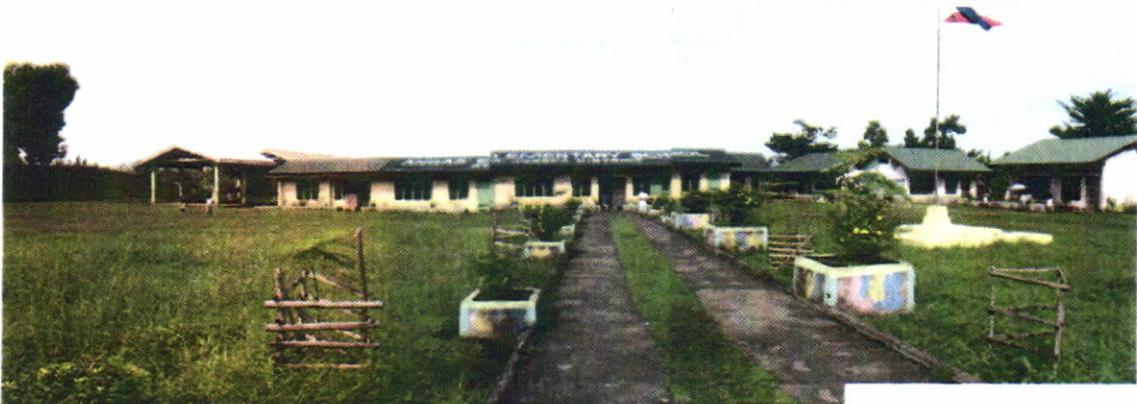
Photos above are areas at Purok 2 including Angas Elementary School. Installation of proper concrete drainage canals at the purok and at the school is recommended.

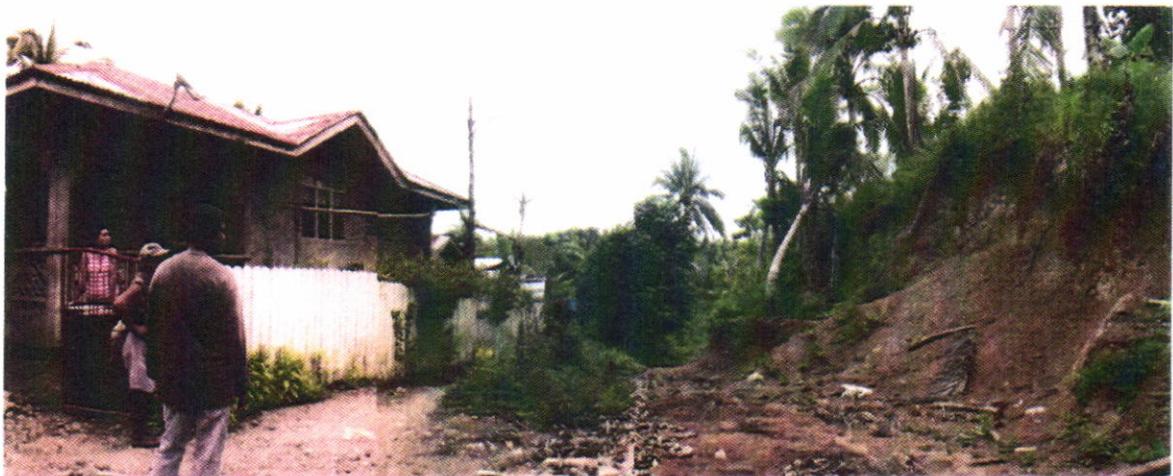
Photo above is an unstable slope with progress of erosion located at Purok 10 Sitio Bacilisi. Stabilization of the slope is recommended. GPS coordinates 07°57'58.3"N/126°02'28.5"E

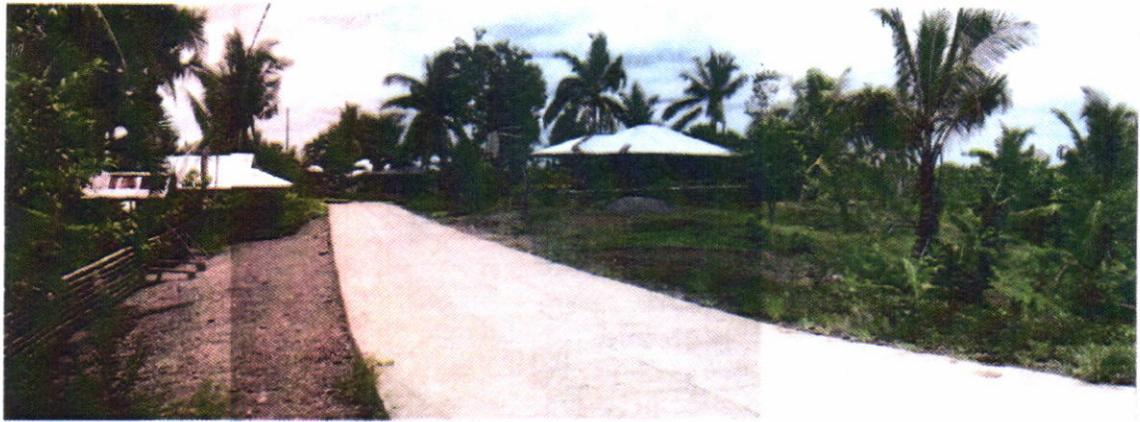
Photo is Purok 14 which is moderate to landslide. Observe for presence of mass movements and prohibit future settlement along ridge edges and footslopes.

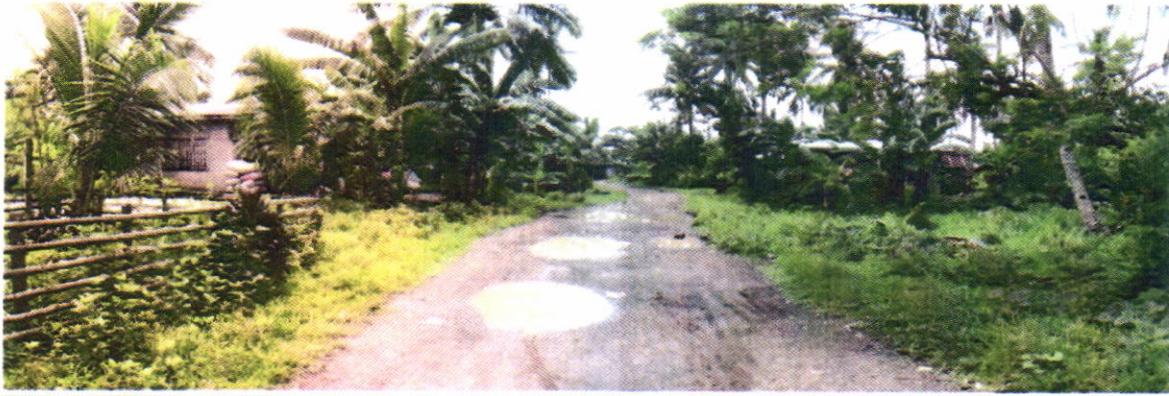
Photos are Purok 18 Sitio Dao which is rated low to moderate to flooding. Right photo is a resident showing the flood height the purok experienced during typhoon Pablo. Recommend to develop an early warning system regarding flooding, and pre-emptive evacuation is advised during typhoons or if unusual flooding is experienced. Also prohibit future settlement on the creeks embankments.

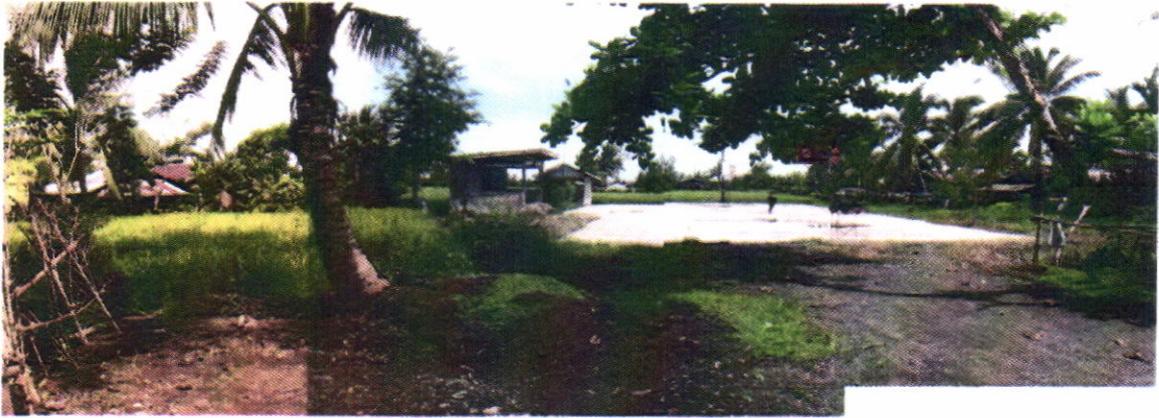
Photo above is the Purok 22 which experiences moderate to high flooding every time the Hinalinan Creek overflows. Recommend to observe for water level at the creek during inclement weather conditions and pre-emptive evacuation is advised. Also prohibit future settlement at the creeks embankments. For long term solution, relocating the entire purok is recommended.

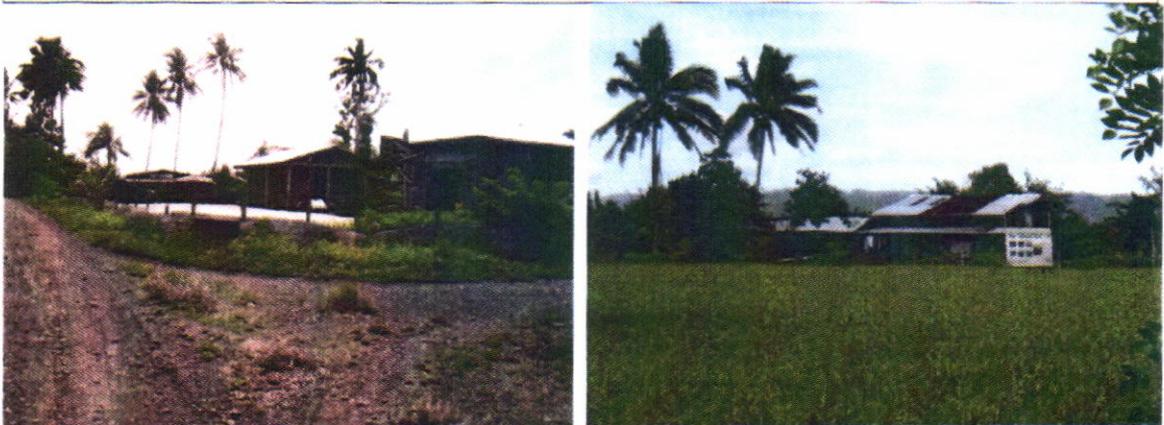
Photos are Purok 23 which is low to flooding.

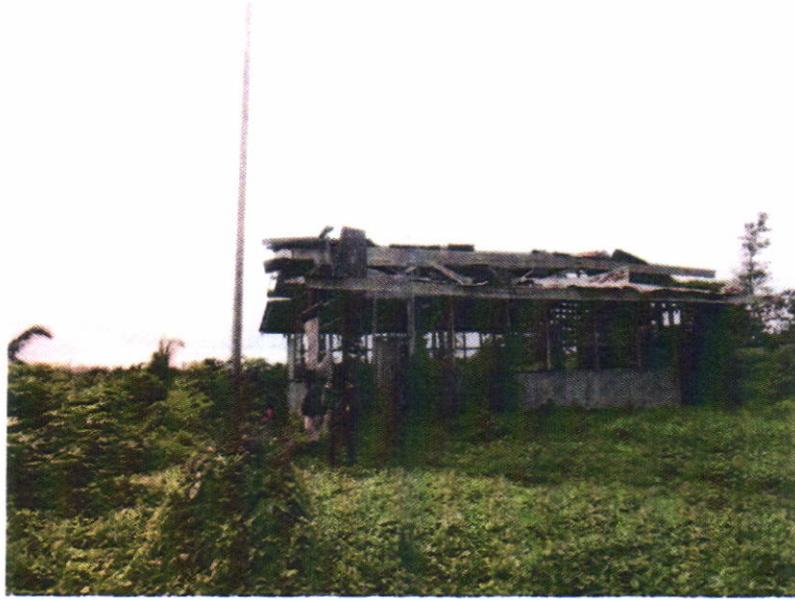
Photo showing the damaged Sitio Hall of Kaangayan I due to the strong winds brought by Typhoon Pablo.

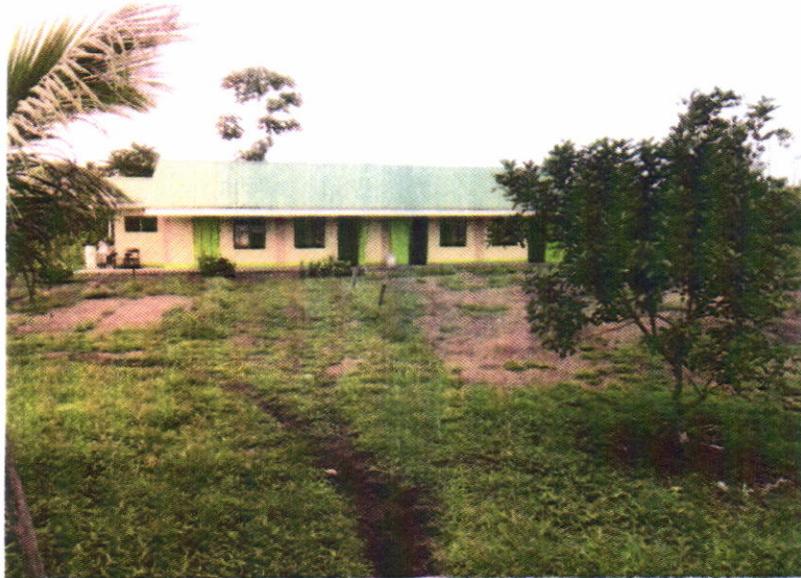
A view of Kaangayan Primary School located at Purok 10 which needs proper drainage system.

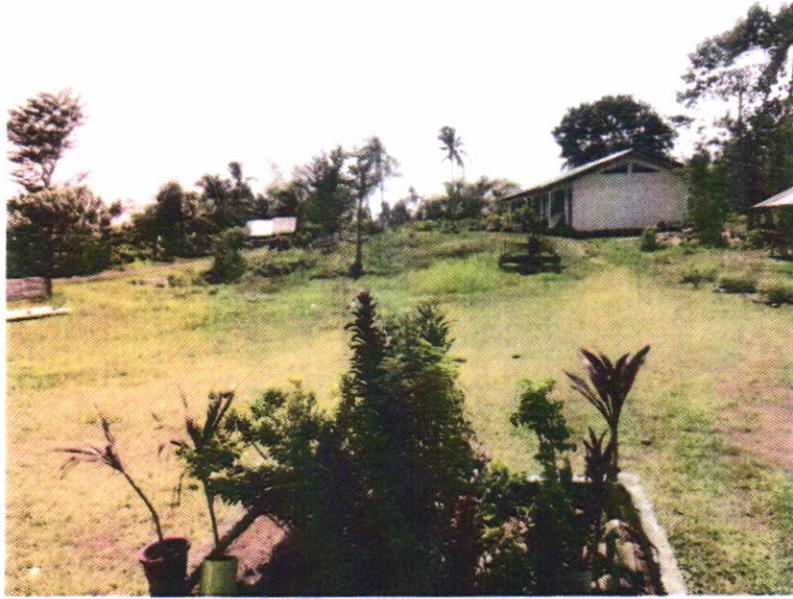
School grounds of Pag-asa Elem. School at Purok 15 located at Sitio Kaangayan 2 that is recommended to be elevated and to be provided with proper drainage system.

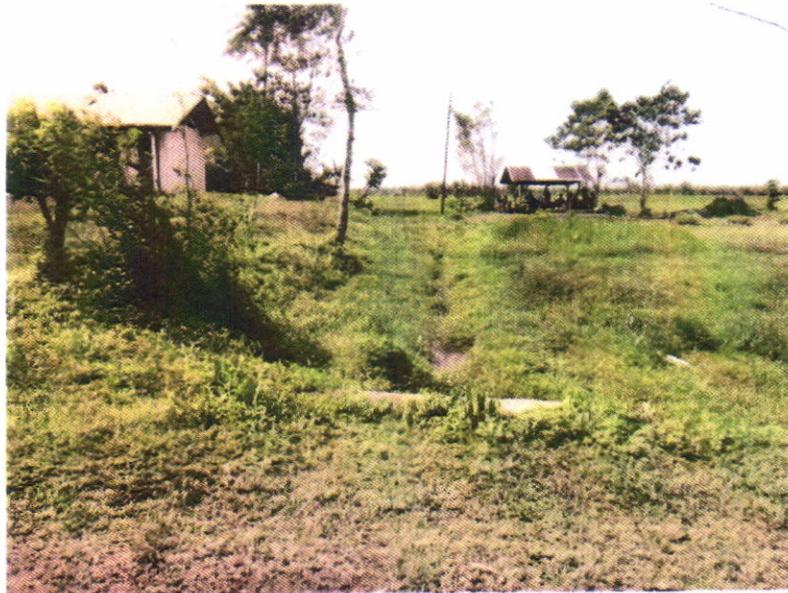
Photo showing the drainage canal at Pag-asa Elem. School that is recommended to be concretized and have its outlet defined to properly drain run-off and prevent further erosion at the school grounds.

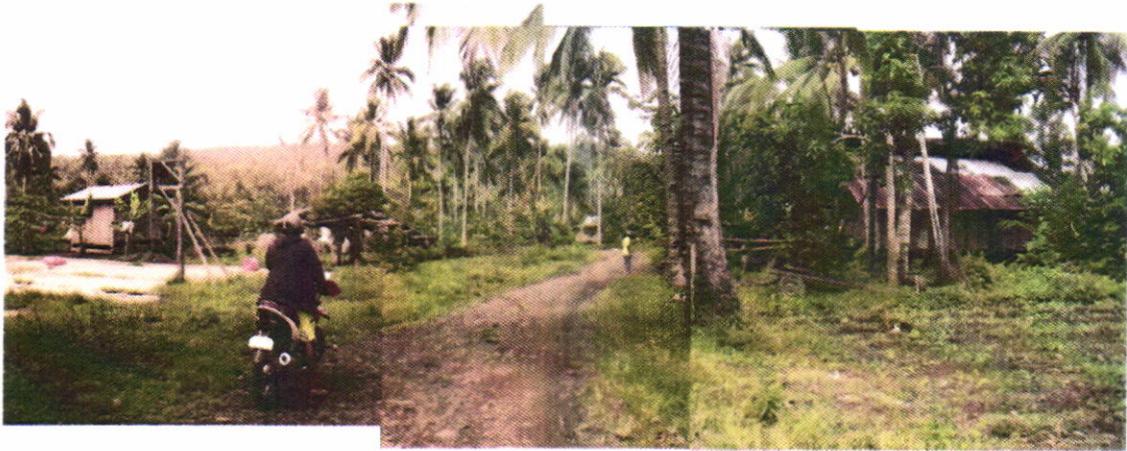
Photo above is an area ok Purok 3 which is moderate to flooding due to the Awao River overflow. Observe for increase/decrease of water level along the river. Develop an early warning system and pre-emptive evacuation is recommended during inclement weather

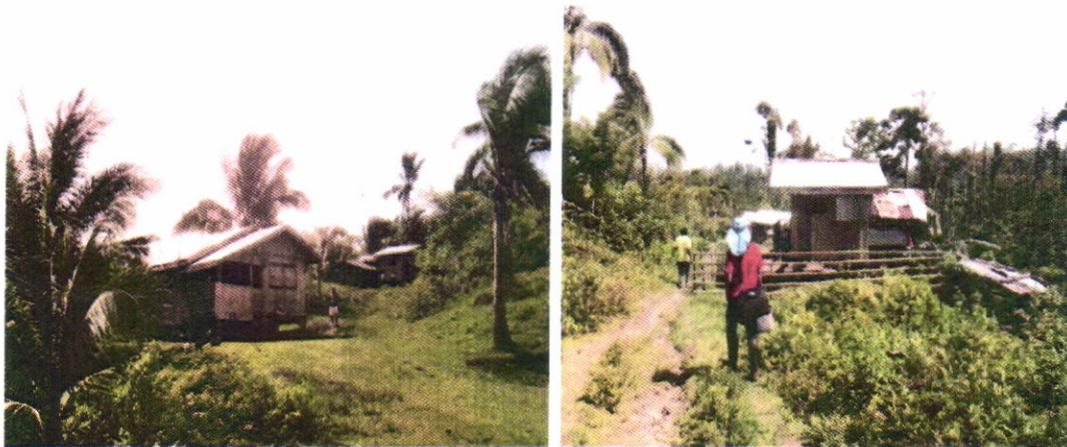
Houses of Purok 10 Sitio Kayakalan are located at the ridge with steep to very steep slopes and are highly susceptible to landslide. Observe for presence of mass movements and prohibit future settlement at the ridge edges and foot of slopes. Also develop an early warning system regarding landslide and pre-emptive evacuation during inclement weather conditions is recommended. Relocating the entire purok is also recommended.

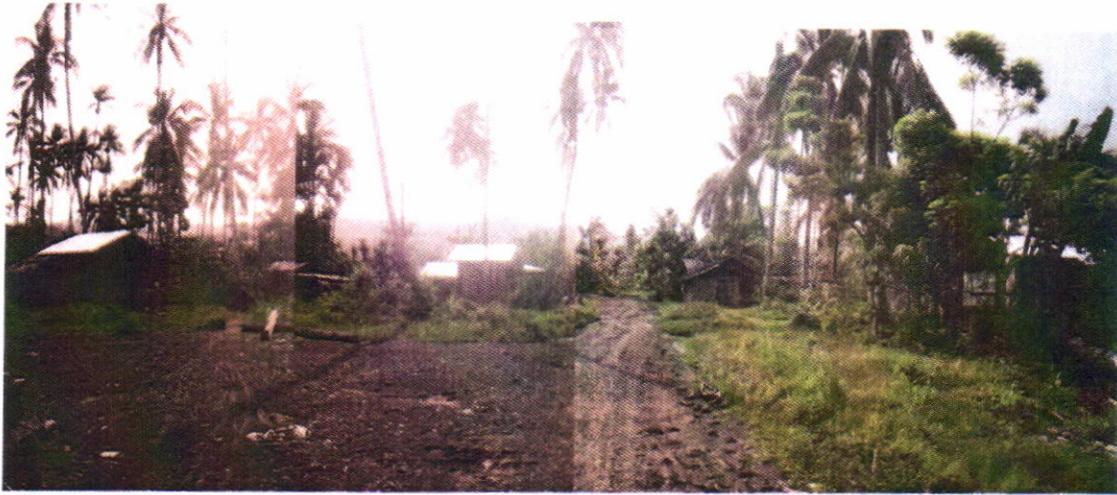
Photo above is Purok 12 which is located close to the Awao River and is rated moderate to flooding. Observe for abnormalities in the water level along the river and pre-emptive evacuation is recommended during extreme weather events. Also prohibit future settlement towards the river embankments.

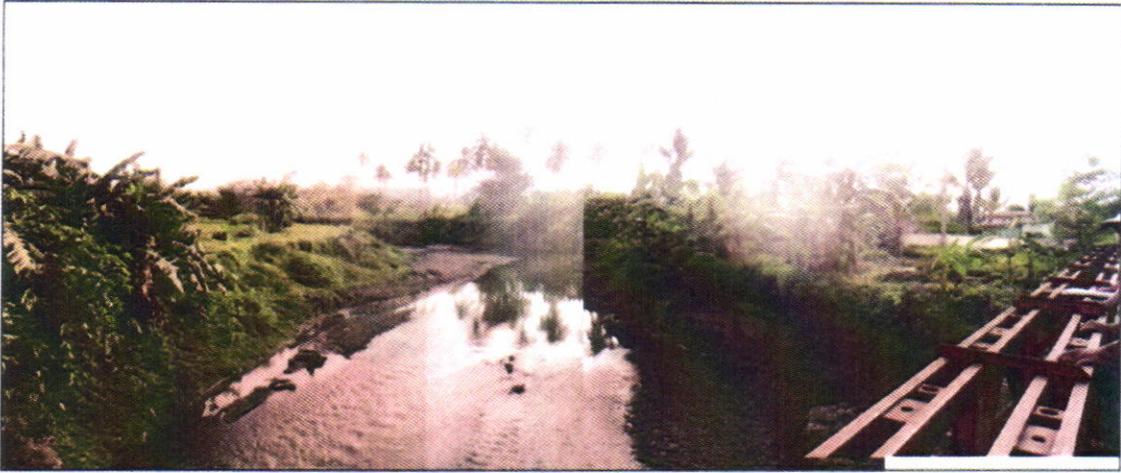
Photo above is a portion of the Awao River near the steel bridge which flooding to the most of the puroks of the barangay usually starts. Recommend a flood protective structure to mitigate or if not lessen the impact of flooding in the barangay. GPS coordinates 07°58' 02.4"N/ 126°00'11.5"E

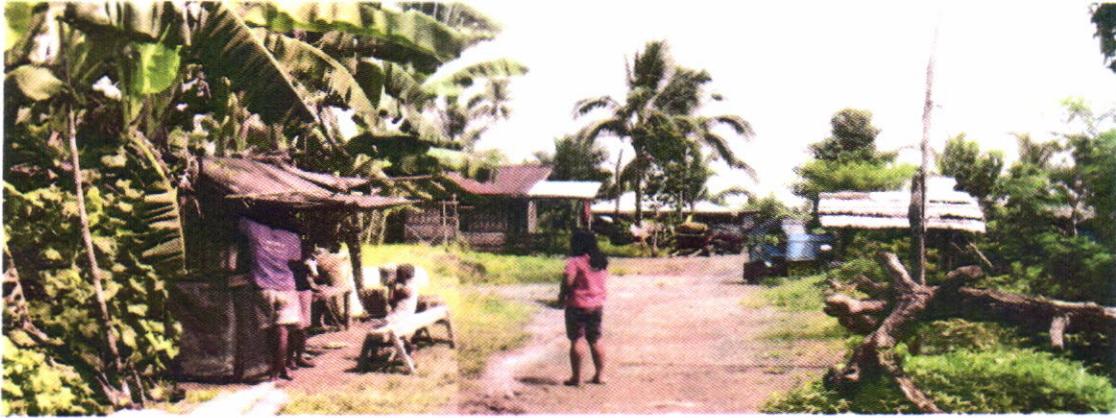
Photos are areas in Purok 3. The purok is rated moderate to high to flooding. Flooding is caused by the Awao river overflow during extreme weather events. Recommend pre-emptive evacuation if abnormalities in the water level at the river is observed. For long term solutions, relocating the entire purok is recommended.

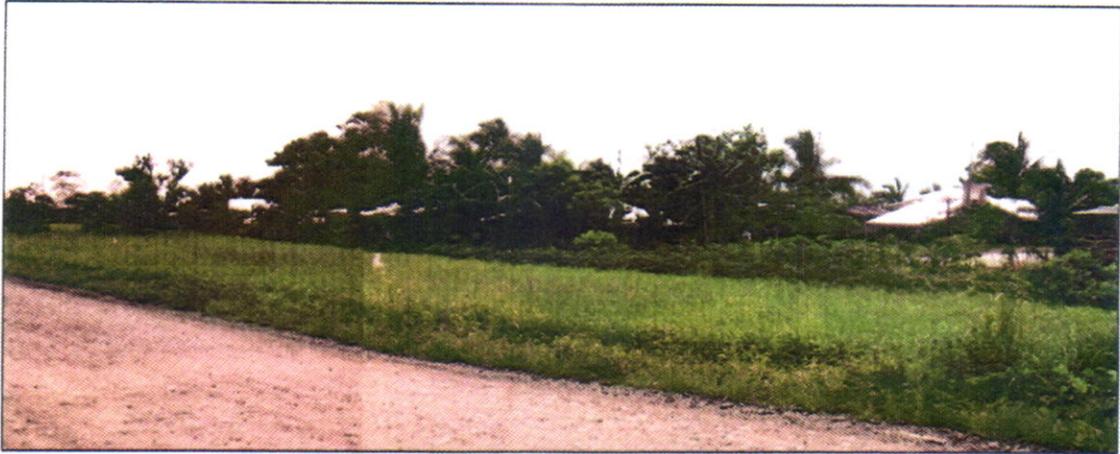
Photo above is Purok 5 which experiences high flooding. Pre-emptive evacuation is advised during inclement weather conditions. For long term solution, relocating the entire purok is recommended.

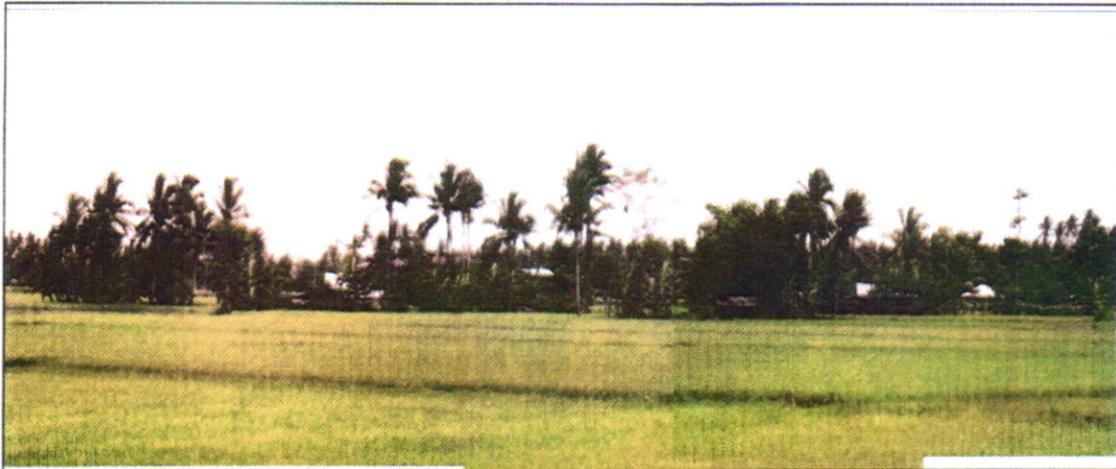
Photo is a panoramic view of Purok 6 which is not affected by flooding from the Awao River. Pre-emptive evacuation during inclement weather conditions is advised.

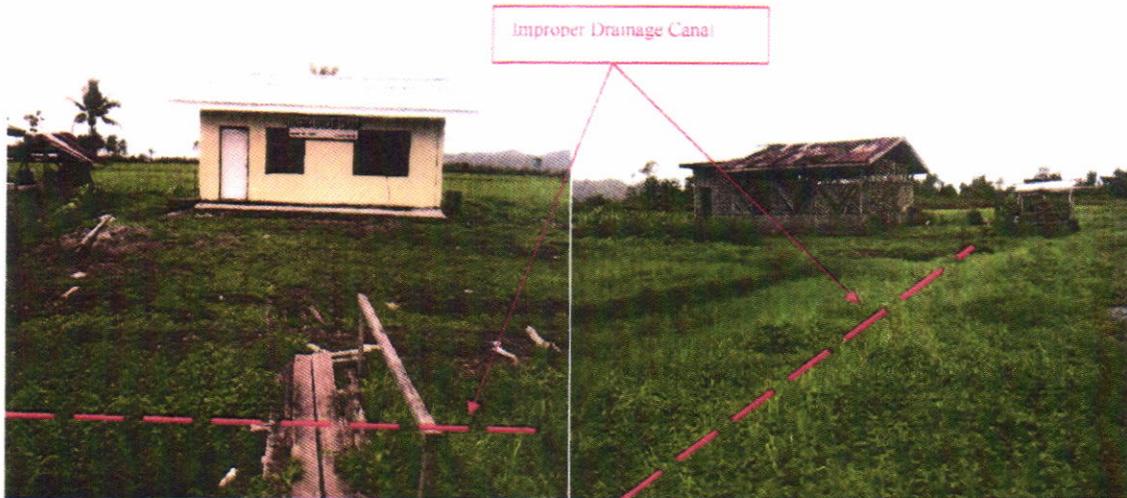
Fig. 1 Improper drainage canals were noted at Purok 1, Brgy. Pag-asa, Sta. Josefa, ADS. Daycare Center and Church buildings are situated within the flood-prone section. GPS reading is  $8^{\circ}04'36.2''\text{-N}/126^{\circ}00'02.8''\text{-E}$  and  $8^{\circ}04'35.9''\text{-N}/126^{\circ}00'05.6''\text{-E}$ , respectively.

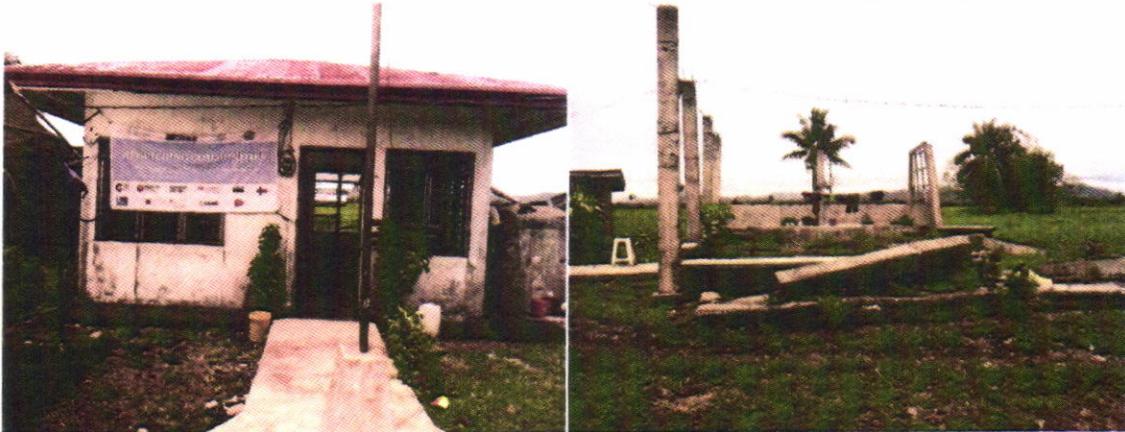
Fig. 2 The Barangay Hall is moderately damaged and completely damaged building of Barangay Multi-purpose by typhoon "Pablo" were observed at Purok 1. GPS reading is  $8^{\circ}04'37.2''\text{-N}/126^{\circ}00'01.4''\text{-E}$  and  $8^{\circ}04'36.8''\text{-N}/126^{\circ}00'01.9''\text{-E}$ , respectively. Flood rating is moderate.

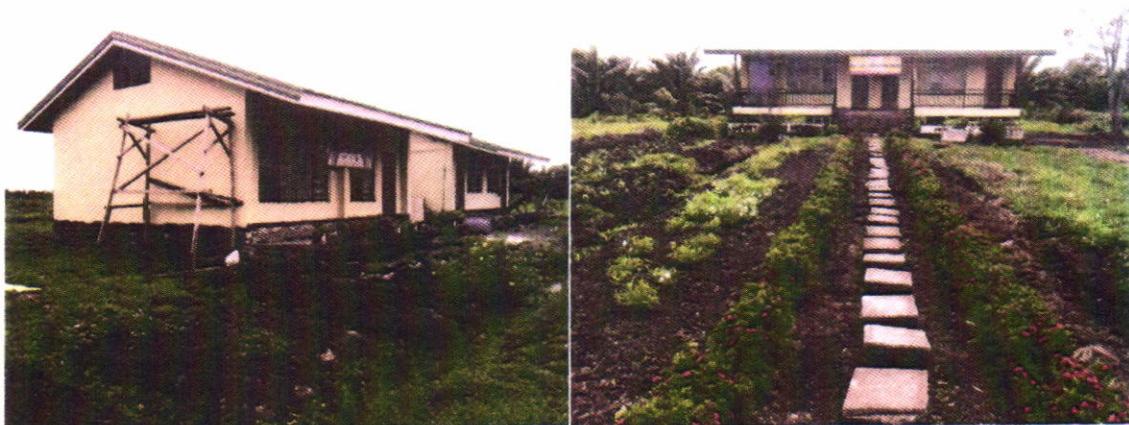
Fig. 3 Construction of concrete drainage canals are highly recommended at San Vicente Elementary School of Purok 1. GPS reading is  $8^{\circ}04'34.7''\text{-N}/126^{\circ}00'02.2''\text{-E}$ .

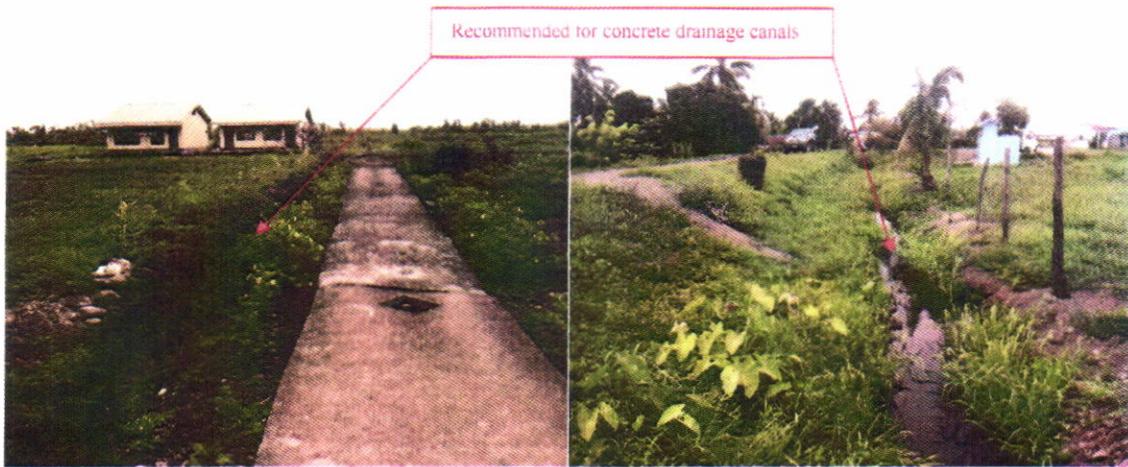
Fig. 4 These sections of Purok 1 are highly recommended for concreting drainage canals.

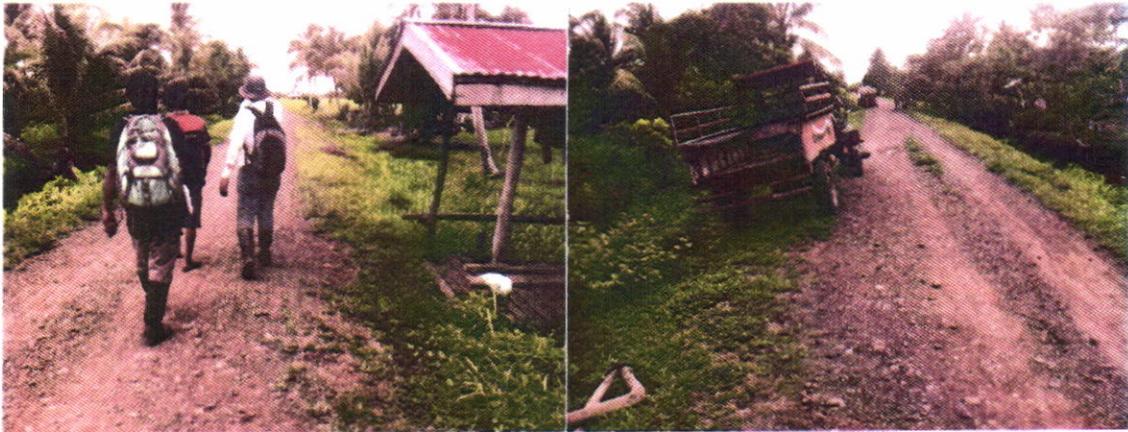
Fig. 5 Concreting of road and drainages are highly recommended at Purok 2. GPS reading is 8°04'45.5"-N/126°00'00"-E.

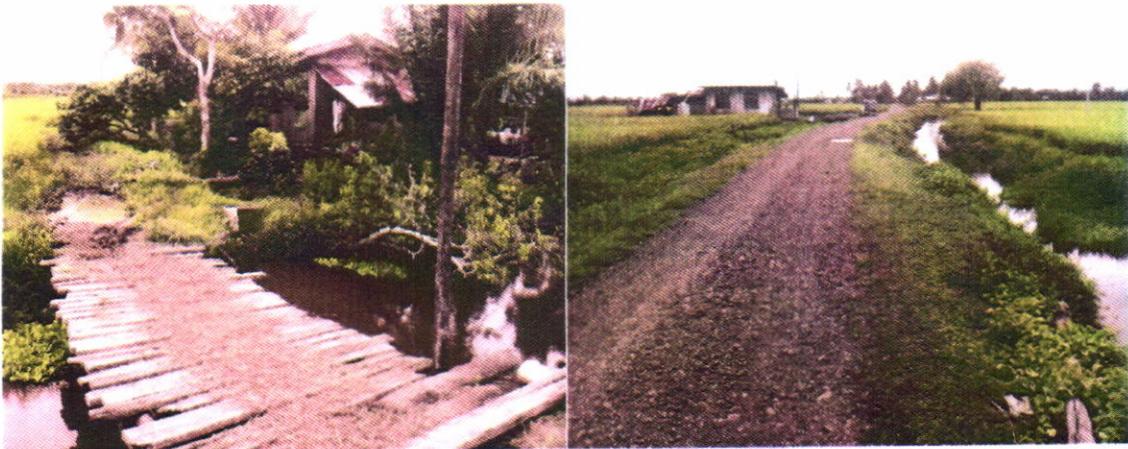
Fig. 6 Local residents are resided along NIA Irrigation canal at Purok 2. Road and NIA Irrigation canals are highly for concreting.

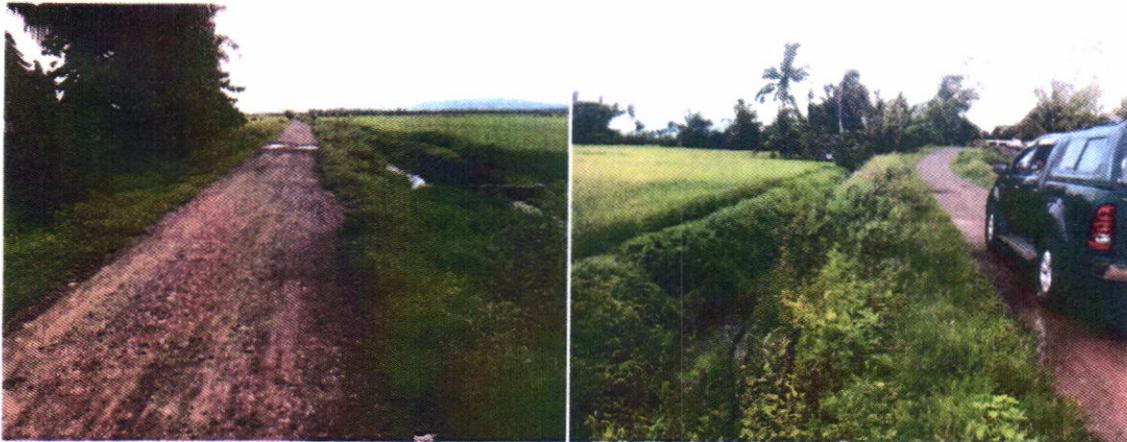
Fig. 7 No concrete road and no concrete drainage canal were noted at Purok 3. GPS reading is 8°04'59.3"-N/125°59'59.9"-E.

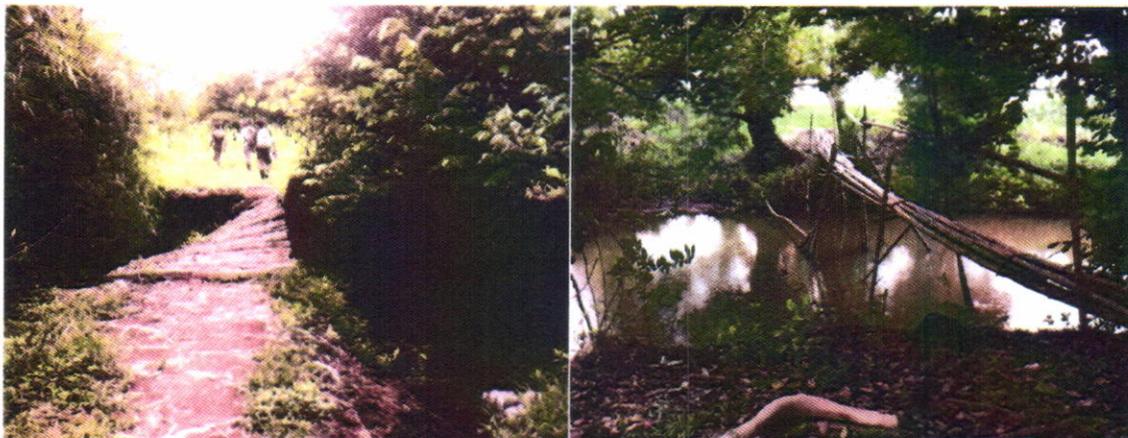
Fig. 8 Wooded bridges are main access across Lukad River. Construction of proper concrete bridge across Lukad River is highly recommended. GPS reading is 8°05'11.8"-N/126°00'17"-E.

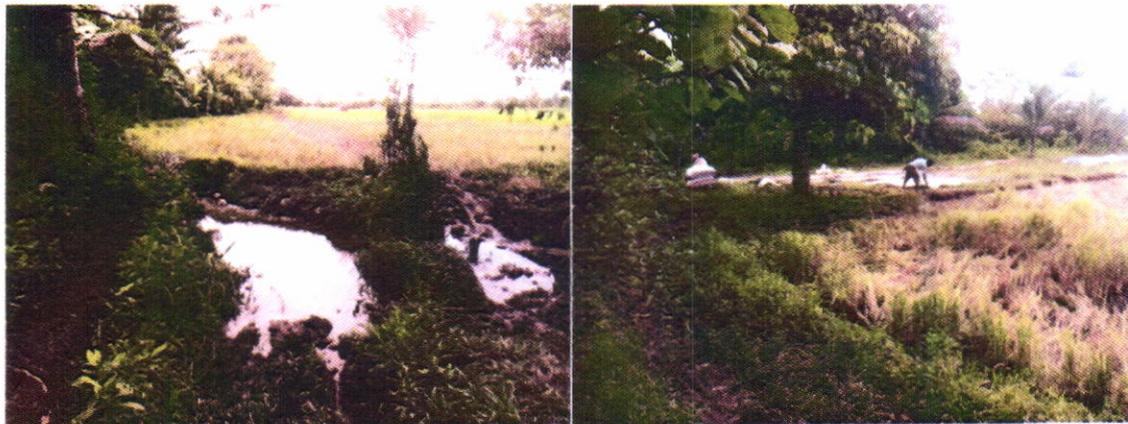
Fig. 9 Trail is main access toward Purok 4 from the barangay road which is parallel to the Lukad River. Proper road-piloting is highly recommended.

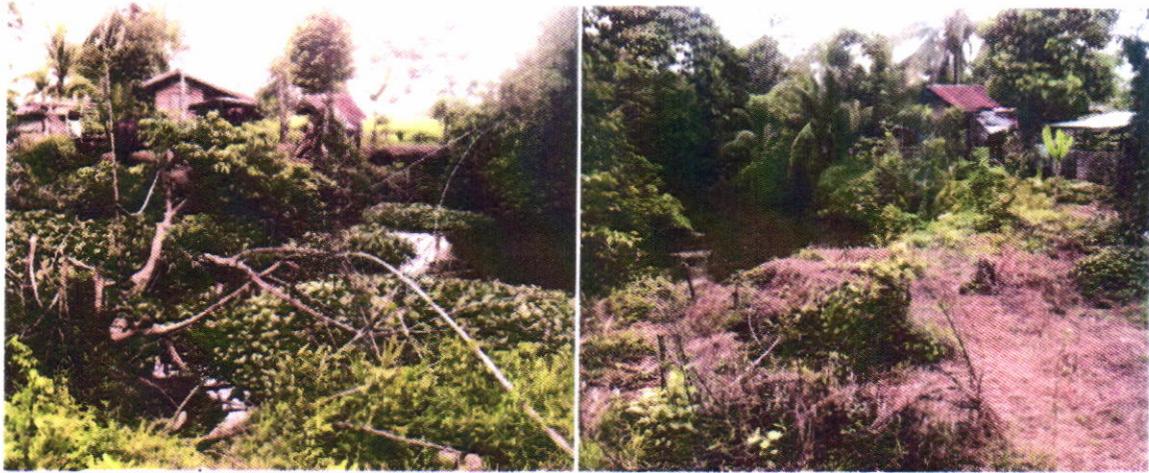
Fig. 10 Most of the local residents of Purok 4 are located along Lukad River embankment which is prone to flooding and river-scouring. GPS reading is 8°04'55.4"-N/126°00'24.2"-E.

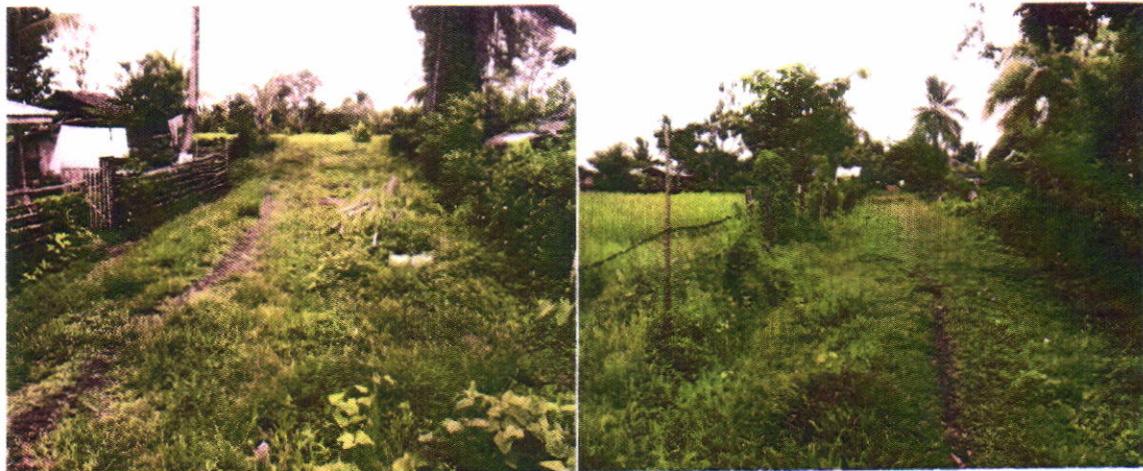
Fig. 12 No proper drainage canals and no concrete road were observed at Purok 6. Construction of concrete drainage canals and concrete roads are highly recommended. GPS reading is 8°04'10.1"-N/126°00'48.5"-E.

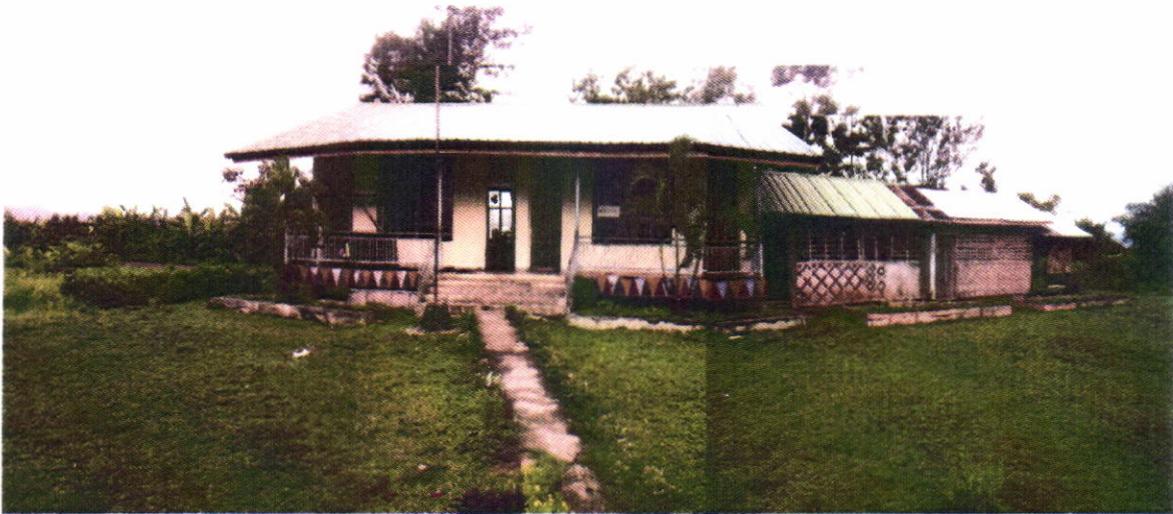
Fig. 13 Construction of proper concrete drainage canals is highly recommended at this school campus of Malipayon Elementary School of Purok 6. GPS reading is  $8^{\circ}04'08.3''$ -N/ $126^{\circ}00'50.7''$ -E.

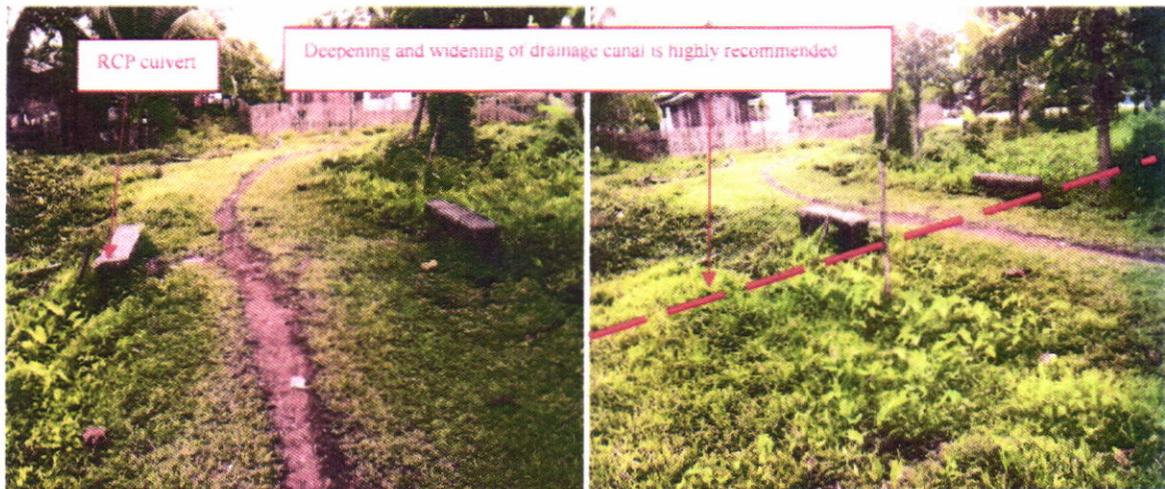
Fig. 14 Deepening, widening and de-clogging is highly recommended on this drainage canal or RCP culvert of Purok 6. GPS reading is  $8^{\circ}04'07.3''$ -N/ $126^{\circ}00'49.7''$ -E.

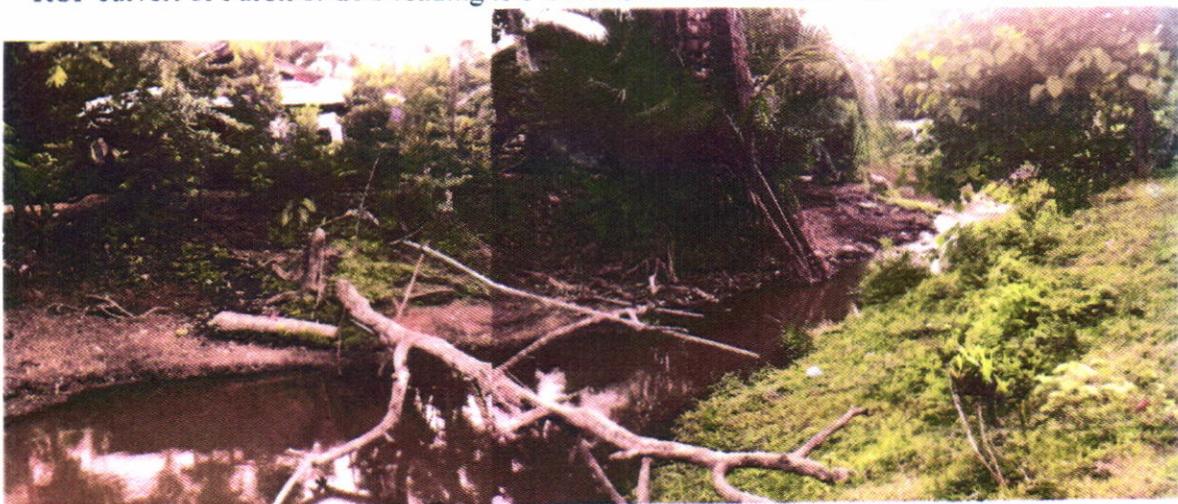
Fig. 15 Embankment concreting and rechanneling are highly recommended along Magabid Creek. Prohibit settlement along creek/river embankment should be implemented.

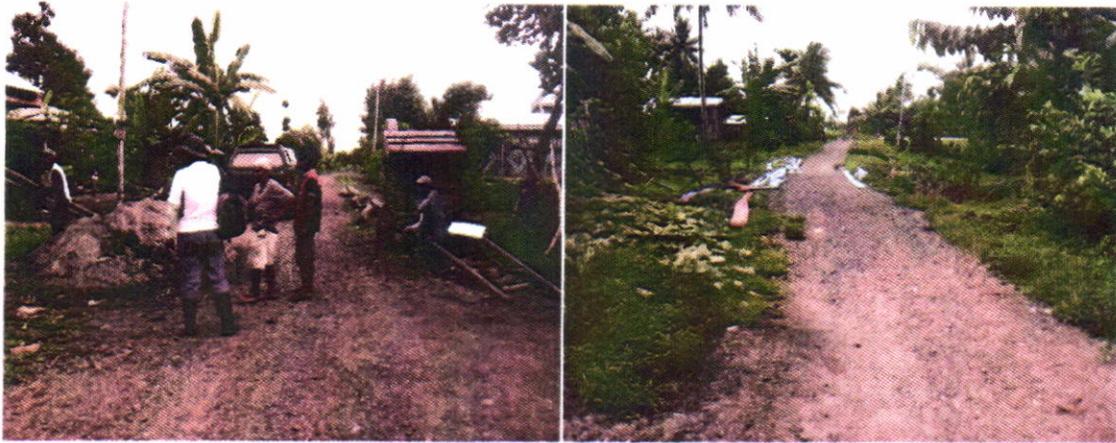
Fig. 16 No concrete drainage road and no drainage canal at Purok 7. GPS reading is 8°04'03.6"-N/126°00'48.3"-E.

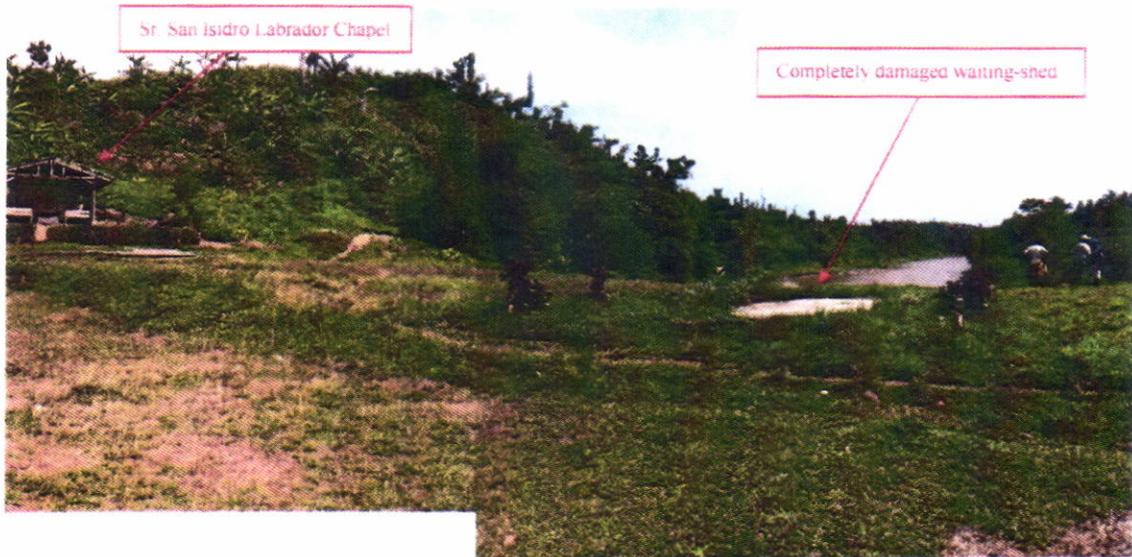
Fig. 3 Sitio Lilo waiting-shed is completely damaged by typhoon “Pablo” and Sr. San Isidro Labrador Chapel is prone to landslide.

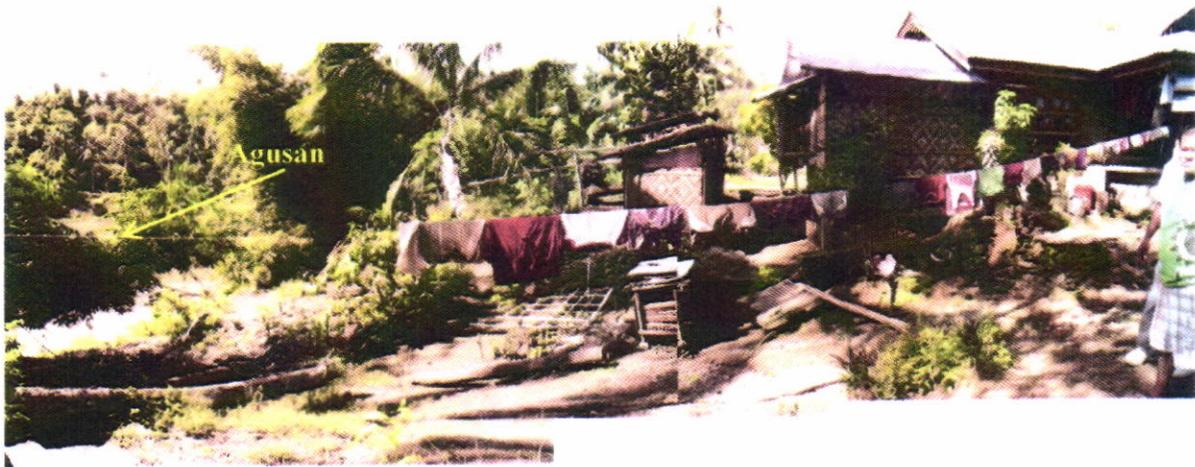
Photo above shows the proximity of some houses at Purok 3 to the Agusan River. According to the residents, Agusan River overflow does not reach the purok but only levels at its embankments. Prohibit future settlement towards and along the Agusan River embankments. Vigilance of residents closest to the river is recommended especially during extreme weather

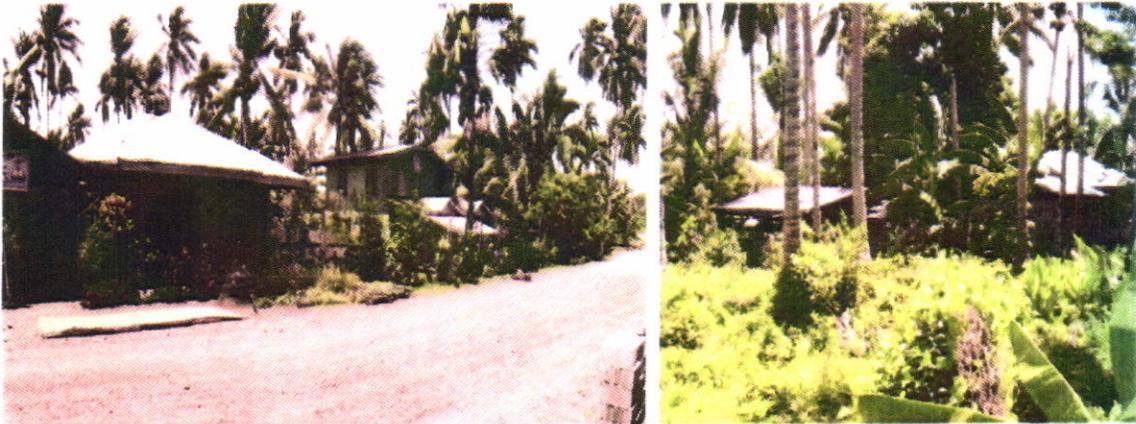
Photos are Purok 5. Installation of concrete drainage canals at the purok is recommended to facilitate surface run-off.

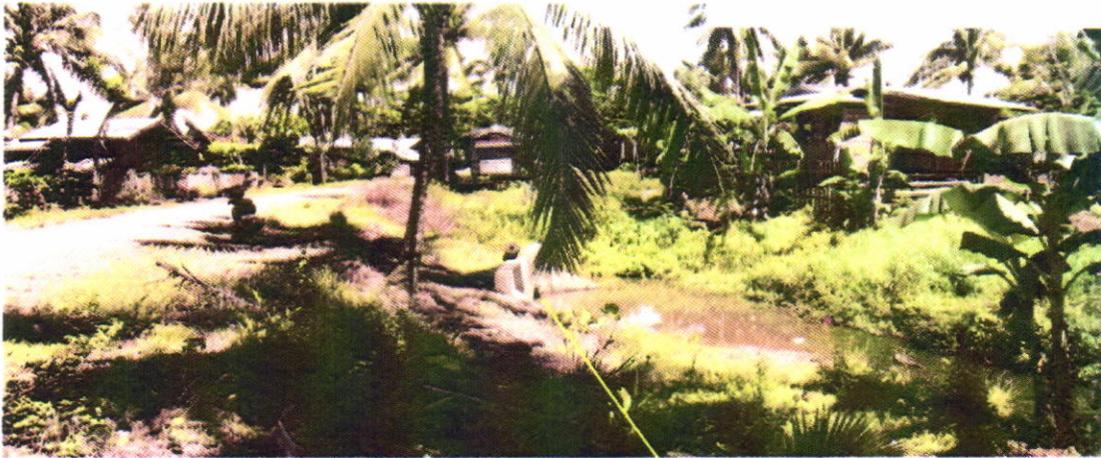
The creek on the above photo is the Mahaba Creek which traverses at Purok 6 Magalibobo and causes flooding up to waist-level at the purok since the existing culvert (close-up at right photo) could not cater too much volume of water during heavy rainfall. Replacing the existing culvert into box-type culvert is recommended to address the problem. GPS coordinates 07°59'48.9"N/126°03'42.3"E

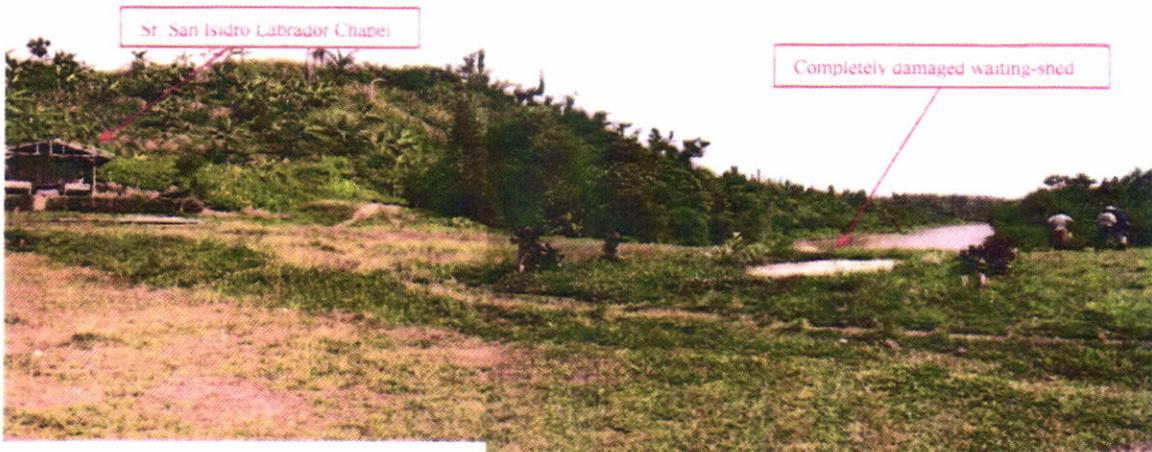
Sitio Lilo waiting-shed is completely damaged by typhoon “Pablo” and Sr. San Isidro Labrador Chapel is prone to landslide.

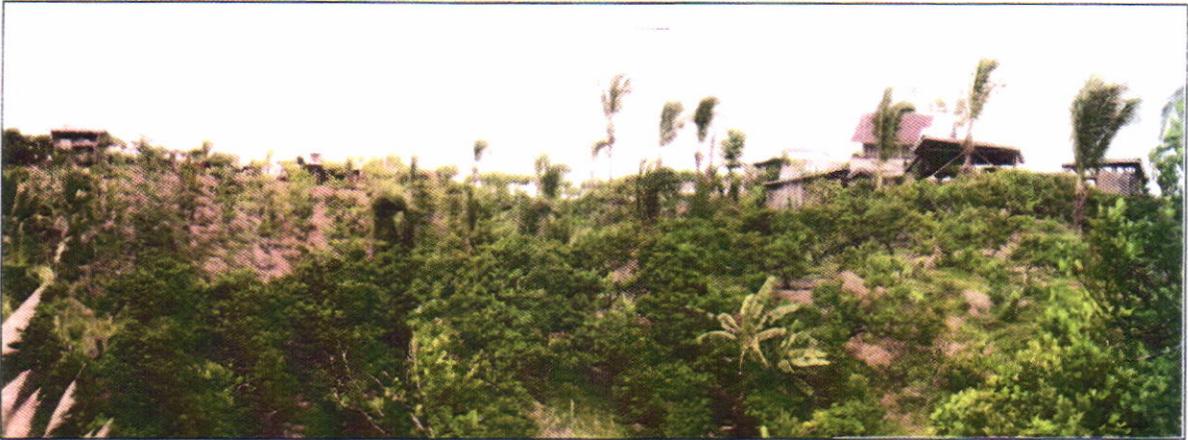
Photo above is Purok 8 Sitio Lemon which houses are located at the top ridge along the calamansi farmland and are moderate to landslide. Recommend to observe for presence of mass movements and prohibit future settlement at the ridge edges and at the foot of slopes.

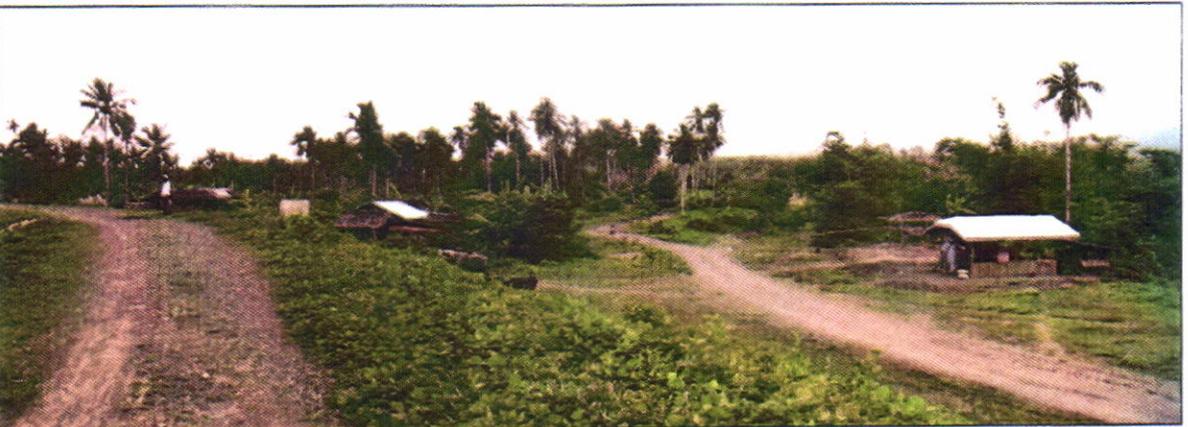
Photo is Purok 10 Sitio Bacilisi which is close to the Agusan River. Recommend to observe for rapid increase/decrease of water level along the river. Pre-emptive evacuation is recommended if abnormalities in the water level of the river are observed.

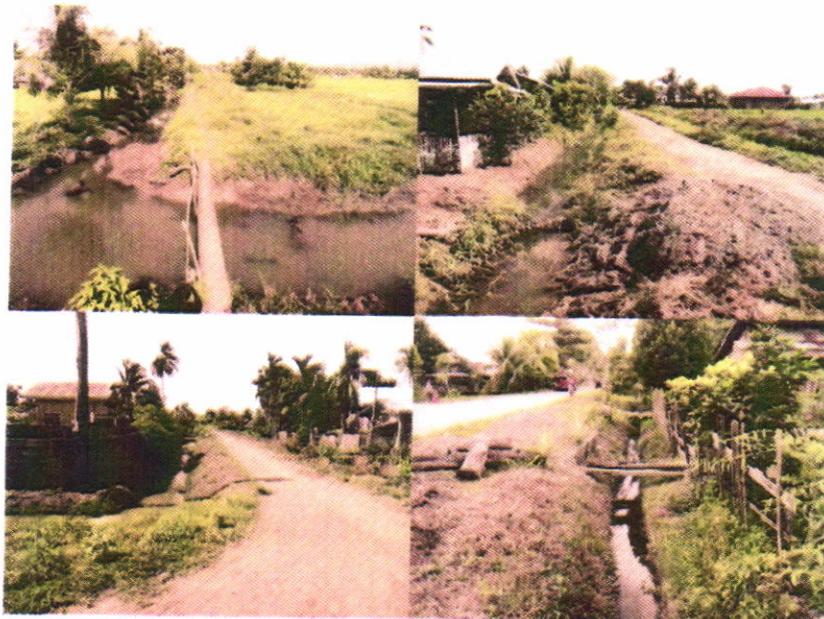
Some examples of existing drainage canals of Brgy. Poblacion located at Purok 9, 9A, 7B and 6(photos in clockwise direction) that need to be improved.
