Republic of the Philippines  
Department of Environment and Natural Resources  
**MINES AND GEOSCIENCES BUREAU**  
Regional Office No. XIII

Respectfully furnishing your end the document entitled "Results of the MGB Landslide and Flood Assessment and Mapping (1:10,000 scale) of the Municipality of Sta. Josefa Agusan del Sur". The assessment is in line with the government's effort aimed at reducing, if not totally mitigating the destructive effects and impacts of natural hazards to the populace.

## RESULTS OF THE MGB LANDSLIDE AND FLOOD ASSESSMENT AND MAPPING (1:10,000 SCALE) OF THE MUNICIPALITY OF STA. JOSEFA, PROVINCE OF AGUSAN DEL SUR

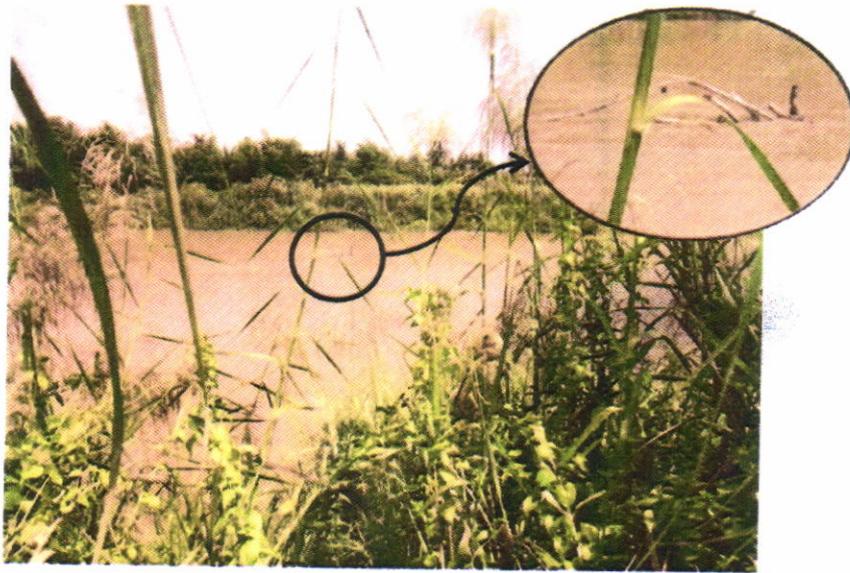
Photo showing the remaining part of an old and damaged bridge that obstructs the flow of Agusan River, causing river scouring on a riverbank located at Purok 1. Removing the obstruction is recommended.

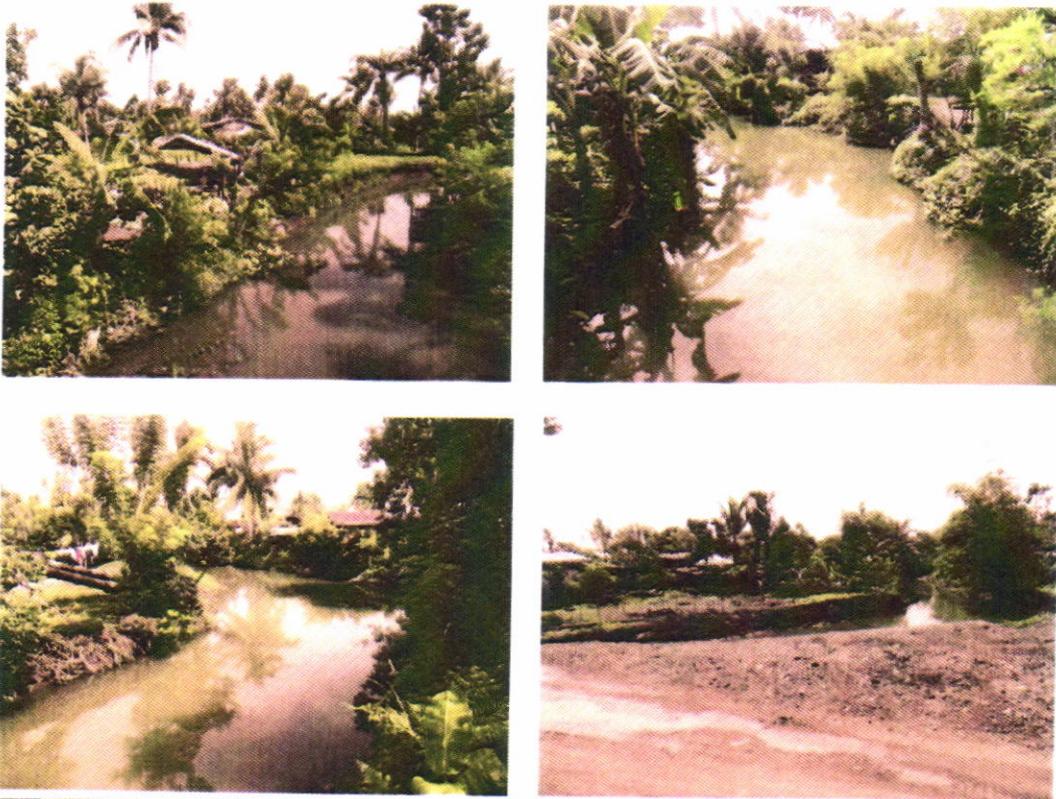
Photos showing the meandering segments of Sayon creek traversing across Puroks 1, 2, 3, 4 and 5 and that also causes major flooding and in the areas. One of the recommendations is to rechannel this creek.

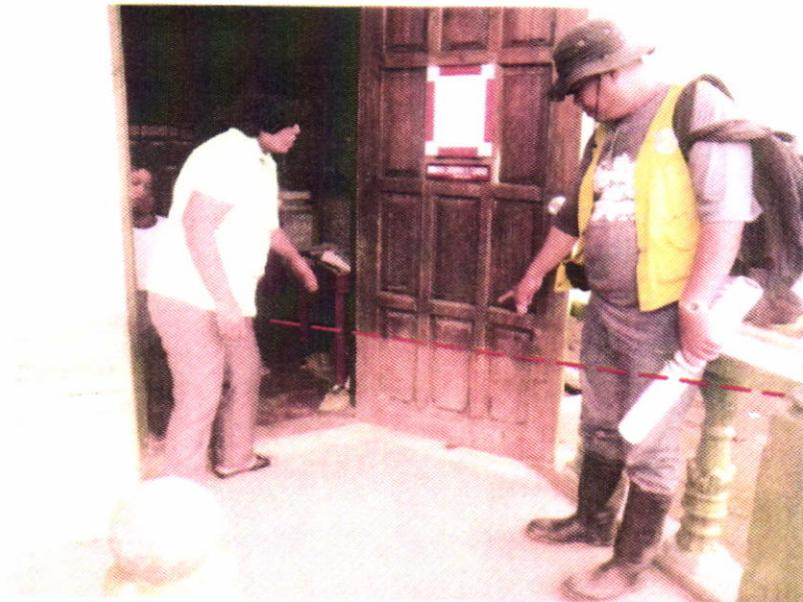
Flood height at Sayon Elem. School located at Purok 2 that approximately reached up to 0.5 meters due to a flashflood event from Sayon creek during Typhoon Pablo.

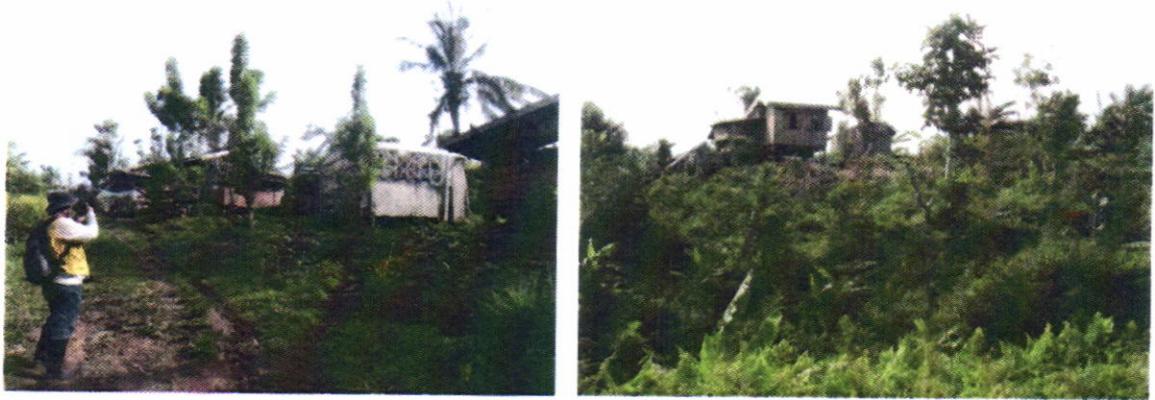
Houses located on the ridge at Purok 9 which is highly susceptible to landslide. For long term solution, relocation of houses on the edge of the ridge is recommended since they are at risk for a possible landslide occurrence.

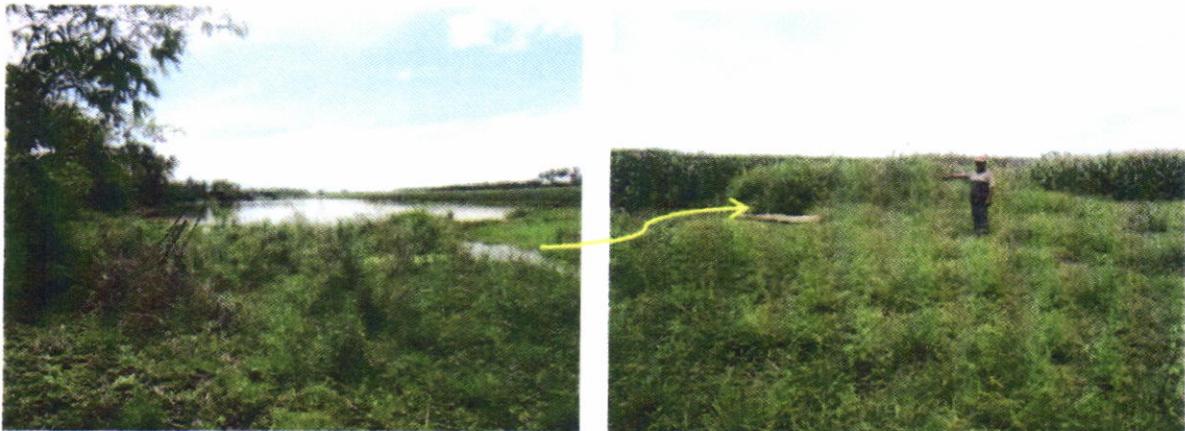
Photos showing the Kanobahan lake (left photo) and its outlet that needs to be widened and that needs to be defined (right photo) located at Purok 1. According to residents, the overflow of Kanobahan Lake is one of the causes of major flooding on the area during heavy rainfall events.

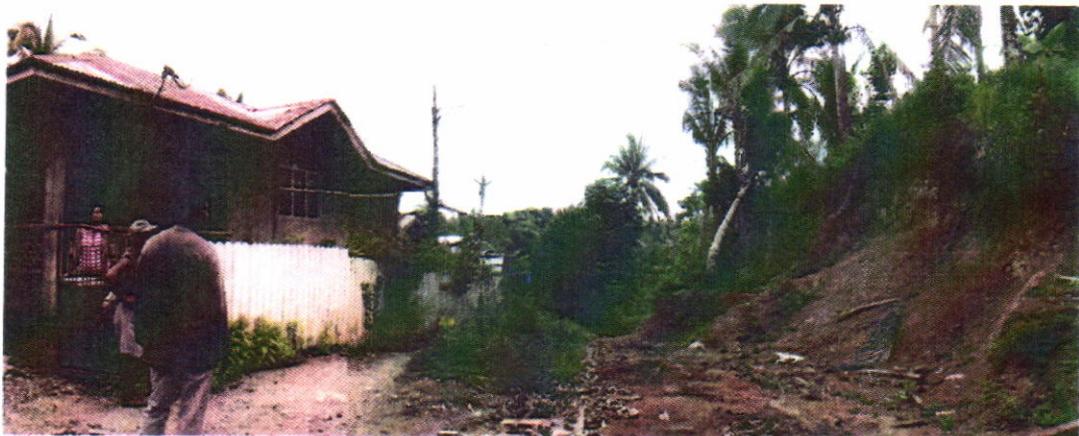
Photo above is an unstable slope with progress of erosion located at Purok 10 Sitio Bacilisi. Stabilization of the slope is recommended. GPS coordinates 07°57'58.3"N/126°02'28.5"E

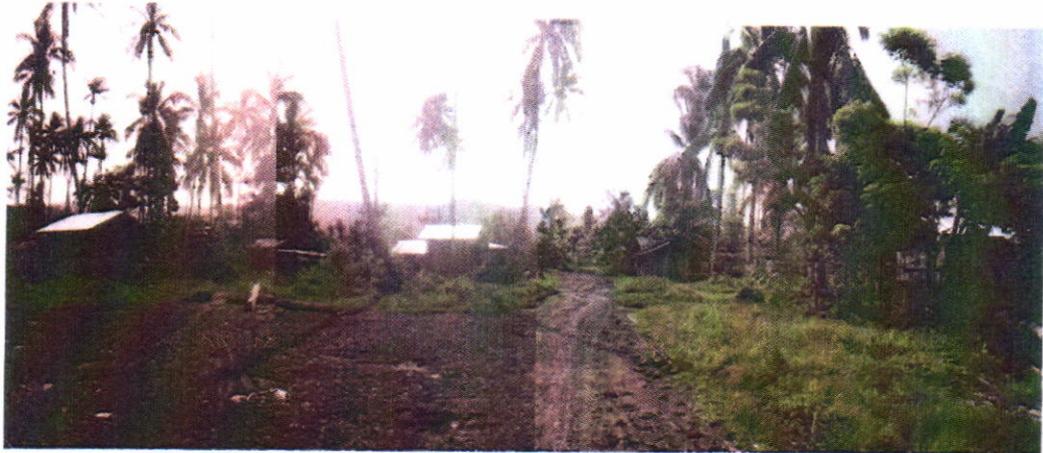
Photo above is Purok 12 which is located close to the Awao River and is rated moderate to flooding. Observe for abnormalities in the water level along the river and pre-emptive evacuation is recommended during extreme weather events. Also prohibit future settlement towards the river embankments.

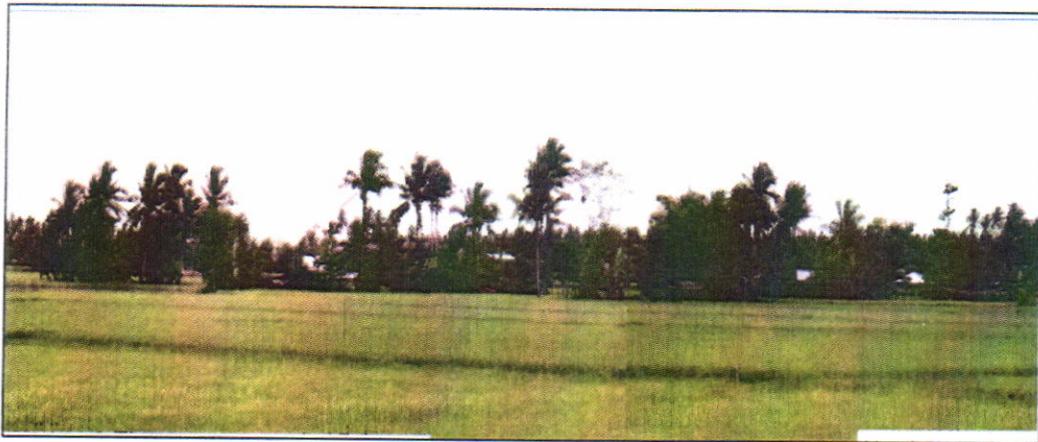
Photo is a panoramic view of Purok 6 which is not affected by flooding from the Awao River. Pre-emptive evacuation during inclement weather conditions is advised.

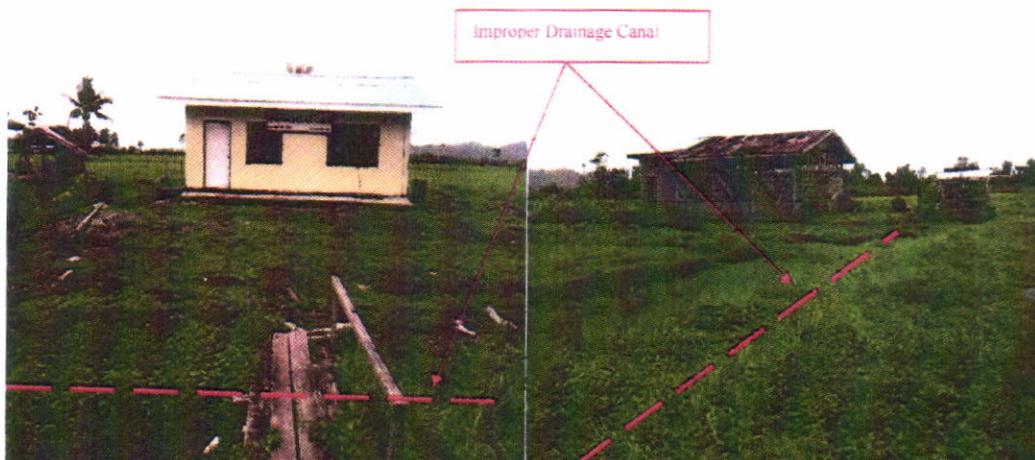
Fig. 1 Improper drainage canals were noted at Purok 1, Brgy. Pag-asa, Sta. Josefa, ADS. Daycare Center and Church buildings are situated within the flood-prone section. GPS reading is 8°04'36.2"-N/ 126°00'02.8"-E and 8°04'35.9"-N/126°00'05.6"-E, respectively.

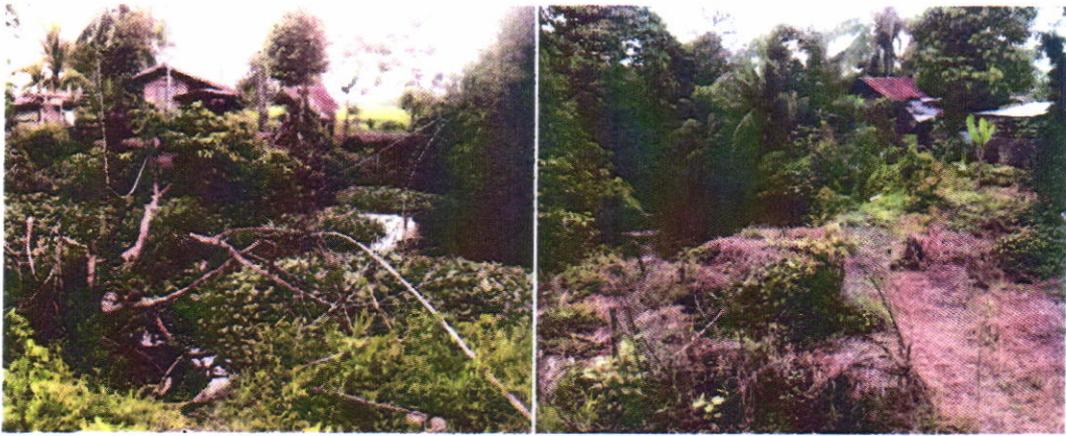
Fig. 10 Most of the local residents of Purok 4 are located along Lukad River embankment which is prone to flooding and river-scouring. GPS reading is 8°04'55.4"-N/126°00'24.2"-E.

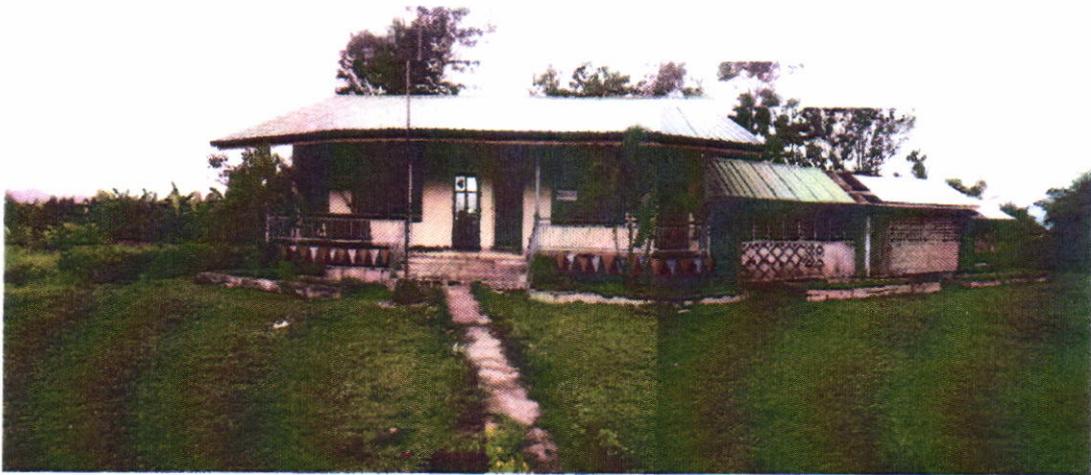
Fig. 13 Construction of proper concrete drainage canals is highly recommended at this school campus of Malipayon Elementary School of Purok 6. GPS reading is 8°04'08.3"-N/126°00'50.7"-E.

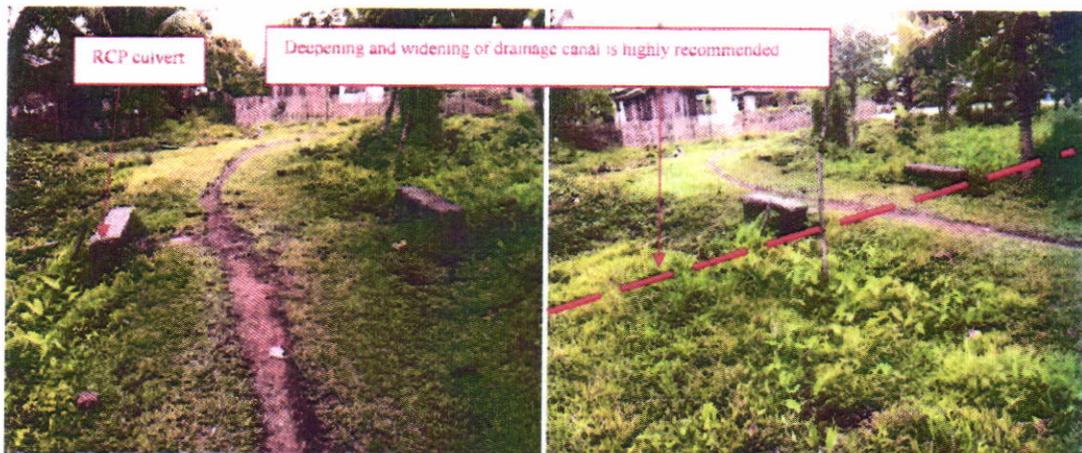
Fig. 14 Deepening, widening and de-clogging is highly recommended on this drainage canal or RCP culvert of Purok 6. GPS reading is 8°04'07.3"-N/126°00'49.7"-E.

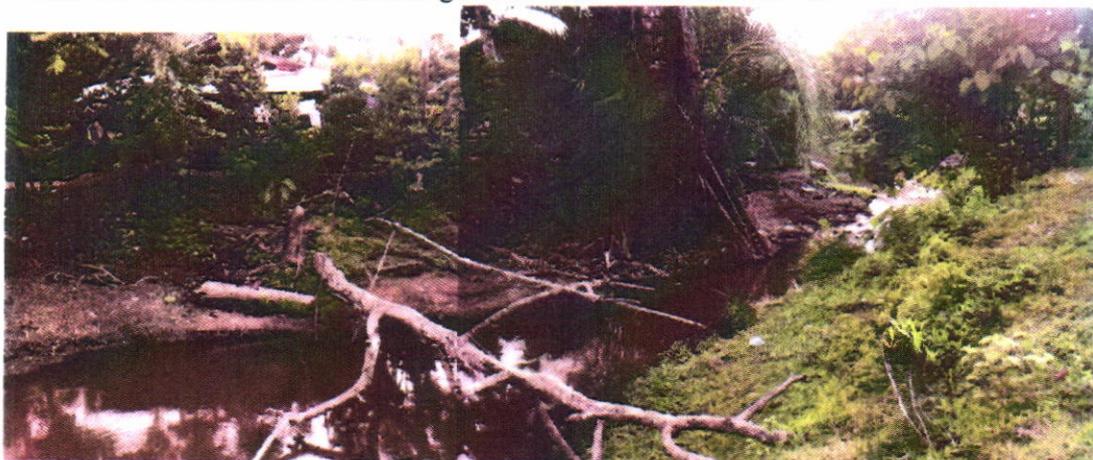
Fig. 15 Embankment concreting and rechanneling are highly recommended along Magabid Creek. Prohibit settlement along creek/river embankment should be implemented.

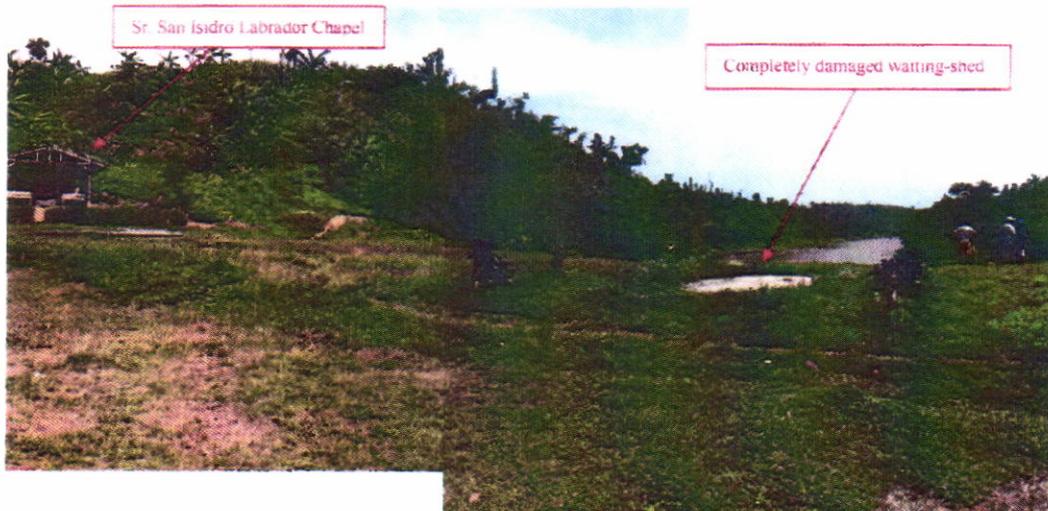
Fig. 3 Sitio Lilo waiting-shed is completely damaged by typhoon “Pablo” and Sr. San Isidro Labrador Chapel is prone to landslide.
