# REPORT ON THE 1:10,000 SCALE GEOHAZARDS ASSESSMENT AND MAPPING OF LORETO, AGUSAN DEL SUR

**SRDP Consulting Inc.**  
Units 119, 420 & 421 SJB Condominium  
130-B Panay Ave, South Triangle  
Quezon City, Philippines

**NOVEMBER 2014**

## REPORT ON THE 1:10,000 SCALE GEOHAZARDS (LANDSLIDE AND FLOODING) ASSESSMENT AND MAPPING OF LORETO, AGUSAN DEL SUR

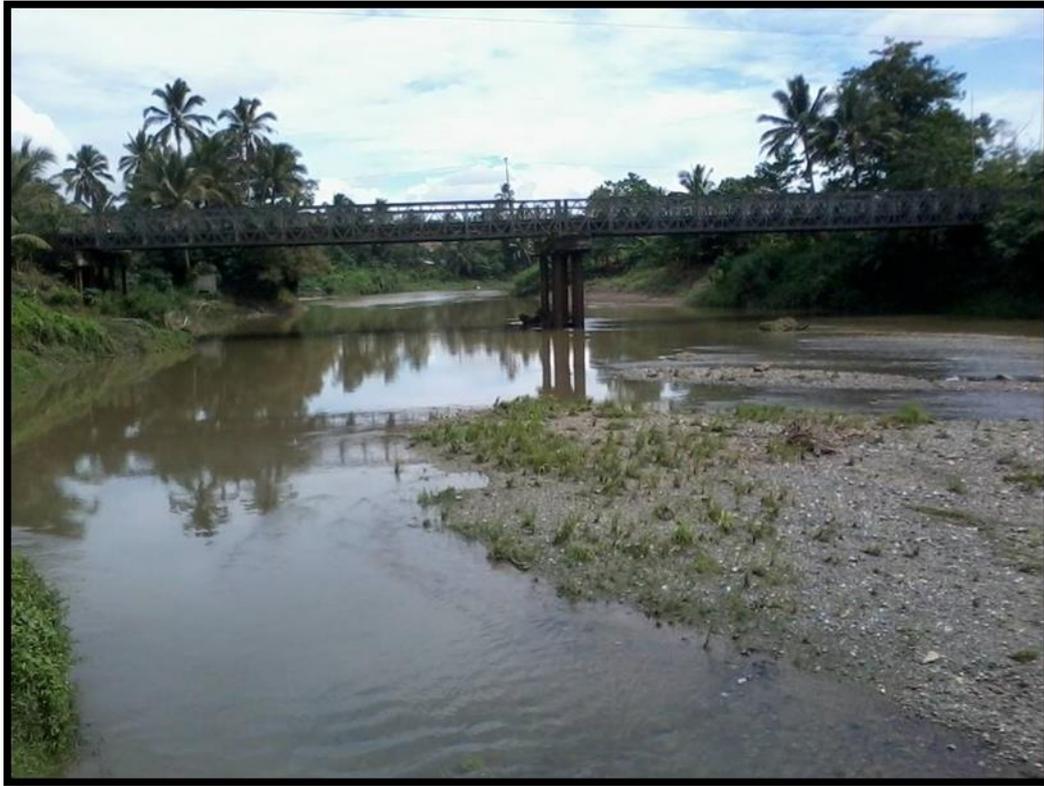
Purok 1 ( $8^{\circ} 0' 37''$  N,  $125^{\circ} 49' 3.4''$ E). A photo showing the Ihawan River at Purok 1, measuring approximately 54 meters wide and 2 meters deep flowing NW.

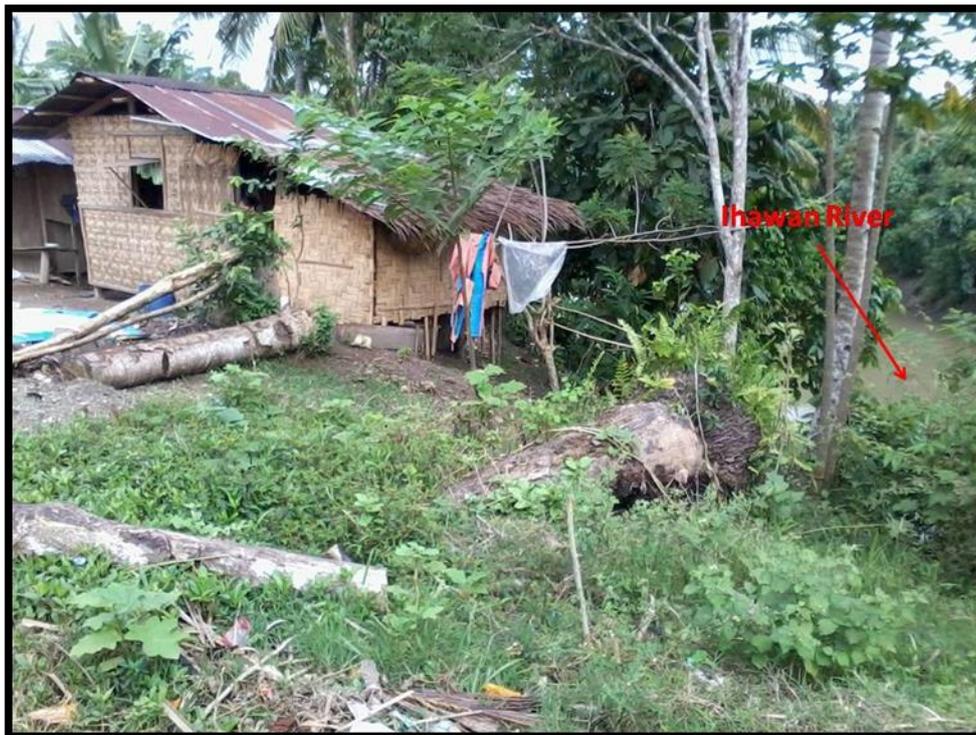
Sitio Boom ( $7^{\circ} 59' 57.1''$  N,  $125^{\circ} 49' 20.9''$ E). A photo showing a settlement near a cliff below Ihawan River, the area is also susceptible to landslide.

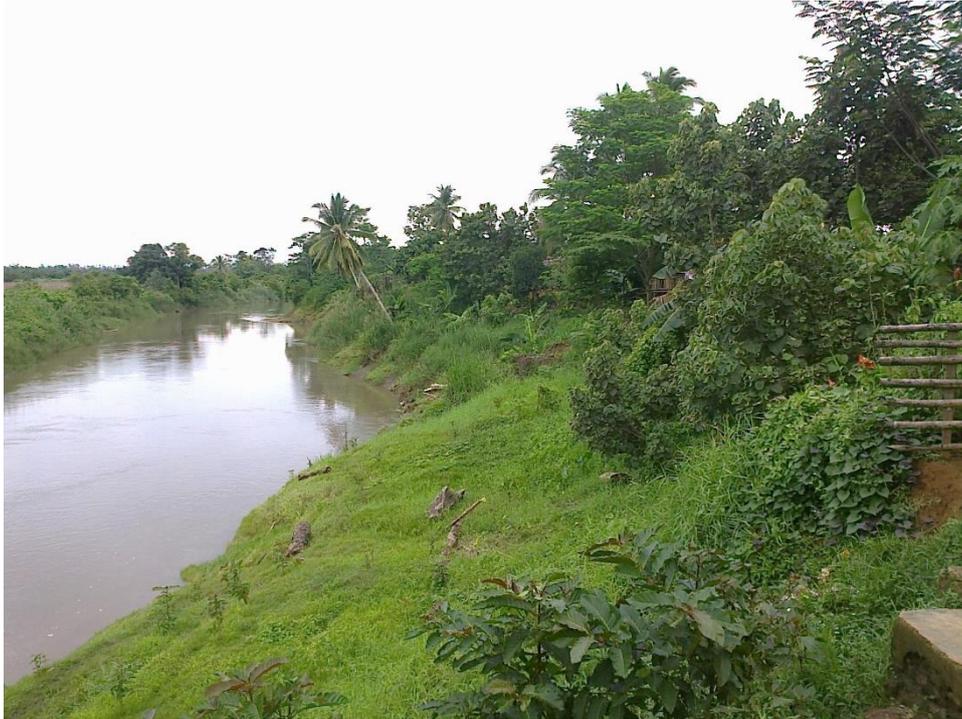
There used to be a street in this part of Purok 1, Barangay Johnson. The rapid erosion of the riverbanks caused the overlying soil materials to collapse.

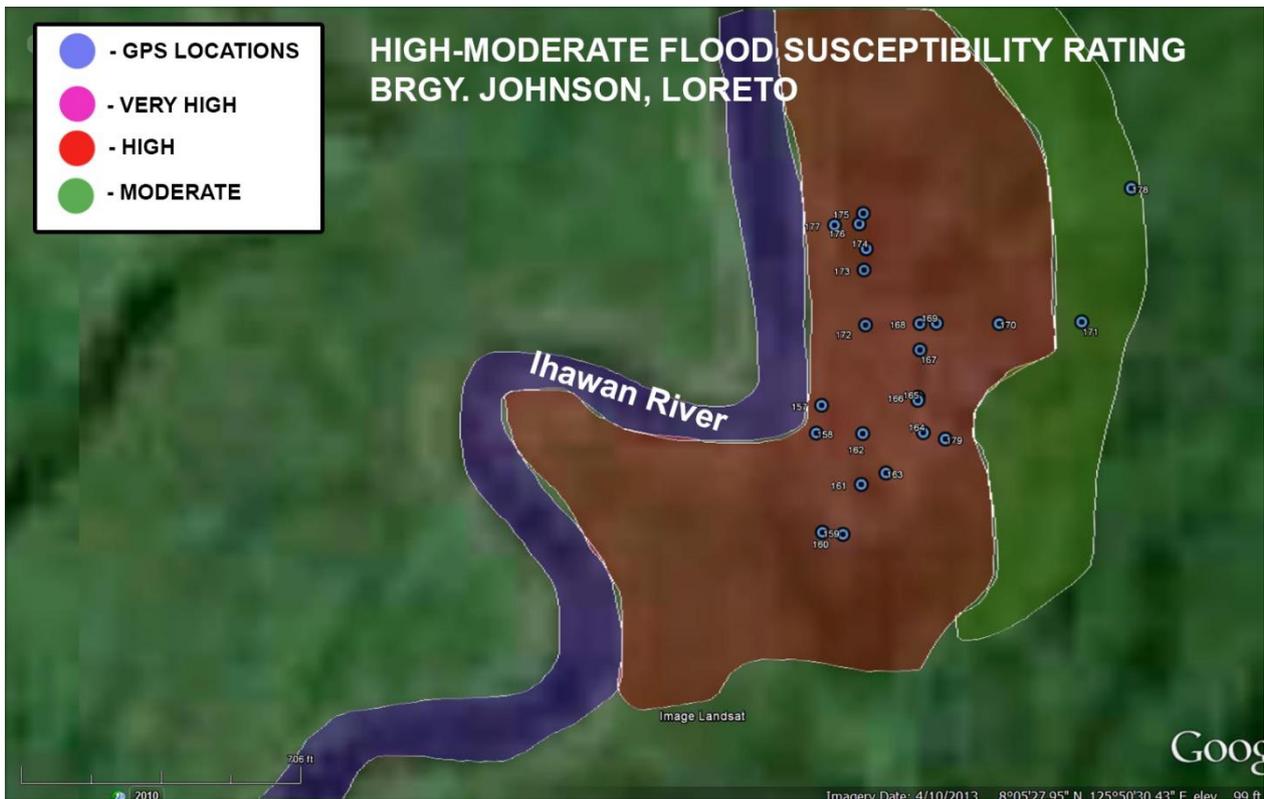
The satellite image above shows the over-all geohazards situation of Barangay Johnson, Loreto. Source: Google Earth

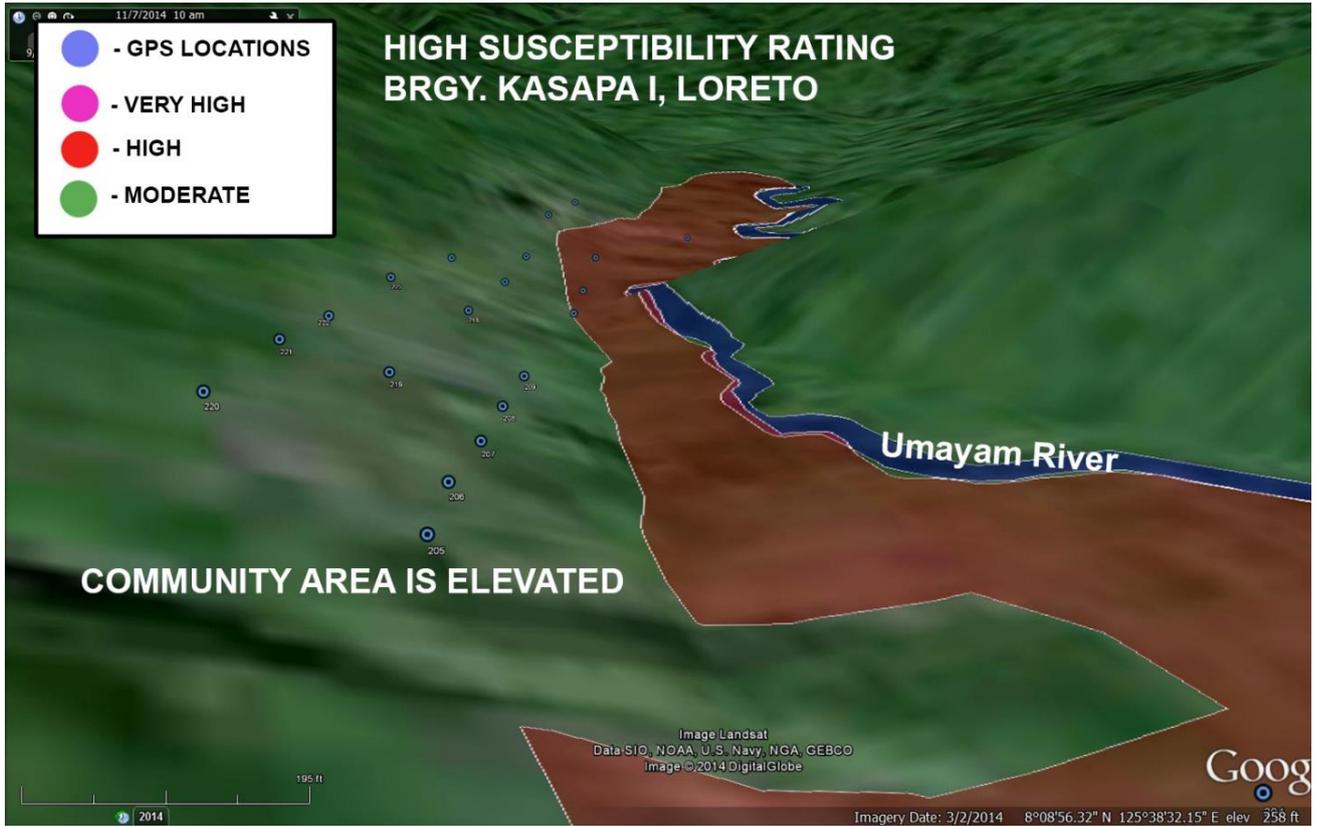
The satellite image above shows the over-all geohazards situation of Barangay Kasapa, Loreto. The community area is relatively elevated compared to Umayam River. Source: Google Earth

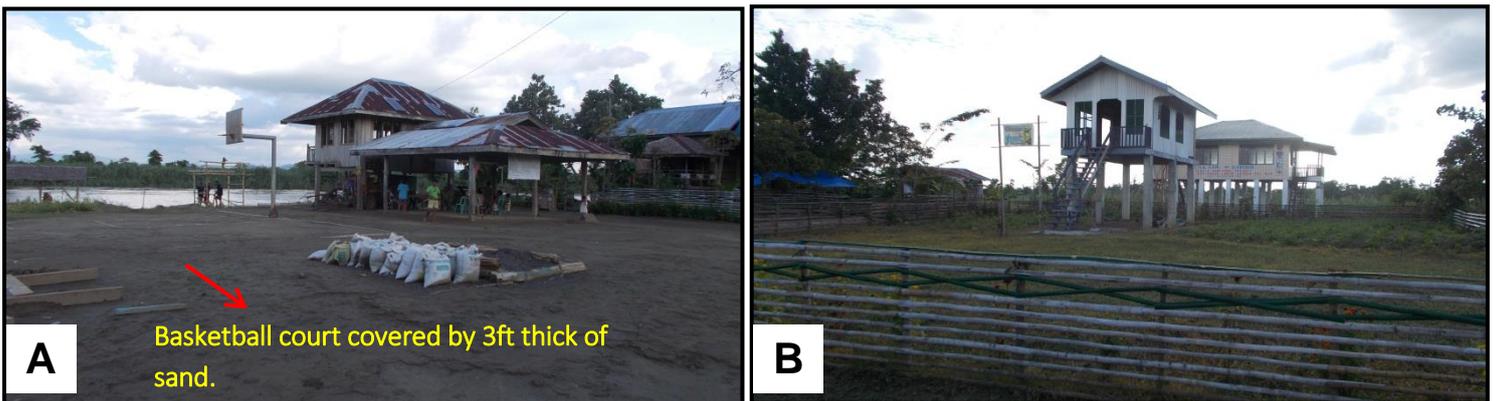
(A) Barangay office of Katipunan. Intense flooding and deposition of sand in the area. In every recorded flood, the deposition of sand reaches ~2ft. During persistent rain Agusan River overflows to the area with flood depth up to 3m. (B) Structural design of daycare center to counter the flood depth. It also serves as an evacuation area during flooding.

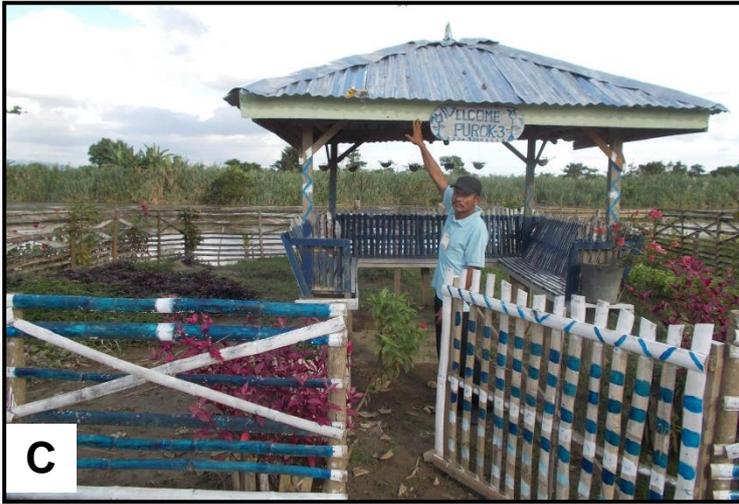
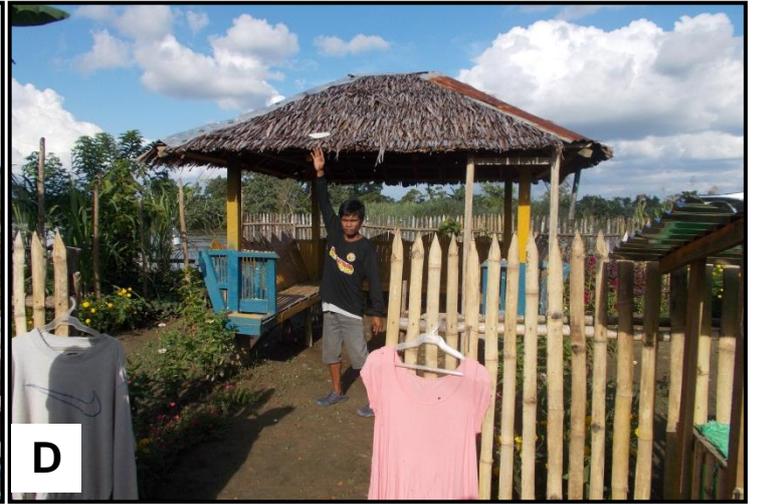
(C and D) Barangay Kagawad pointing the highest recorded flood depth in the area.

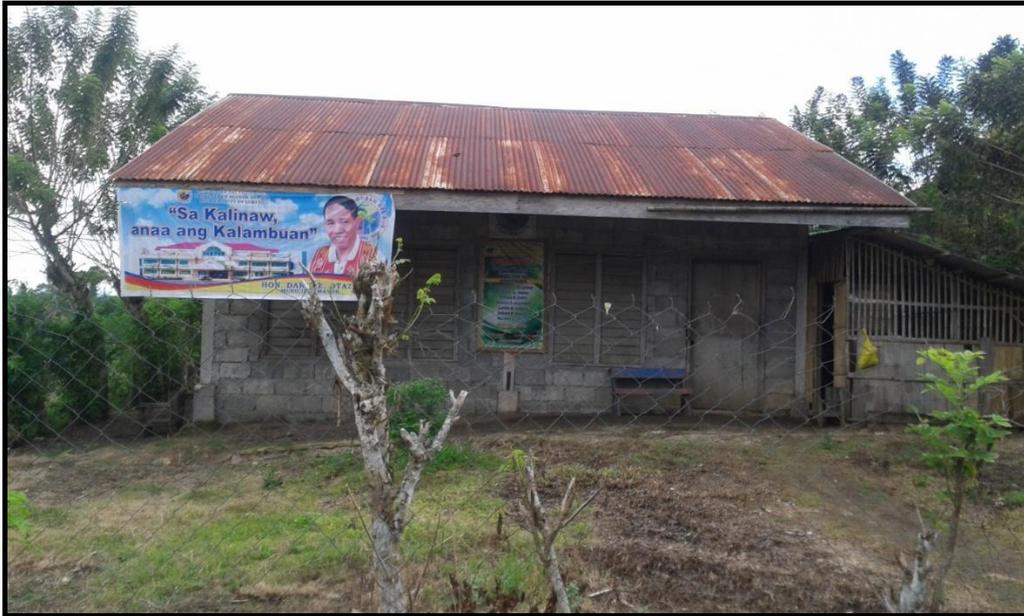
Barangay Hall of Kauswagan, Purok 1. Photo showing Barangay Hall of Kauswagan. Area situated on a gentle terrain. No flooding recorded in the area. GPS Coordinates: 125° 46' 1.2"E 7° 59' 45.2" N

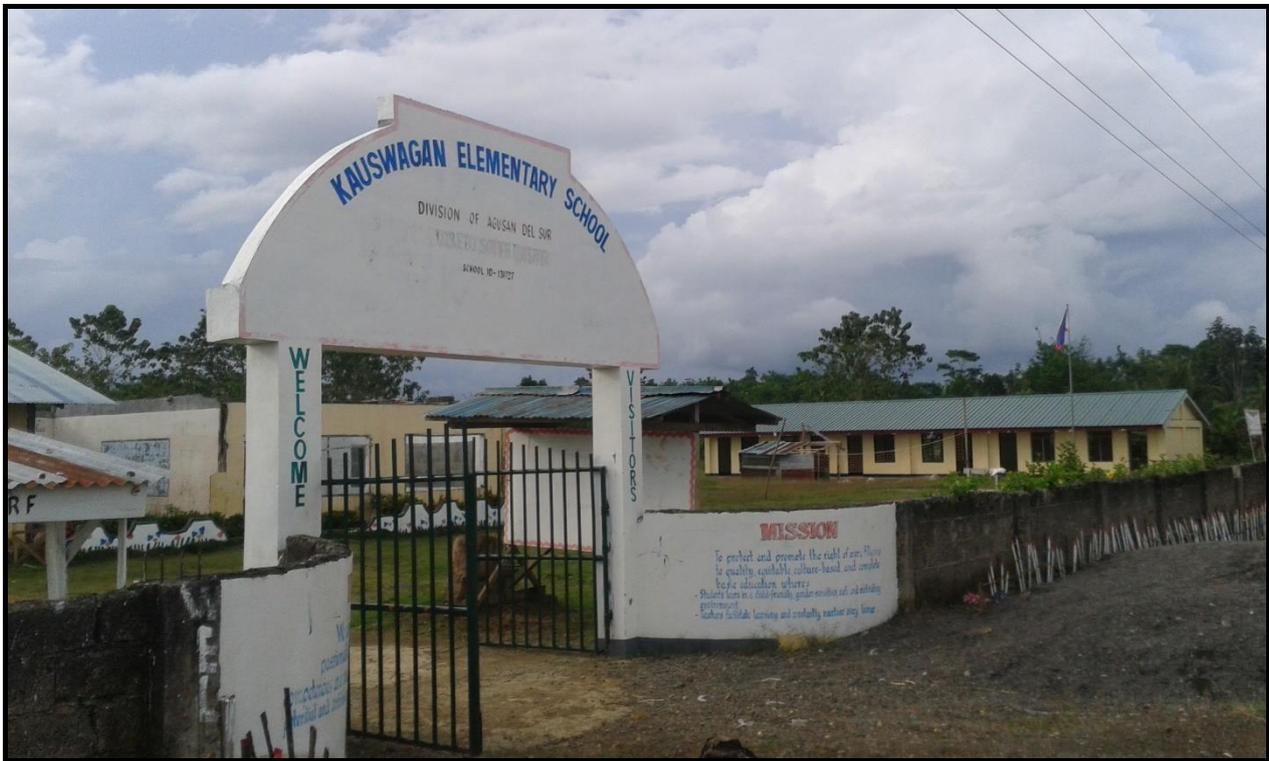
Kauswagan Elementary School, Purok 2-B. Photo showing Kauswagan Elementary School. The area is situated in a gentle terrain. No flooding recorded in the area. GPS Coordinates: 125° 45' 40.7"E 7° 59' 32.2" N

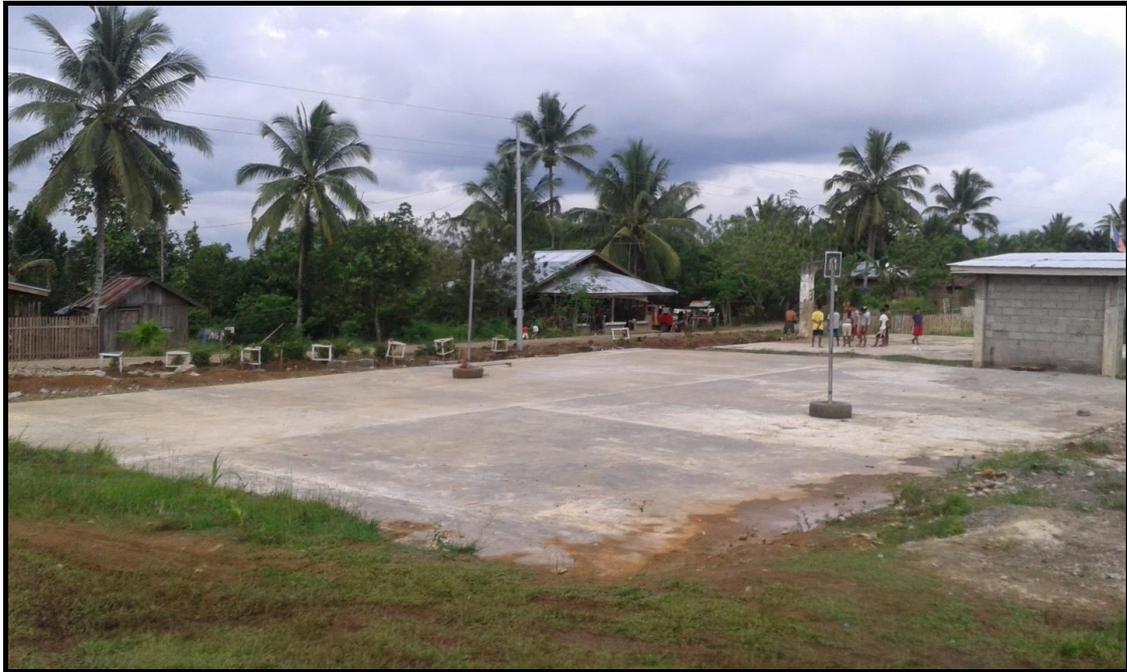
Recreational Area/Kauswagan Plaza, Purok 1. Area adjacent to Barangay Hall. The area is situated in a flat terrain. No flooding recorded in the area. GPS Coordinates: 125° 46' 1.2"E 7° 59' 45.2" N

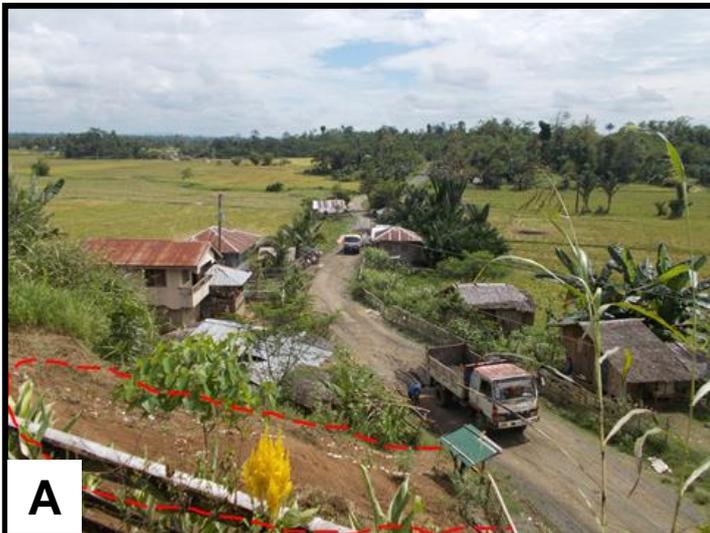
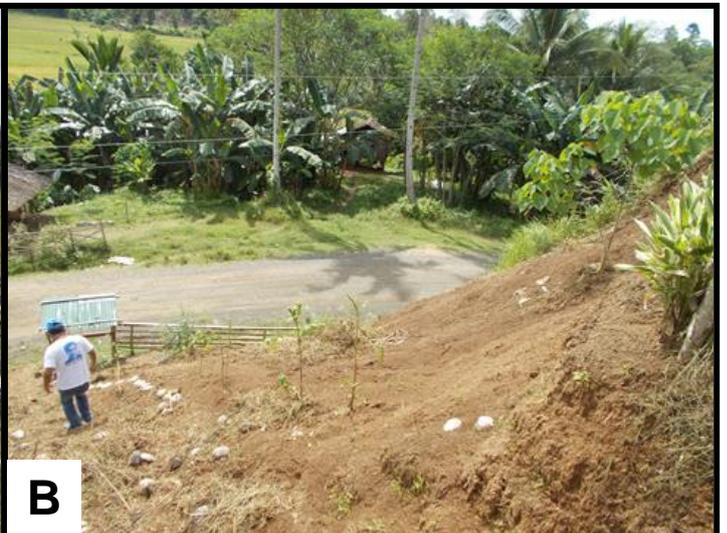
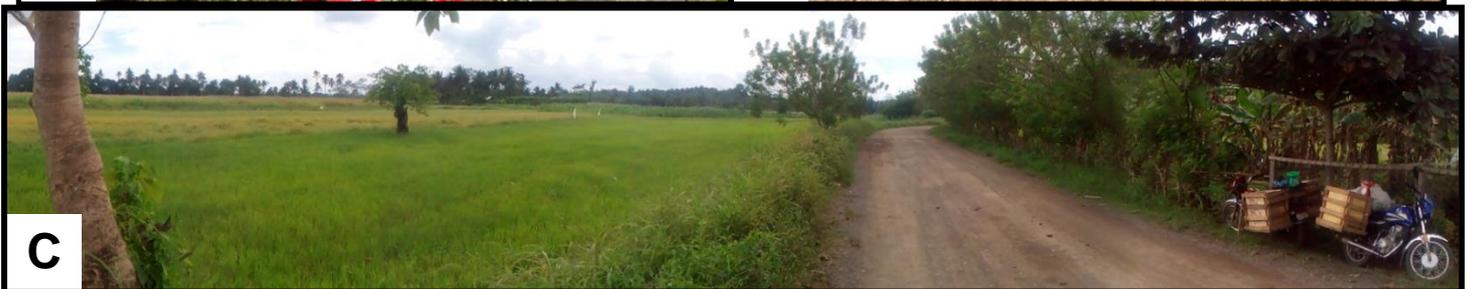
(A and B) Sitio Kabuhayan shed is on top of a moderate to steep slope. Houses at the bottom of the hill are at risk of landslide. The overlooking area at the bottom is generally flat that could be flooded easily. (C.) During persistent heavy rains, floodwaters in Purok 7 are ~1.0 m deep especially in the rice field areas.

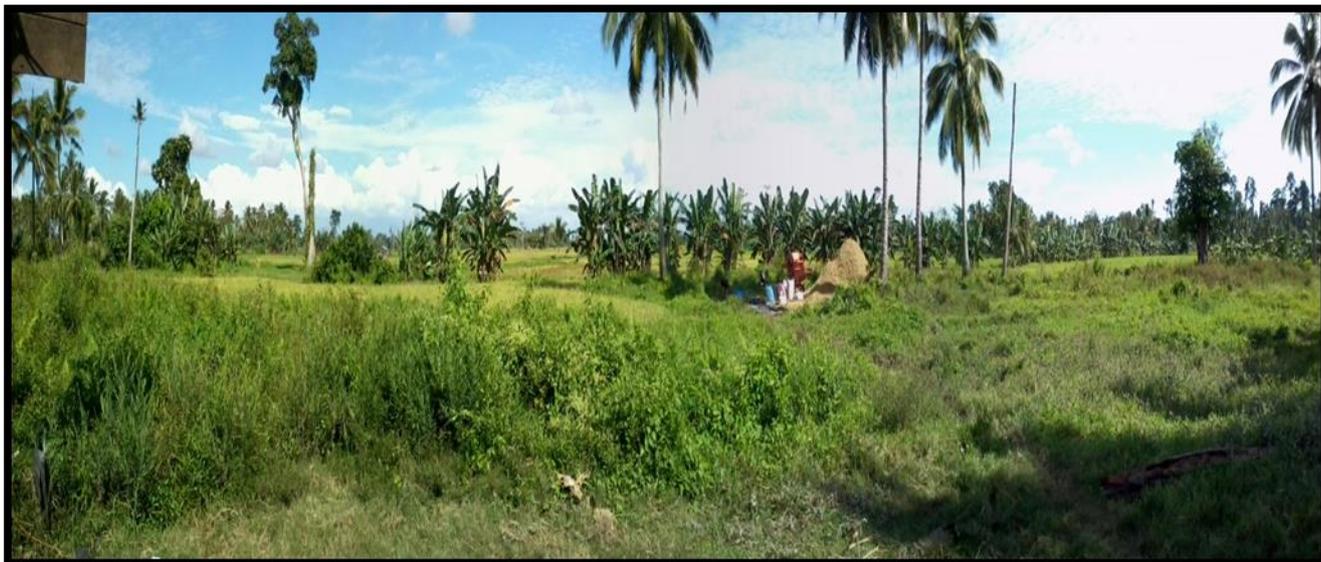
Sitio Bayug (8° 6' 29.7" N,125° 52' 31.8"E). Panoramic view of a residential and farmland areas in Sitio Bayug. This area is inundated when Ihawan River and Kibanog Creek overflow. Flood depth is approximately 2 meters.

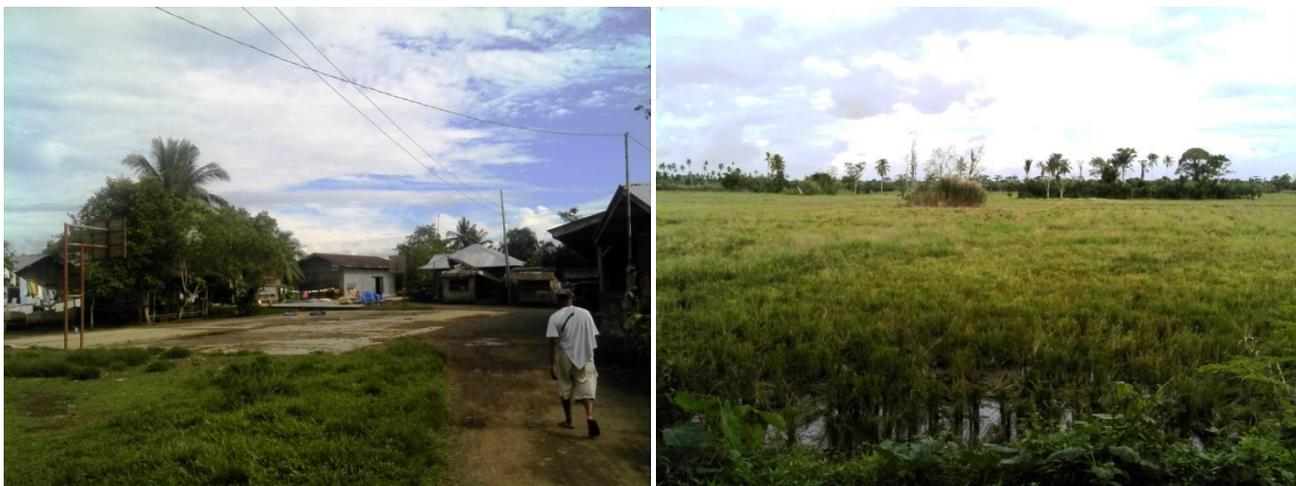
Areas affected with sheet flooding at Sitio Proper Ilo-an (left) and agricultural area at Purok 6 (right).

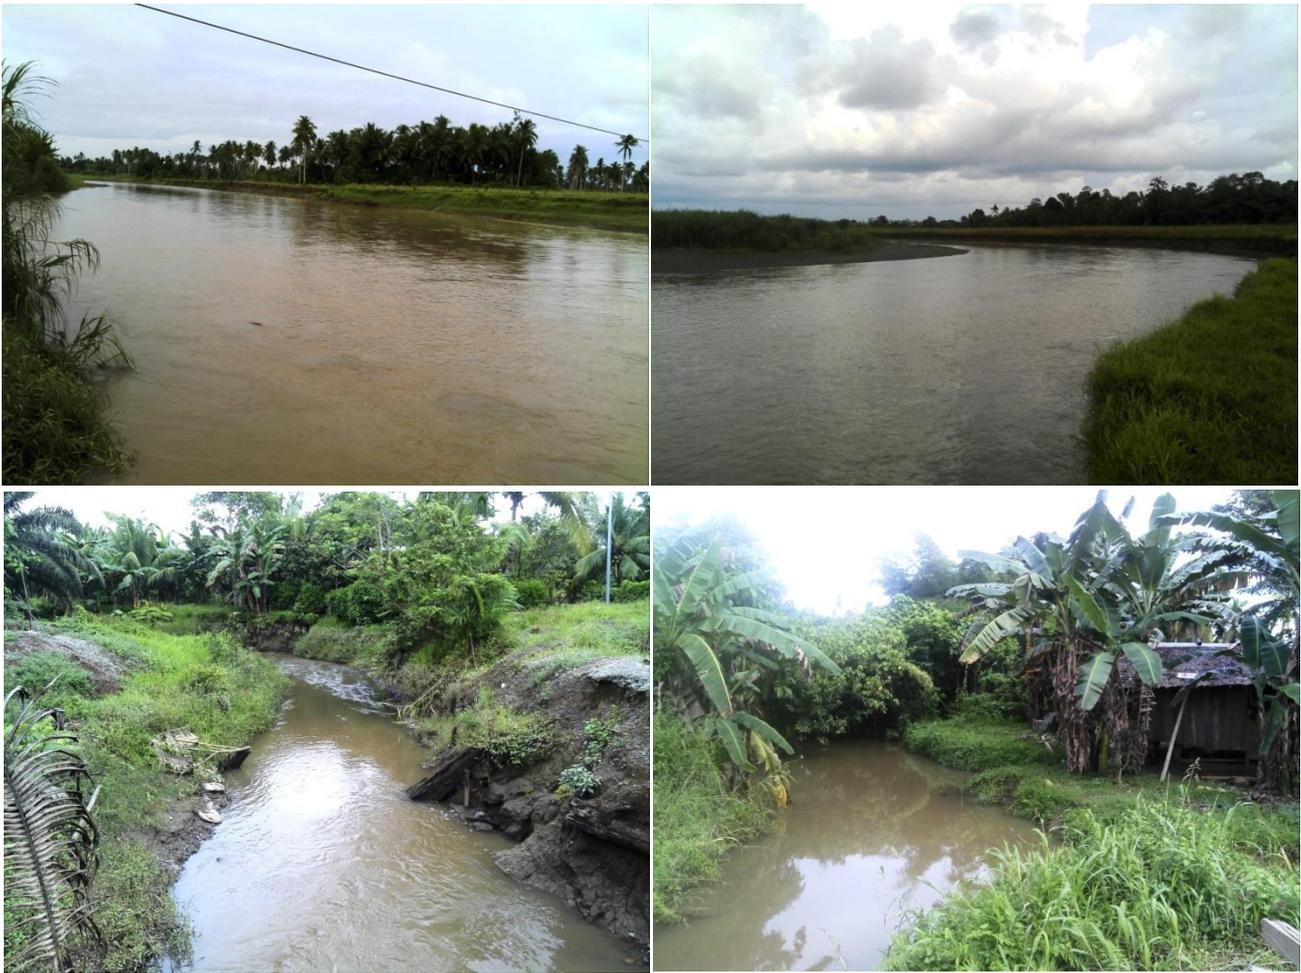
Photos. Main cause of flooding at the area is overflowing of river and creek. Image of Umayam River taken at Purok 1 (above left) and Purok 5 (above right) with noticeable bank erosion along agricultural areas and creeks at Sitio Upper Ilo-an (bottom left) and Sitio Mambaos (bottom right).

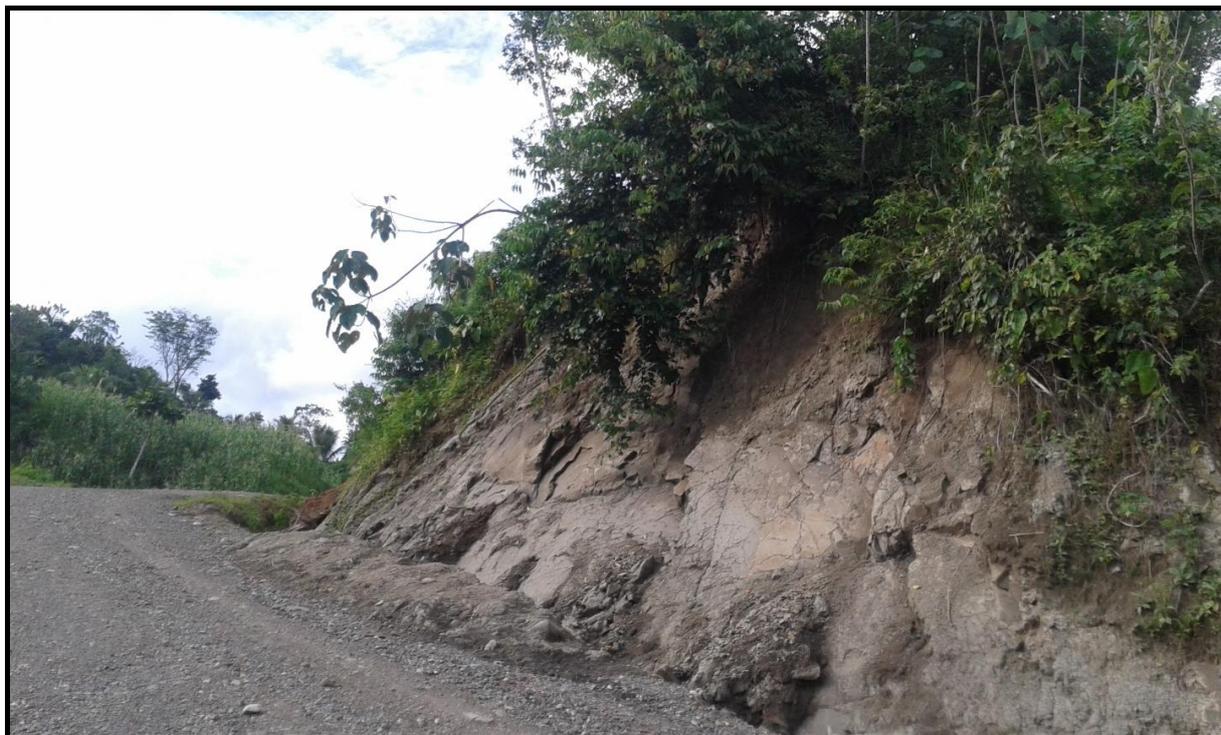
Barangay road, Purok 1. Photo showing a road cut with an active landslide. Area is approximately 30 meters wide with slope of 20 to 25 meters high. Slope material is mudstone overlain by loose soil deposit. GPS Coordinates: 125° 43' 6.2"E 7° 59' 9.1" N

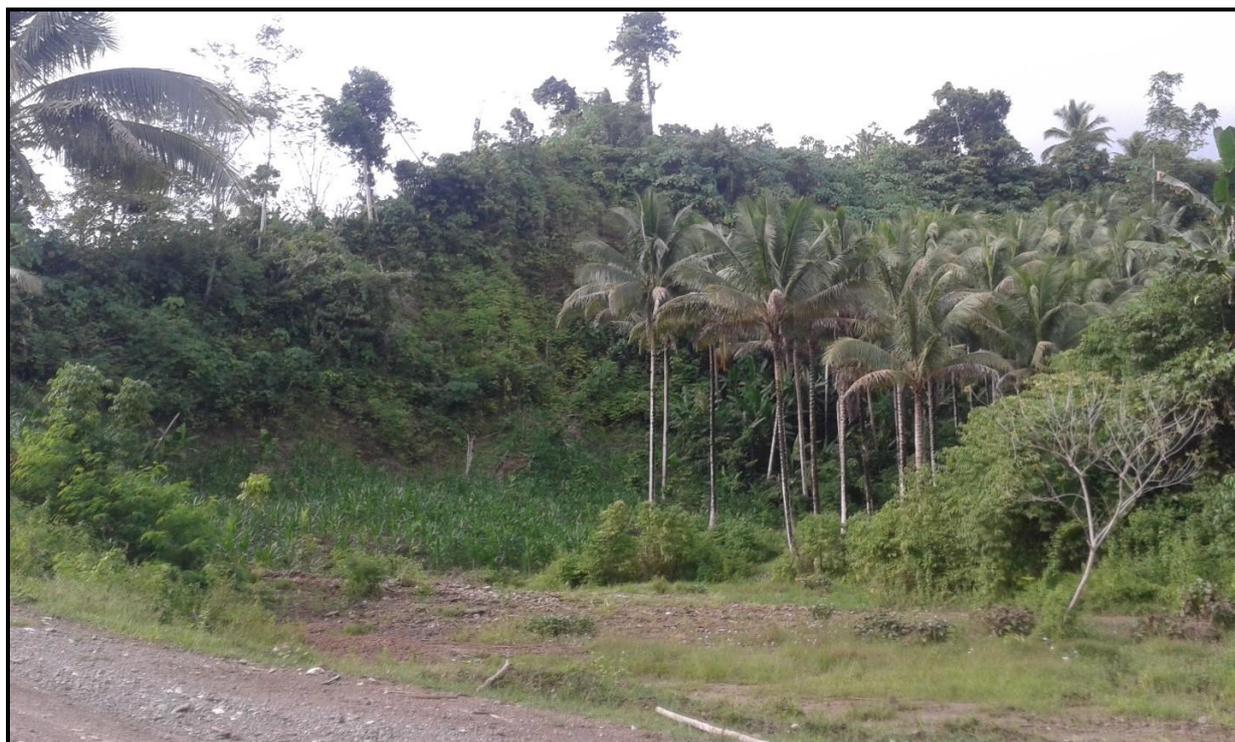
<p>LOR-SBD-186 Residential area in Purok 1/Purok 1 proper 7°59'11" N 125°43'2.2" E</p>	<p>Moderate</p>	<p>Relic landslide that took place during Typhoon Pablo was observed. Houses were built on top of an unstable slope with an approximate slope height of 8-10 meters.</p> <p>Recommendations: Observe for and/or monitor for presence of mass movement regeneration and report to MGB/municipal authorities (e.g. landslide, tension cracks). Constant communication and updates with Brgy. Sabud on geohazard situation.</p>
<p>LOR-SBD-184 Residential area in Purok 1/Purok 1 proper 7°59'12.4" N 125°43'5.4" E</p>	<p>Moderate</p>	<p>Residential area in Purok 1/Purok 1 proper is located on top of a moderate steep slope. Soil creep was observed.</p> <p>Recommendations: Observe for and/or monitor for presence of mass movement and report to MGB/municipal authorities (e.g. landslide, tension cracks). Constant communication and updates with Brgy. Sabud on geohazard situation.</p>

Relic Landslide, Purok 1. Photo showing relic landslide approximately 25-30 meters wide. Landslide took place during Typhoon Pablo. Area situated adjacent to Tanionan Creek. GPS Coordinates: 125° 43' 11.8"E 7° 59' 3.8" N

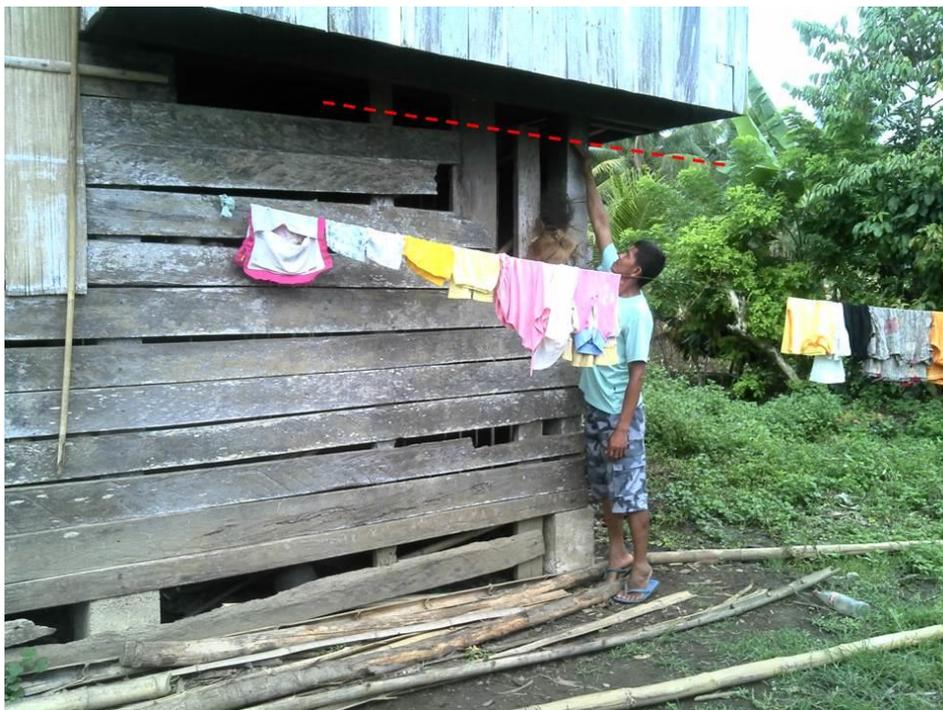
A barangay official shows the approximate flood height of 1.8 meters in one of the residences of Purok 2 during typhoon Pablo. (Geographical Location: 8° 2' 50.8" N 125° 48' 45.6" E)

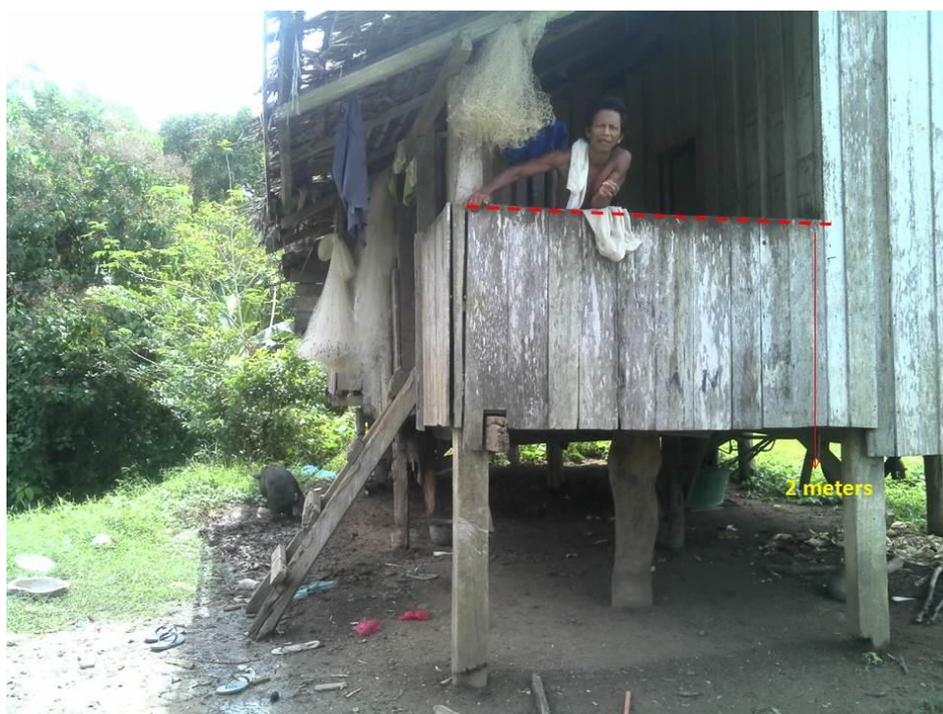
A resident of Purok 2 shows the approximate flood height of 2.1 meters in his house during typhoon Pablo. (Geographical Location: 8° 2' 52.8" N 125° 48' 55.4" E)

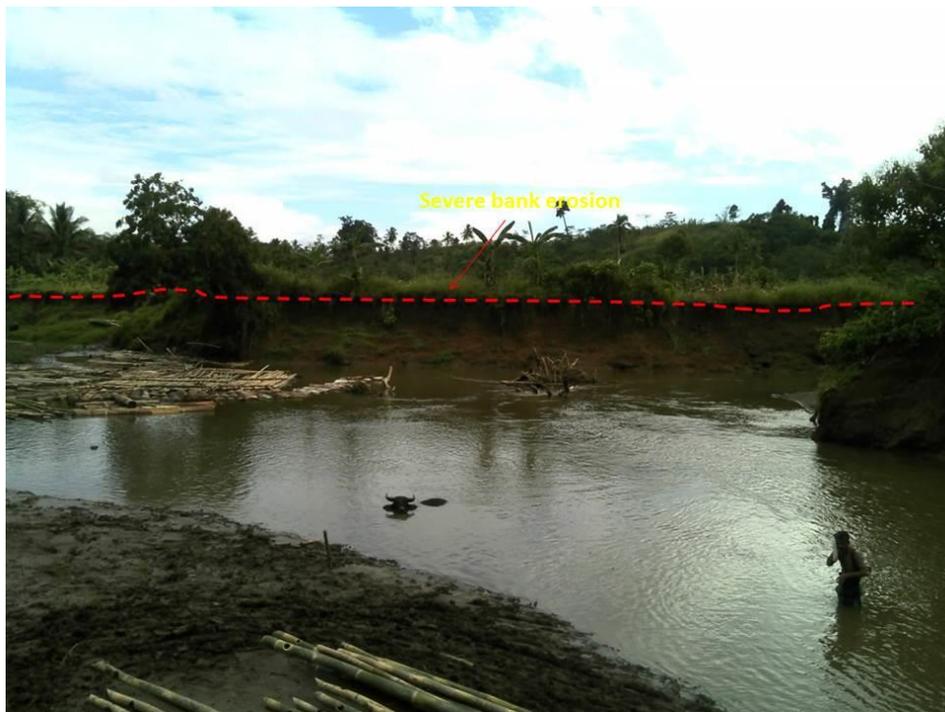
This photo shows severe bank erosion along the riverbank of Anahawan River. (Geographical Location: 8° 2' 39.6" N 125° 47' 20.5" E)

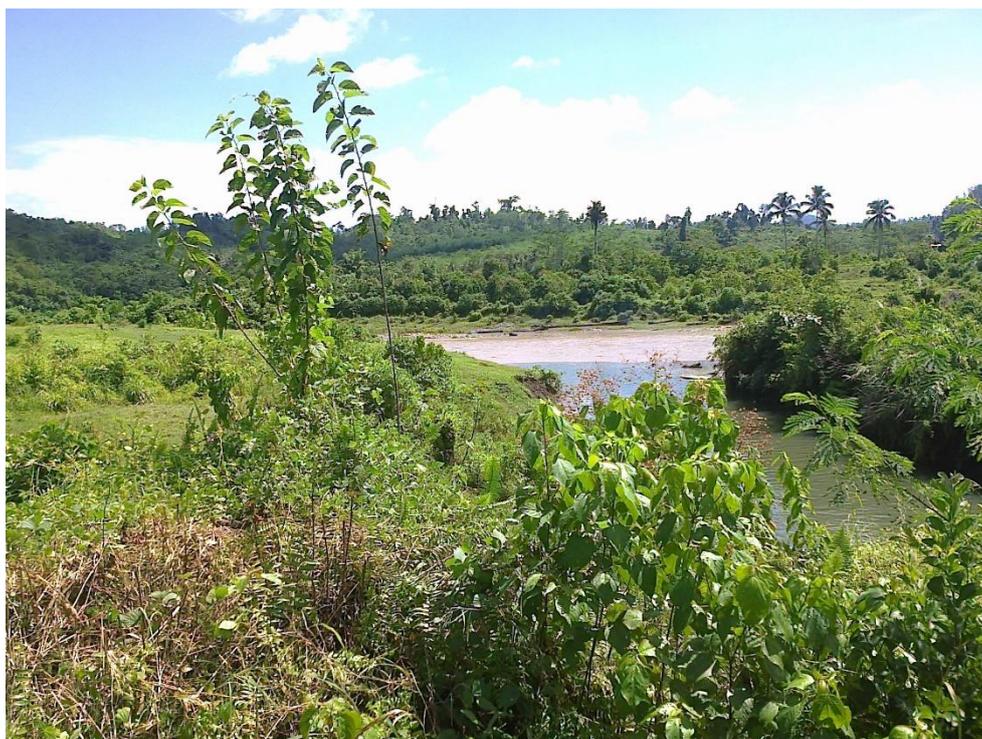
Tigbawan Creek, a tributary of Ihawan River, is shown in the photo. This stream tend to overflow once Ihawan reaches its maximum water capacity.

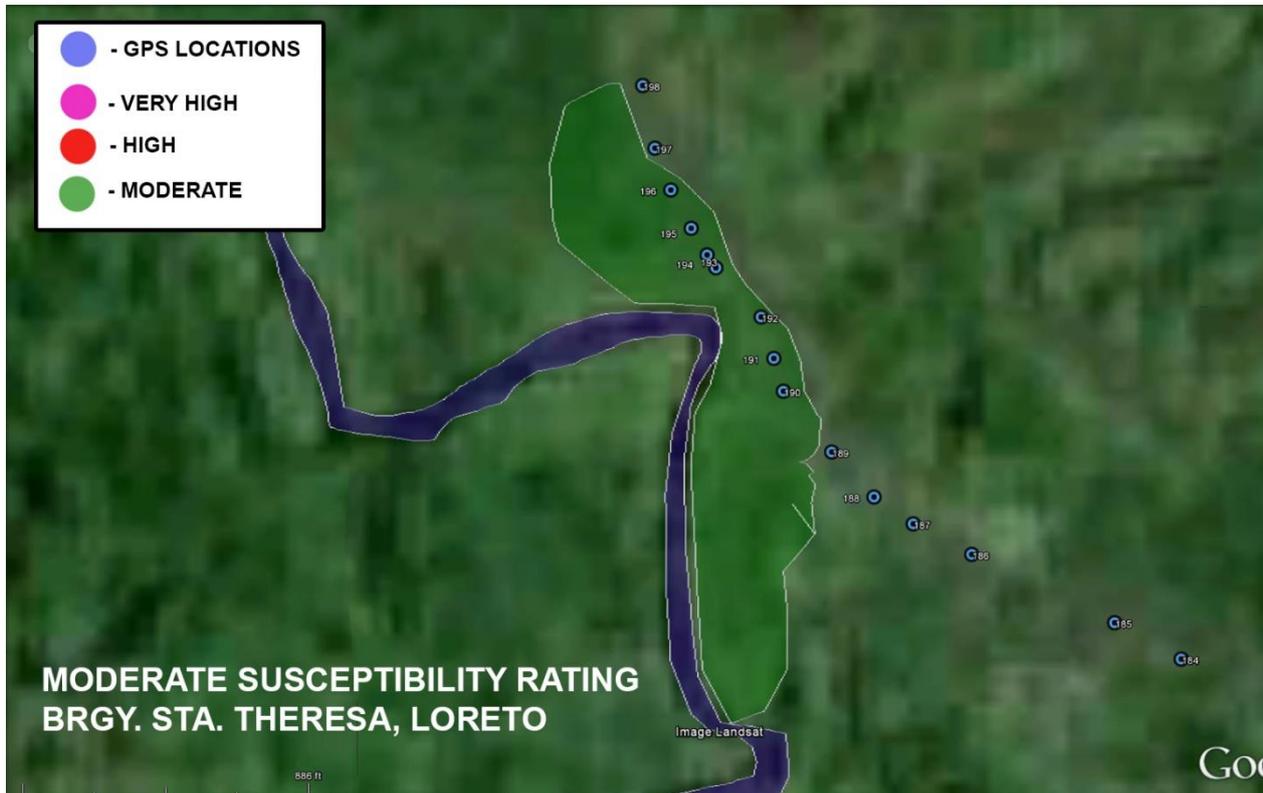
The satellite image above shows the over-all geohazards situation of Barangay Sta. Theresa, Loreto. Source: Google Earth

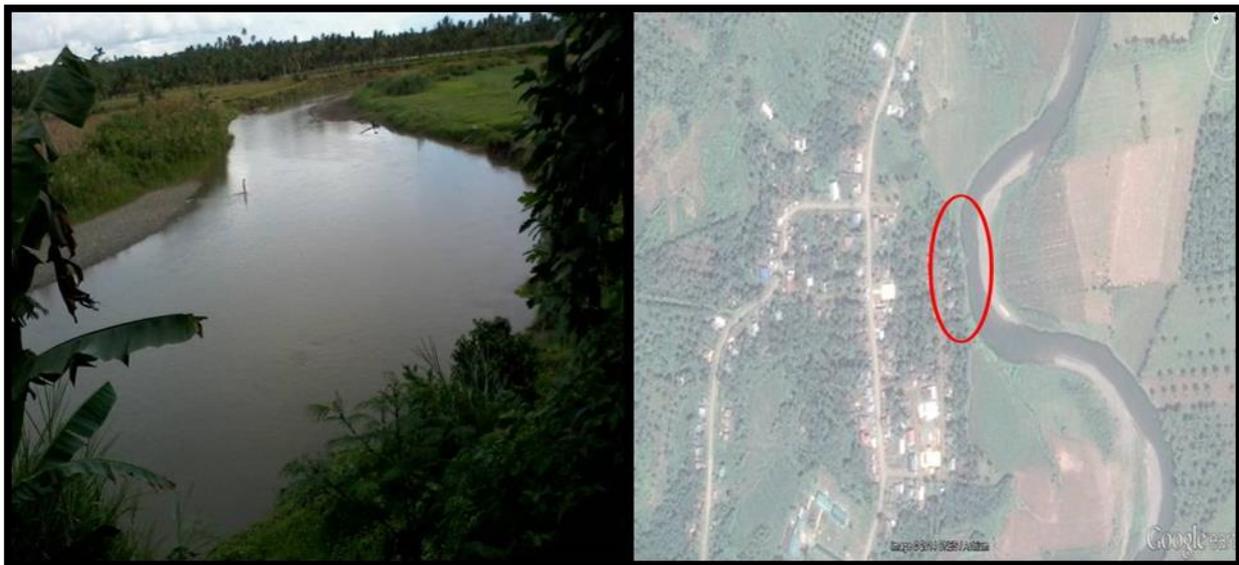
Purok 7 (8° 1' 14.3" N 125° 48' 40.7"E). A photo showing the Ithawan River where bank erosion is highly active (left) affecting the land area of Purok 7. Photo on the left is a google earth generated image of the barangay showing the area of concern (red circle).

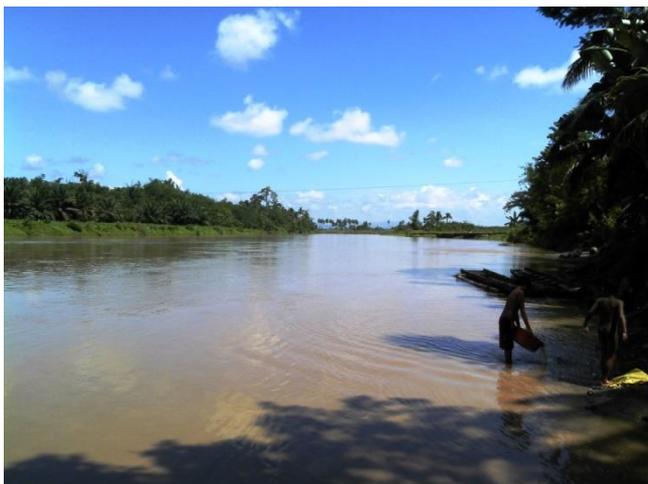
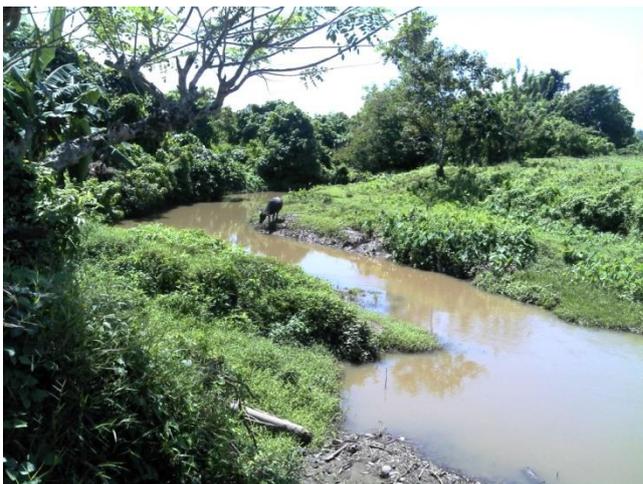
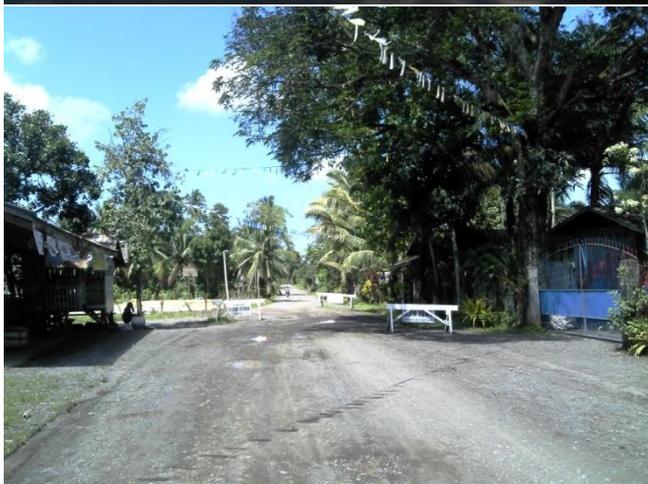
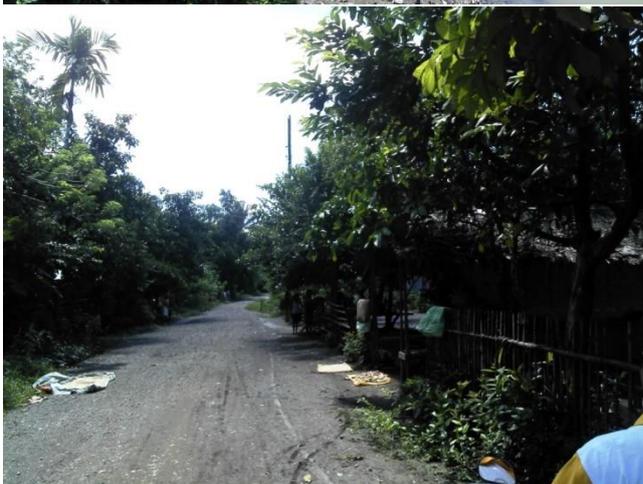
Clockwise: Images of Umayam River taken at Purok 1 and Kinawan Creek at Purok 1 Sitio New Visayas. These are the main cause of sheet flooding at the area. Some of the residential area affected with sheet flooding at Purok 2 Sitio New Visayas and Purok 5 (photos below).

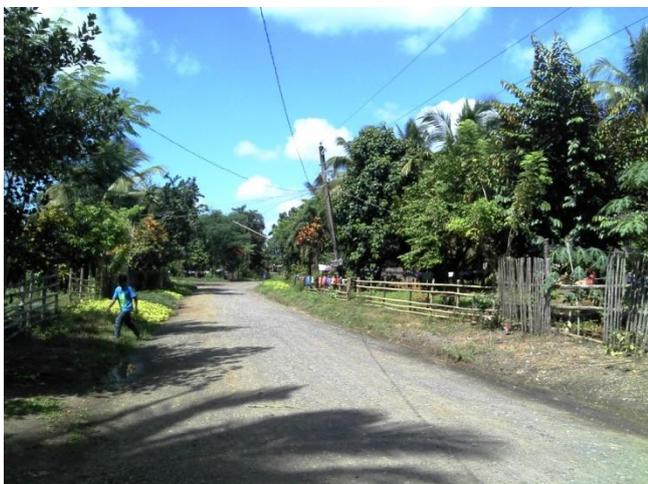
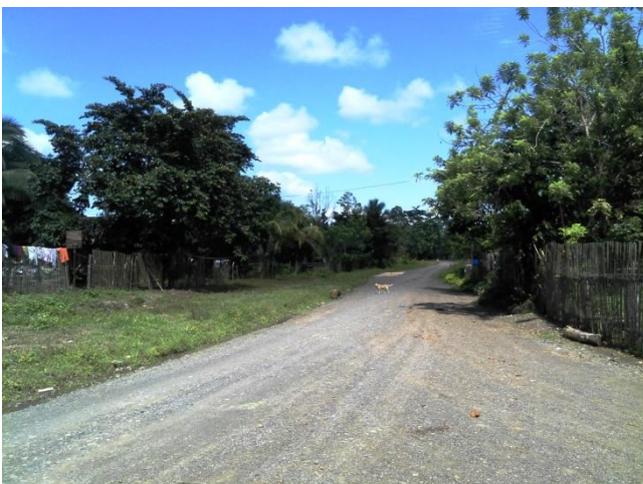
LOR-TOM-22 Sitio Manawe (Special Barangay) 8°9'7.09" N 125°48'33.59" E	Moderate	Most of the residential areas at Sitio Manawe are located along moderately sloping ground.  Recommendations: Observe for and/or monitor for presence of mass movement (e.g., landslides, tension cracks), saturated ground or seeps and sunken or displaced road surfaces and report to MGB/municipal authorities. Develop an early warning system (e.g., signages). Constant communication and updates with Brgy. Sto. Tomas on geohazard situation. Avoid building of houses near slope areas prone to ground failure.

LOR-TOM-23 Sitio Manawe (Special Barangay) 8°9'25.34" N 125°48'43.74" E	Moderate	Most of the residential areas at Sitio Manawe are located along moderately sloping ground.  Recommendations: Observe for and/or monitor for presence of mass movement (e.g., landslides, tension cracks), saturated ground or seeps and sunken or displaced road surfaces and report to MGB/municipal authorities. Develop an early warning system (e.g., signages). Constant communication and updates with Brgy. Sto. Tomas on geohazard situation. Avoid building of houses near slope areas prone to ground failure.
LOR-TOM-24 Sitio Manawe (Special Barangay) 8°9'27.4" N 125°48'36.65" E	Moderate	
LOR-TOM-25 Sitio Manawe (Special Barangay) 8°9'35.64" N 125°48'46.33" E	Moderate	
LOR-TOM-26 Sitio Manawe (Special Barangay) 8°9'36.14" N 125°48'47.88" E	Moderate	
LOR-TOM-27 Sitio Manawe (Special Barangay) 8°10'4.15" N 125°48'56.84" E	Moderate

Sitio Manawe considered as a special Barangay by the local government is generally situated along moderately sloping terrain. Images above show some of the residential areas at Purok 3 (left) and Purok 4 (right).

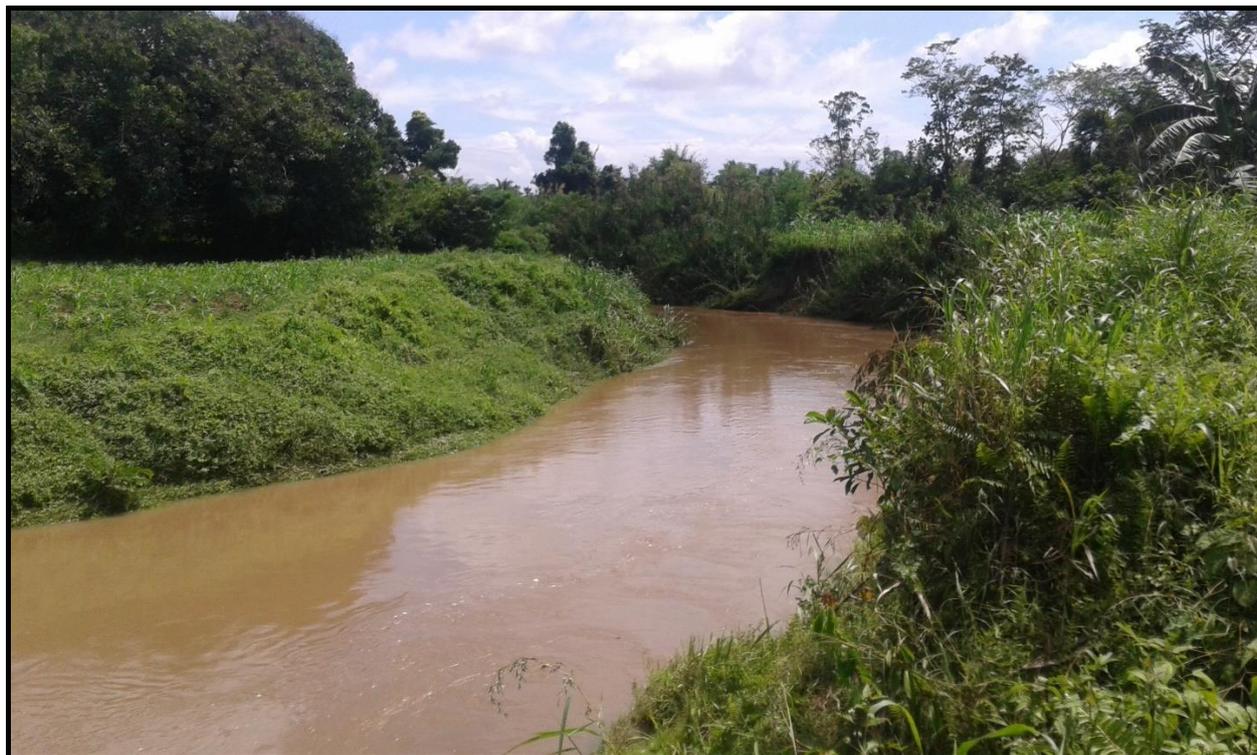
Danuman River, Sitio Macopahon. Photo showing Danuman River. Area adjacent to this river is frequently flooded especially during heavy rainfall. Highest recorded flooding reaches up to 1.2 meters during typhoon Pablo. GPS Coordinates: 125° 49' 2.2"E 8° 7' 15.7" N
