# REPORT ON THE 1:10,000 SCALE GEOHAZARDS ASSESSMENT AND MAPPING OF LORETO, AGUSAN DEL SUR

**SRDP Consulting Inc.**  
Units 119, 420 & 421 SJB Condominium  
130-B Panay Ave, South Triangle  
Quezon City, Philippines

**NOVEMBER 2014**

## REPORT ON THE 1:10,000 SCALE GEOHAZARDS (LANDSLIDE AND FLOODING) ASSESSMENT AND MAPPING OF LORETO, AGUSAN DEL SUR

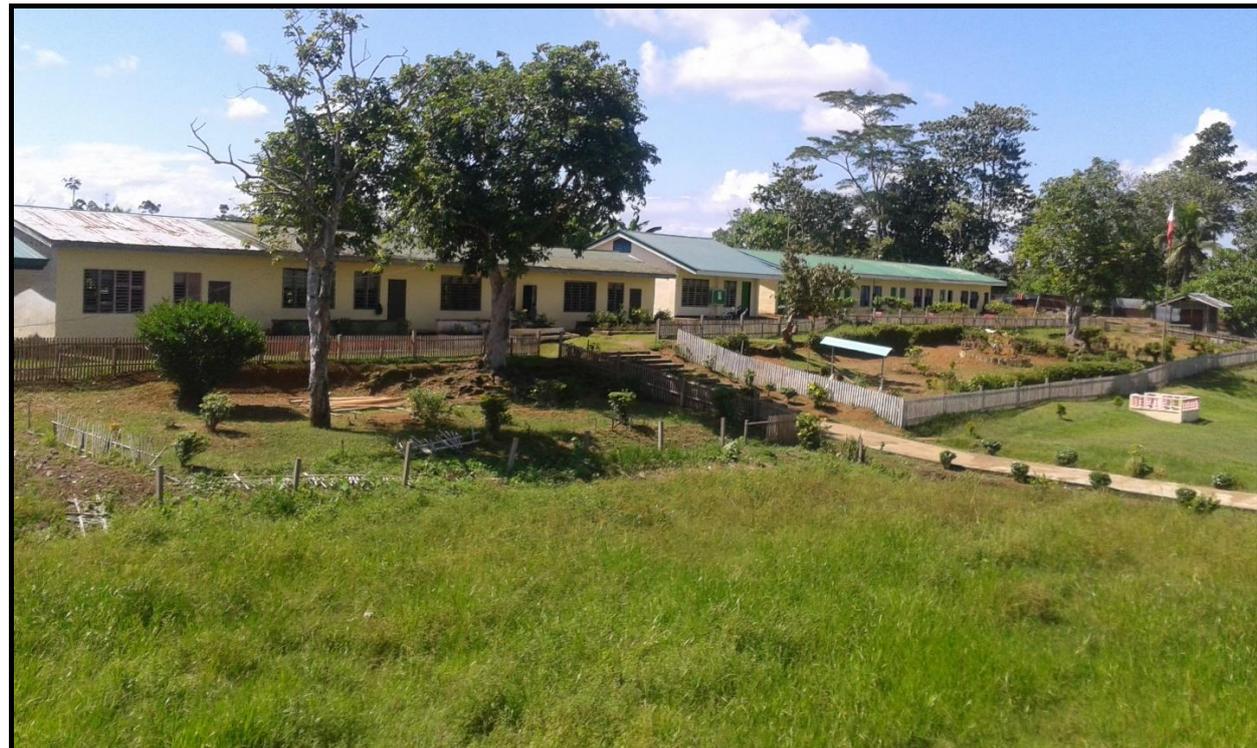
Paciencia Elementary School, Purok 3. Photo showing Paciencia Elementary School. The school is situated in a flat terrain with no flooding recorded. Area can be used as evacuation center. GPS Coordinates: 125° 47' 55"E 8° 7' 29" N

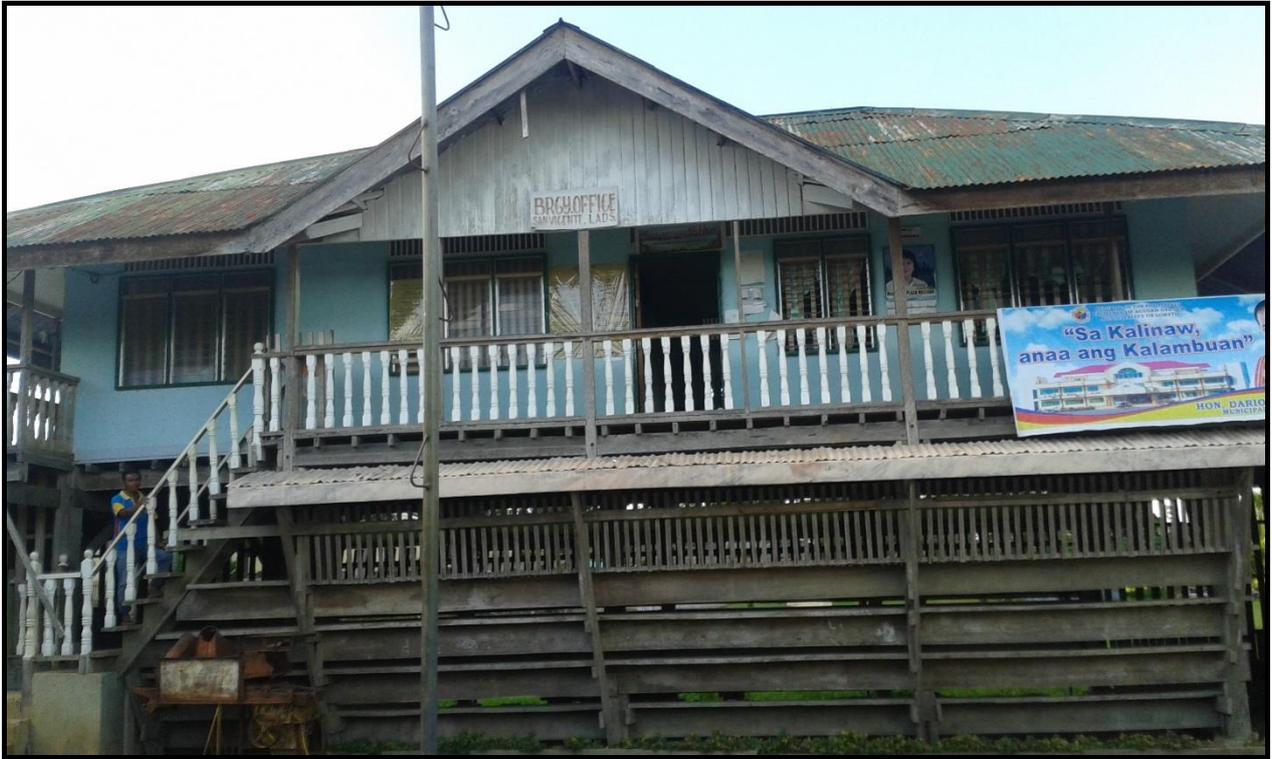
Barangay Hall of San Vicente, Purok 3. Photo showing Barangay Hall of San Vicente. This area is situated in a flat terrain with no flooding recorded. Area can be used as evacuation center. GPS Coordinates: 125° 47' 55.4"E 8° 7' 28.7" N

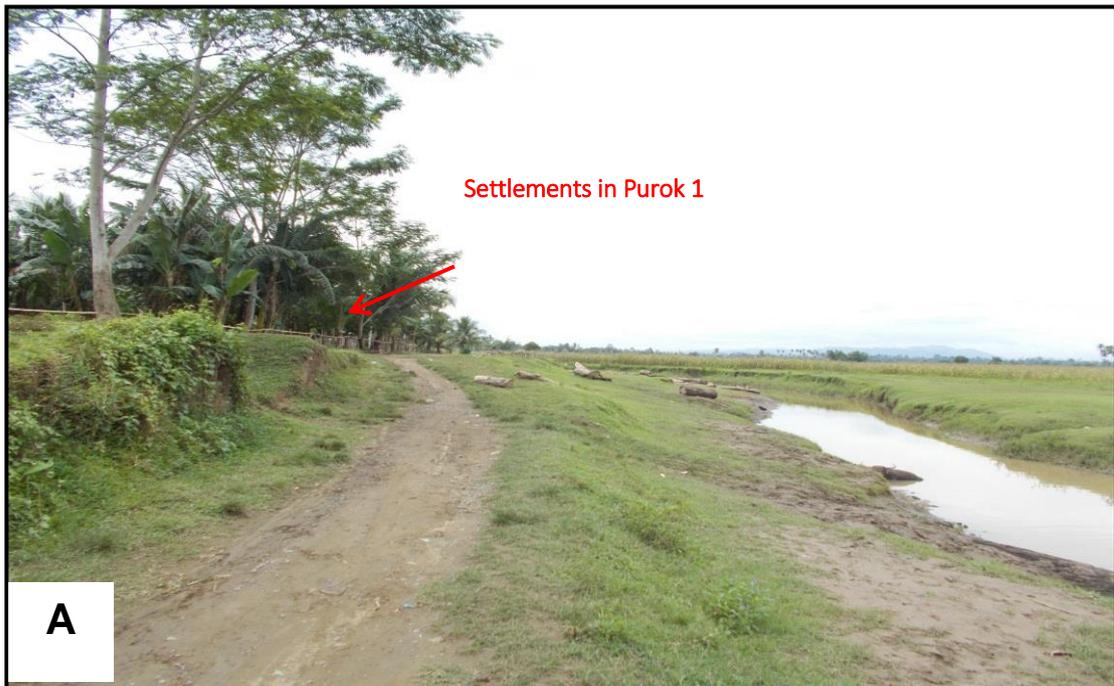
Photo A Showing the original path of Tagabaka Creek that inundates the surrounding area.

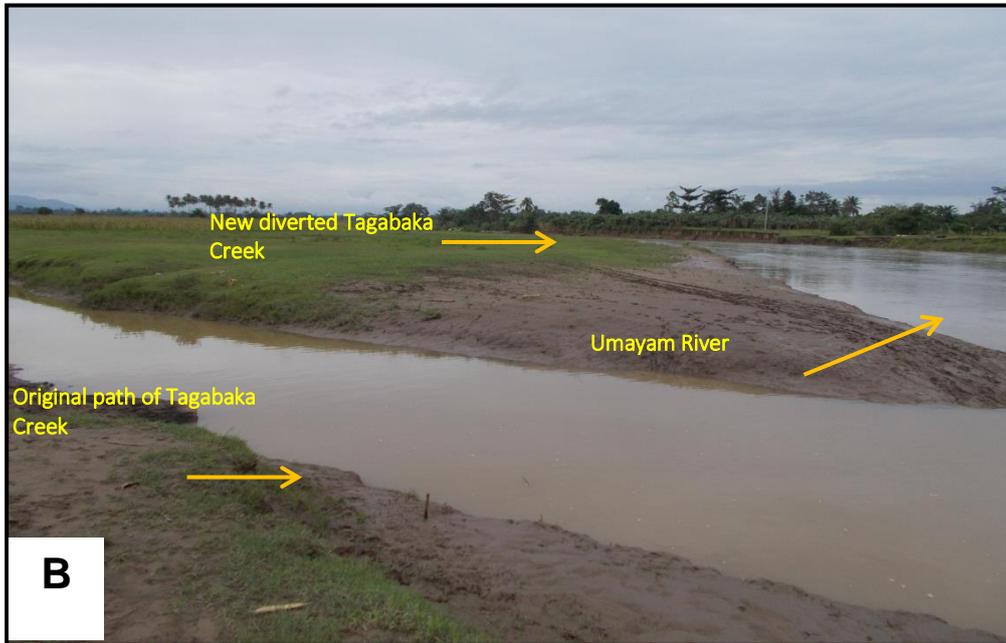
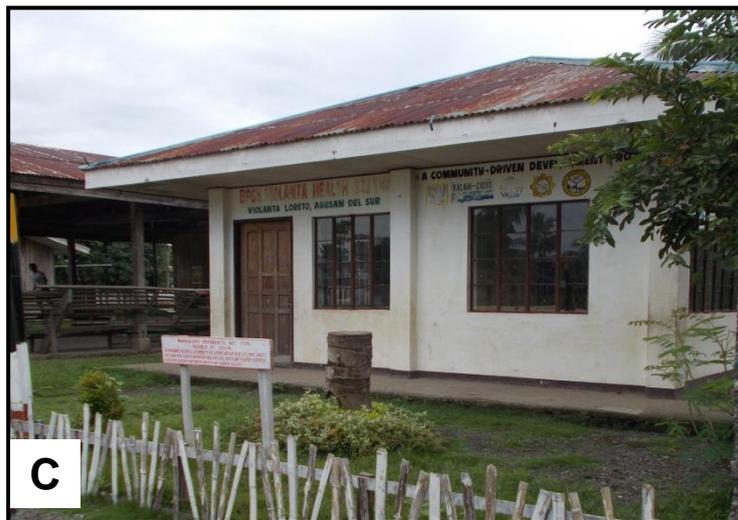
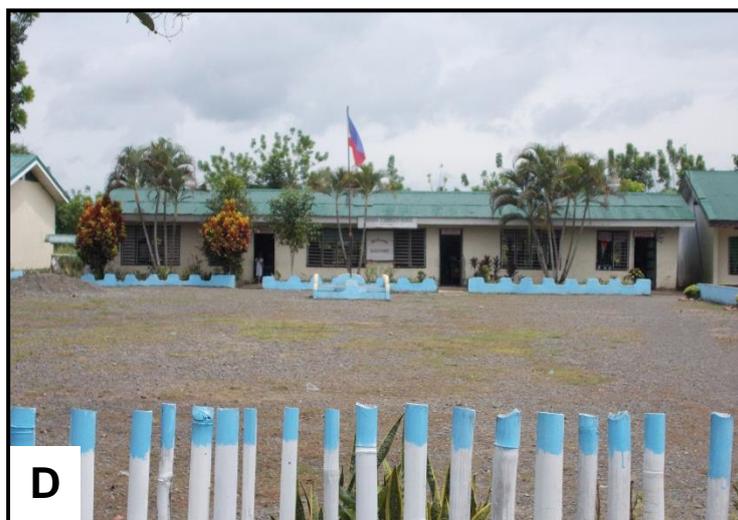
Photo B Shows the diverted Tagabaka creek beside Umayam River. It was diverted under the leadership of Mr. Ely Ybanez on October 1996 to prevent flooding on the residential area of the barangay. Photos C and D The barangay hall and School is in an elevated ground, with a flat terrain.

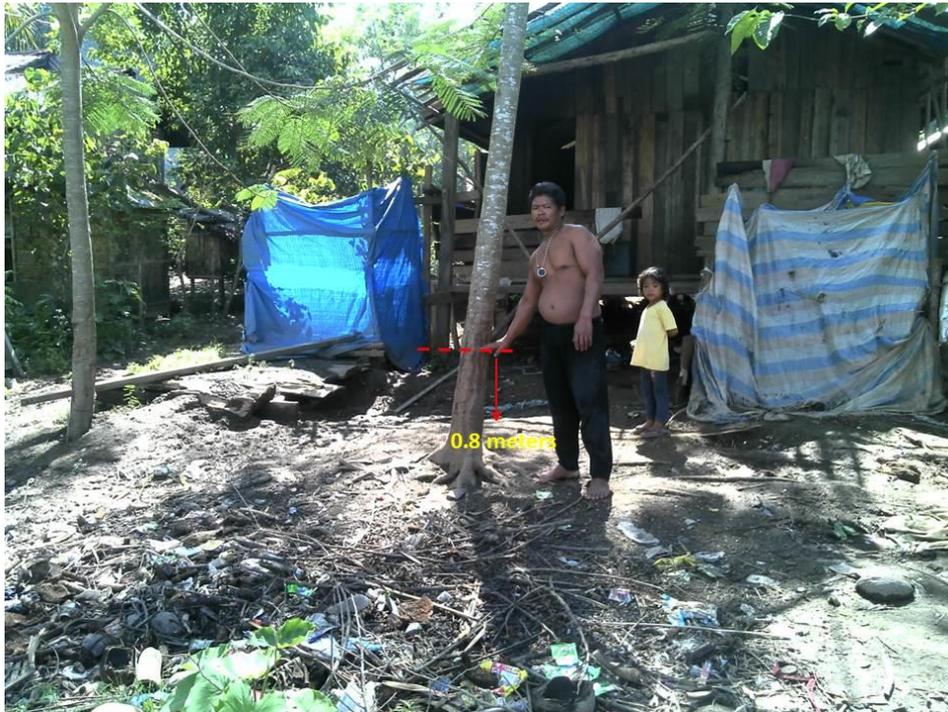
A resident of Sitio Guitas shows the approximate flood height of 0.8 meter during Typhoon Pablo.  
(Geographical Location: 8° 11' 32.5" N 125° 46' 35.2" E)
