# REPORT ON THE 1:10,000 SCALE GEOHAZARDS ASSESSMENT AND MAPPING OF BAYUGAN, AGUSAN DEL SUR

**OCTOBER 2014**

## REPORT ON THE 1:10,000 SCALE GEOHAZARDS (LANDSLIDE AND FLOODING) ASSESSMENT AND MAPPING OF BAYUGAN, AGUSAN DEL SUR

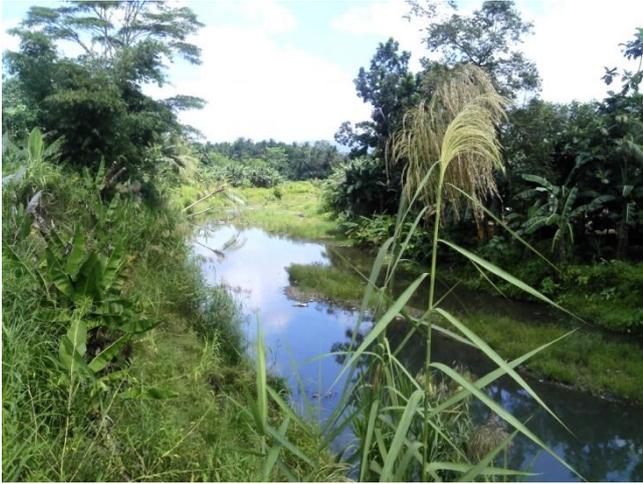
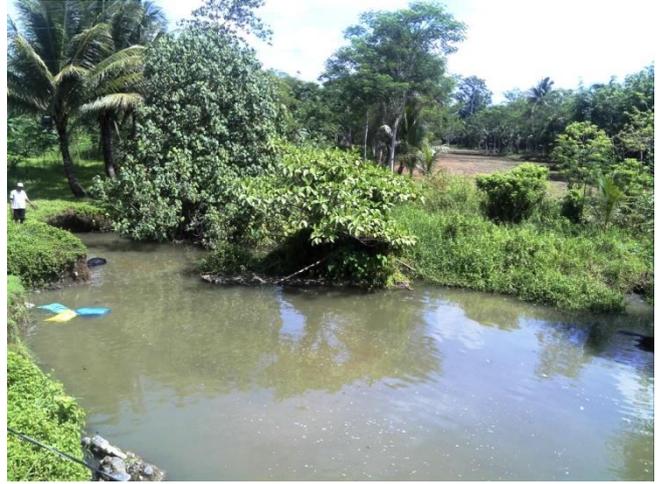
Images of Hamogaway Creek at Purok 1 with active river bank erosion(left) and Labaw Creek at Purok 6 (right).

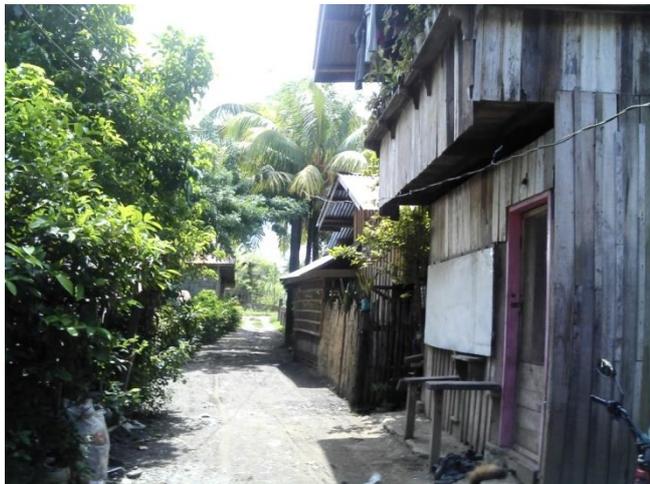
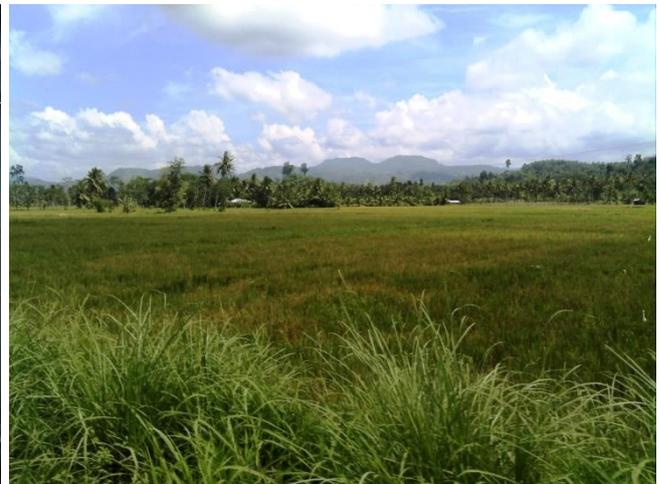
Areas affected by sheet flooding coming from the overflowing Hamogaway Creek at Purok 1 (left) and from Labaw Creek at Purok 5 (right).

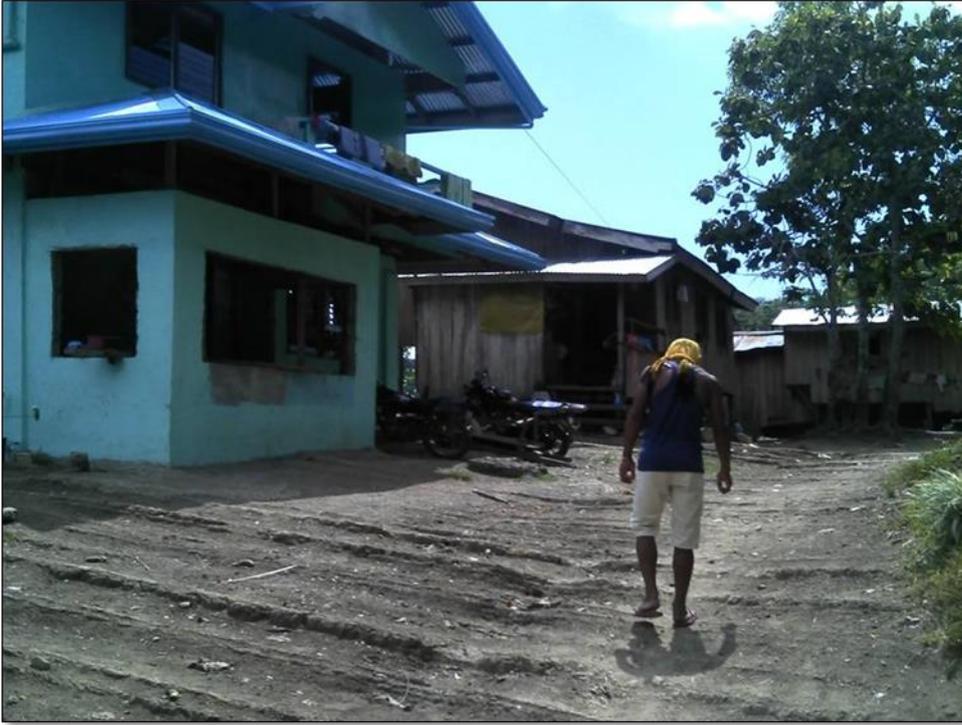
Purok 2 (8° 47' 53.1" N, 125° 45' 0.1"E). A photo showing the residential area in Purok 2. The area is underlain by steeply dipping sedimentary rocks.

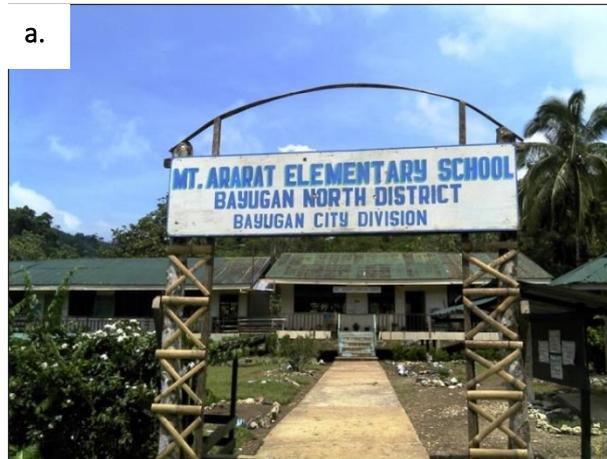
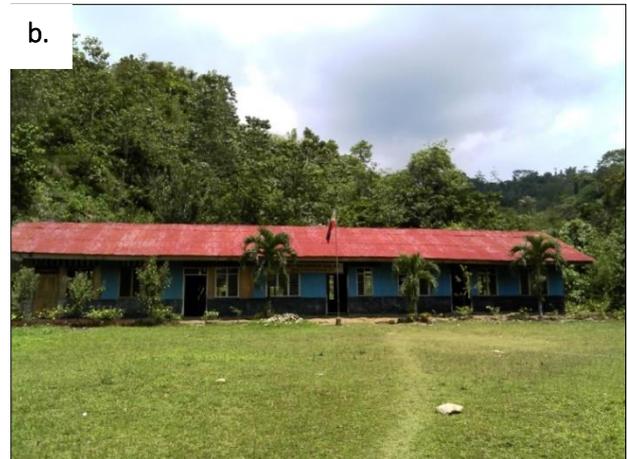
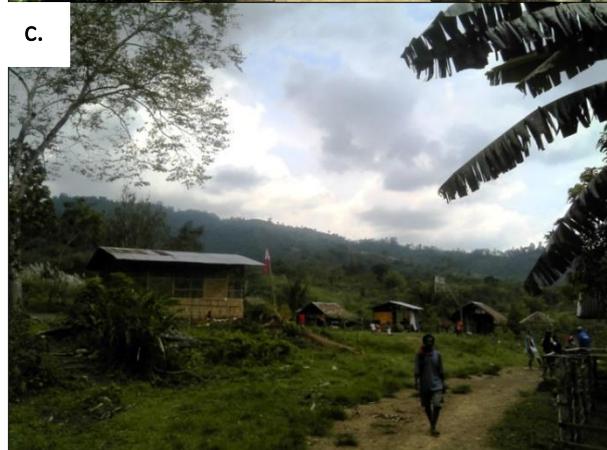
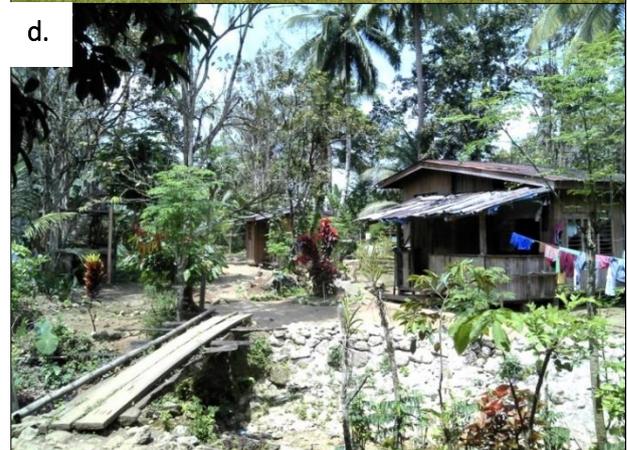
Photos. Mt. Ararat Elementary School at Purok 8 situated within a flat to gently rolling terrain (a) and New Moriah Adventist Elementary School located near base of slope (b). Residential area at Purok 1 (c) on a gently rolling ground and Purok 6 (d).

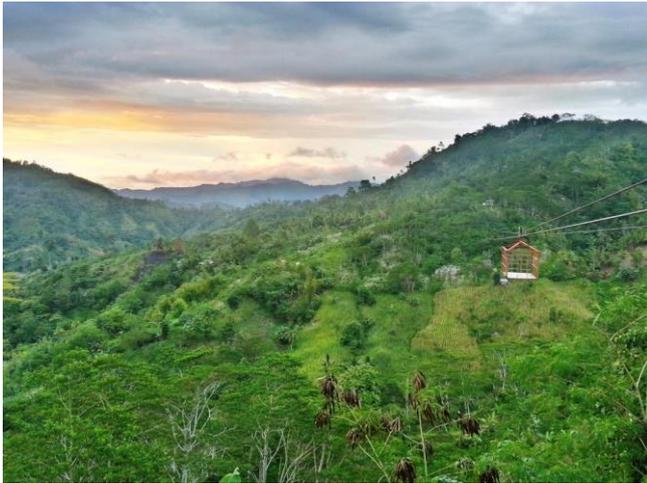
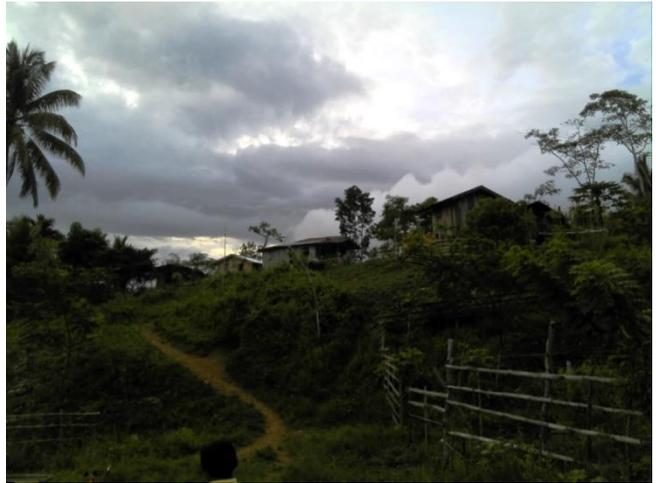
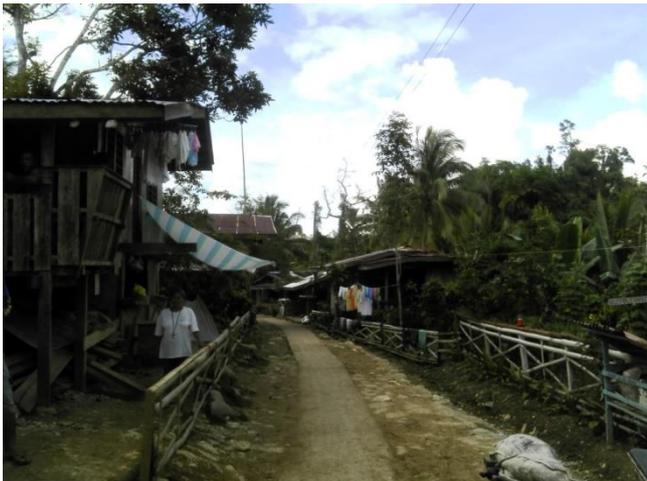
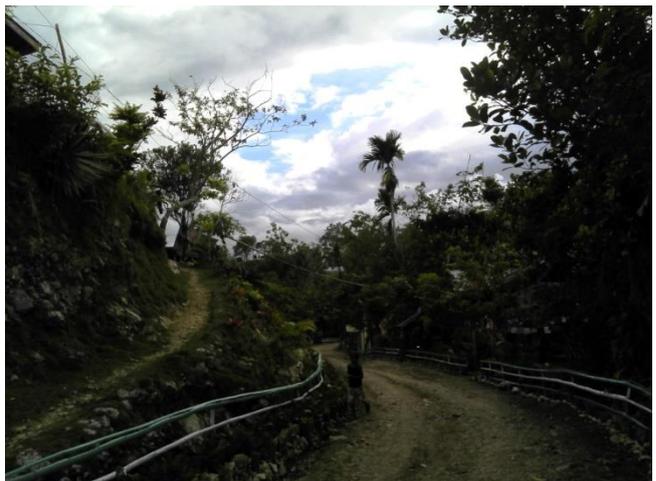
Clockwise: Images of residential areas along steep slopes in the following puroks; Purok 1A, Purok 3A, Purok 7A and Purok 7C.

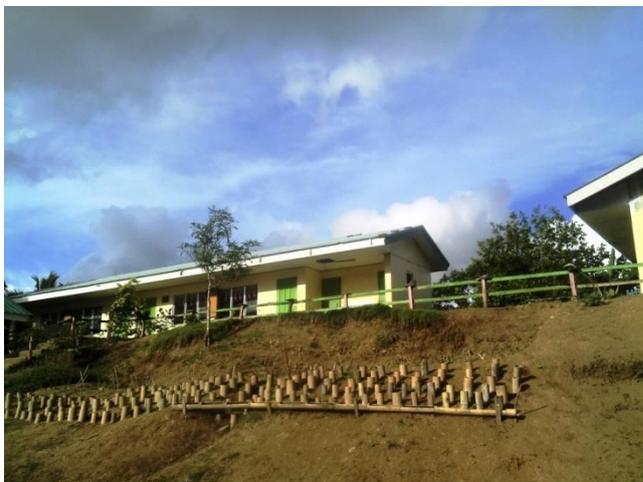
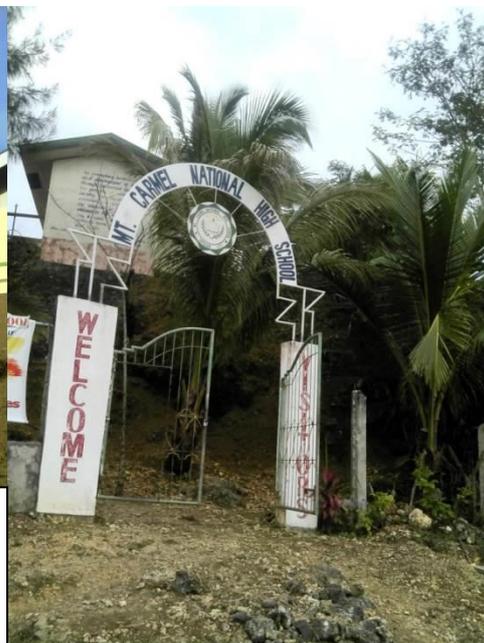
Image of Wilderness Elementary School at Purok 7A (left) and Mt. Carmel National High School at Purok 4 (right) both are situated near steep sloping ground.

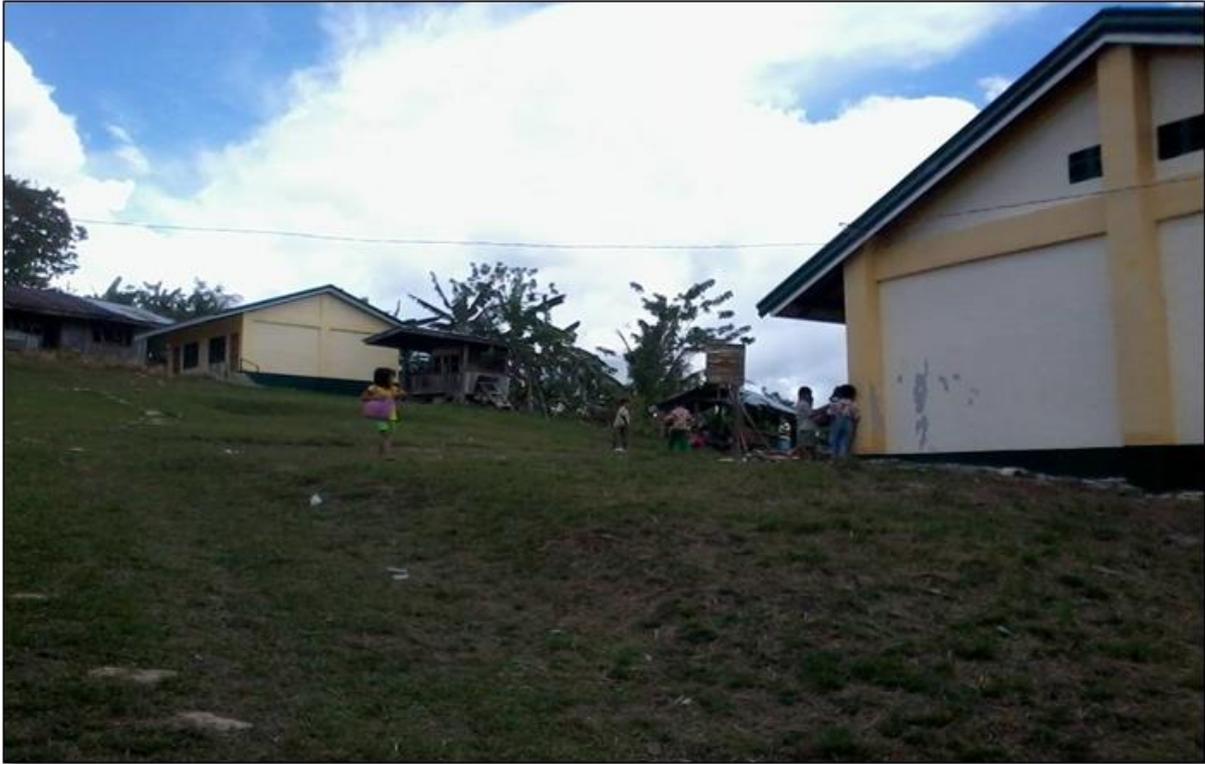
Purok 3 (8° 45' 49.1" N, 125° 51' 30.8"E) Moderate. A photo showing New Salem Elementary School. The site is situated in moderate slope underlain by interbedded sedimentary rocks.

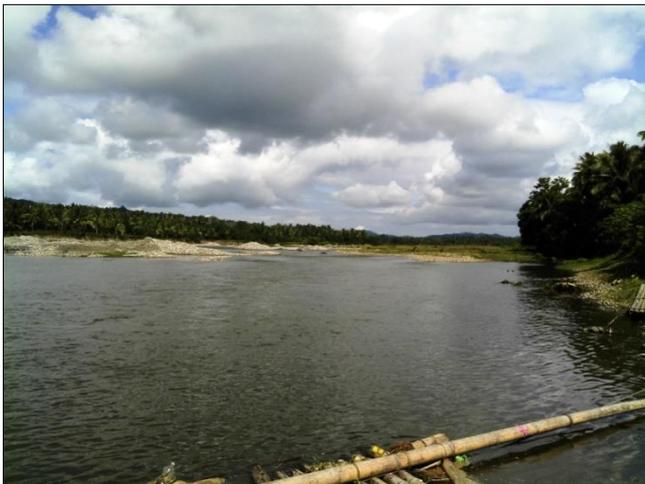
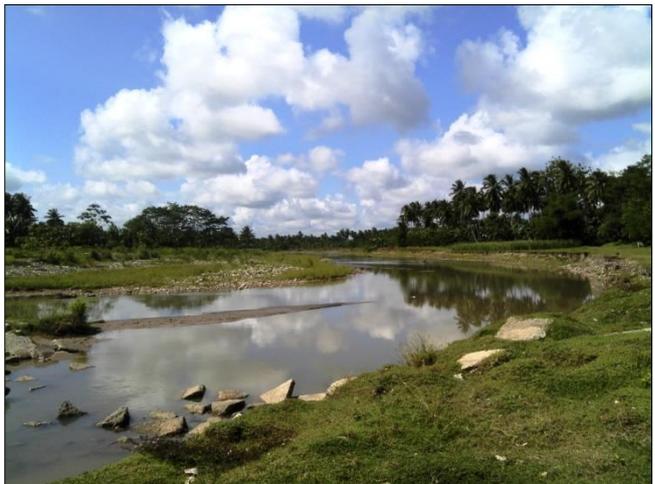
Images of Wawa River at Purok 6 (left) and Andanan River at Purok 7 (right).

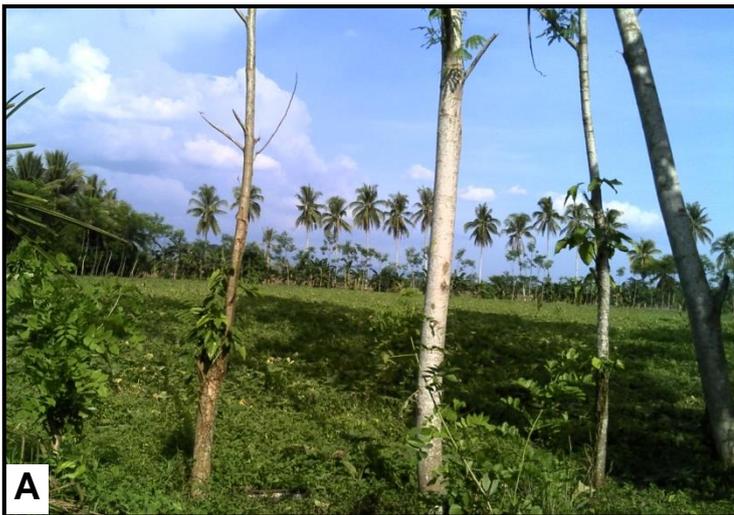
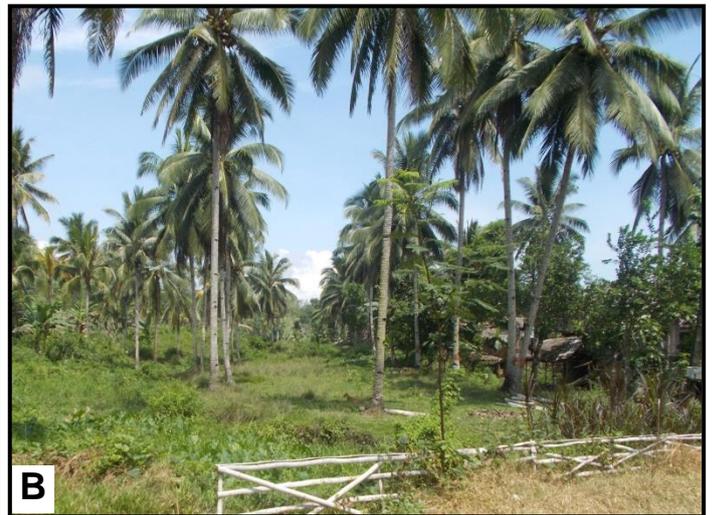
Photo A (Purok 3) and B (Purok 1) shows an agricultural area that is prone to intense flooding where flood water reaches 1.5meter.

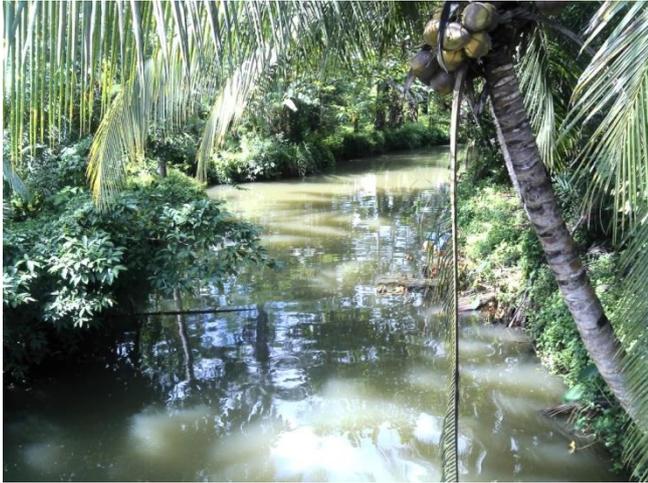
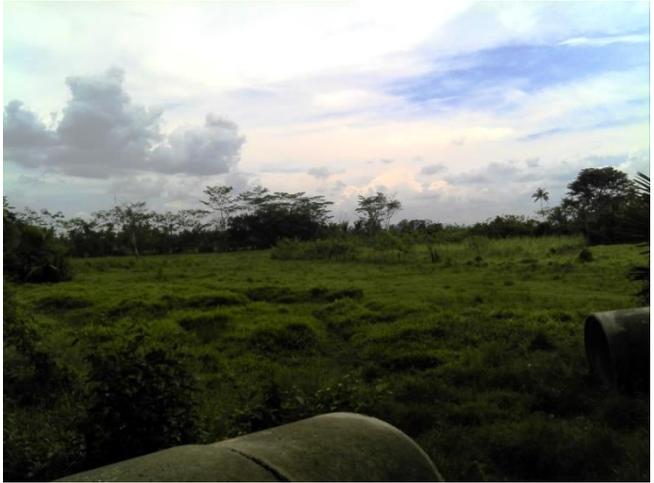
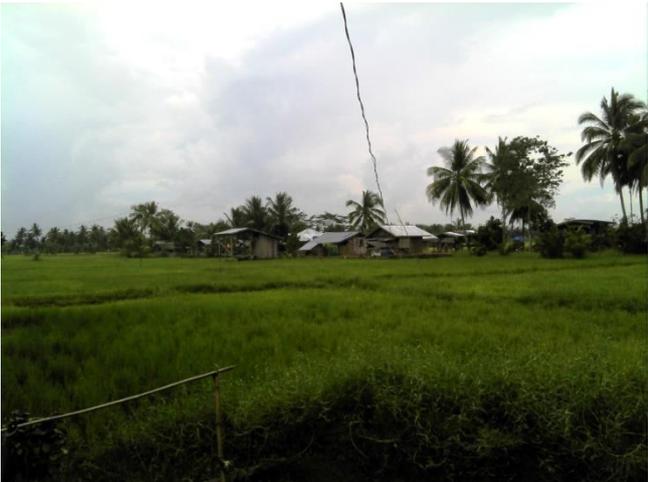
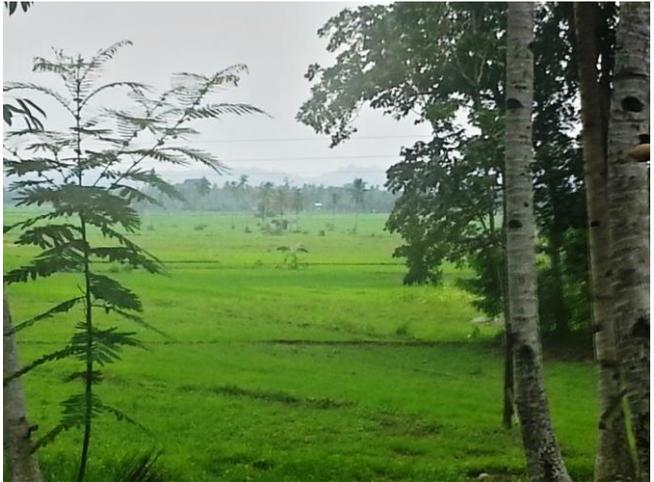
Clockwise: Image of Labaw Creek taken at Purok 5. This is the creek where most of the sheet flooding along the agricultural area, Purok 2, Purok 4, and Purok 6 is associated (succeeding photos).

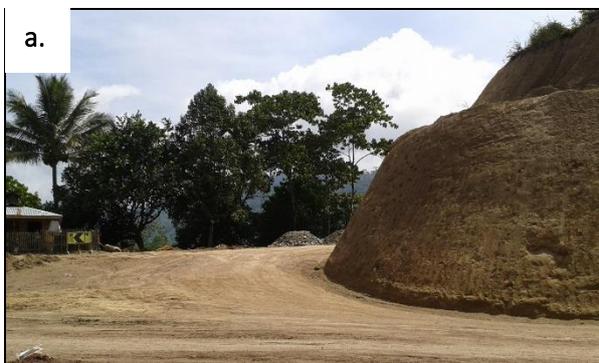
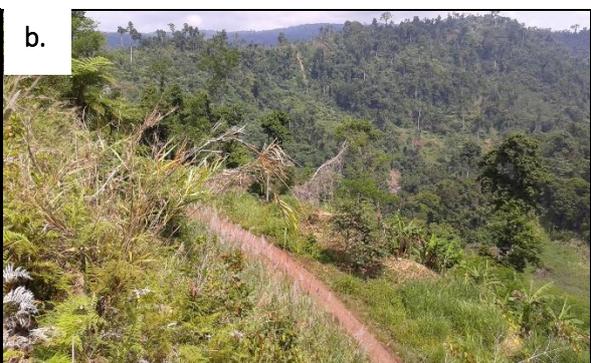
Road cut in Purok 12 showing the benching applied to reduce slope (a) and increase slope stability. Very steep slope along road bend downslope of Purok 12 (b).

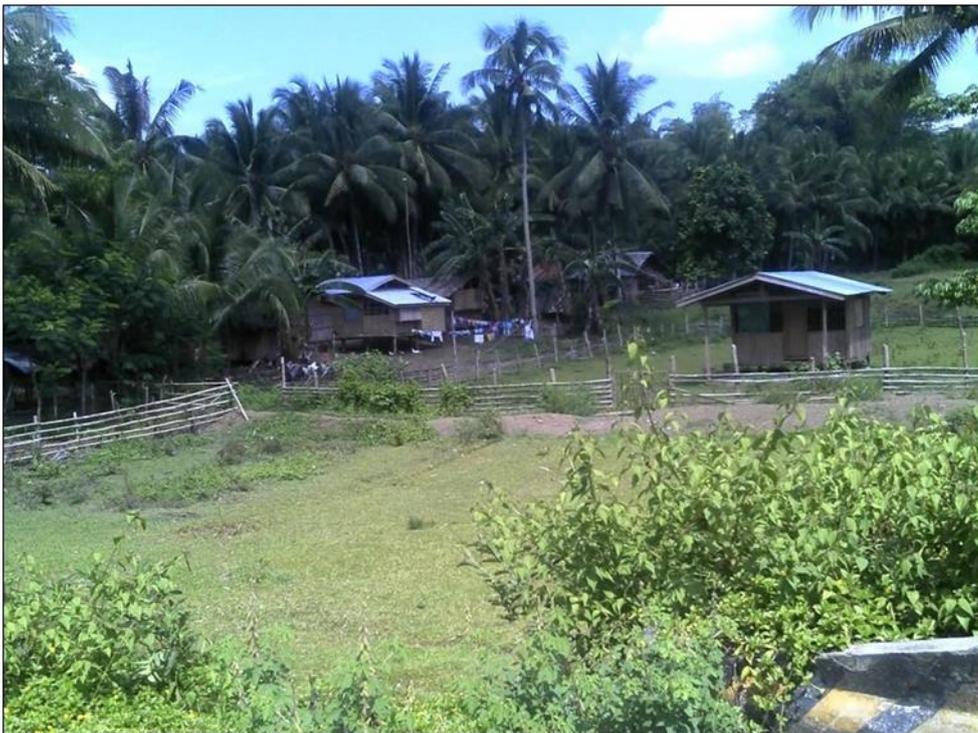
Photograph of the residential area near Tagubay River. Purok 4 (8° 46' 36.7" N, 125° 43' 37.9"E)

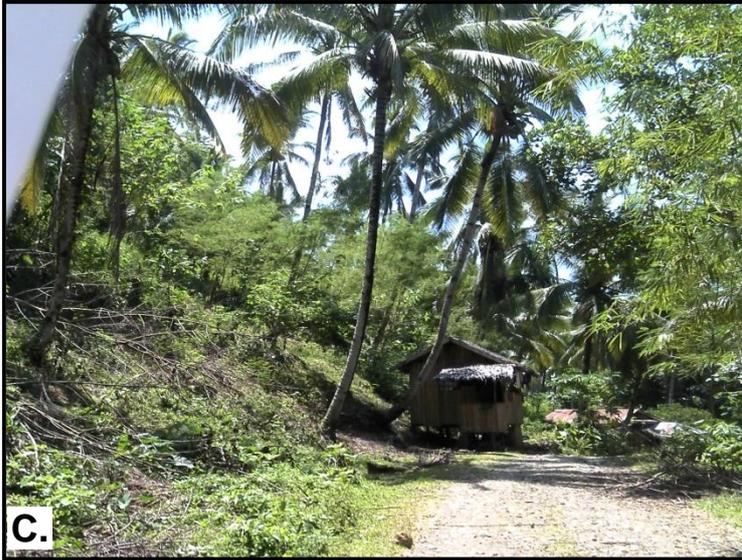
**C.**

(C) House adjacent to a slope where soil creep is observed indicated by bent coconut trees. (D) Clogged creek due to accumulation of garbage and plants at the back of Wawa Elementary School in Purok 1 where minor flooding is partly associated.
