REPORT ON THE 1:10,000 SCALE GEOHAZARDS ASSESSMENT AND MAPPING OF ESPERANZA, AGUSAN DEL SUR

OCTOBER 2014

REPORT ON THE 1:10,000 SCALE GEOHAZARDS (LANDSLIDE AND FLOODING) ASSESSMENT AND MAPPING OF ESPERANZA, AGUSAN DEL SUR

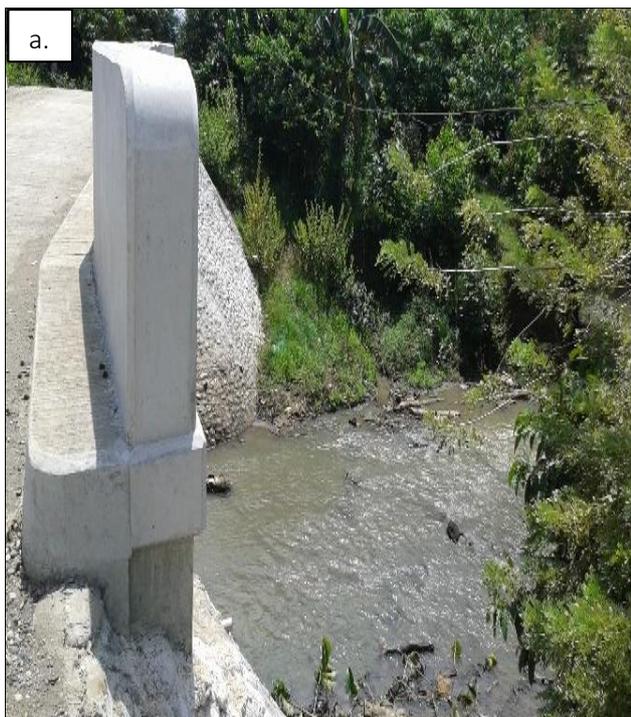
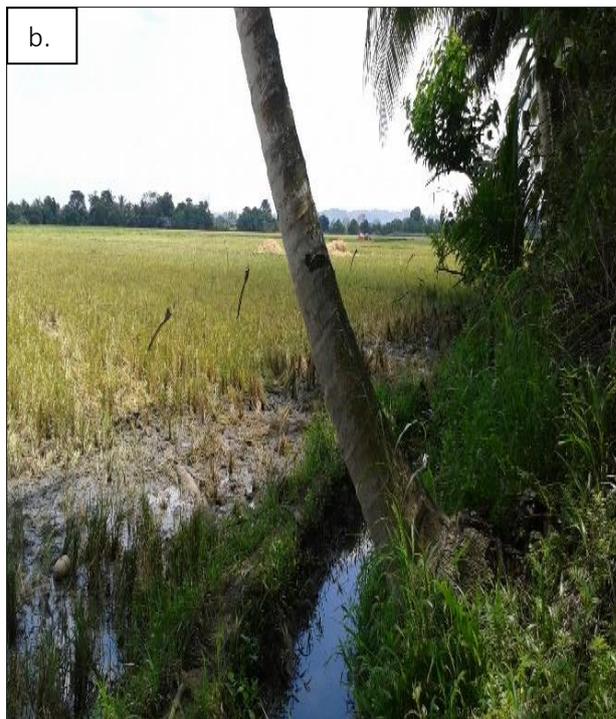
Photos. Gumpaitan Creek taken from bridge approach (a) and rice field in Purok 3 (b) that is usually flooded during rainy season.

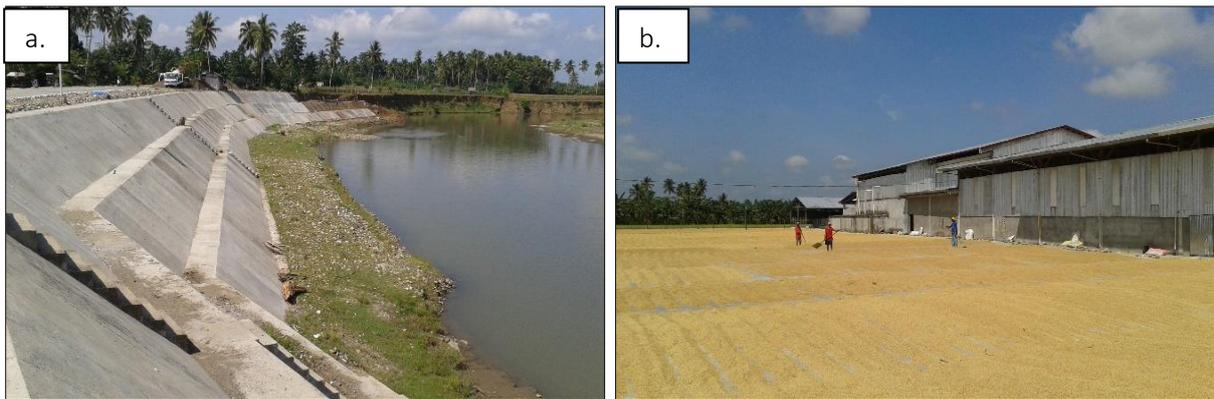
Photos. Dike constructed along the bank of Wawa River to mitigate rapid bank erosion as shown in the upper right of Photo a (active dike construction). Solar drier for corn and rice grains during summer (b).

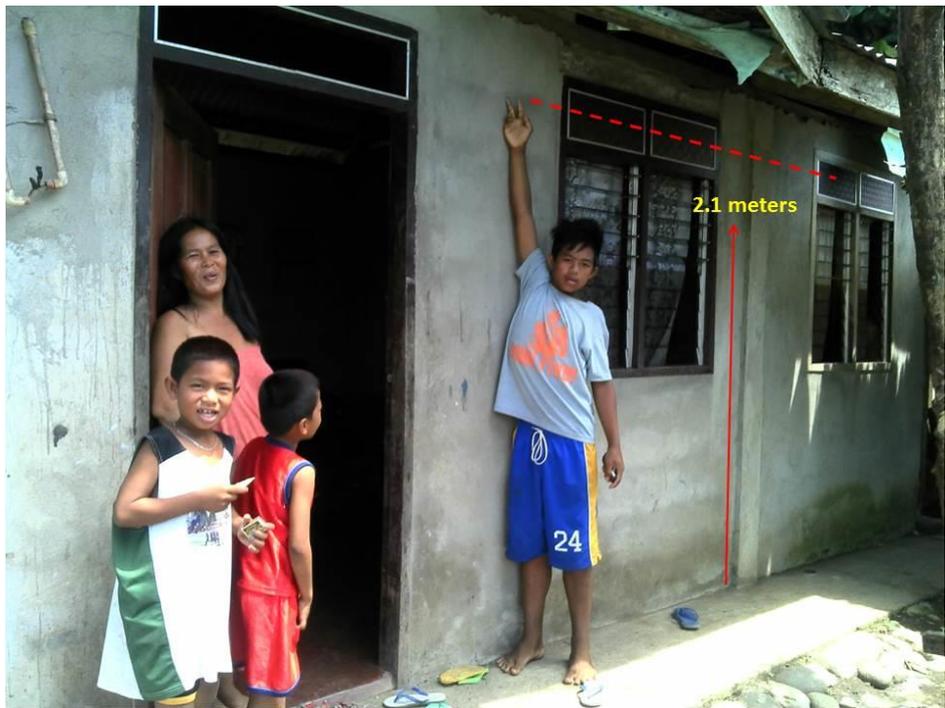
A resident in Purok 3 shows the flood height of approximately 2.1 meters in their house which lasted for 9 days. (Geographical Location: 8° 41' 36.7" N 125° 39' 1.7" E)

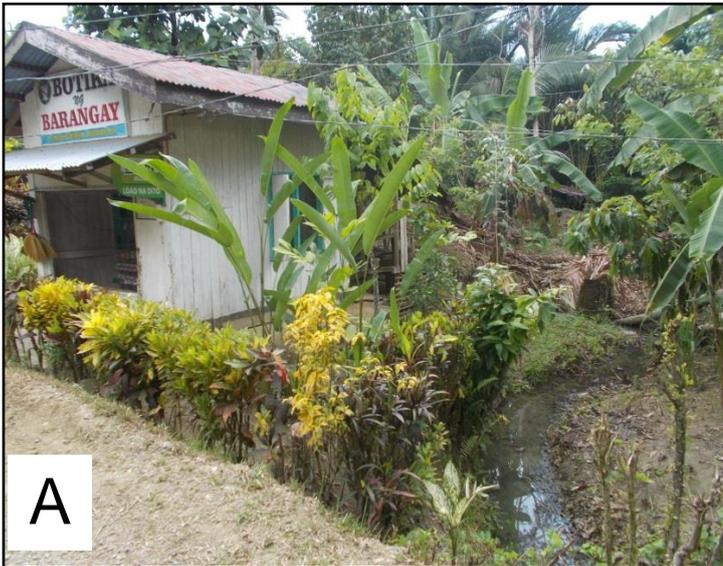
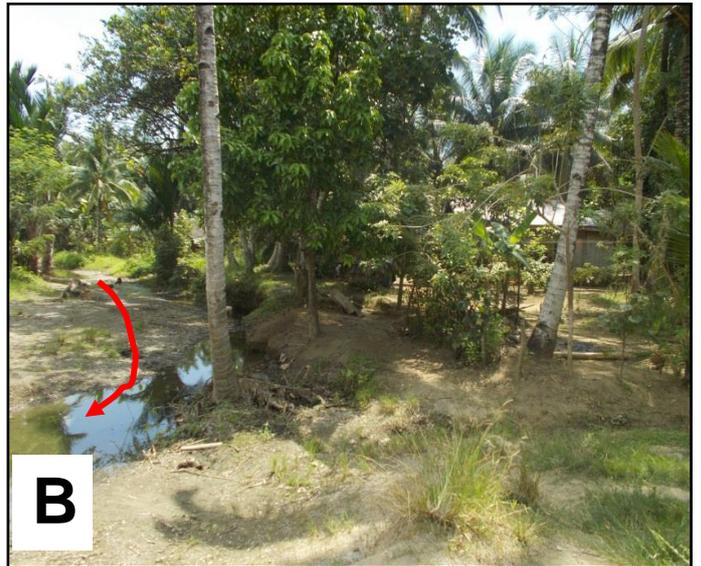
(A and B) Several creeks dissecting the barangay. Areas near/beside the creek are prone to flashfloods.

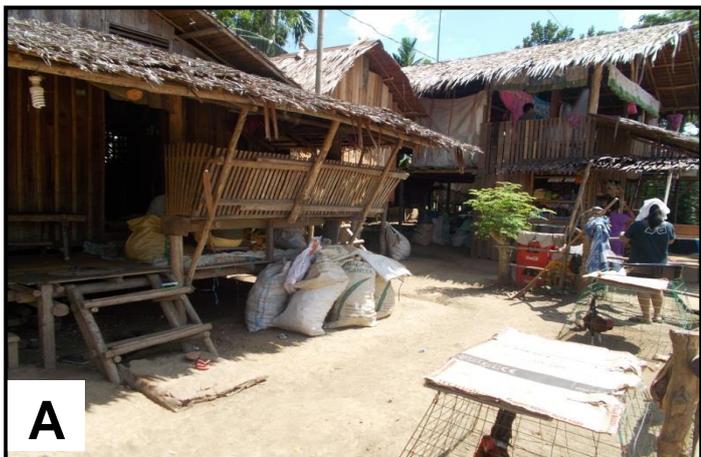
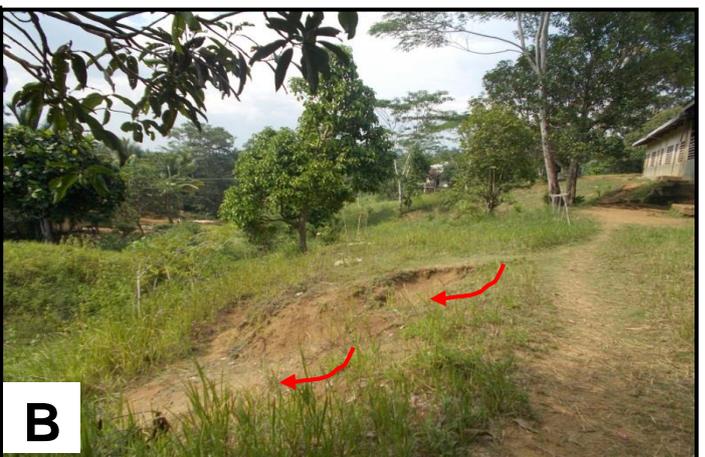
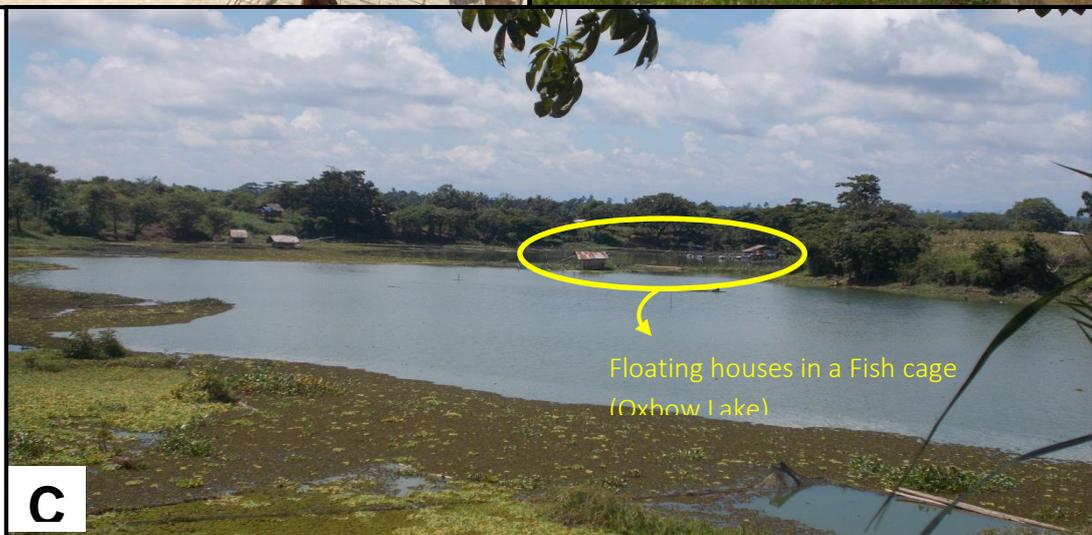
Photo (A) Flood depth in Purok 9 when Agusan River overflows. (B) Ulios Elementary School on top of a moderate slope. (C) A fish cage (Oxbow lake) in Purok 9, residents designed their houses to float in case of flooding.

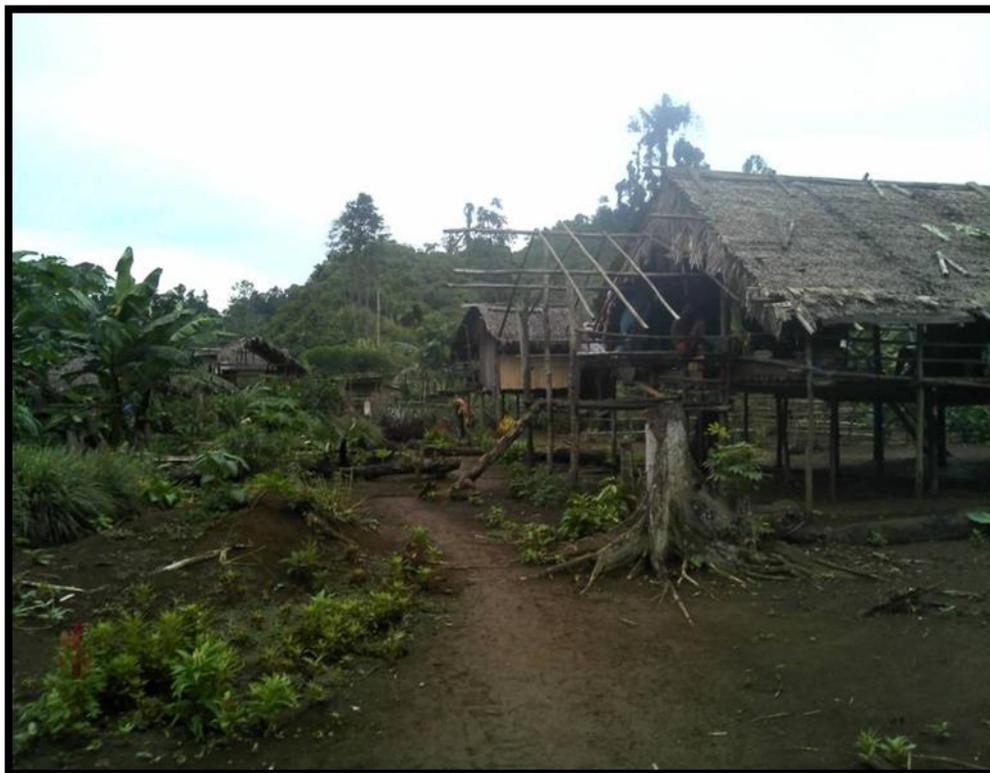
Purok 1 (8° 36' 46.7" N, 125° 20' 51.4"E) Low. This photo shows the residential area of Purok 1 and also the center of baranggay, there are no report of geohazards in the area but its access road is situated in a very steep slope and there are event of landslide in farmlands of some puroks.

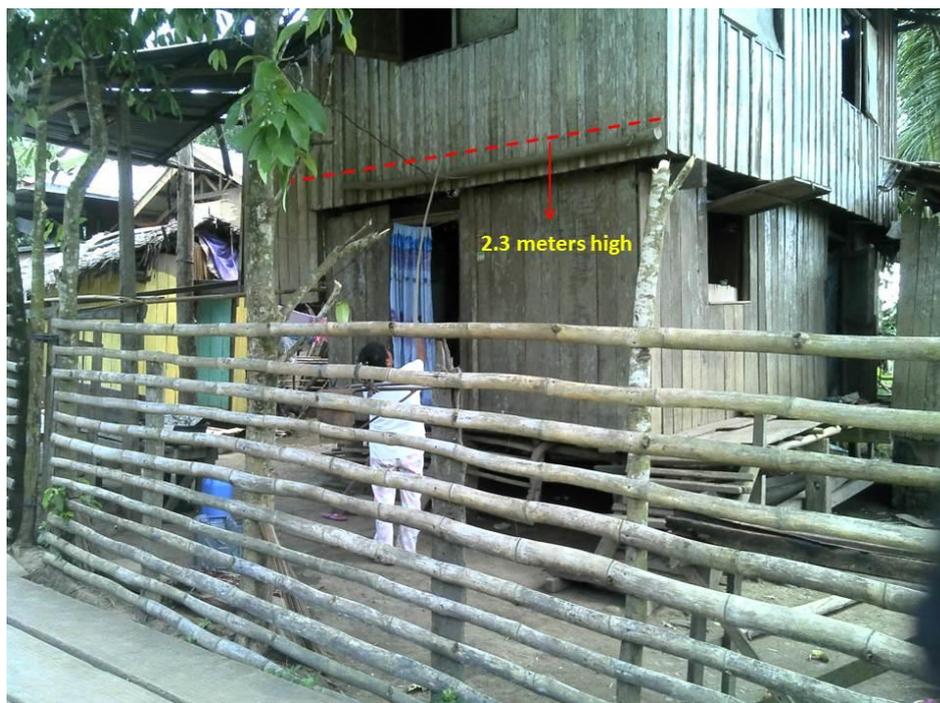
A resident shows the flood height of 2.3 meters in her house which lasts for two weeks during typhoon Agaton. (Geographical Location: 8° 40' 20.7" N 125° 38' 21.1" E)

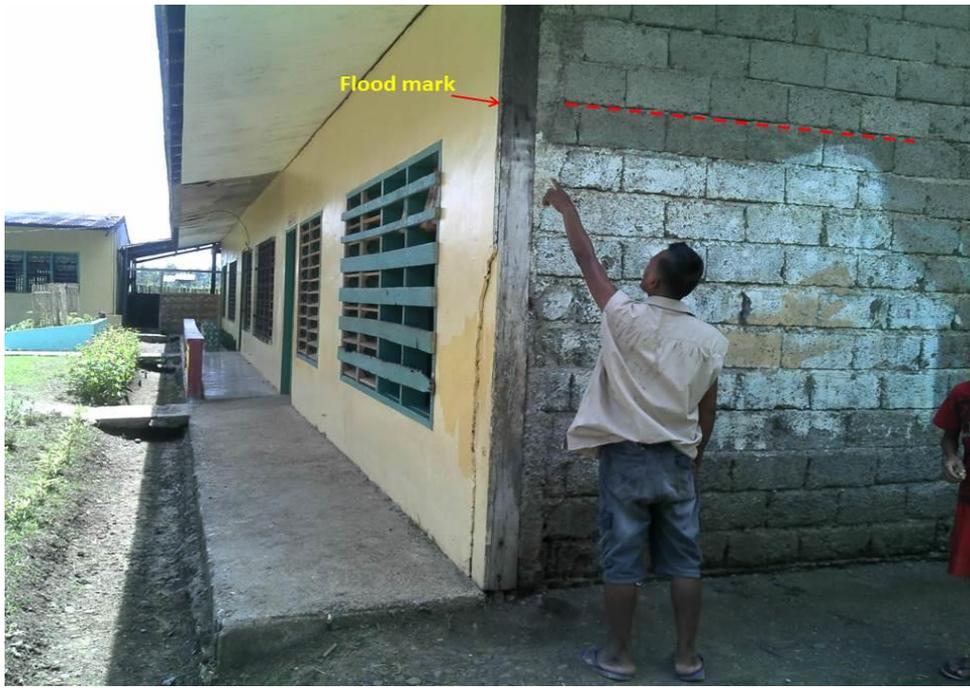
A barangay official points the worst flood height of 1.8 meters in the Elementary School. This area is usually flooded in the months of December to February. (Geographical Location: 8° 40' 18.8" N 125° 38' 14" E)

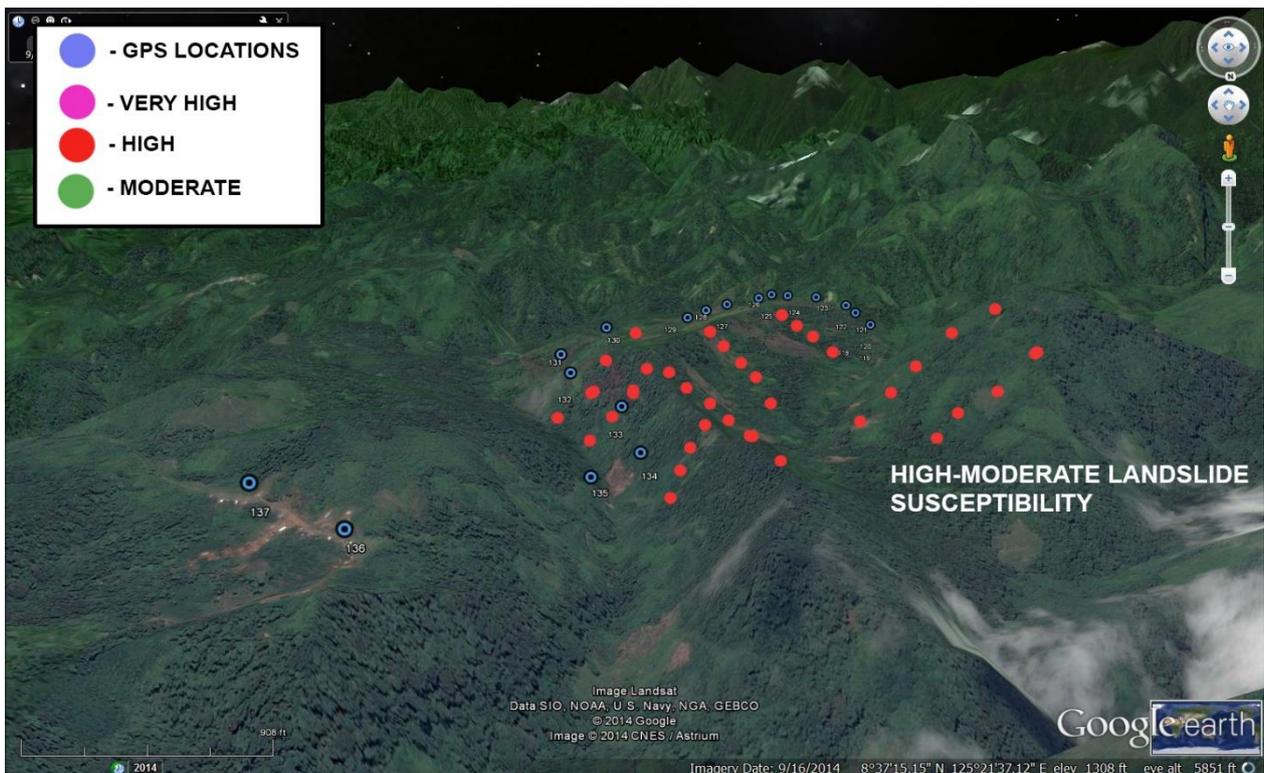
The photo above shows the over-all geohazards situation of Barangay Kalabuan, Esperanza. Source: Google Earth.

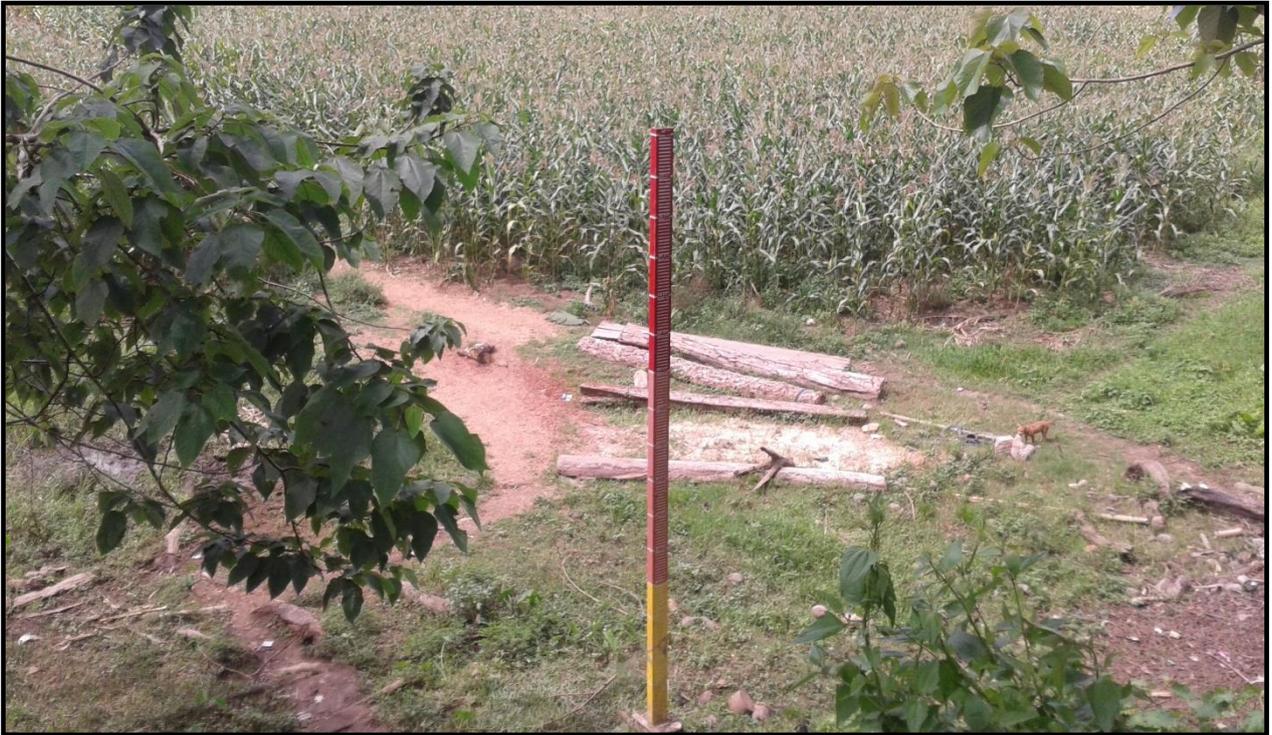
Agsabo River, Purok 1. Photo showing a flood monitoring post installed in the area to determine flood level of Agsabo River. GPS Coordinates: 125° 28' 31.6"E 8° 41' 1.3" N

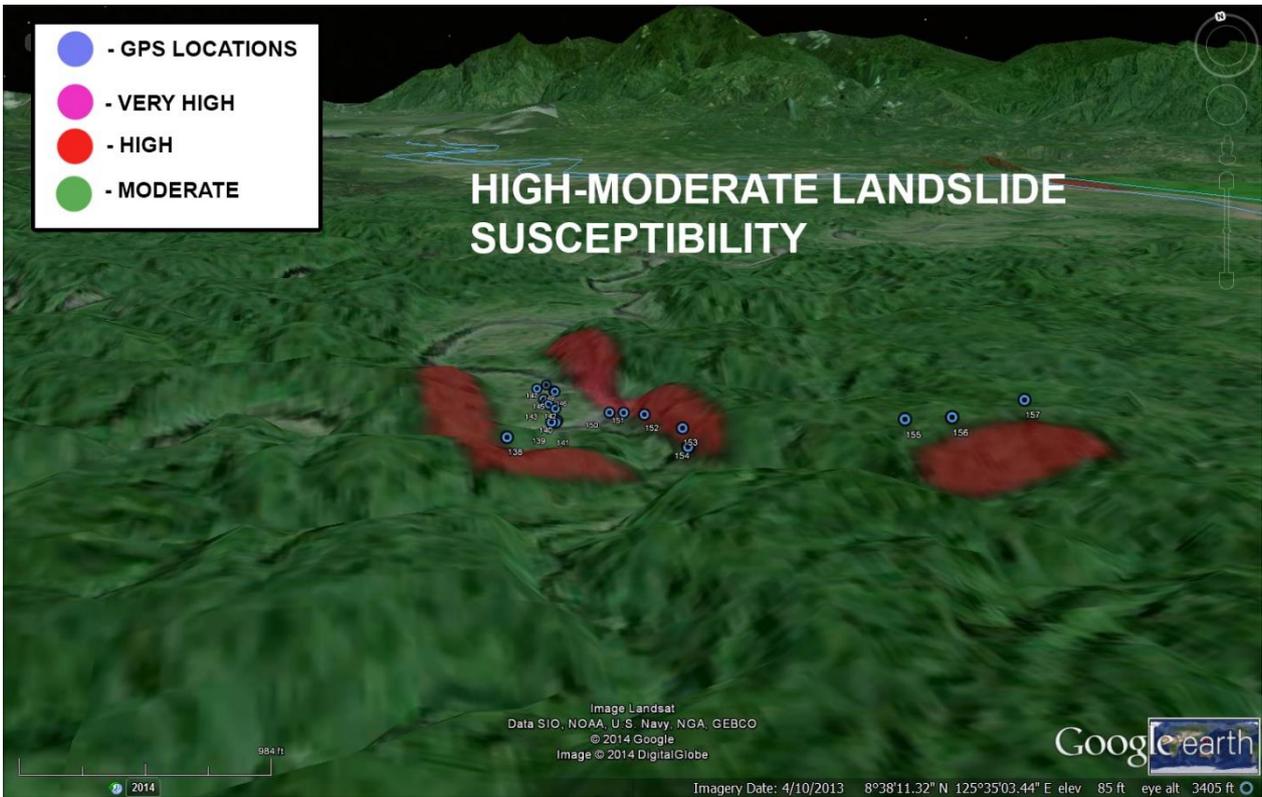
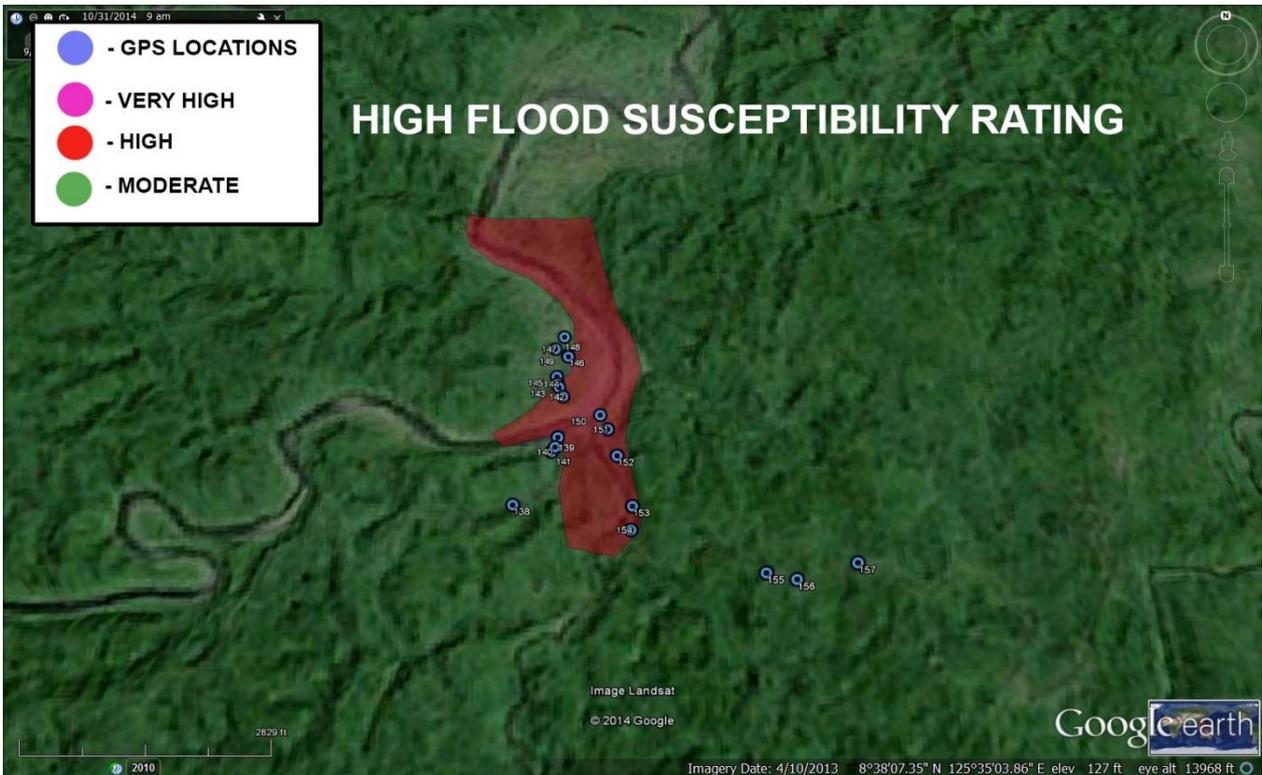
The two satellite photos above portrays the over-all geohazards situation of Barangay Milagros, Esperanza. Source: Google Earth

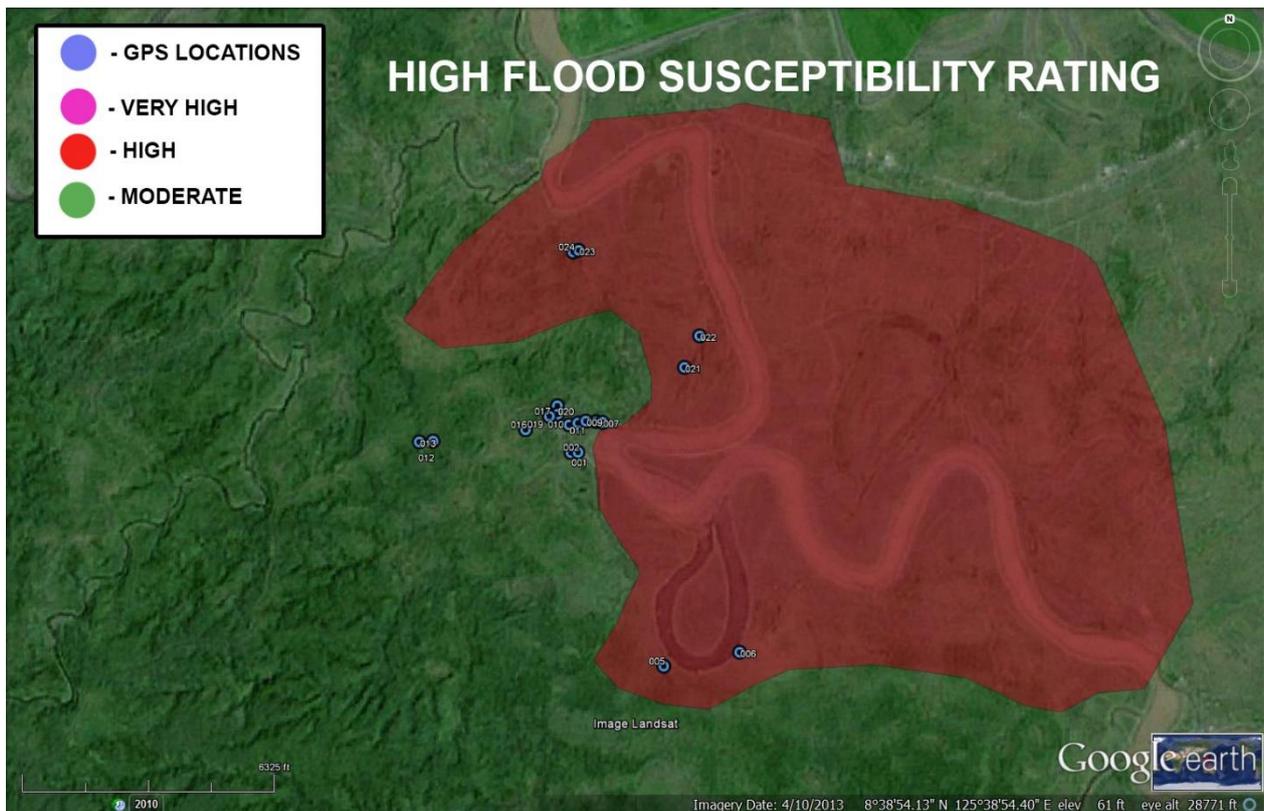
This satellite photo above portrays the over-all geohazards situation of Barangay Nato, Esperanza. Source: Google Earth

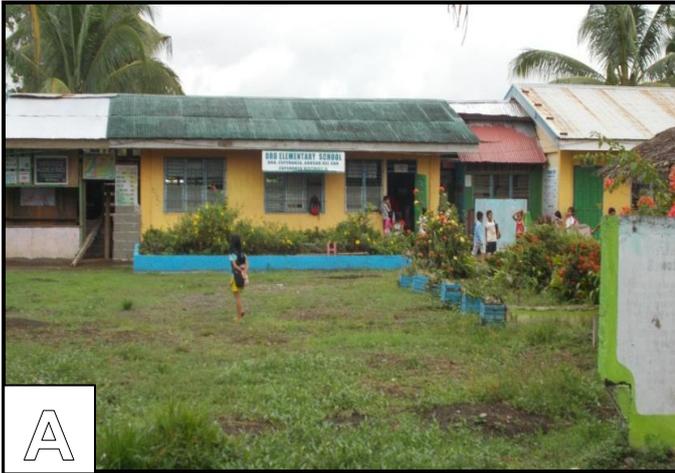
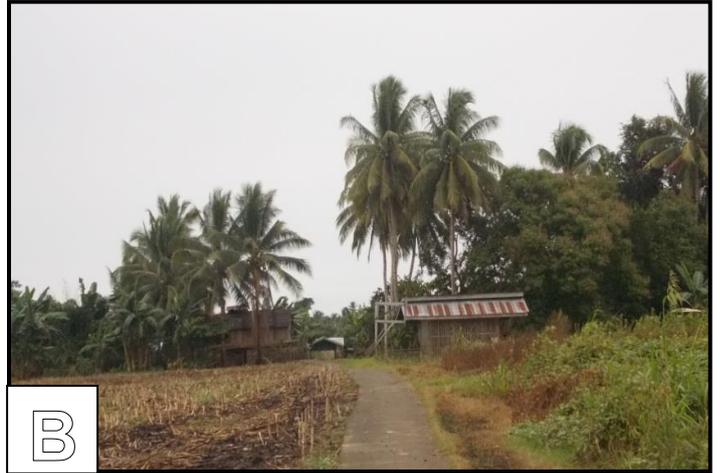
(A) Oro Elementary School inundated during heavy rains; floodwater reached up to 0.7 m. (B) Areas in Purok 5 are highly susceptible to flooding because they generally flat and lie along Agusan River flood plain.

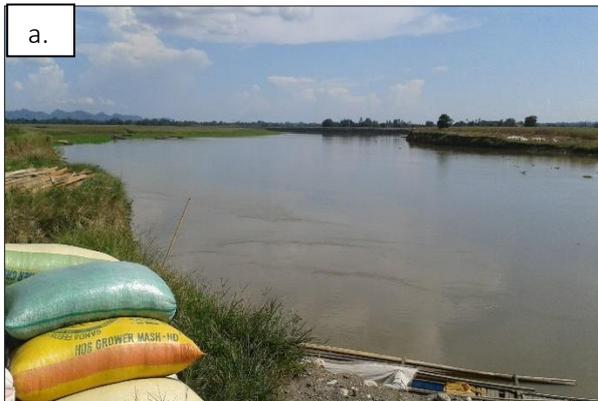
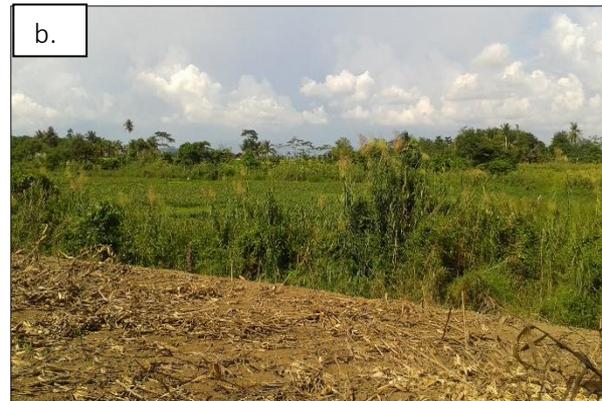
Photos. Portion of Agusan River adjacent to the wide corn fields in Purok 7 (a) and old Agusan River channel forming an oxbow lake created from channel migration (b).

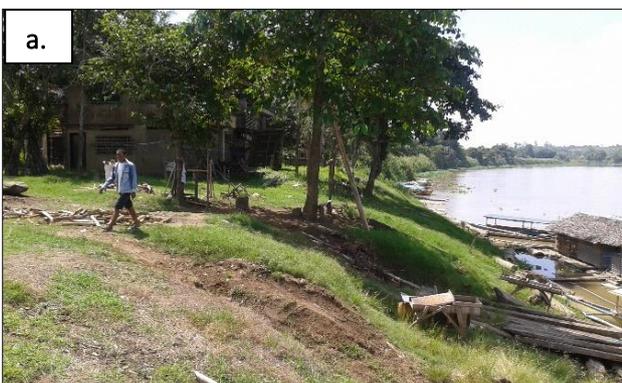
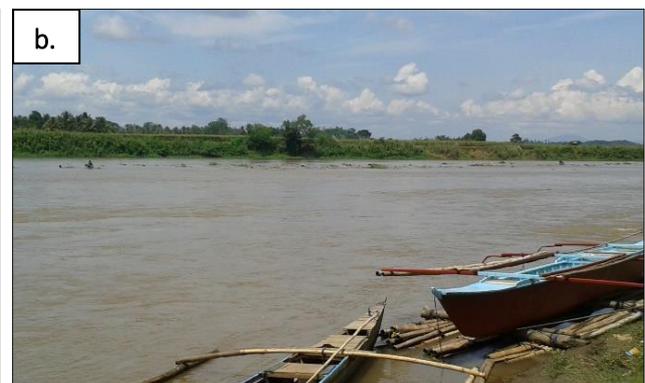
Photos. Segments of Agusan River in Purok 21 (a) and Purok 6 (b). These areas have very high flooding susceptibility.

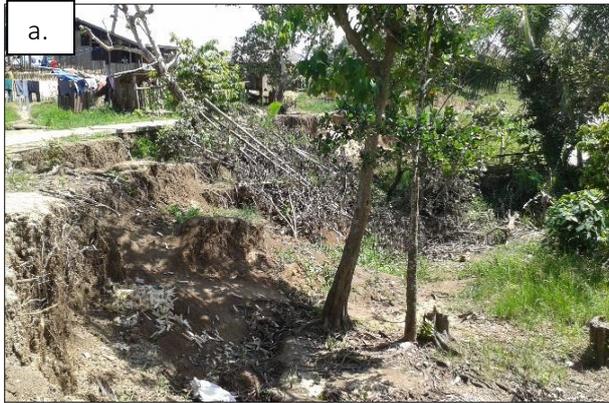
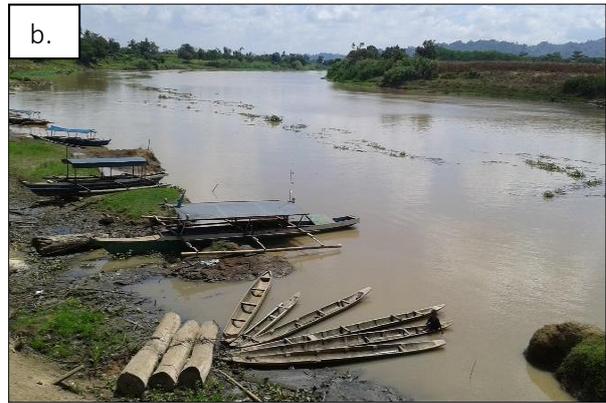
Photos.Head of landslide (a) in Purok 5 where about five house relocated. Segment of Agusan River showing round logs and boats (bangka). The river also serves as major navigational line when transporting of agricultural products in the downstream areas.

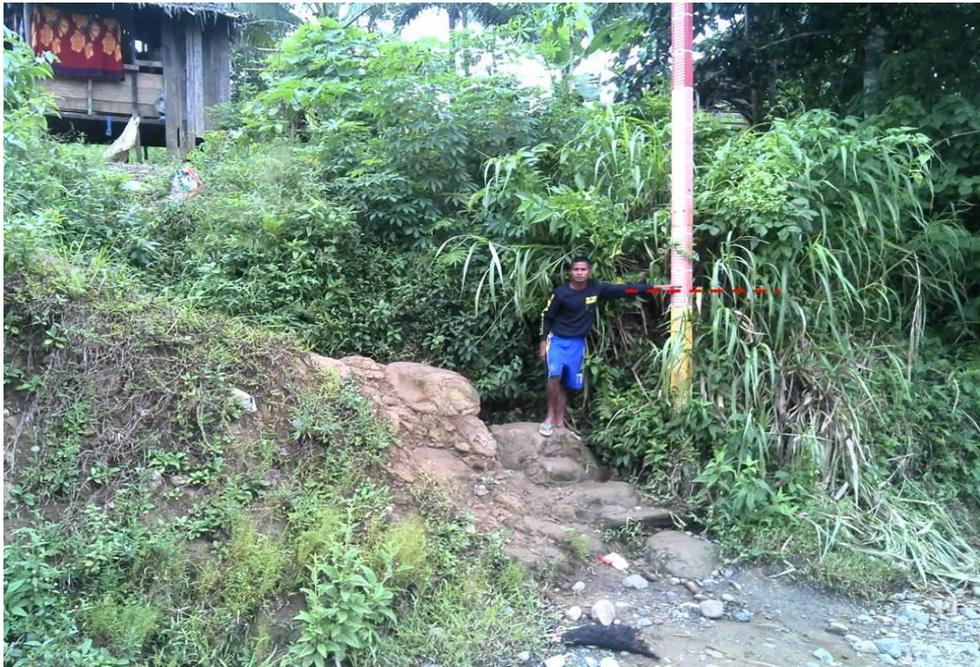
A barangay official shows the approximate flood height of Libang River which reaches as high as 2.5 meters during Typhoon Agaton. (Geographical Location: 8° 32' 42.2" N 125° 26' 18.5" E)

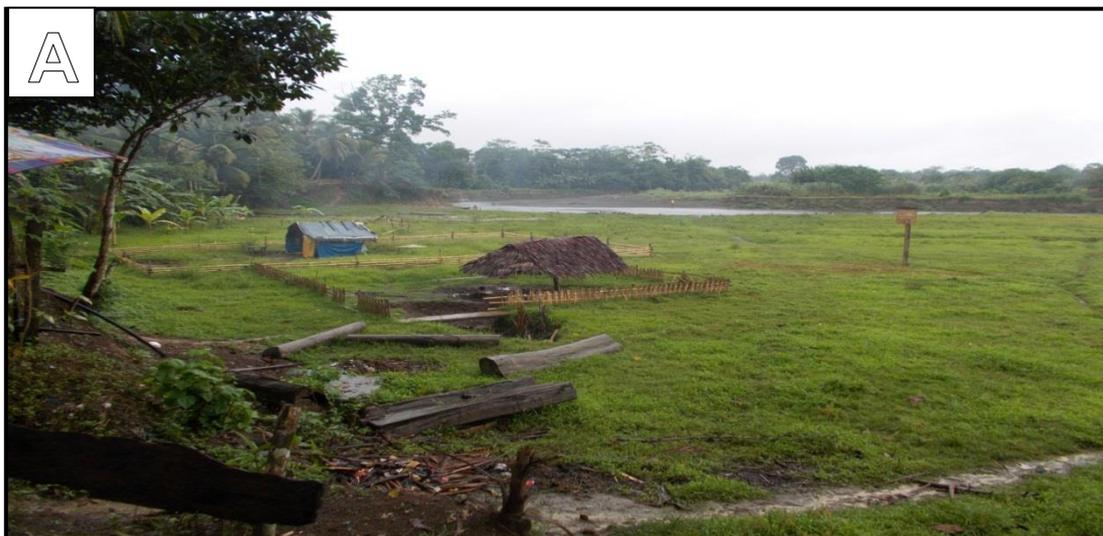
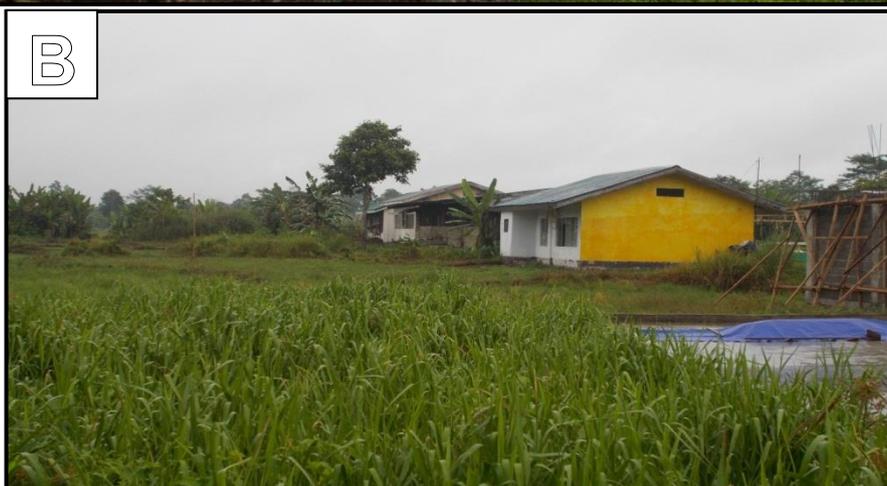
(A) “Viewing direction: SSW” View of Libang River and the land area inundated by flood water. (B) The area is situated on a flat low-lying terrain. Flood depth could reach up to 0.8m.

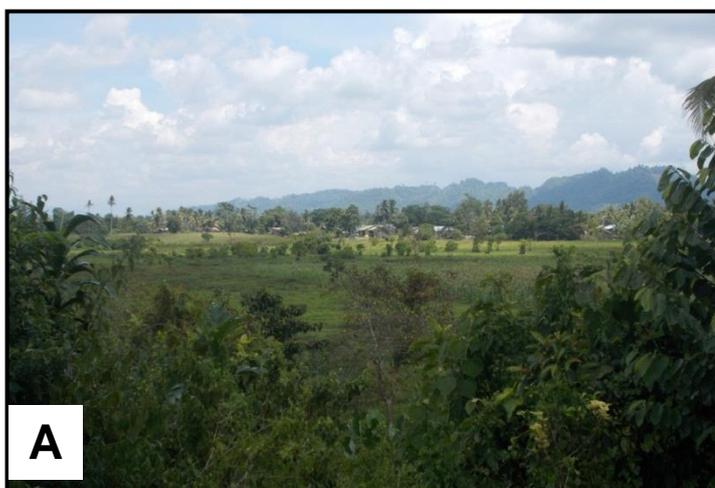
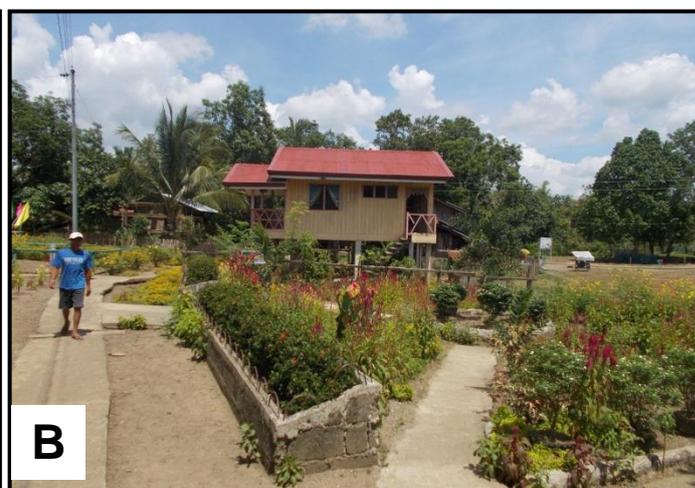
(A) This area is mainly covered with rice fields that are normally flooded during intense heavy rainfall and overflow of Agusan river. (B) showing structurally adapted house to flooding.

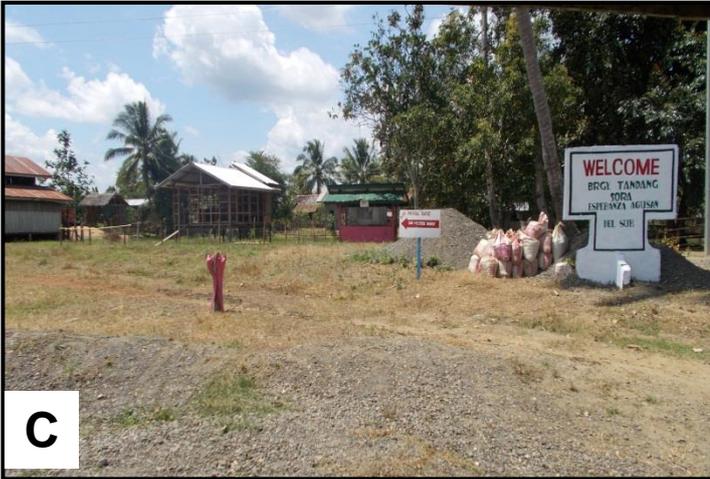
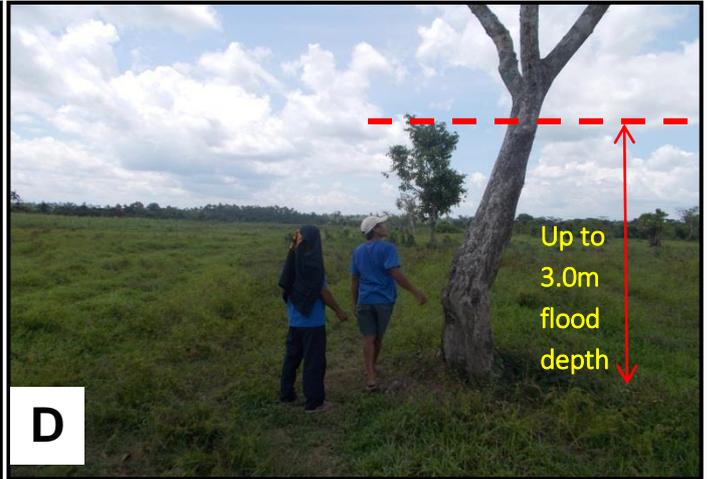
(C) Barangay Tandang Sora's welcome signage from the Agusan river port. (D.) Kagawad looking at the level of flood water during typhoon Pablo.

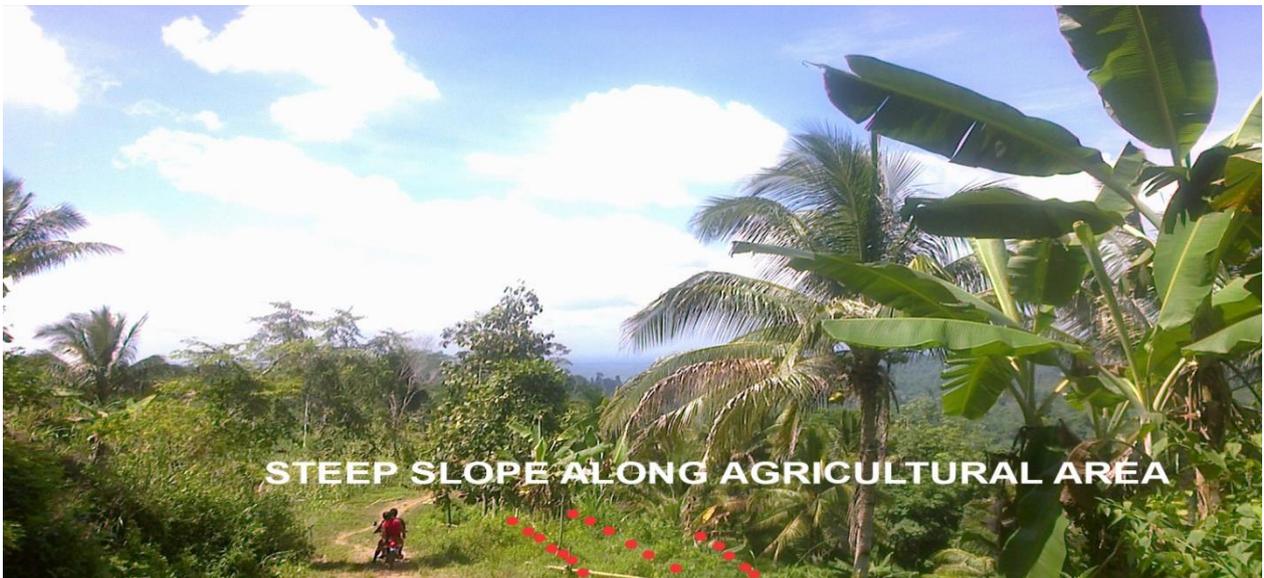
A flat narrow area approximately 20M wide along a 130M-high ridge. Both sides are found to have very steep slopes with notable signs of mass movement indicated by tilted trees. At Purok 3 with GPS location: 8° 33' 59.6" N/125° 44' 39.3" E

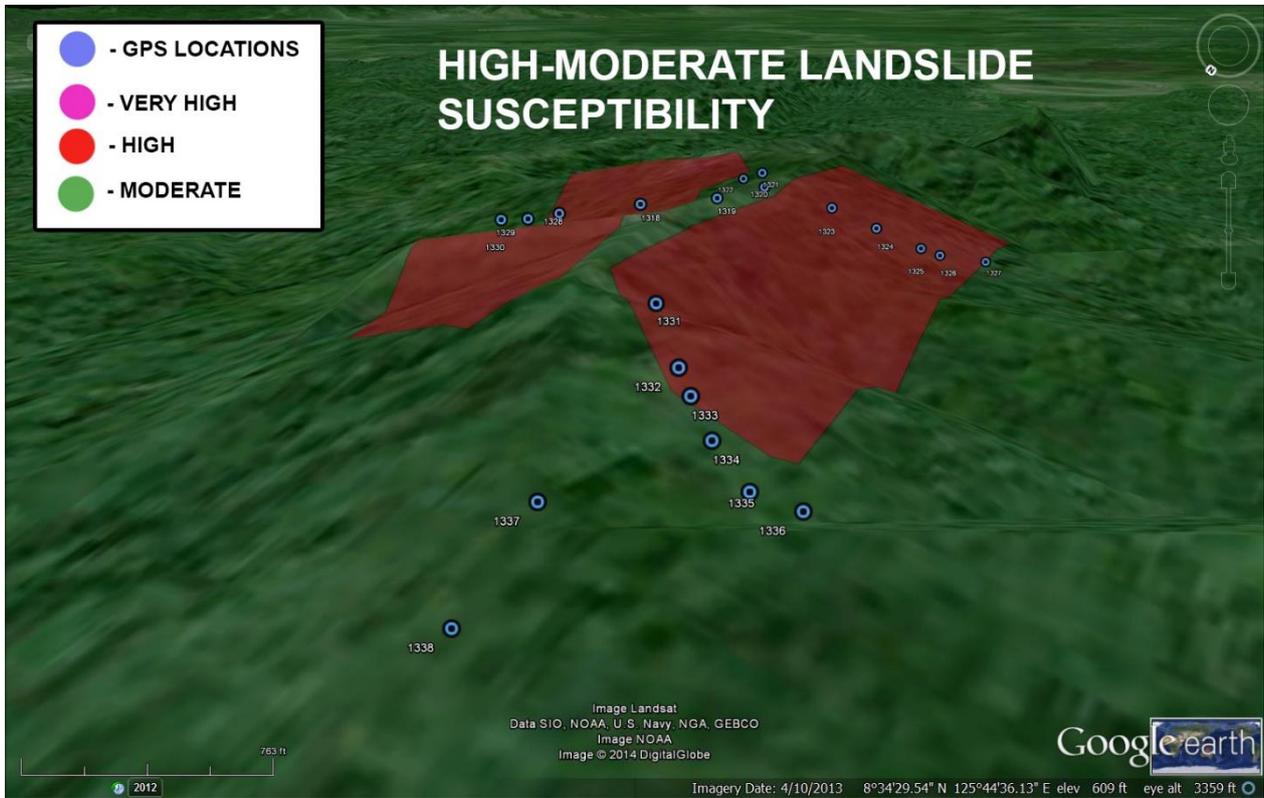
This satellite photo above shows the over-all geohazards situation of Barangay Milagros, Esperanza. Source: Google Earth
