REPORT ON THE 1:10,000 SCALE GEOHAZARDS ASSESSMENT AND MAPPING OF SIBAGAT, AGUSAN DEL SUR

SRDP Consulting Inc.
Units 119, 420 & 421 SJB Condominium
130-B Panay Ave, South Triangle
Quezon City, Philippines

OCTOBER 2014

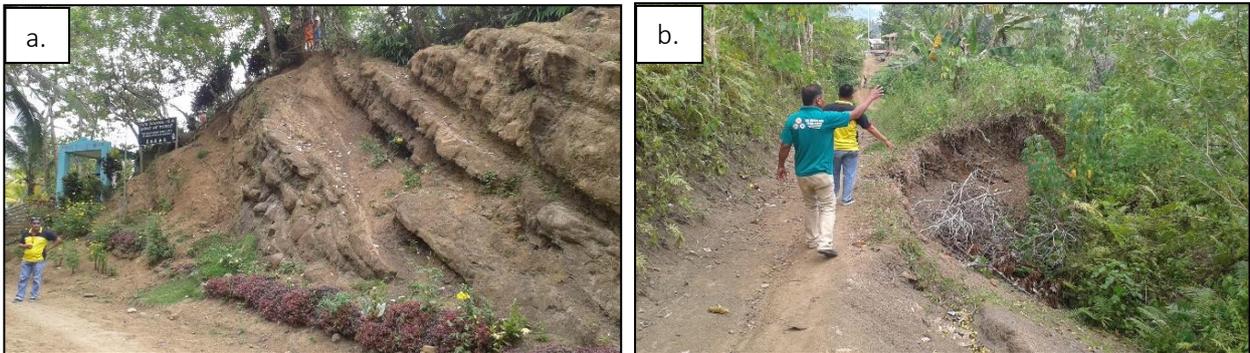
Photos. Tilted bedded sedimentary rocks exposed along the road cut in Anahawan Elementary School (a) and minor landslide along the access road to Purok 5 (b).

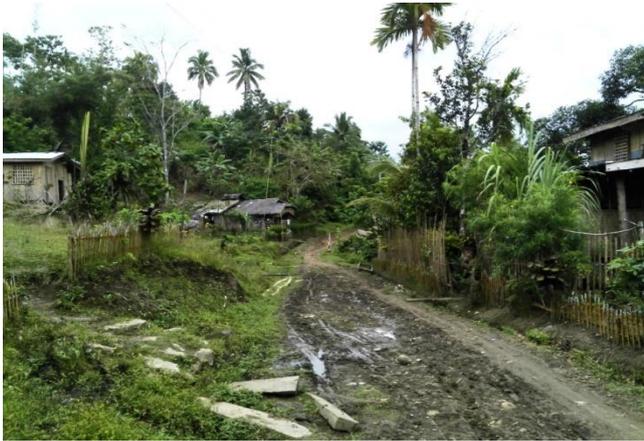
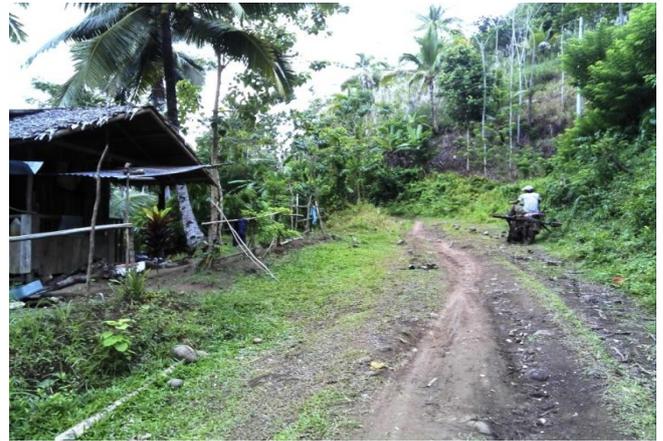
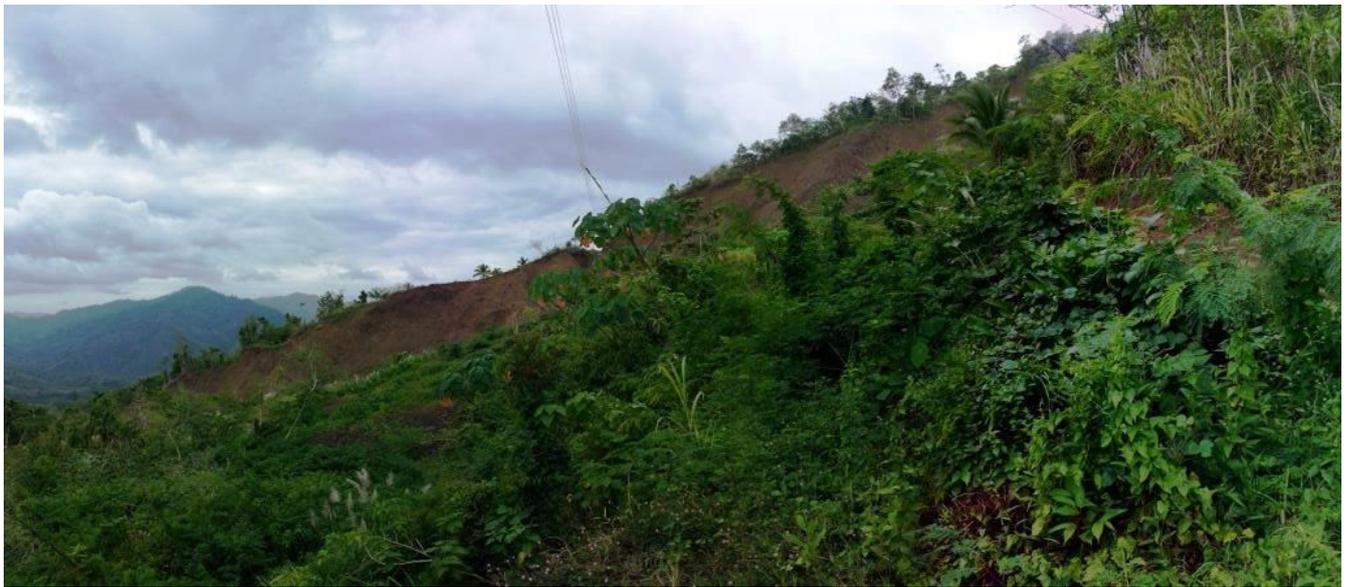
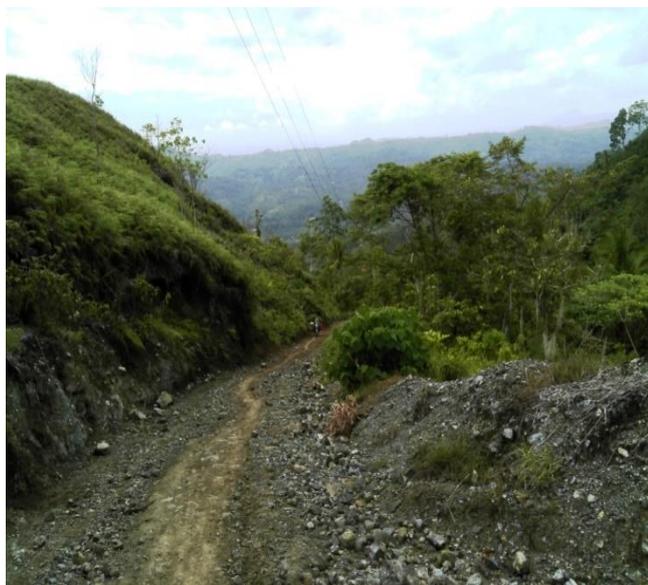
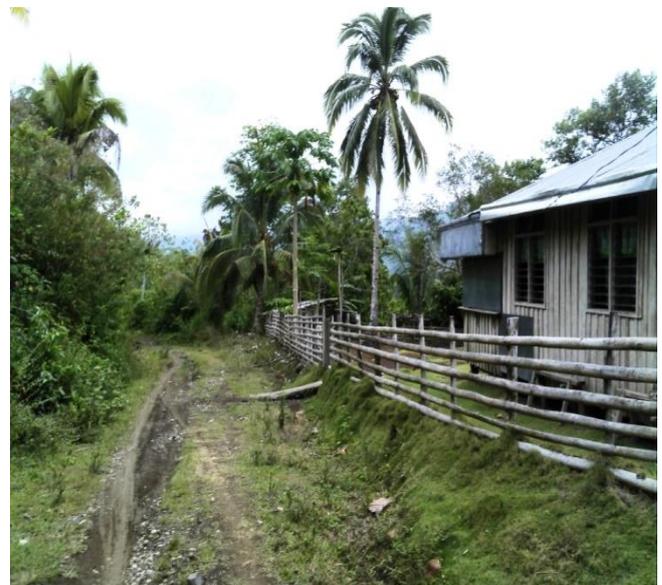
Clockwise: Residential area situated along a rugged terrain; Purok 1B, Purok 3, Purok 5, and access road within a steep terrain along Purok 2

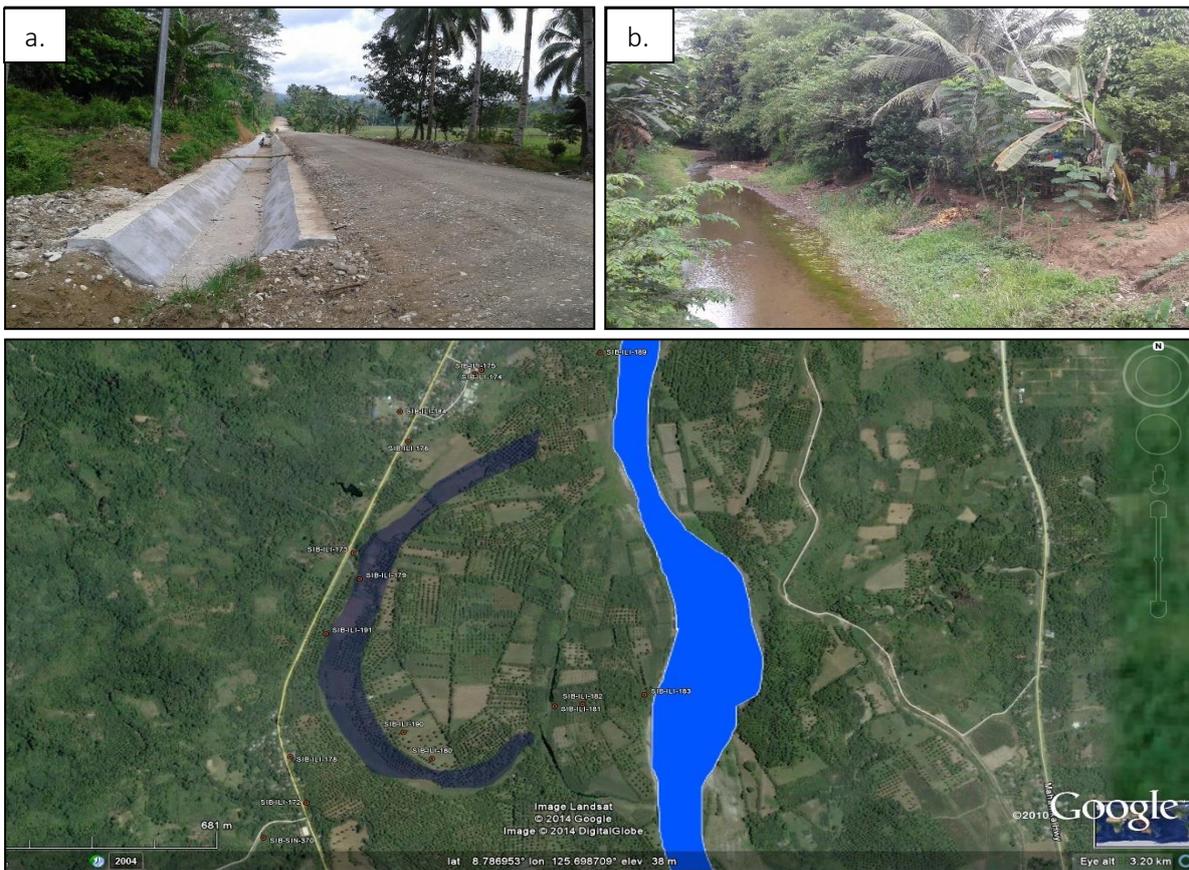
Photos.Active road gravelling and drainage construction in Barangay Ilihan (a) and Sinay Creek in Purok 6. Google generated image showing the old river channel along segment of Wawa River in Purok 4 (c).

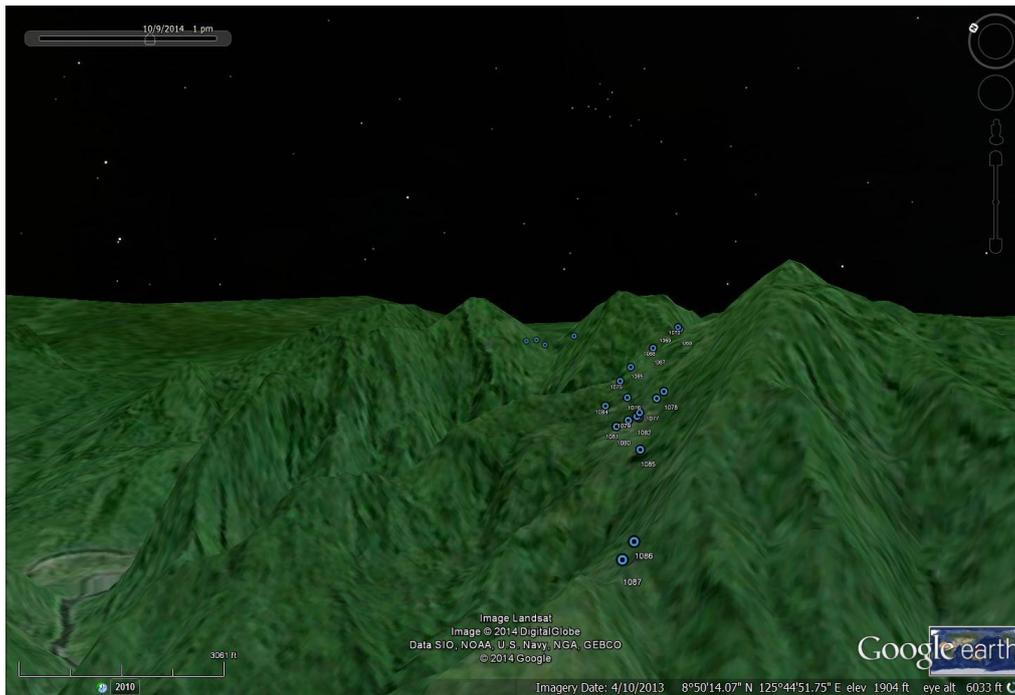
The blue icons indicate the locations taken in Barangay Kioya. The entire barangay is located along a steep to very steep slope, approximately 400-500 meters high. All the residents are advised to relocate immediately. There are no safe spots or a place conducive for habitation in this area.

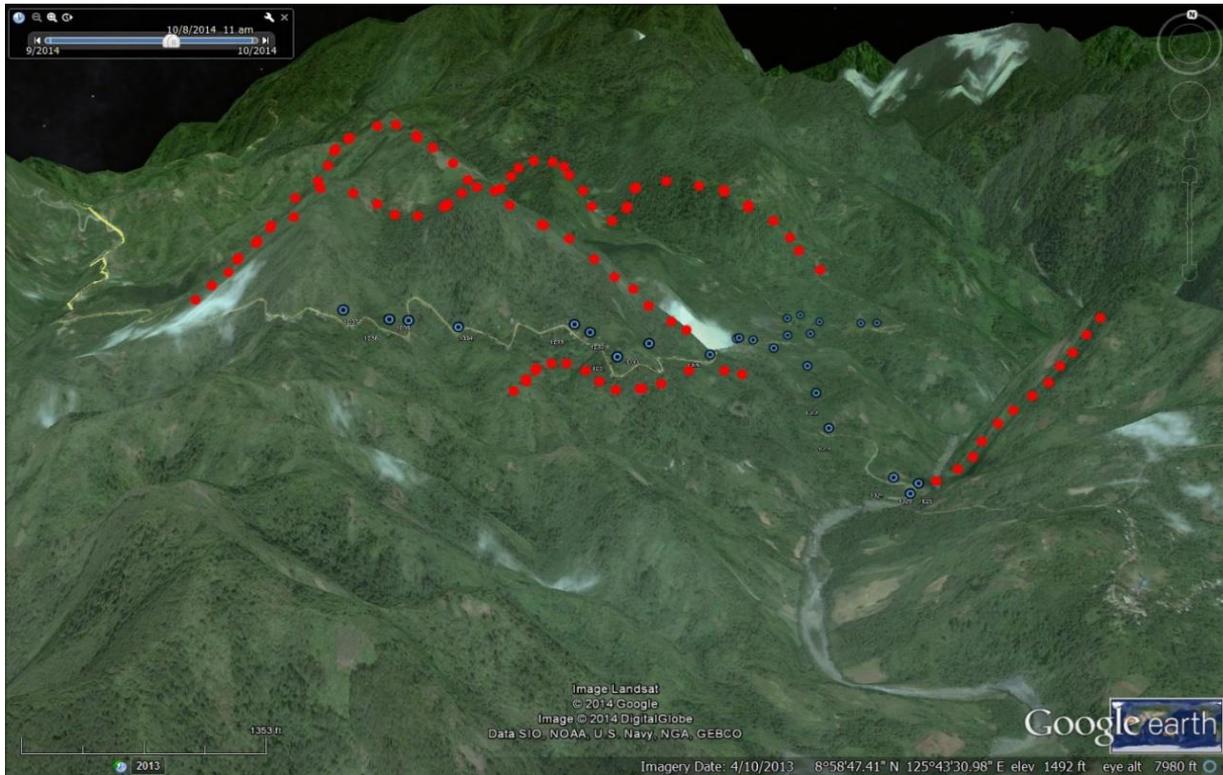
The area is located on a steep to very steep, relatively elevated slope, approximately 500 meters high. The slope is composed entirely of weathered sedimentary materials making it highly susceptible to landslide. Presence of mass movement is observed due to soil creep and subtle disintegration of overlying sedimentary units. (At Purok 4 with GPS location: 8° 58' 59.9" N 125° 43' 19.2" E)

This digital photo describes the over-all geohazards situation of Barangay Kolambugan. The blue icons indicate the GPS locations that were taken around/along the barangay area, while the red dots, those that form semi-circular shape tracing the mountain ridges, represent the areas that are highly to moderately susceptible to landslide.

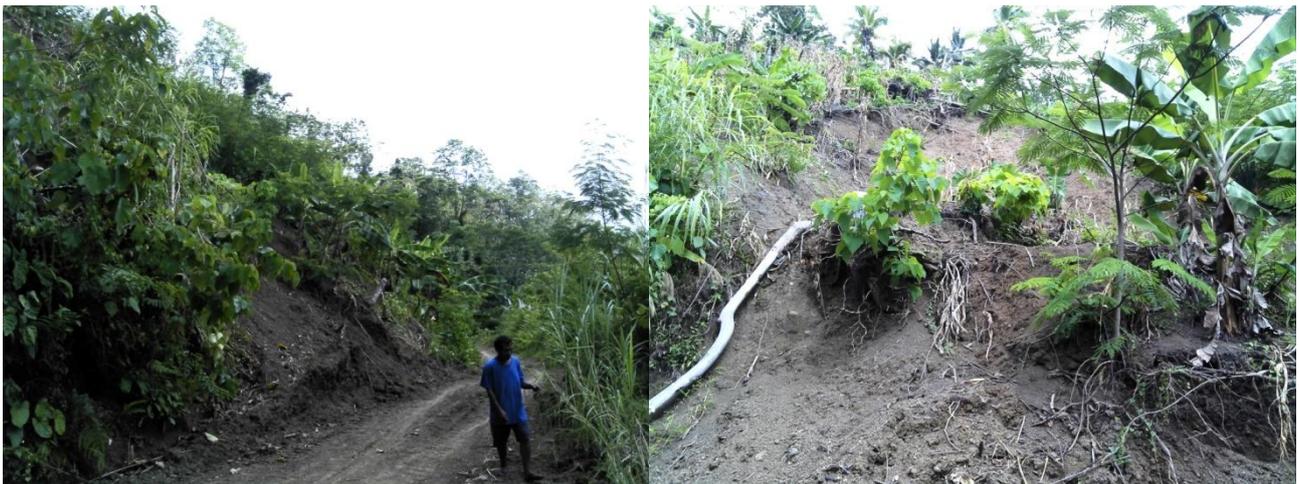
Photographs of minor landslide area mapped along the road in Purok 1.

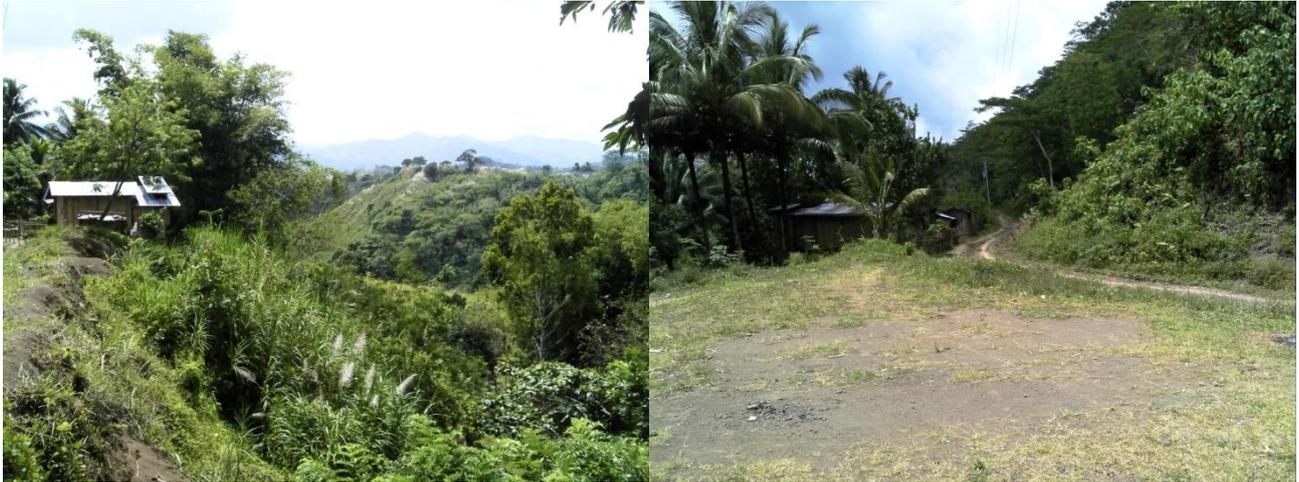
Images of residential area along steep slopes in Purok 1 and Purok 3.

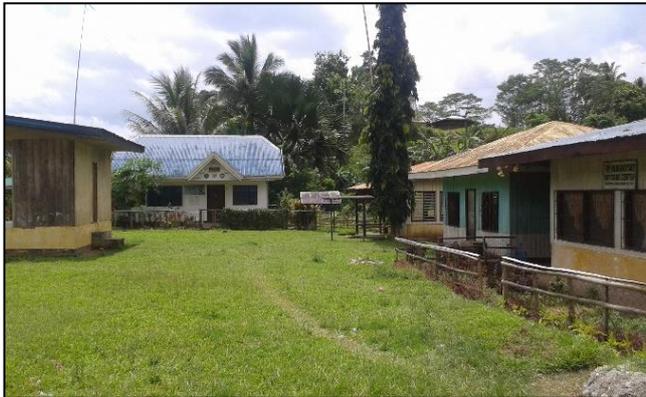
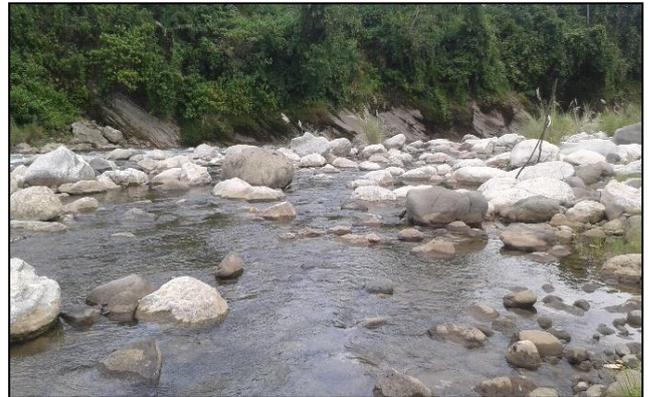
Photos. Magsaysay Barangay Hall (a) and segment of Wawa River in Purok 1 showing varied boulder size bed loads (b).

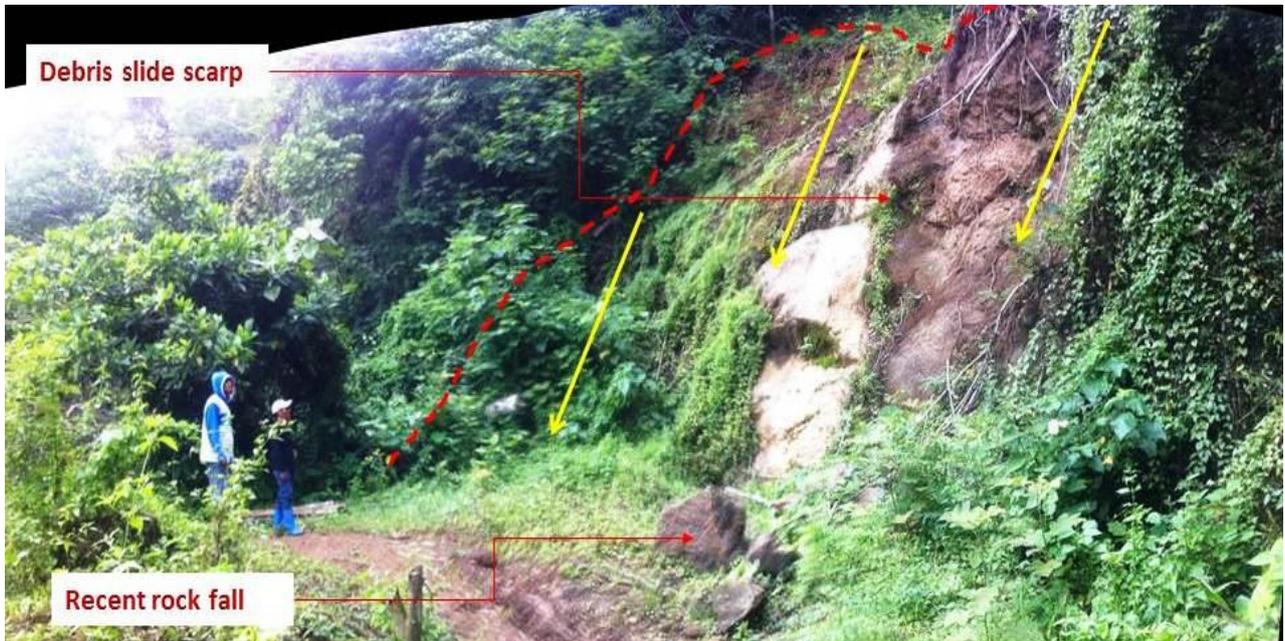
Debris slide with rock fall at Purok 2. These mass movements are common on ridge areas characterized by very steep slope profile.

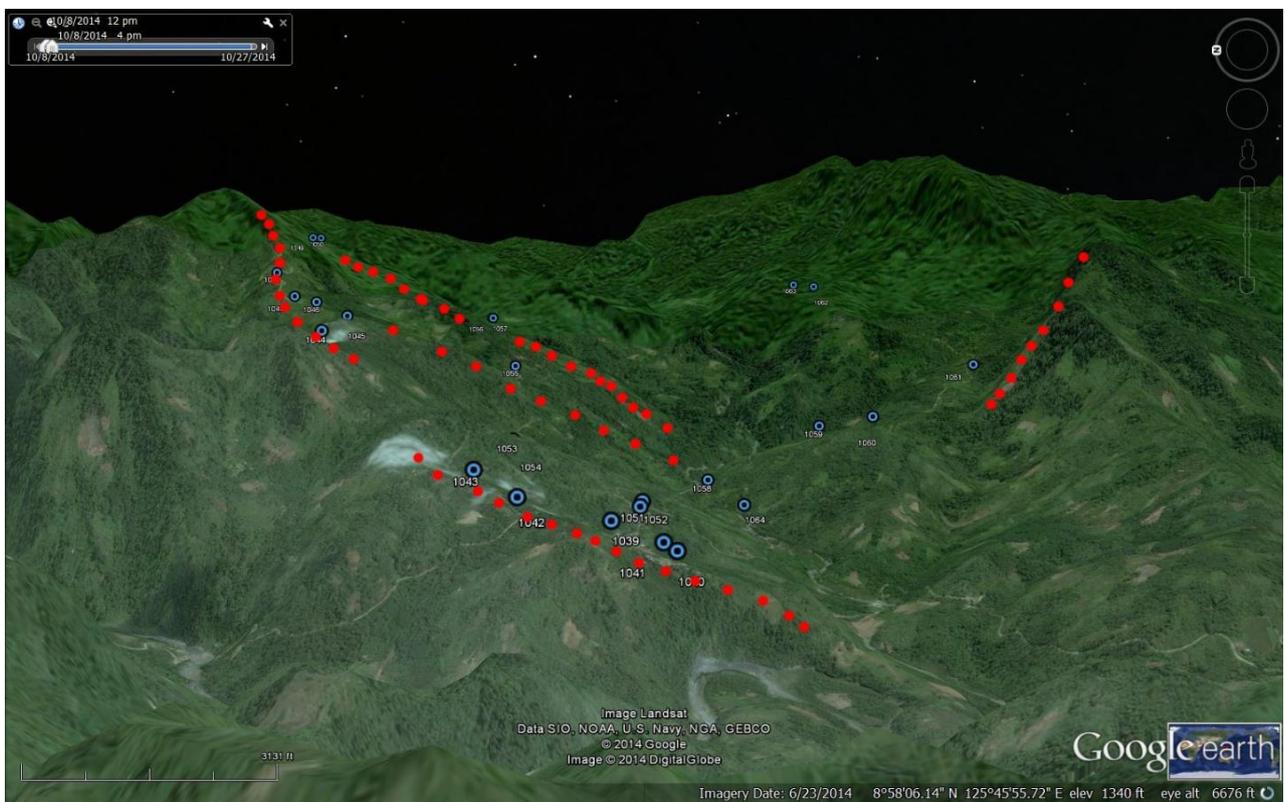
The picture above depicts the over-all geohazards situation in Barangay Padiay. The blue icons represent the GPS locations of where they were taken. These locations, inhabited by local residents, are subjected to a significant geohazards susceptibility. The red dots tracing the mountain ridges, on the other hand, are the areas with susceptibility ratings to landslide; moderate to high.

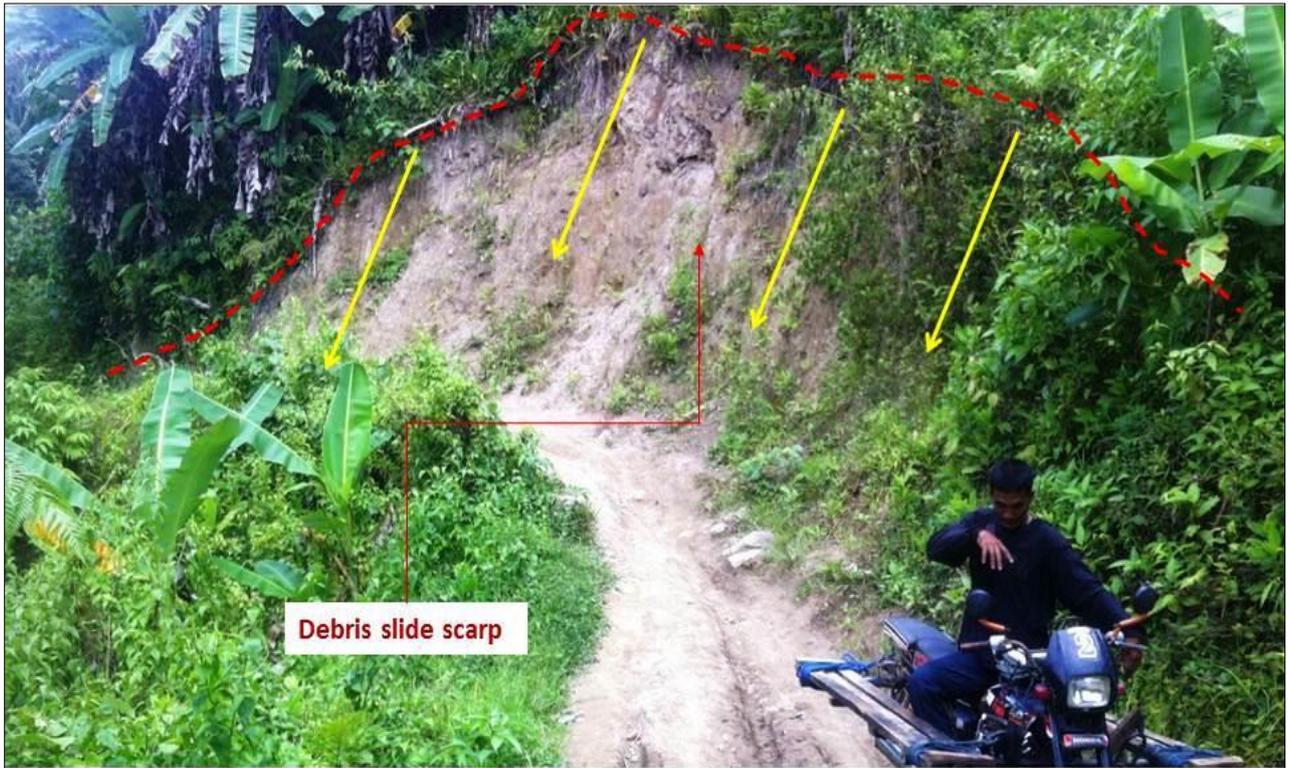
Segment of an all-weather road where landslide has occurred associated with unmitigated road cut slope.

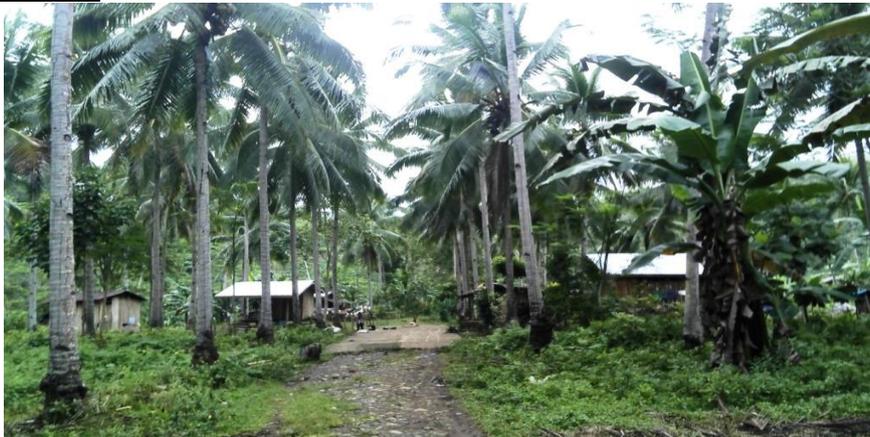
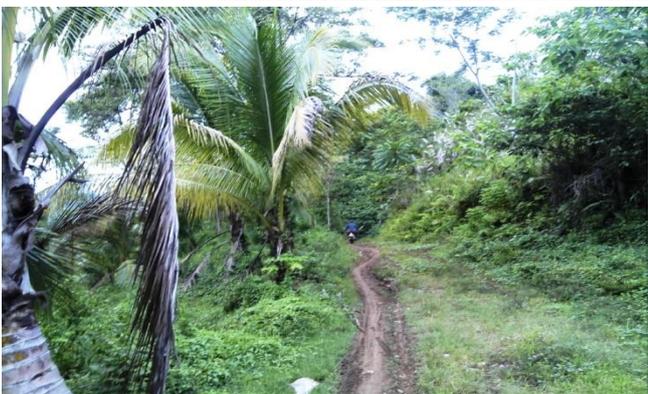
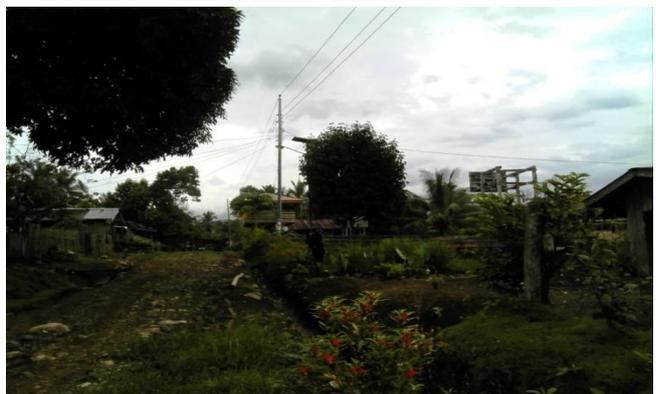
Clockwise: Residential area along low undulating ground at Purok 1, Purok 2 and main access road that is situated near the base of slope in Purok 5B.

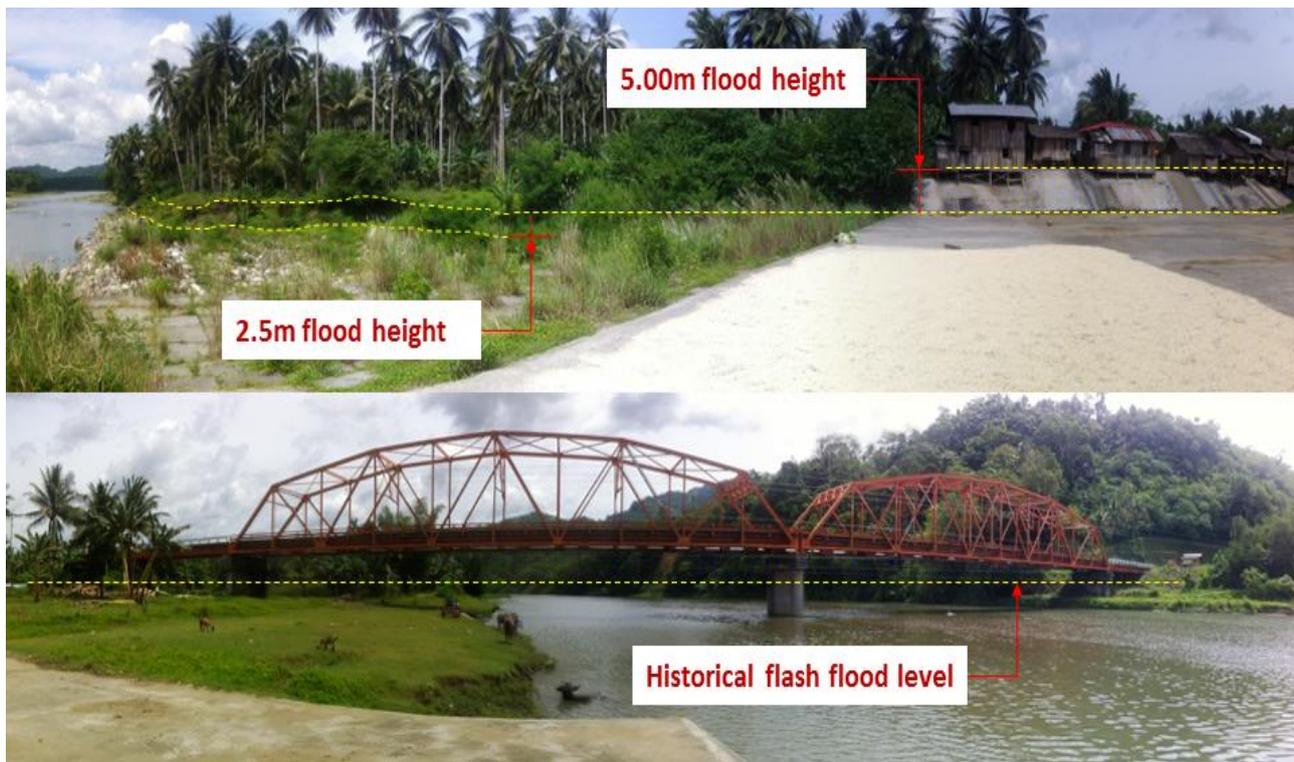
Wawa River along Barangay San Vicente. Yellow dashed line indicates previous flash flood level.

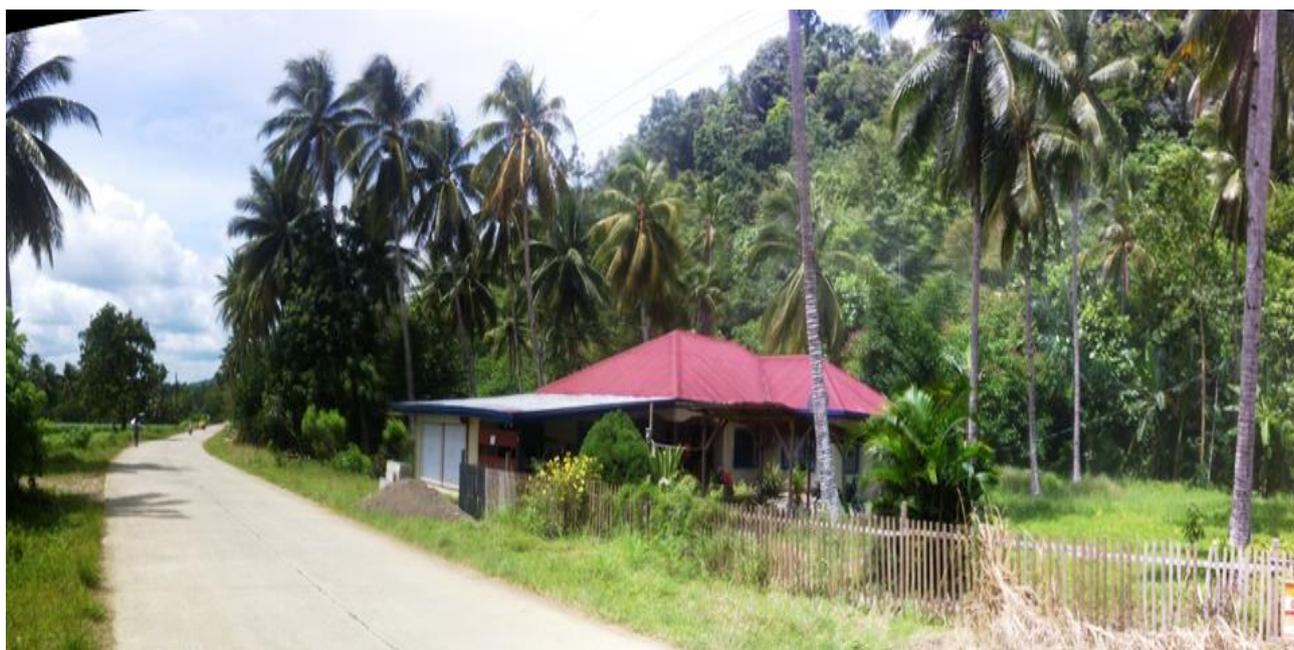
Looking southwest along section of concrete road going to Barangay Ilihan. This area is susceptible to soil creep and localized debris slides.

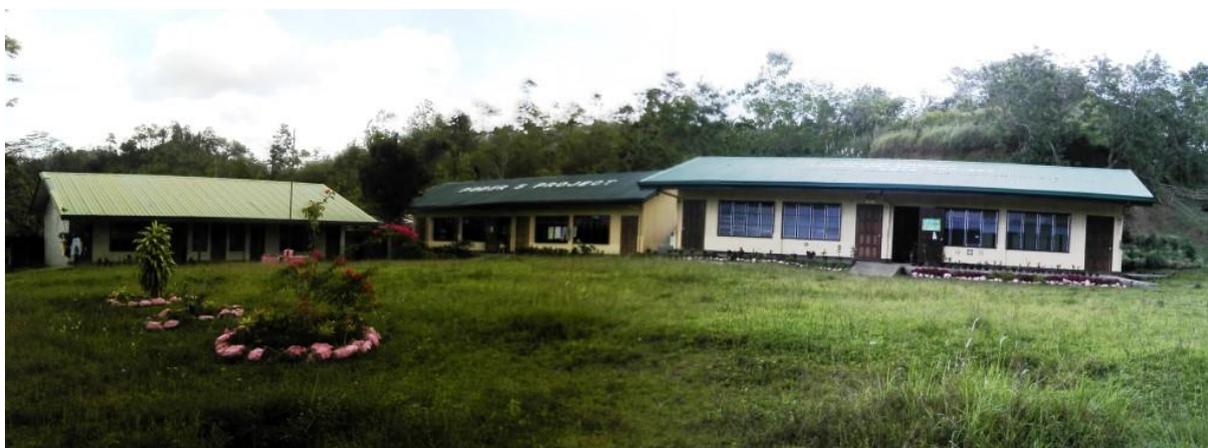
Sta. Maria Elementary School at Purok 1 situated near a low but moderately sloping terrain

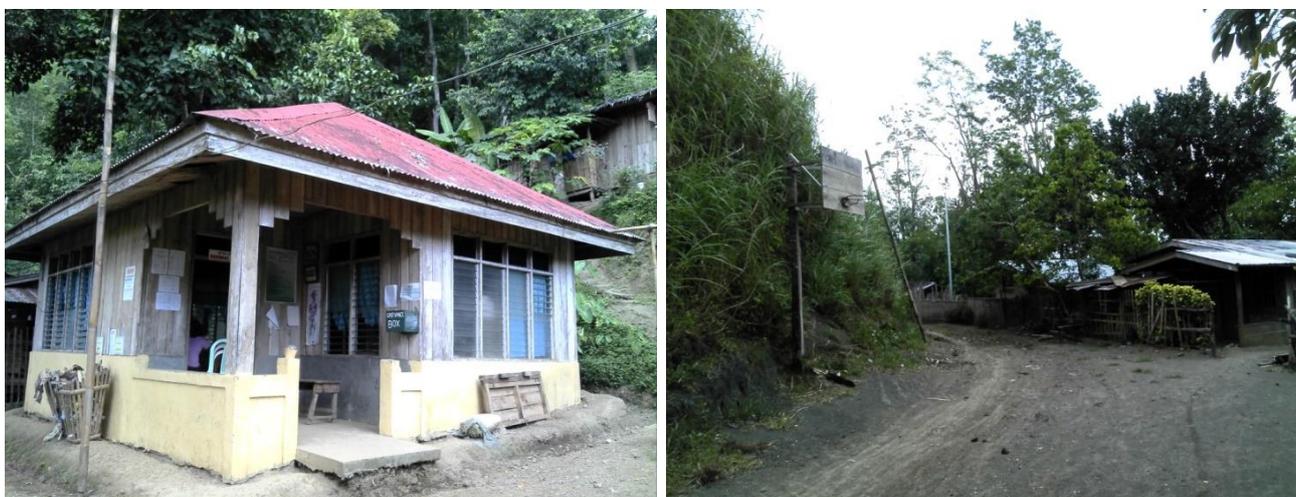
Barangay office at Purok 1 is positioned along a moderately sloping ground and is also at the base of a steep terrain (left) and residential area at Purok 3 along steep sloping ground.

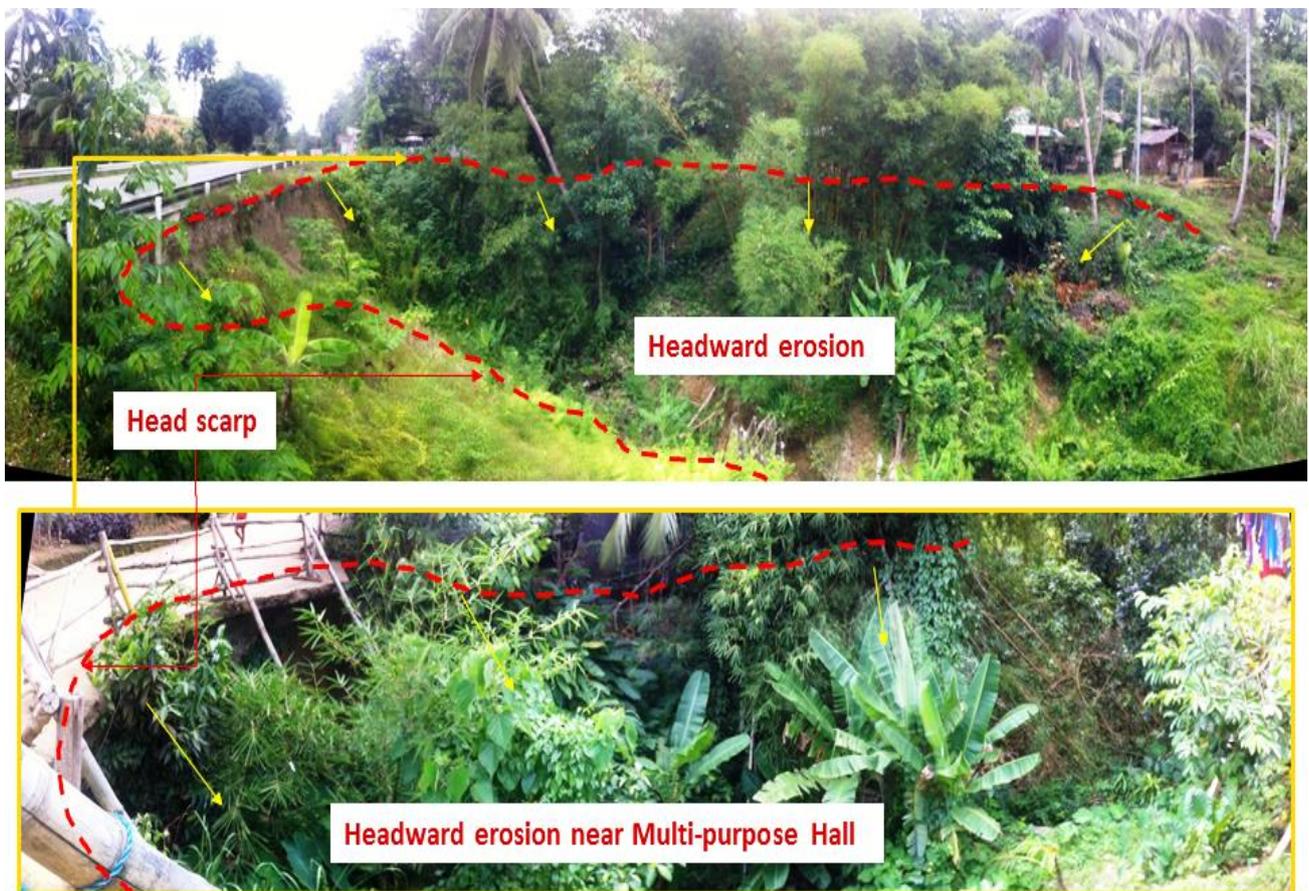
Headward erosion located near Barangay Tabontabon proper.

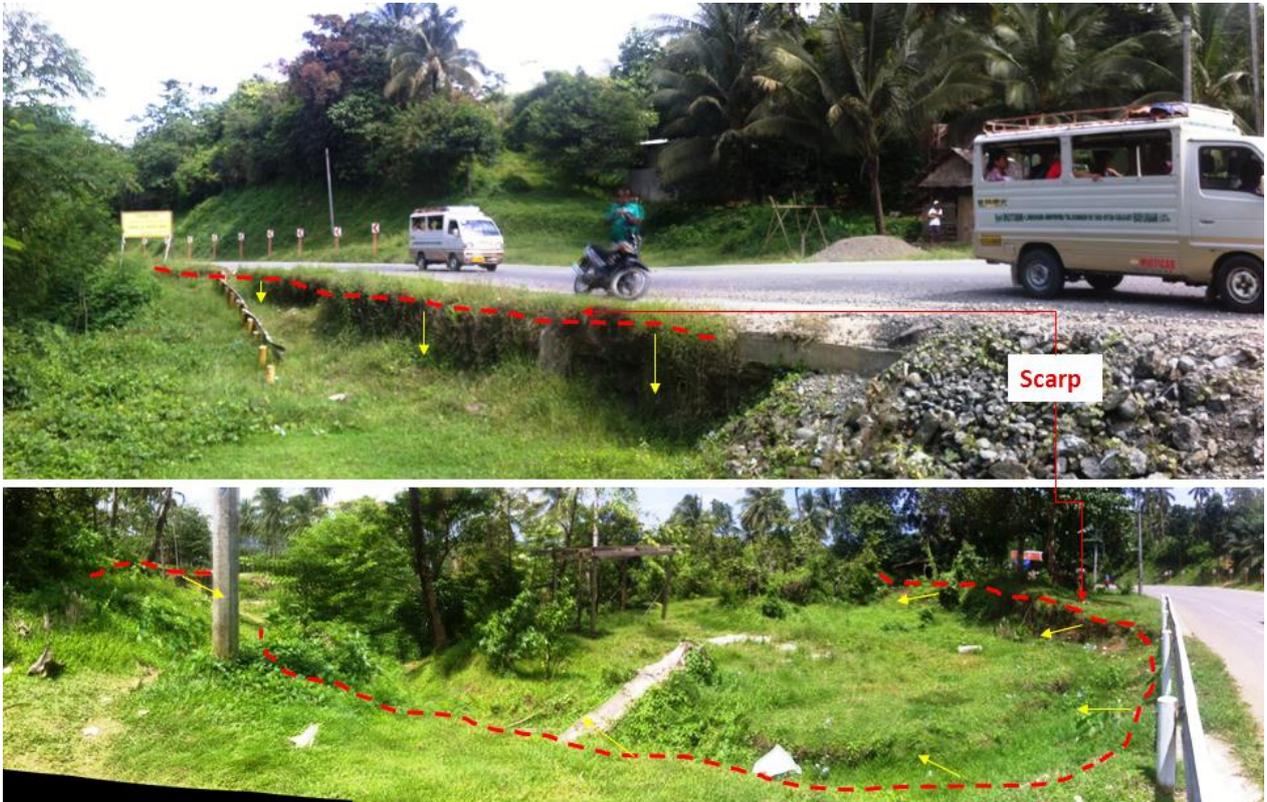
Subsidence/landslide along Maharlika Highway.

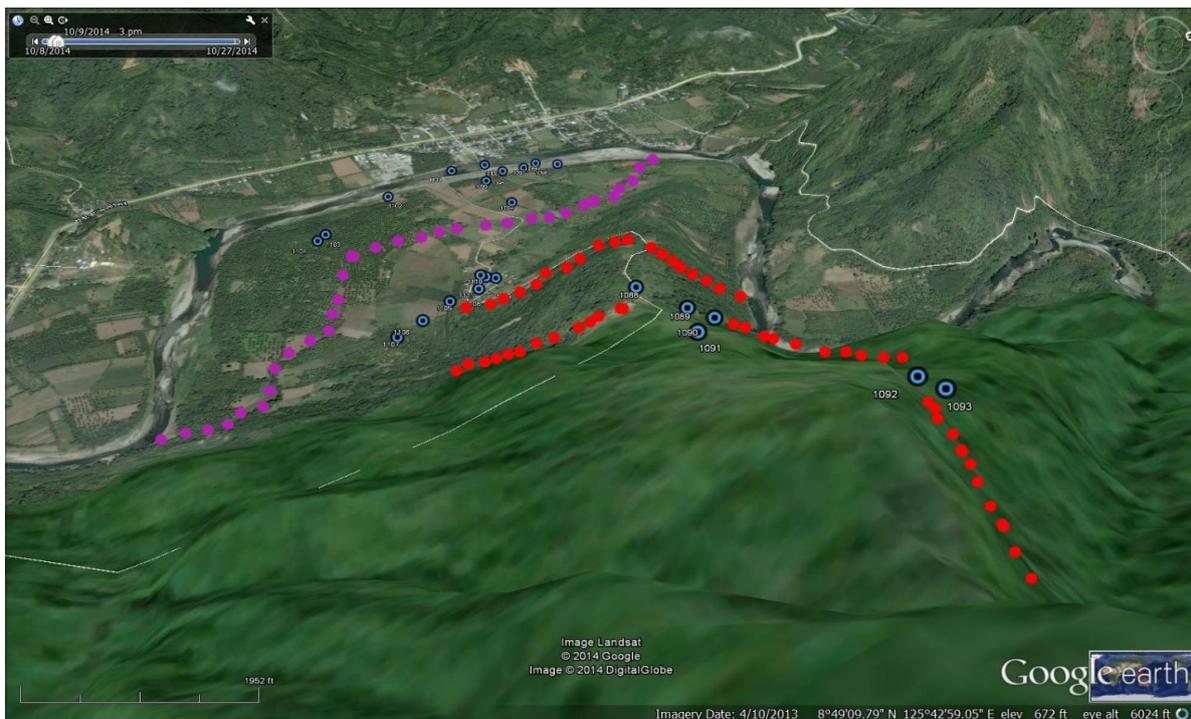
The figure above is a google earth generated image showing the typical terrain of Barangay Tag-Oyango. The blue dots represent the GPS stations of the residential areas. The red and violet dots are traces of mountain ridges and areas that are susceptible to landslide.

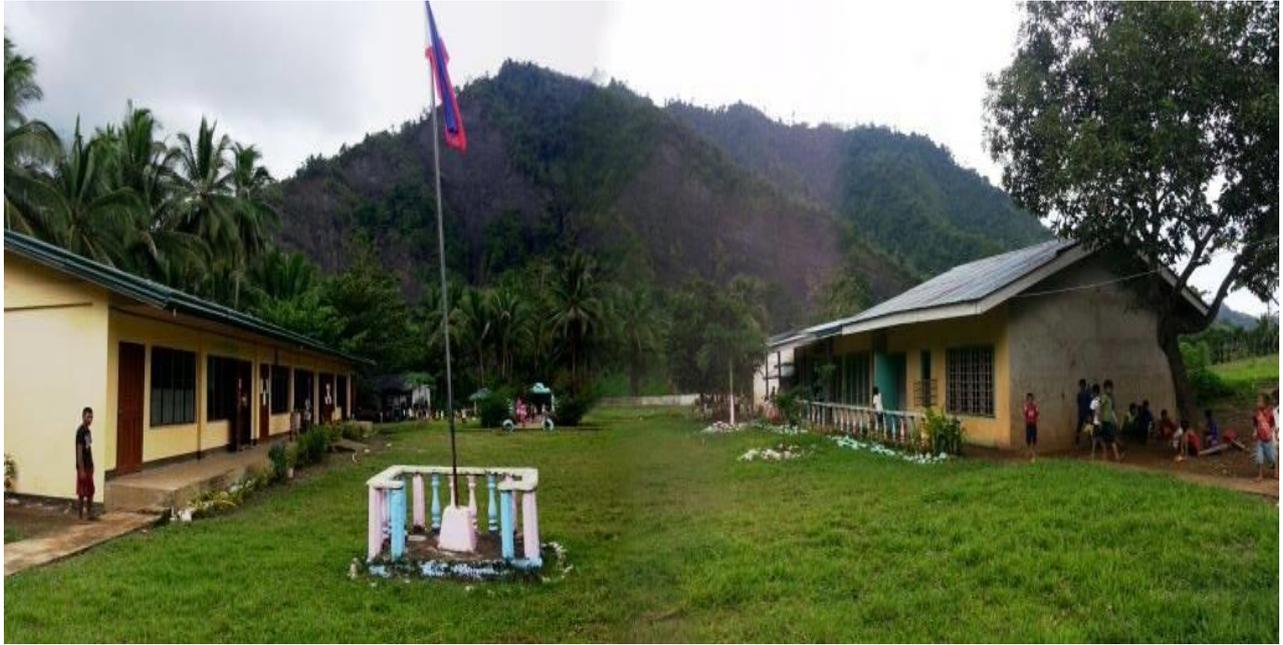
Villangit Elementary School at Purok 1 is situated near the base of a very steep slope.

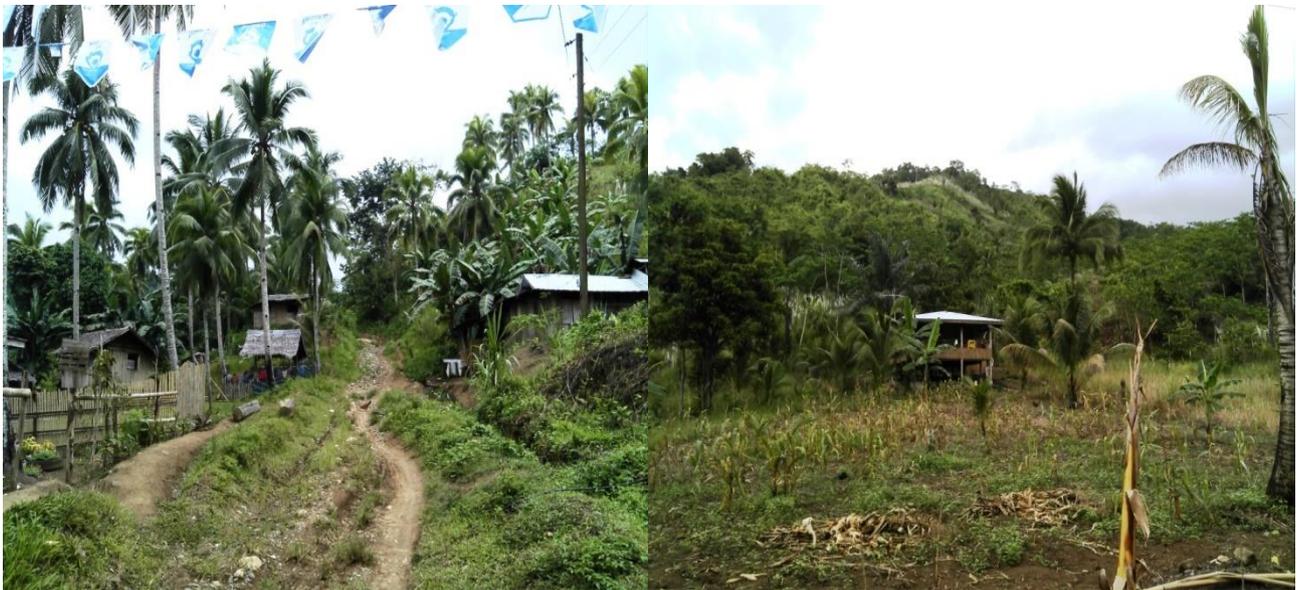
Some of the images from residential area at Purok 4A situated along moderately sloping ground and residential area at Purok 5 positioned near the base of a low but steep sloping terrain.

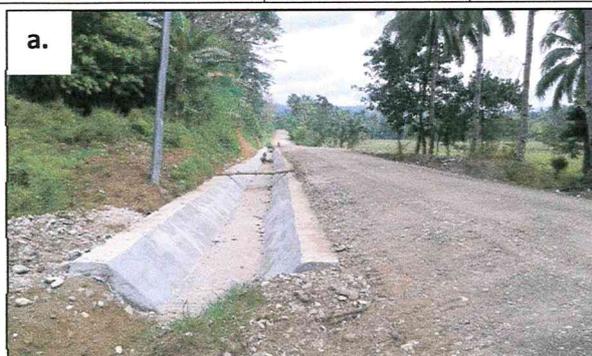
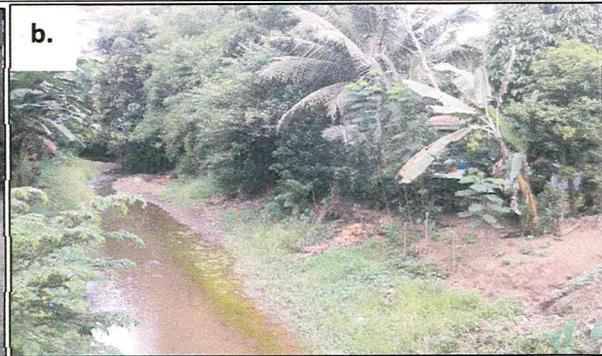
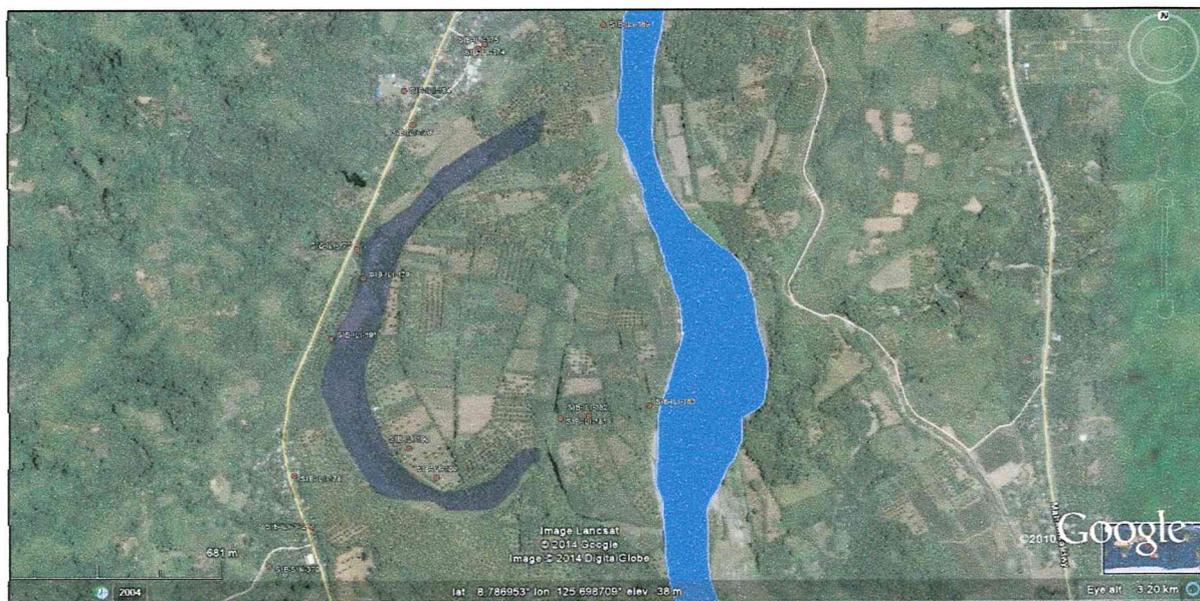
Agricultural field, Creek 125°41'48.59" E 8°47'6.18" N		
Agricultural field 125°41'51.25" E 8°47'6.4" N		
Agricultural field 125°41'26.72" E 8°47'13.87" N		
Agricultural field, Wawa River 125°41'57.19" E 8°47'7.4" N	Very High	Located along the flood plain of an old river channel created from channel migration. Recommendations: Observe for rapid increase/decrease in creek/river water levels, possibly accompanied by increased turbidity (soil content). Advise for pre-emptive evacuation during inclement weather condition and occasions of heavy and

Photos. Active road graveling and drainage construction in Barangay Ilihan (a) and Sinay Creek in Purok 6. Google generated image showing the old river channel along segment of Wawa River in Purok 4 (c).

prolonged rainfall. Observe proper easement along bodies of water. Avoid construction of important infrastructures within the identified flood prone areas.
Agricultural field 125°41'50.5" E 8°47'51.29" N	Very High	<p>Located along the flood plain presently utilized as agricultural area.</p> <p>Recommendations: Observe for rapid increase/decrease in creek/river water levels, possibly accompanied by increased turbidity (soil content). Advise for pre-emptive evacuation during inclement weather condition and occasions of heavy and prolonged rainfall. Observe proper easement along bodies of water. Avoid construction of important infrastructures within the identified flood prone areas.</p>
Agricultural field, Wawa River 125°41'54.2" E 8°47'45.78" N		
Agricultural field, Wawa River 125°41'52.92" E 8°47'43.67" N		
Agricultural field 125°41'34.12" E 8°47'3.42" N		
Sinay Creek, Bridge 125°41'24.94" E 8°46'55.99" N	High	<p>Sinay bridge.</p> <p>Recommendations: Observe for rapid increase/decrease in creek/river water levels, possibly accompanied by increased turbidity (soil content). Advise for pre-emptive evacuation during inclement weather condition and occasions of heavy and prolonged rainfall. Observe proper easement along bodies of water. Avoid construction of important infrastructures within the identified flood prone areas and along/near river banks.</p>

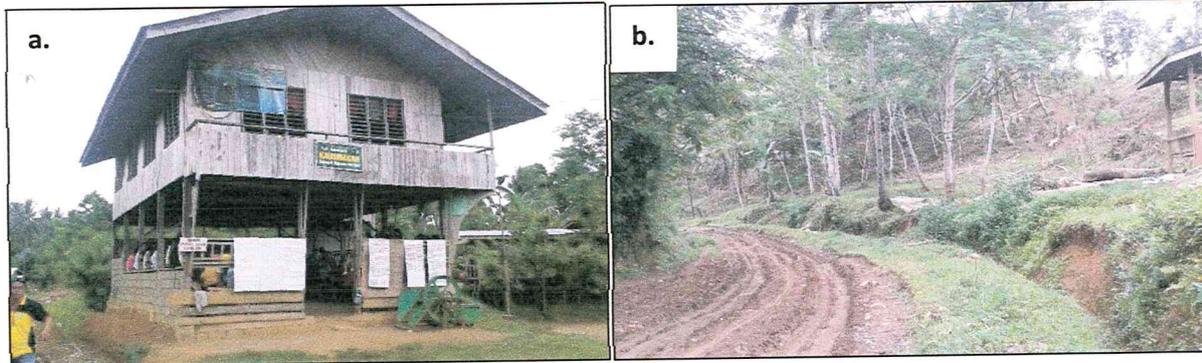
Residential area, Brgy. road 125°40'43.54" E 8°48'22.1" N		
Kauswagan Primary School 125°40'52.75" E 8°48'19.84" N	High	The school area is characterized by highly rolling topography with locally steep slopes.
Kauswagan Brgy. Hall, residential area 125°40'35.65" E 8°48'33.12" N	High	Recommendations: Observe for and/or monitor for presence of mass movement (e.g., landslides, tension cracks), saturated ground or seeps and sunken or displaced road surfaces and immediately report to MGB/municipal authorities. Avoid construction of new infrastructures along steep slopes.

Photos. Kauswagan Barangay Hall (a). Falcata plantation in Purok 1 (b).

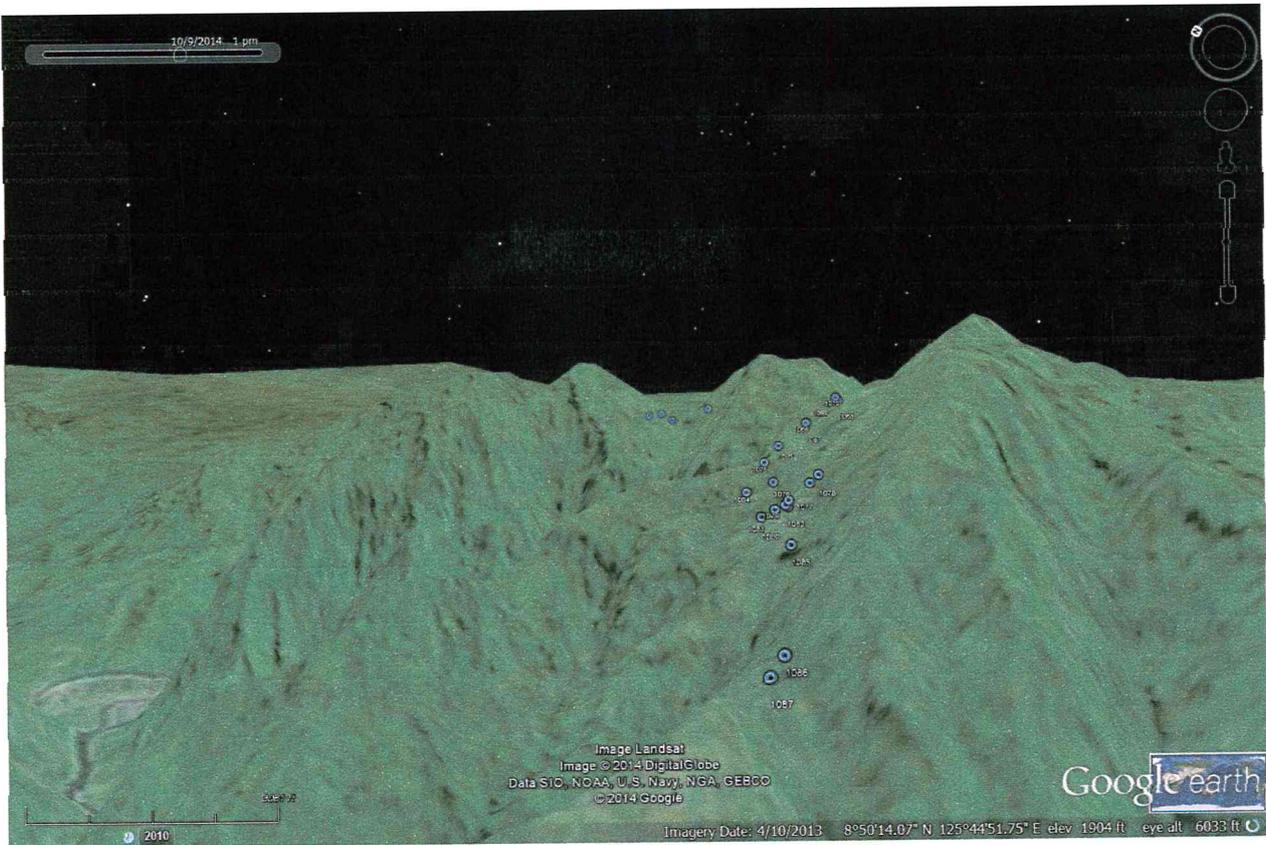
The blue icons indicate the locations taken in Barangay Kioya. The entire barangay is located along a steep to very steep slope, approximately 400-500 meters high. All the residents are advised to relocate immediately. There are no safe spots or a place conducive for habitation in this area.
