REPORT ON THE 1:10,000 SCALE GEOHAZARDS ASSESSMENT AND MAPPING OF SIBAGAT, AGUSAN DEL SUR

SRDP Consulting Inc.
Units 119, 420 & 421 SJB Condominium
130-B Panay Ave, South Triangle
Quezon City, Philippines

OCTOBER 2014

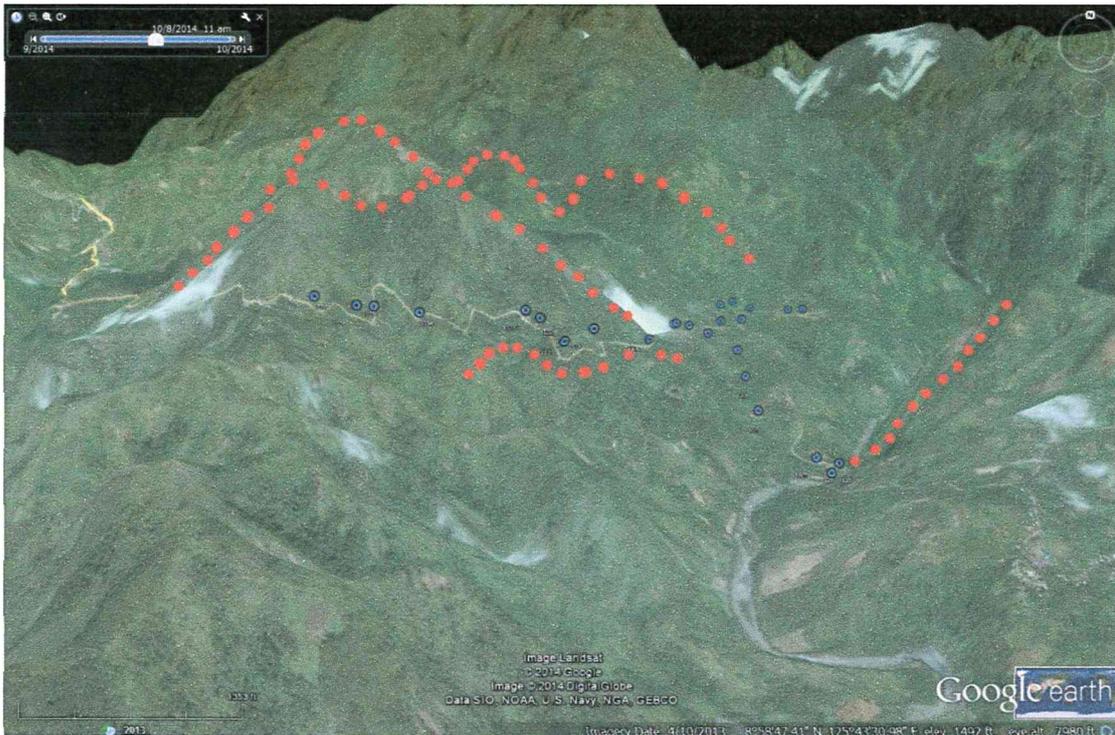
This digital photo describes the over-all geohazards situation of Barangay Kolambugan. The blue icons indicate the GPS locations that were taken around/along the barangay area, while the red dots, those that form semi-circular shape tracing the mountain ridges, represent the areas that are highly to moderately susceptible to landslide.

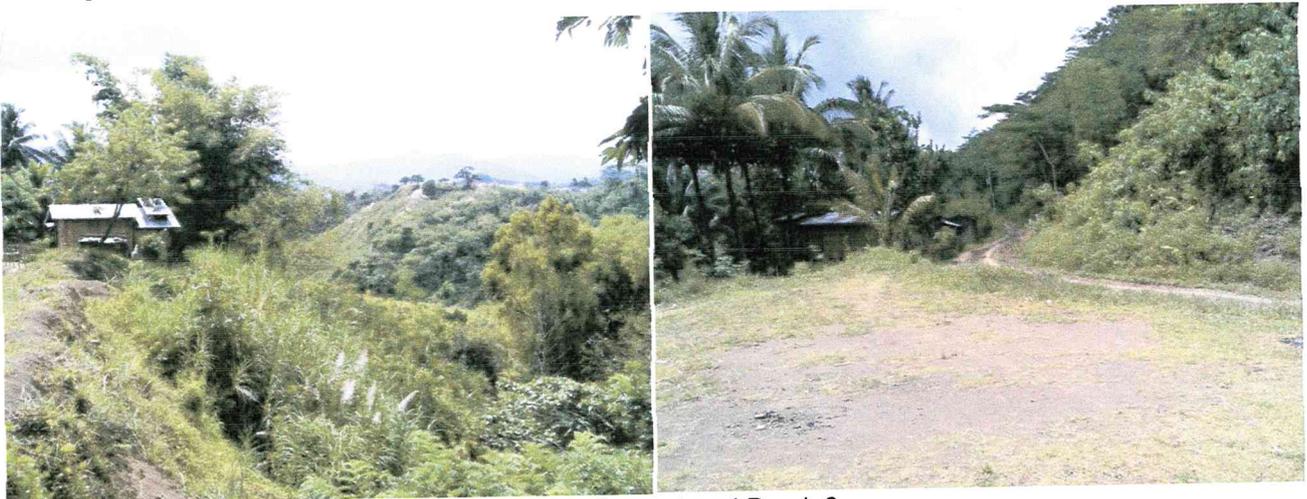
Images of residential area along steep slopes in Purok 1 and Purok 3.

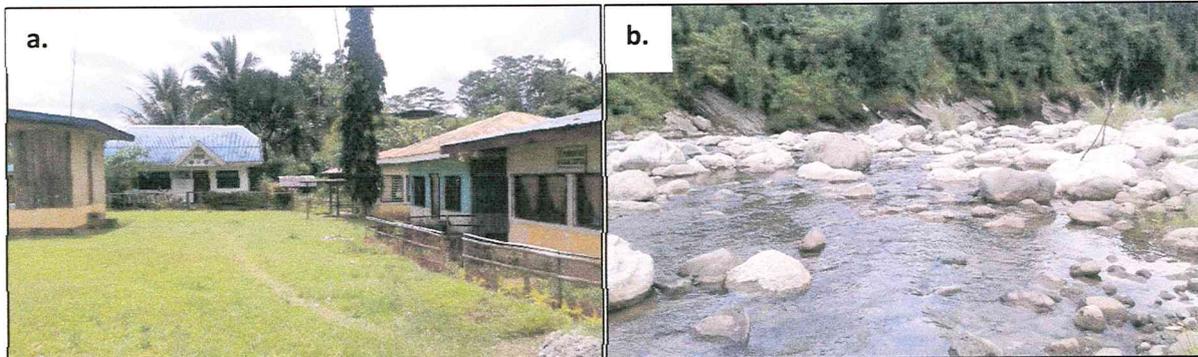
Photos. Magsaysay Barangay Hall (a) and segment of Wawa River in Purok 1 showing varied boulder size bed loads (b).

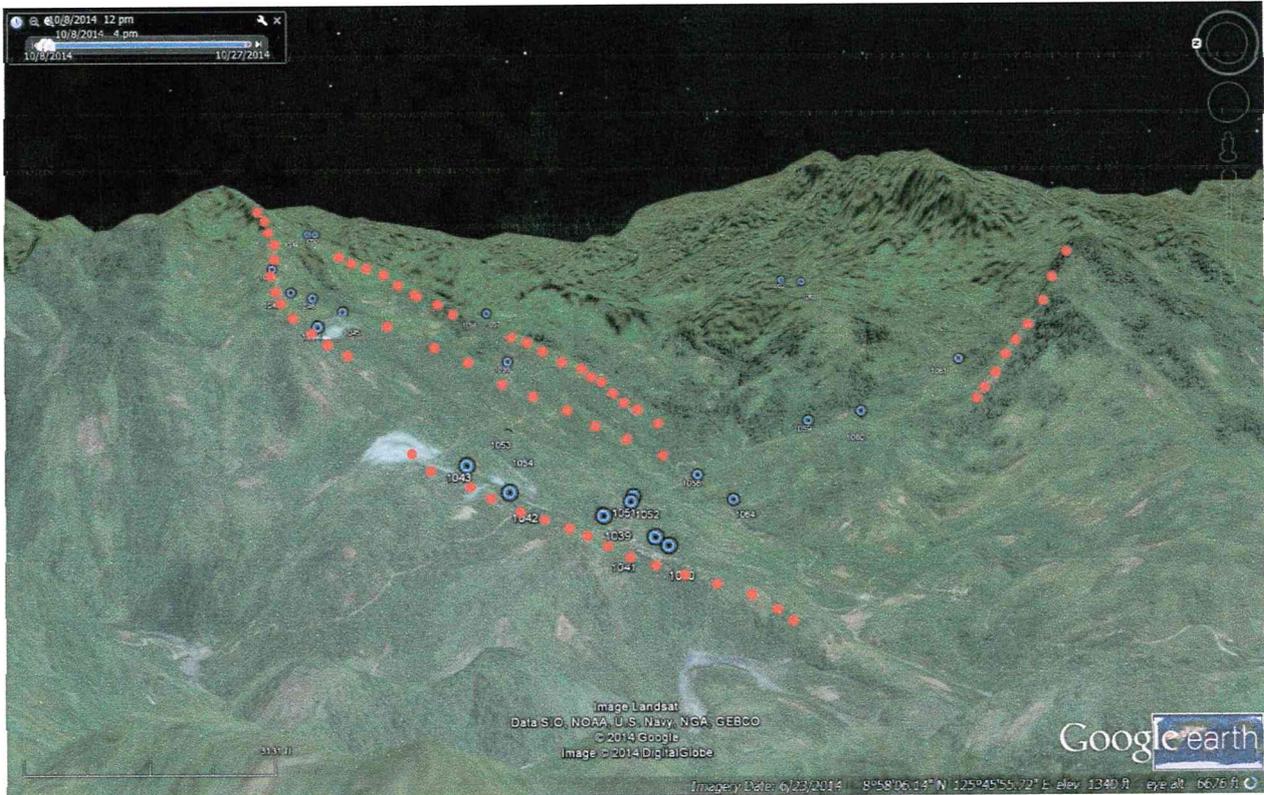
The picture above depicts the over-all geohazards situation in Barangay Padiay. The blue icons represent the GPS locations of where they were taken. These locations, inhabited by local residents, are subjected to a significant geohazards susceptibility. The red dots tracing the mountain ridges, on the other hand, are the areas with susceptibility ratings to landslide; moderate to high.

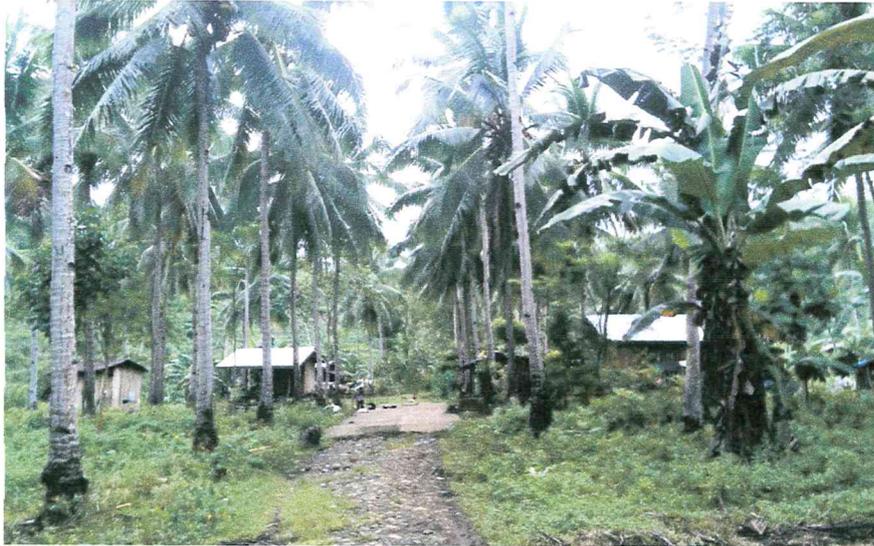
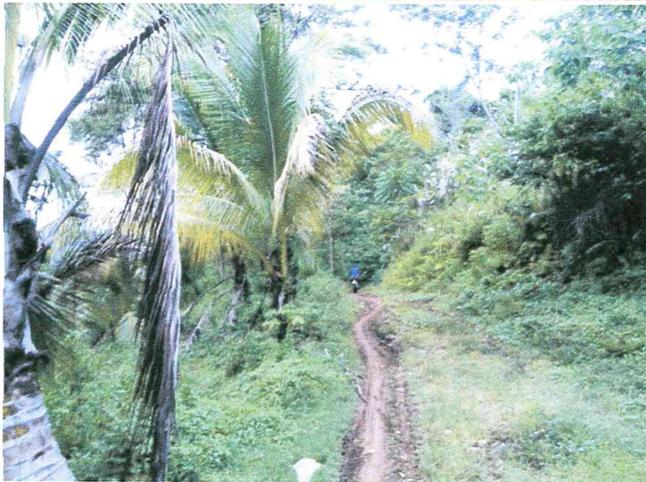
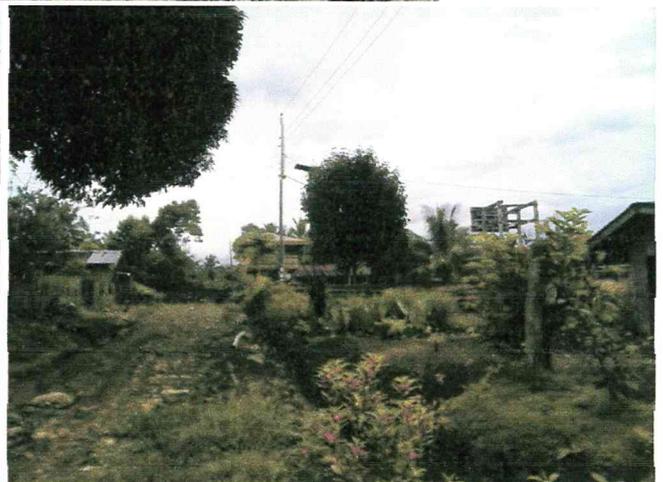
Clockwise: Residential area along low undulating ground at Purok 1, Purok 2 and main access road that is situated near the base of slope in Purok 5B.

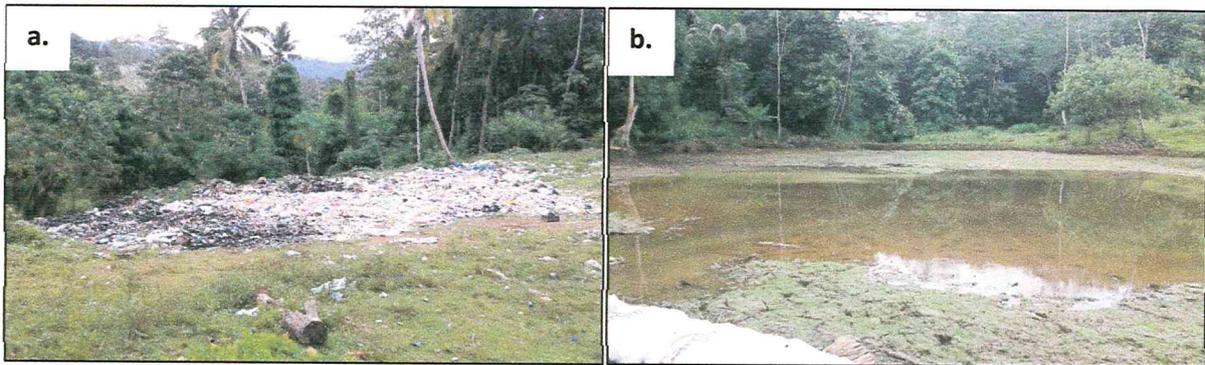
<p>Municipal Dump Site 125°40'42.78" E 8°47'18.78" N</p>	<p>High</p>	<p>The area is characterized by highly rolling topography with locally steep slopes presently utilized as municipal dump site.</p> <p>Recommendations: Discontinue land utilization as dumpsite. The area is located along the slopes with no proper underground lining. Highly susceptible to ground water contamination associated with leachate generated from garbage. Observe for and/or monitor for presence of mass movement (e.g., landslides, tension cracks), saturated ground or seeps and sunken or displaced road surfaces and immediately report to MGB/municipal authorities. Avoid construction of new infrastructures along steep slopes.</p>
--	-------------	--

Photos. Sibagat Municipal Dump Site located in Sinai (a) and fish pond project of the barangay and associated organization (b).

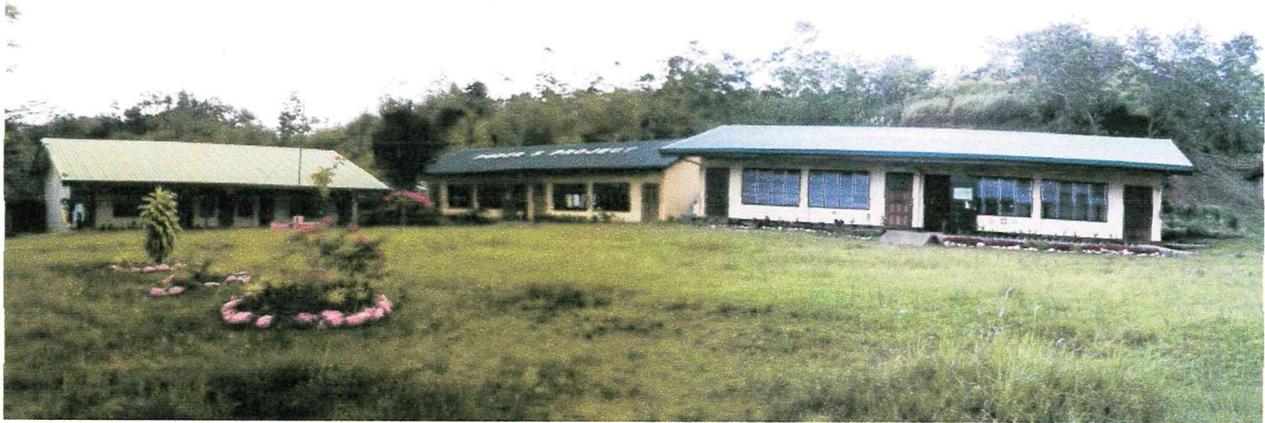
Sta. Maria Elementary School at Purok 1 situated near a low but moderately sloping terrain

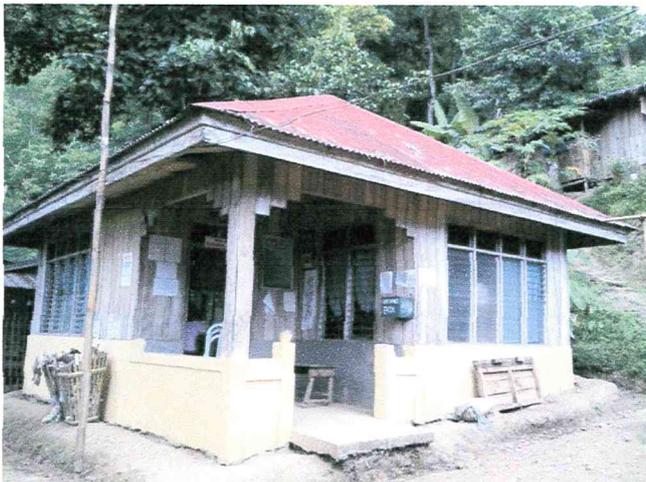
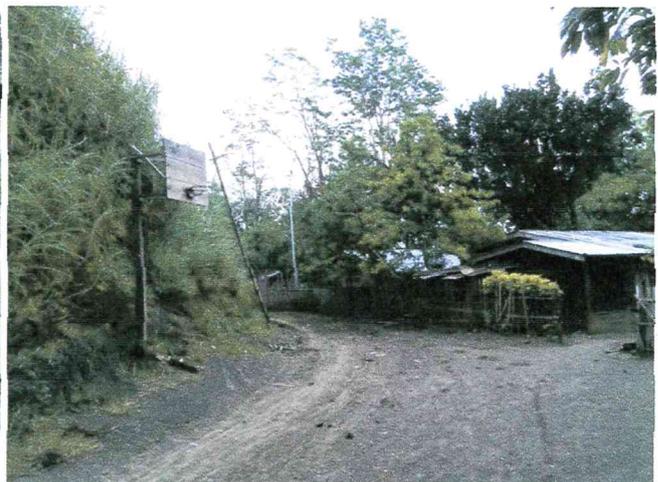
Barangay office at Purok 1 is positioned along a moderately sloping ground and is also at the base of a steep terrain (left) and residential area at Purok 3 along steep sloping ground.

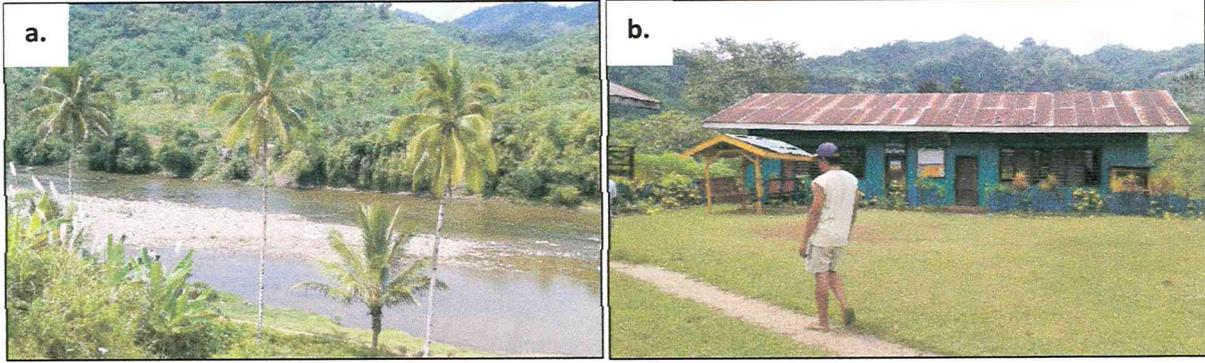
Location	Landslide Susceptibility Rating	Remarks/Recommendations
Residential area, Wawa river bank 125°43'21.26" E 8°54'59.7" N	High	Steep river banks. Locally susceptible to landslide. Recommendation: Observe for and/or monitor for presence of mass movement (e.g., landslides, tension cracks), saturated ground or seeps and sunken or displaced road surfaces and immediately report to MGB/municipal authorities.
Location	Flood Susceptibility Rating	Remarks/Recommendations
Residential area, Wawa river bank 125°43'21.26" E 8°54'59.7" N	Moderate	Residential area located along/near the flood plain. Recommendations: Observe for rapid increase/decrease in creek/river water levels, possibly accompanied by increased turbidity (soil content). Advise for pre-emptive evacuation during inclement weather condition and occasions of heavy and prolonged rainfall. Observe proper easement along bodies of water. Avoid construction of important infrastructures within the identified flood prone areas. Relocate houses to safer ground away from the identified flood prone areas.

Photos. View of Purok 4 on the other side of Wawa River (a) and Sta. Cruz Elementary School (b).

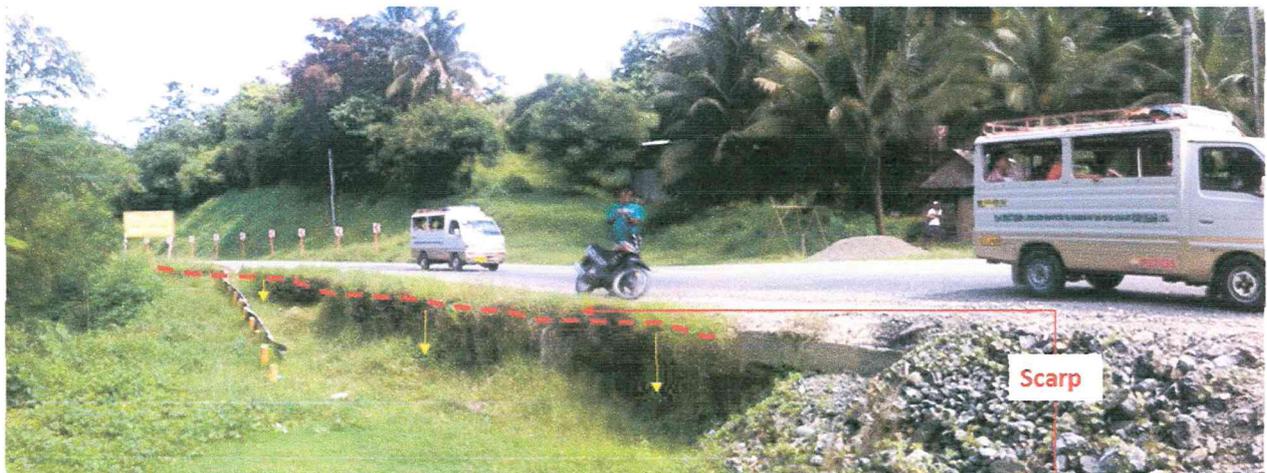
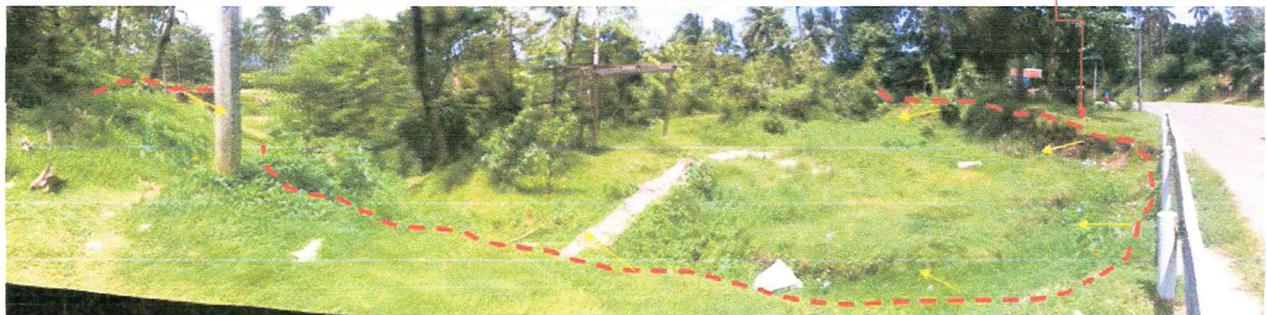
Subsidence/landslide along Maharlika Highway.

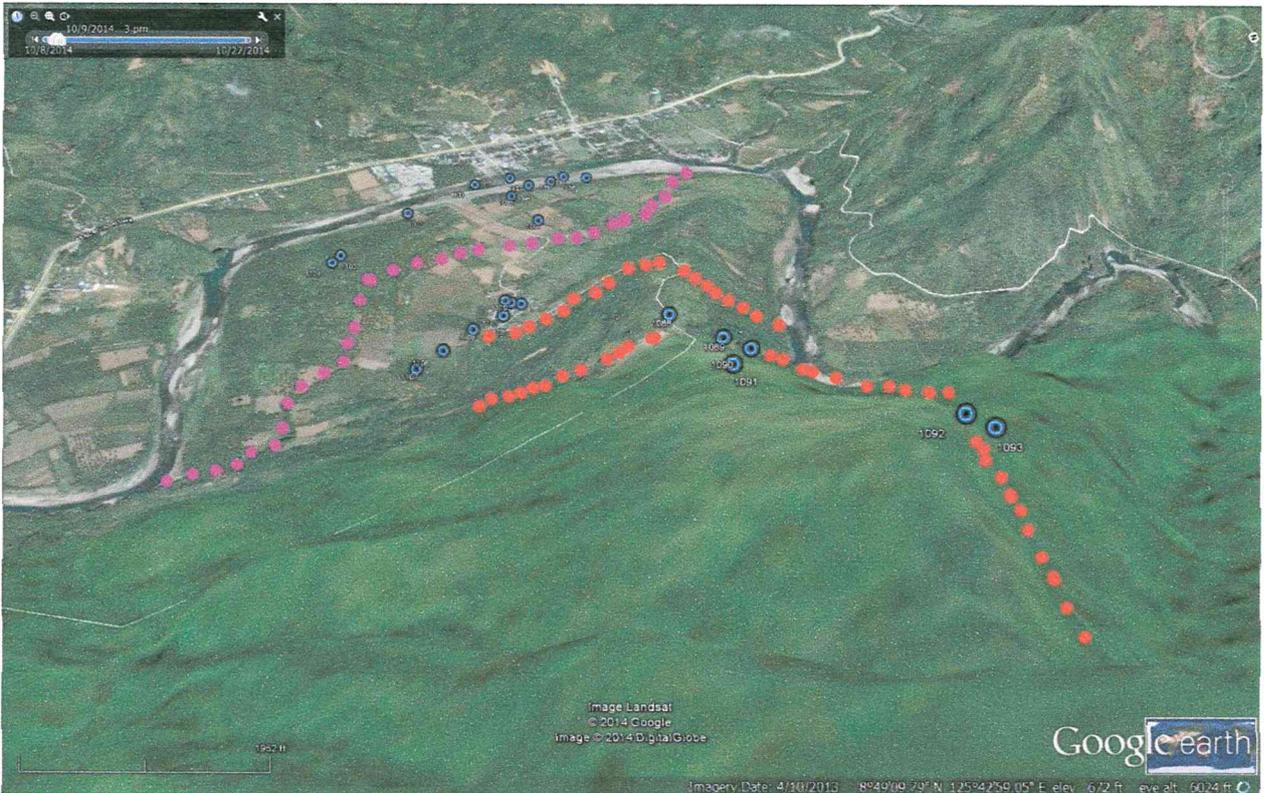
Location	Landslide Susceptibility rating	Remarks/Recommendations
Purok 8 8° 49' 21.8" N 125° 42' 39.4" E	High	<i>The area is located on a steep to very steep, relatively elevated slope, approximately 120 meters high. The slope is composed entirely of weathered sedimentary materials making it highly susceptible to landslide. Presence of mass movement is observed due to soil creep and subtle disintegration of overlying sedimentary units.</i> Recommendations: Habitation on this area is highly discouraged.
Purok 8 8° 49' 23.4" N 125° 42' 46.2" E	High	<i>The area is located on a steep to very steep, relatively elevated slope, approximately 120 meters high. The slope is composed entirely of weathered sedimentary materials making it highly susceptible to landslide. Presence of mass movement is observed due to soil creep and subtle disintegration of overlying sedimentary units.</i> Recommendations: Habitation on this area is highly discouraged.

The figure above is a google earth generated image showing the typical terrain of Barangay Tag-Oyango. The blue dots represent the GPS stations of the residential areas. The red and violet dots are traces of mountain ridges and areas that are susceptible to landslide.

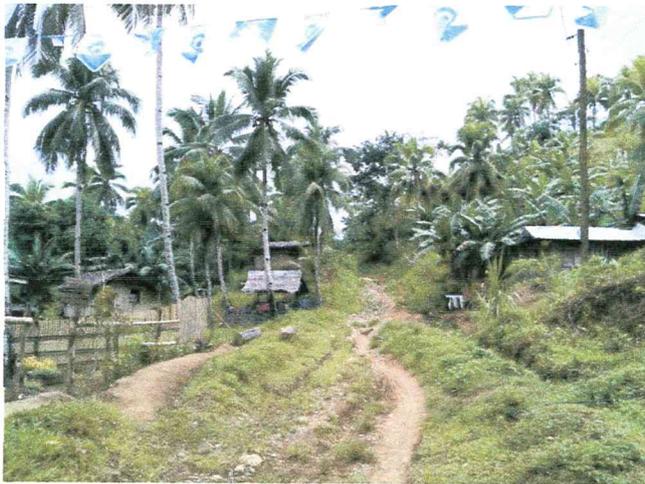
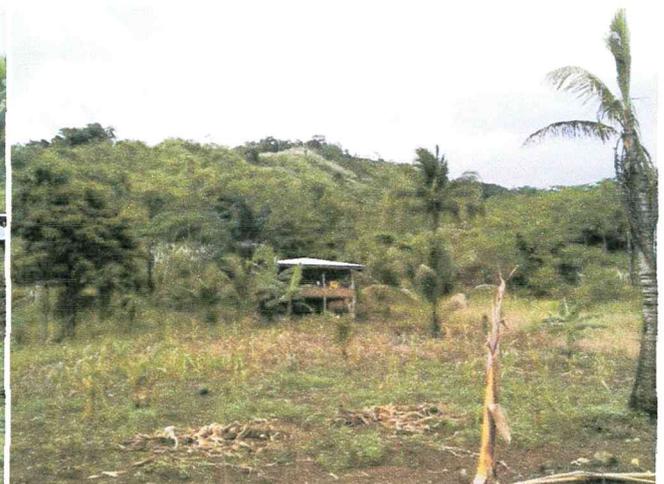
Some of the images from residential area at Purok 4A situated along moderately sloping ground and residential area at Purok 5 positioned near the base of a low but steep sloping terrain.
