Republic of the Philippines  
Department of Environment and Natural Resources  
**MINES AND GEOSCIENCES BUREAU**  
Regional Office No. XIII

Respectfully furnishing your end the document entitled "Results of the MGB Landslide and Flood Assessment and Mapping (1:10,000 scale) of the Municipality of Sta. Josefa Agusan del Sur". The assessment is in line with the government's effort aimed at reducing, if not totally mitigating the destructive effects and impacts of natural hazards to the populace.

## RESULTS OF THE MGB LANDSLIDE AND FLOOD ASSESSMENT AND MAPPING (1:10,000 SCALE) OF THE MUNICIPALITY OF STA. JOSEFA, PROVINCE OF AGUSAN DEL SUR

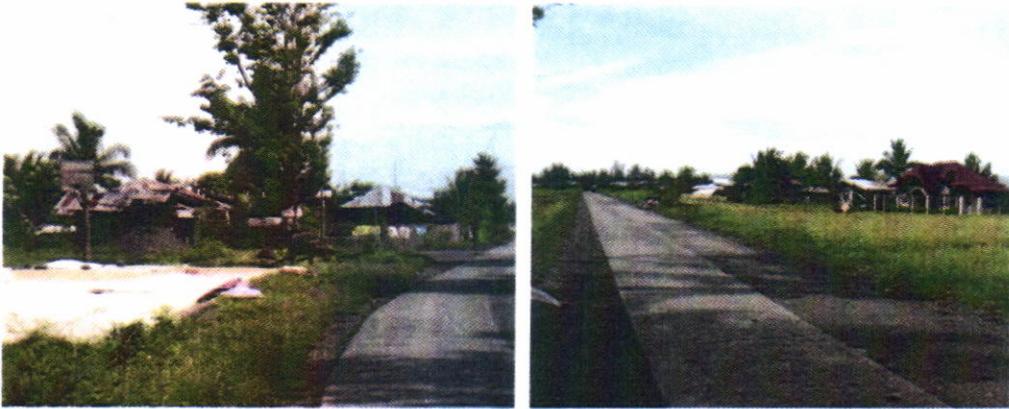
Photos are Purok 1 which is recommended to install proper concrete drainage canals to facilitate surface run-off especially

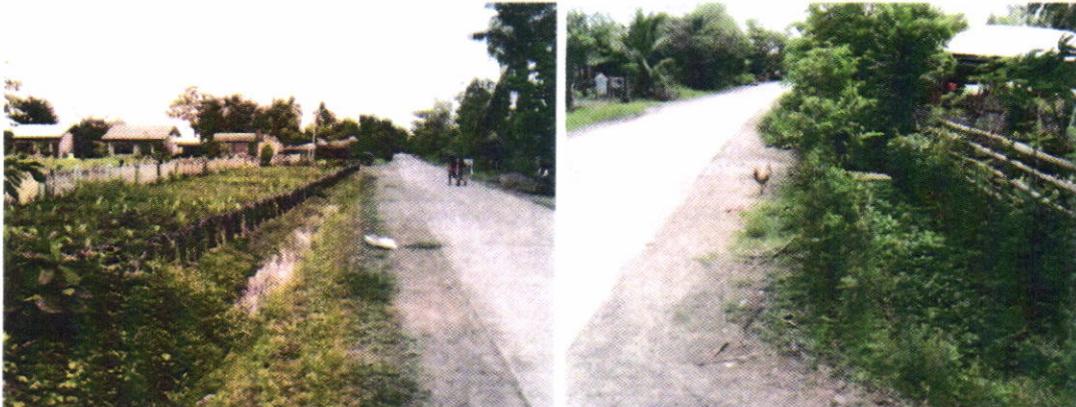
Photos above are areas at Purok 2 including Angas Elementary School. Installation of proper concrete drainage canals at the purok and at the school is recommended.

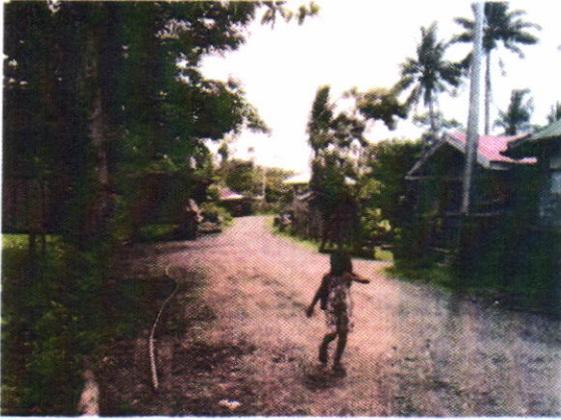
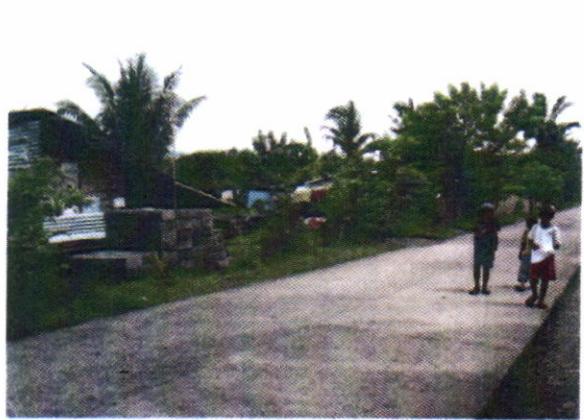
Photos are Purok 3 which is recommended to install proper concrete drainage canals to facilitate surface run-off.

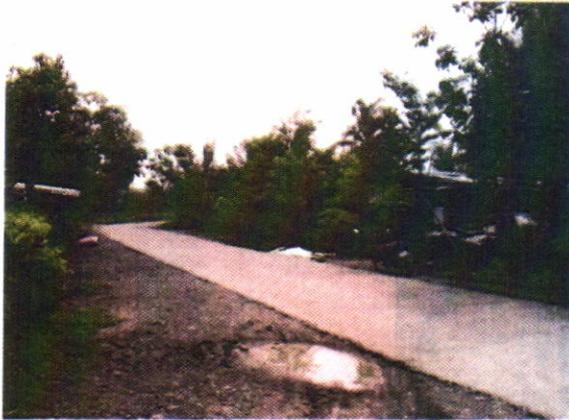
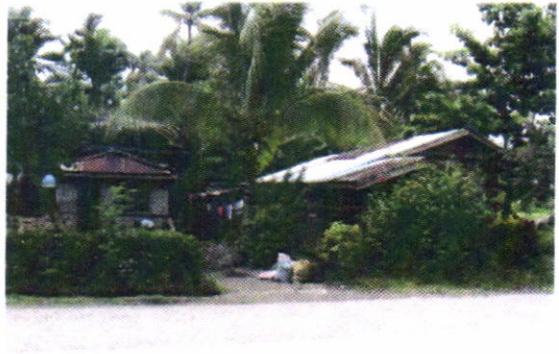
Photos are Purok 4 Lower Angas. Installation of proper concrete drainage canals to facilitate surface run-off is recommended.

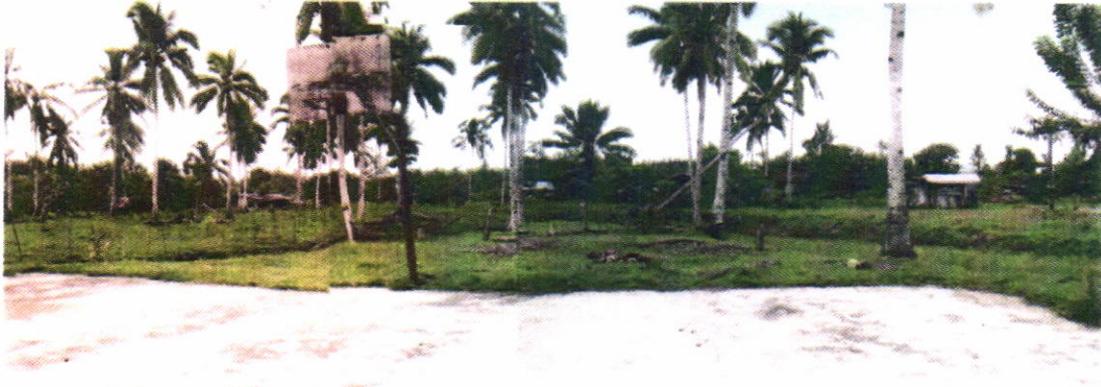
Photo above is a panoramic view of Purok 11 Sitio Cebuli which is rated low to landslide and flooding.

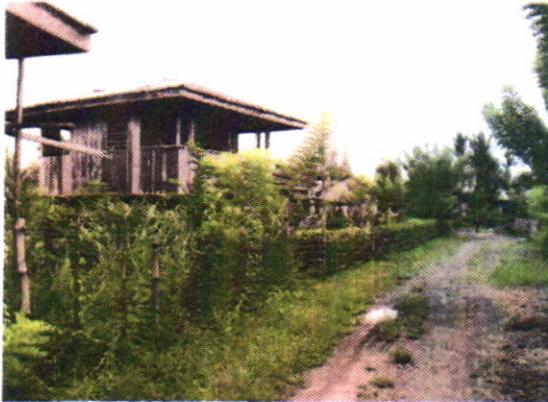
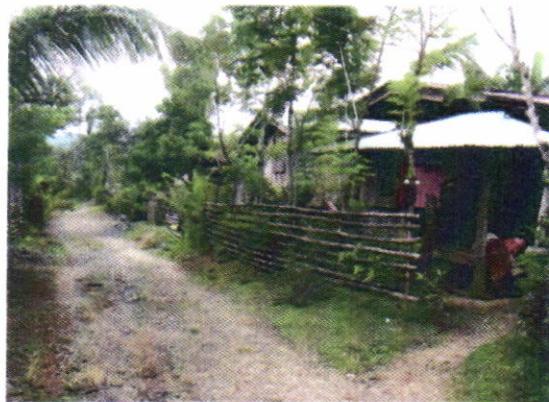
Photos above are houses of Purok 12 which are located at the ridge and rated moderate to landslide. Observe for presence of mass movements and prohibit future settlement along ridge edges and footslopes.

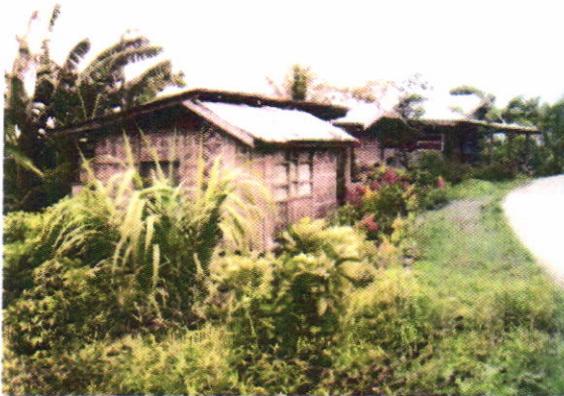
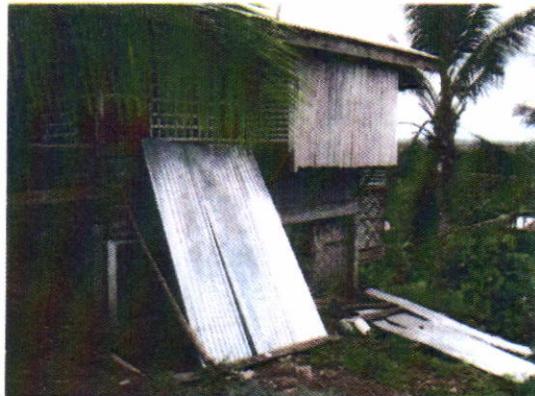
Photos are some of the houses of Purok 13 which are on the ridge edges and highly susceptible to landslide. Prohibit future settlement along ridge edges and footslopes. For long term solution, relocating the residents located at the ridge with very steep slopes is highly recommended.

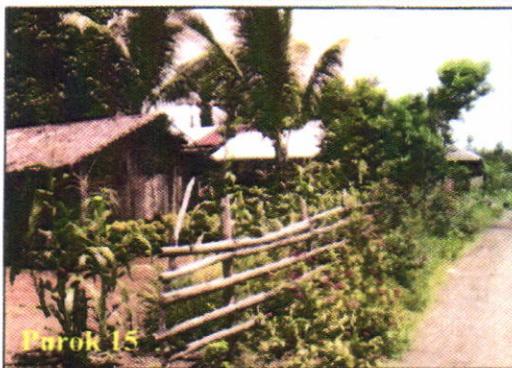
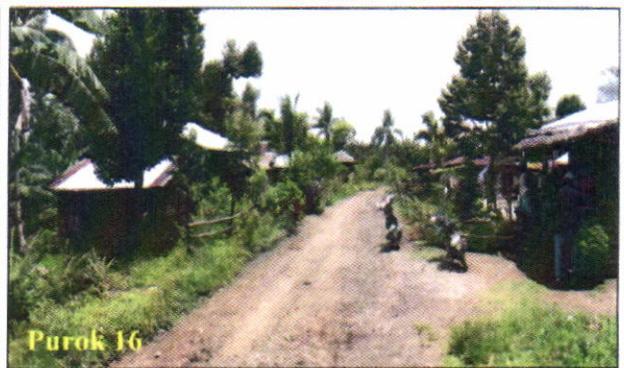
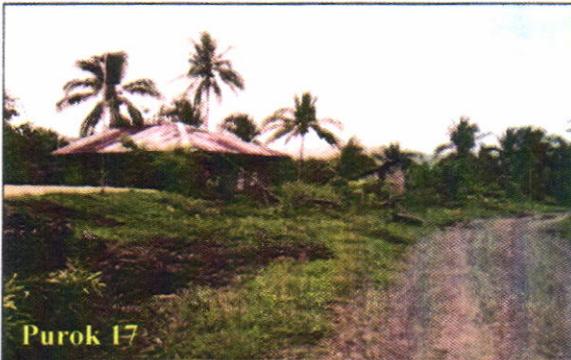
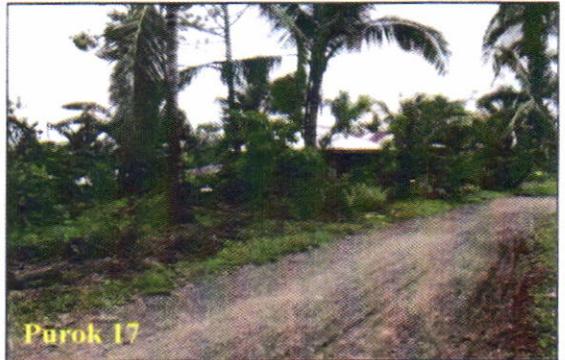
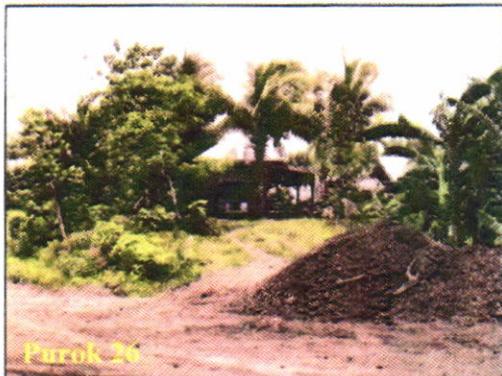
Photos are Puroks 15, 16, 17, and 26 located at Sitio Durian. The puroks are elevated from its surrounding ricefields and are rated low to landslide and flooding. Proper drainage canals are recommended to be installed to facilitate surface run-off especially during heavy precipitation.

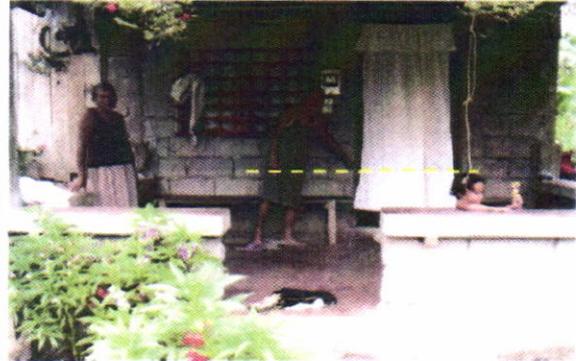
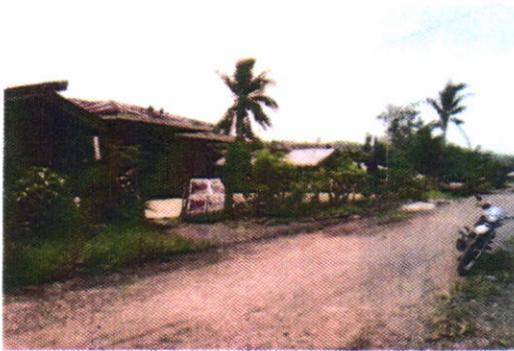
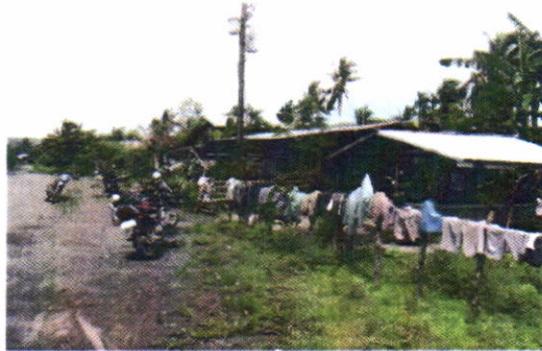
Photos are Purok 19 Sitio Dao which is rated low to moderate to flooding. Right photo is a resident showing the flood height the purok experienced during typhoon Pablo. Recommend to develop an early warning system regarding flooding, and pre-emptive evacuation is advised during typhoons or if unusual flooding is experienced. Proper concrete drainage canals are also recommended to install.

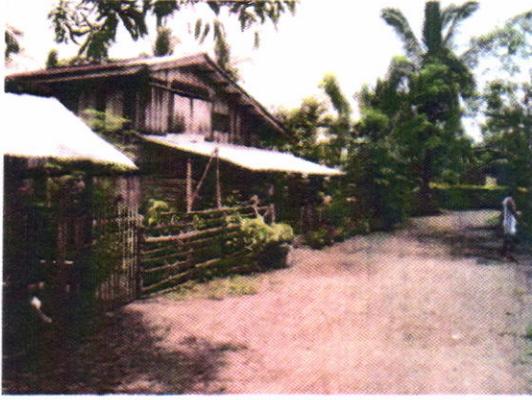
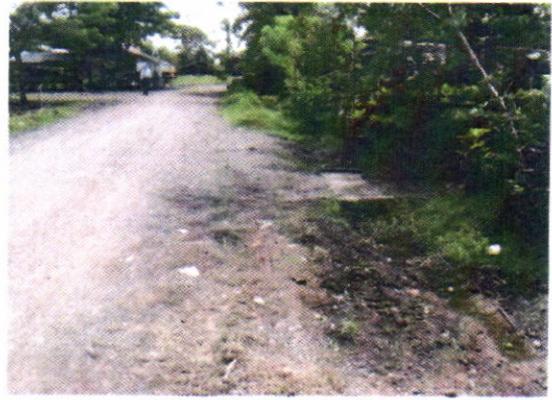
Photos are Purok 20 Sitio Dao and some of its existing drainage canals. The purok had experienced a moderate flooding during the typhoon Pablo. Recommend to develop an early warning system regarding flooding, and pre-emptive evacuation is advised during typhoons or if unusual flooding is experienced. Proper concrete drainage canals are also recommended to install.

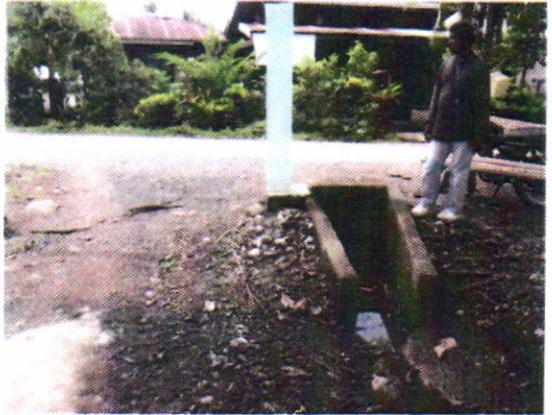
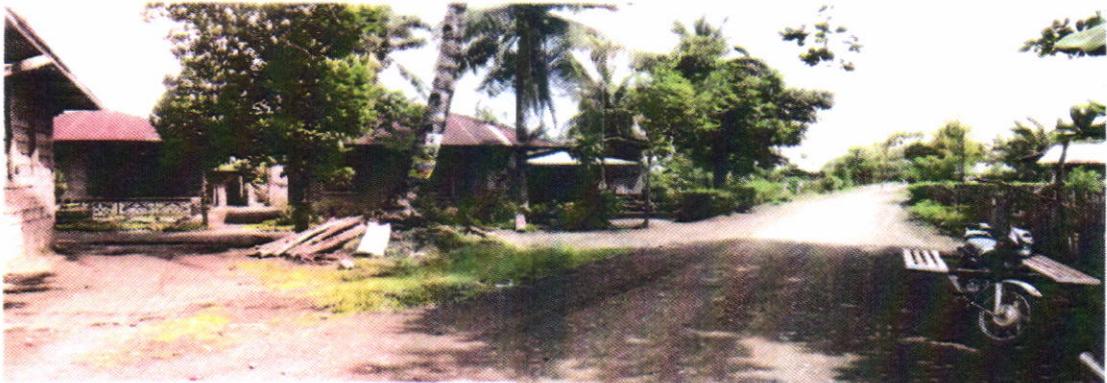
Photos are Purok 21 Sitio Dao which also experienced moderate flooding during typhoon Pablo. Recommend to develop an early warning system regarding flooding, and pre-emptive evacuation is advised during typhoons or if unusual flooding is experienced. Proper concrete drainage canals are also recommended to install.

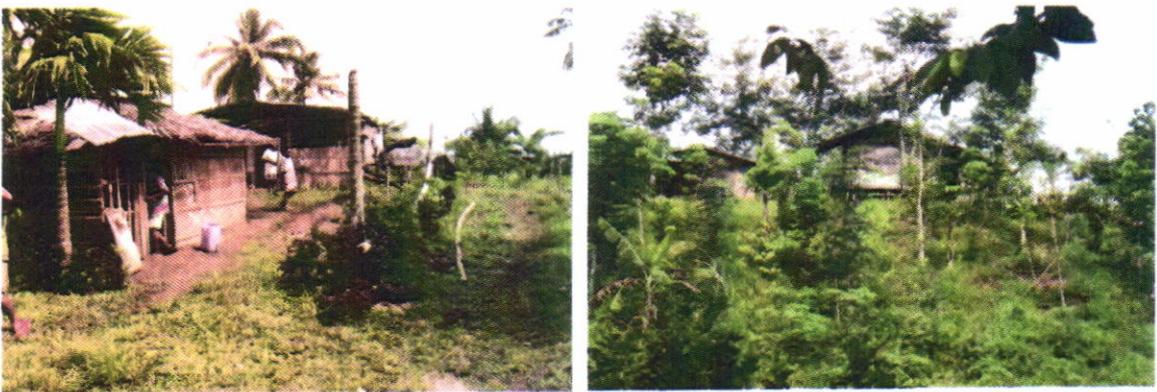
Photos above are houses of Purok 24 which are elevated from the surrounding ricefields. The purok is both low to landslide and flooding.

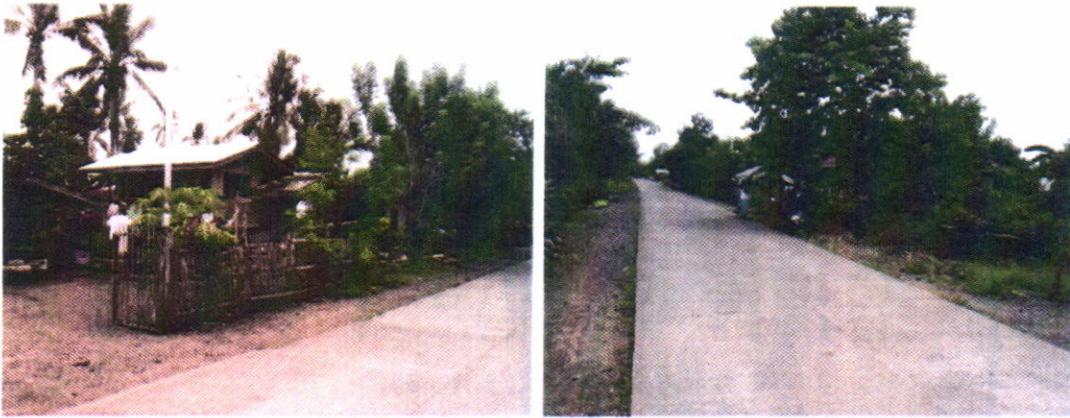
Photos are areas of Purok 25 which are recommended to install proper concrete drainage canals to facilitate surface run-off.

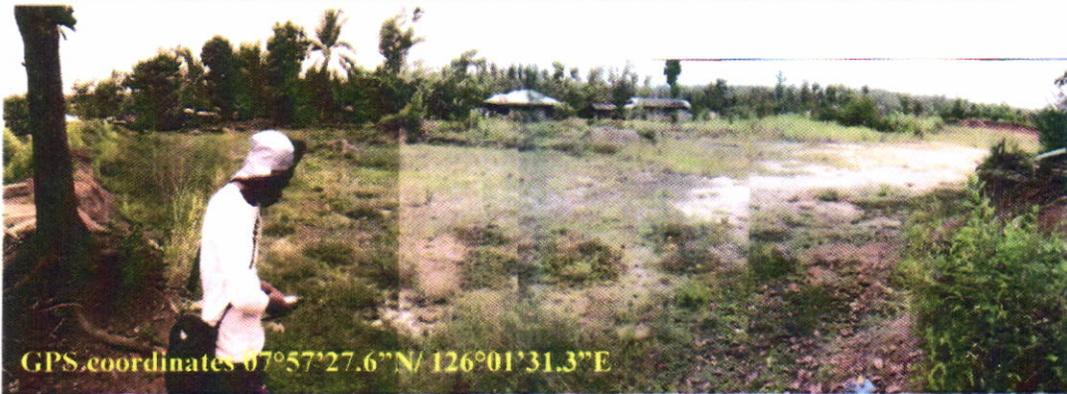
GPS coordinates 07°57'27.6"N/ 126°01'31.3"E

The two photos above are the proposed relocation sites of Barangay Angas both located at Purok 13. The sites are subject for detailed mapping and/or Geohazard identification Report.

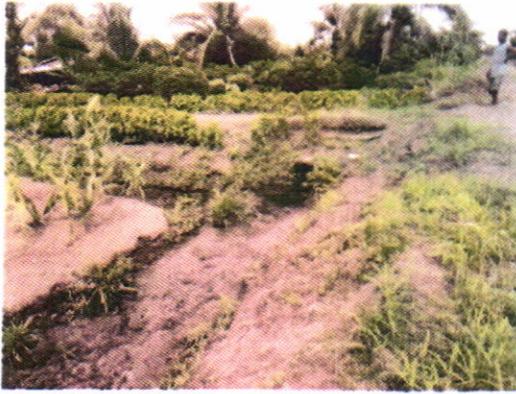
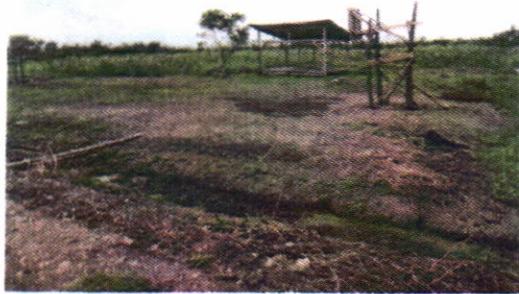
Drainage canals at Sitio Kaangayan I that needs to be defined and deepened so as to prevent its overflow.

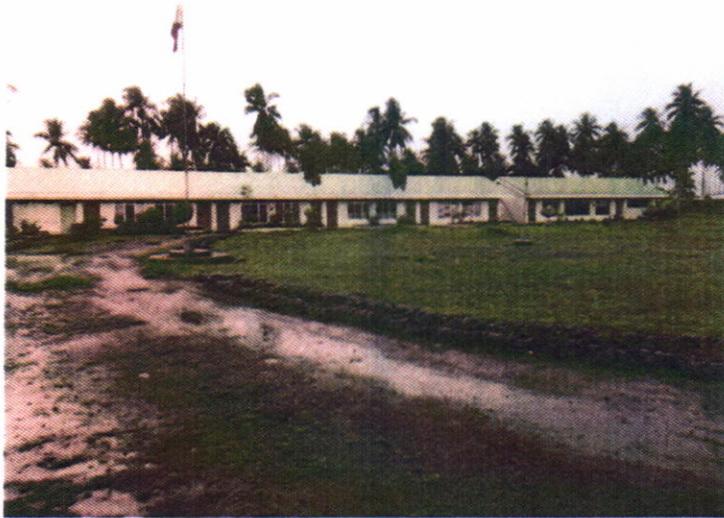
Photo showing the school ground located at Aurora Nat'l High School that needs to be provided with concrete line canals.

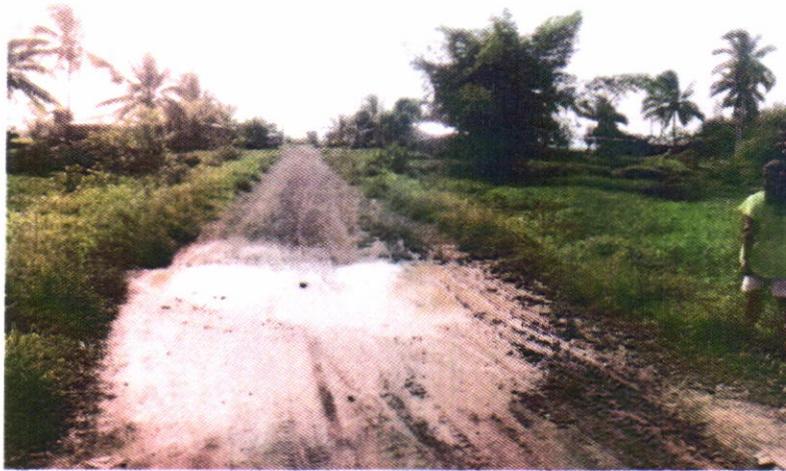
Barangay road located at Sitio Kaangayan 2 that is recommended to be elevated and to be provided with drainage canals to lessen the effects of flooding at the area.

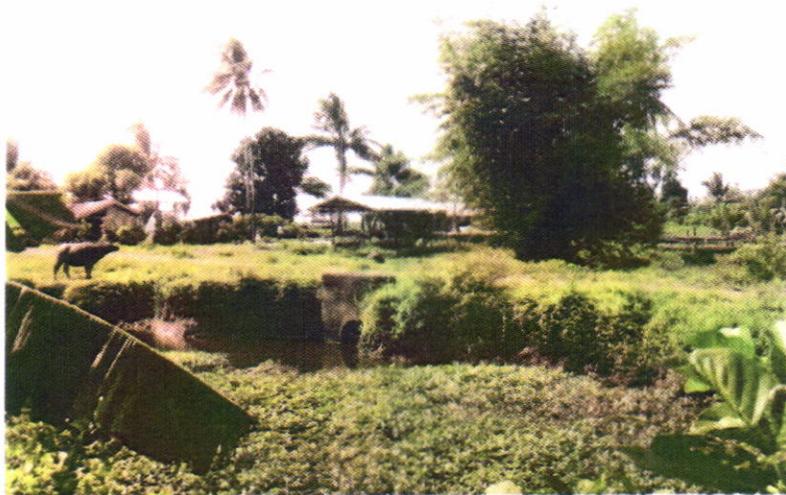
Area at Purok 13 located at Sitio Kaangayan 2 that is recommended to be provided with additional box-type culvert to aid in draining out water from the area.

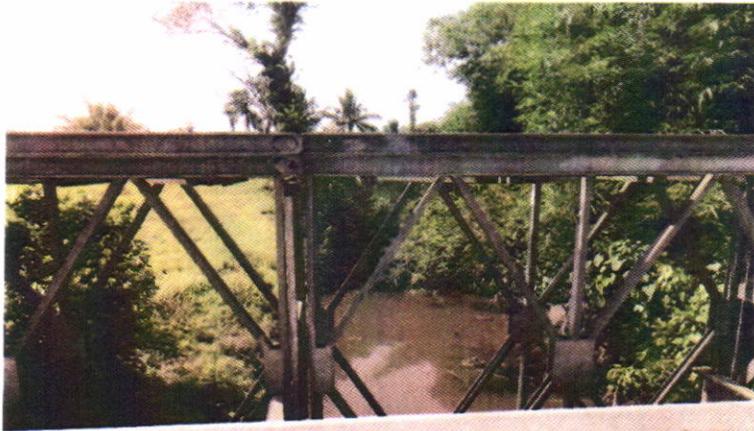
A view of Lucad creek flowing under the steel bridge located at Purok 15 which is the main cause of the major flooding at Sitio Kaangayan 2. Rechanneling the creek is recommended.

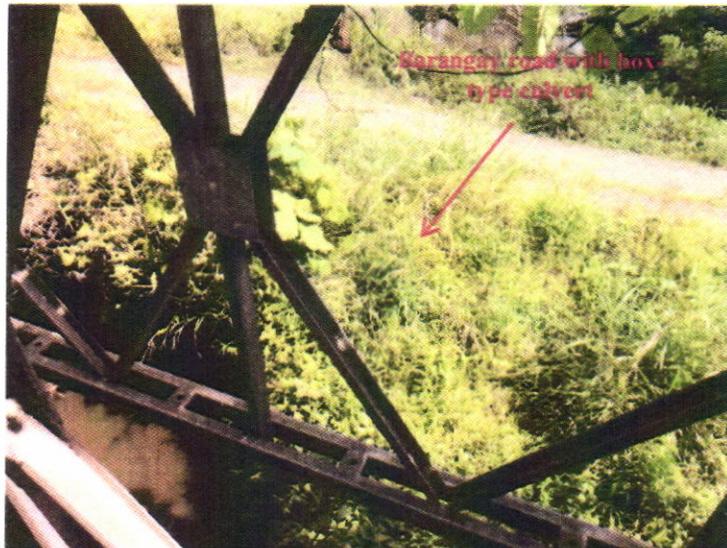
Also under the Lucad steel bridge is a part of barangay road (above photo) installed with box-type culvert which obstructs the flow of the Lucad creek during inclement weather condition causing it to overflow. Removing such obstructions as well as realigning the barangay road directly to the steel bridge is recommended.

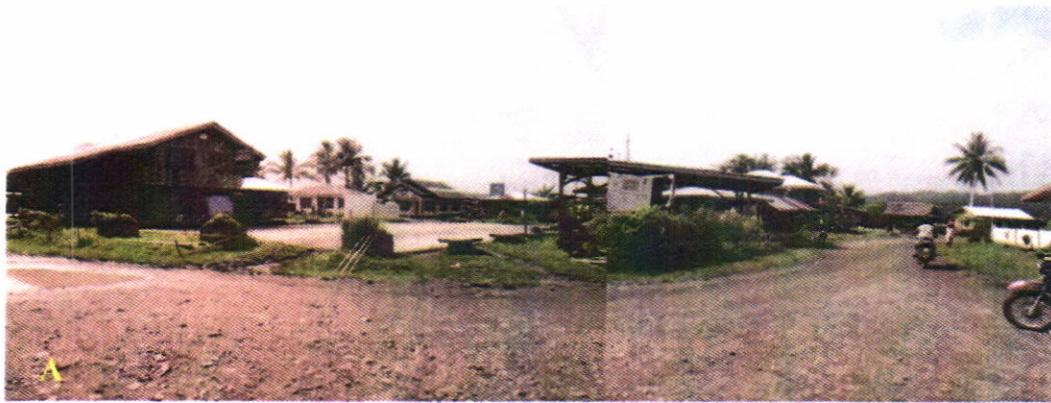
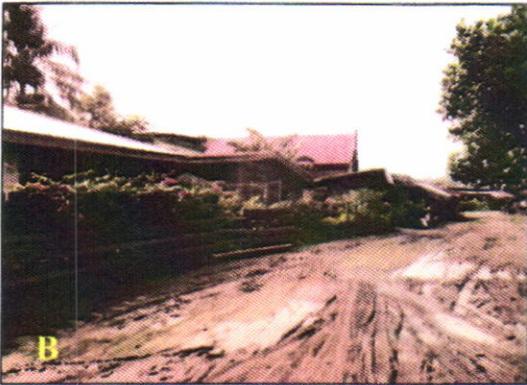
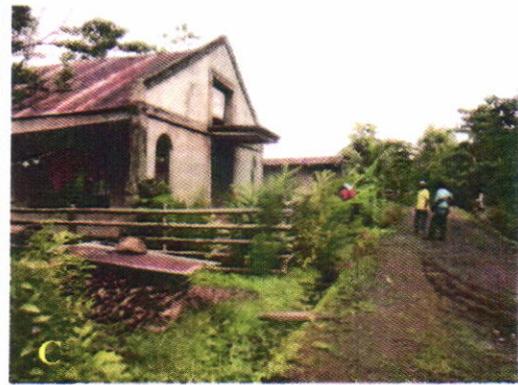
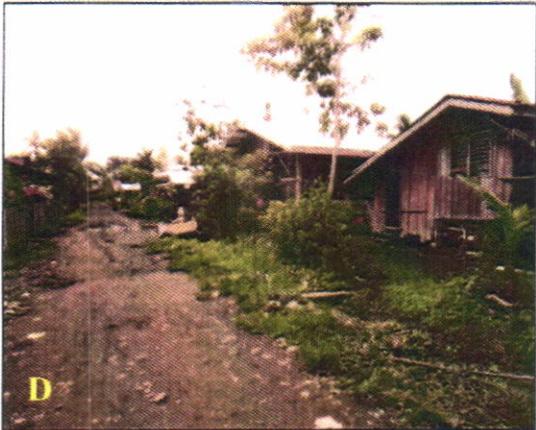
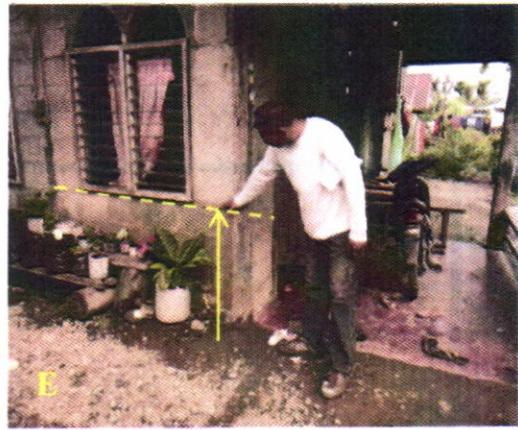
Photos above are areas of Purok 1 and Purok 2 which are experiencing high flooding due to Awao River overflow during extreme weather events. Photo E shows the flood height the houses experienced during flooding. Observe for increase/decrease of water level along the river. Develop an early warning system and pre-emptive evacuation is recommended during inclement weather conditions. Proper drainage canals are also recommended.

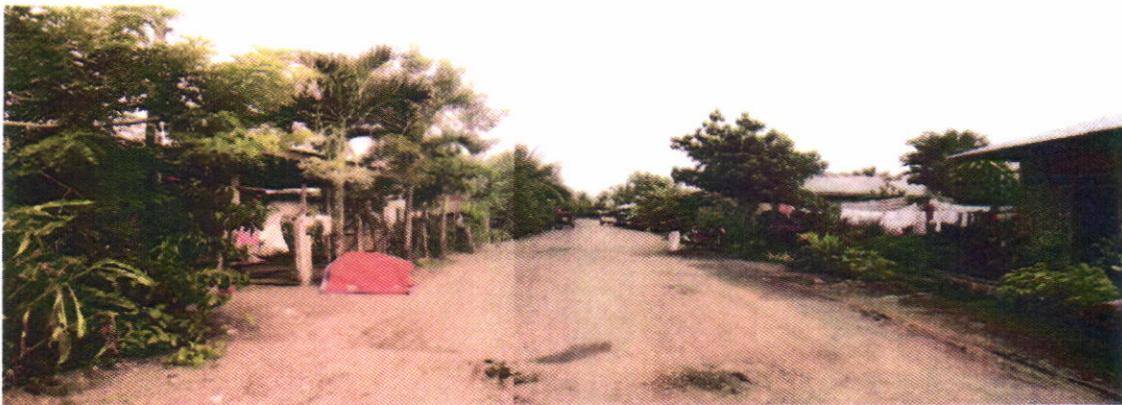
Photos are Purok 4 which is rated moderate to flooding. Develop an early warning system and pre-emptive evacuation is recommended during inclement weather conditions. Proper drainage canals are also recommended to install

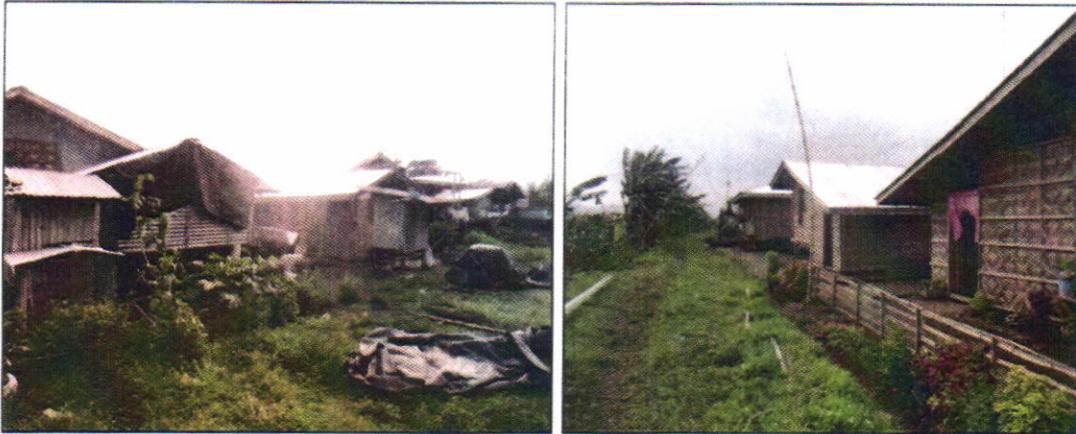
Photos are houses of Purok 5. The purok is rated low to flooding. According to the residents, Awao River overflow do not reach up to

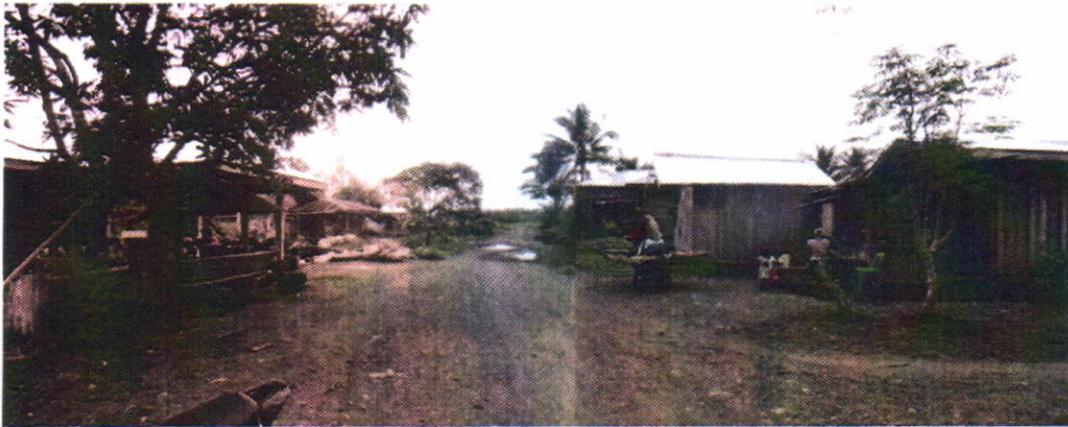
Photos are Purok 6 which is moderate to flooding. Develop an early warning system and pre-emptive evacuation is recommended during inclement weather conditions. Proper drainage canals are also recommended to install.

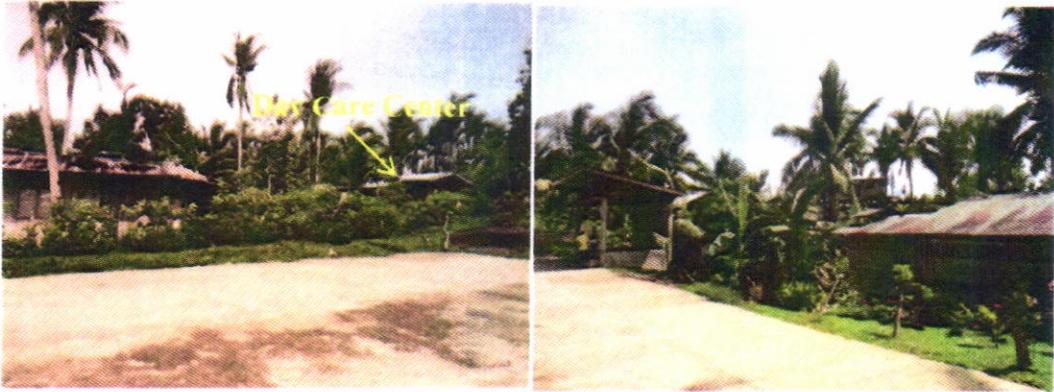
Photos are areas at Purok 7 which are located at the ridge characterized with moderately steep slopes. Observe for presence of mass movements and prohibit future settlement at the ridge edges and foot of slopes.

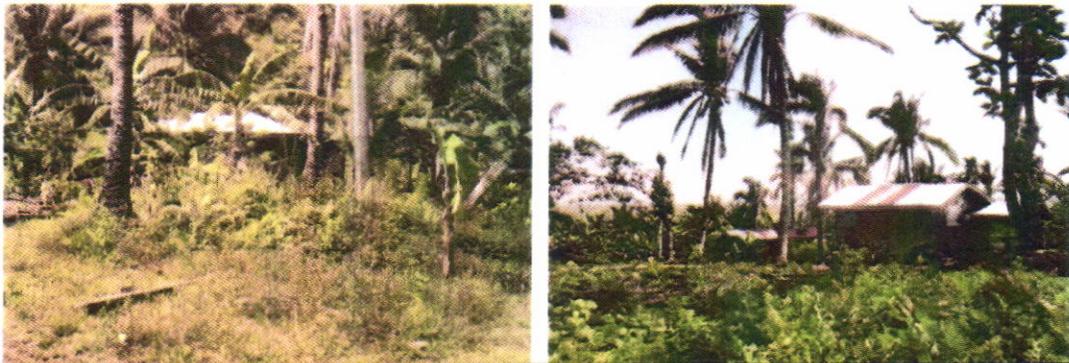
Photos are some houses of Purok 8 which are located at the ridge and are rated moderate to high to landslide. Observe for presence of mass movements and prohibit future settlement at the ridge edges and foot of slopes. Also develop an early warning system regarding landslide and pre-emptive evacuation during inclement weather conditions is recommended.

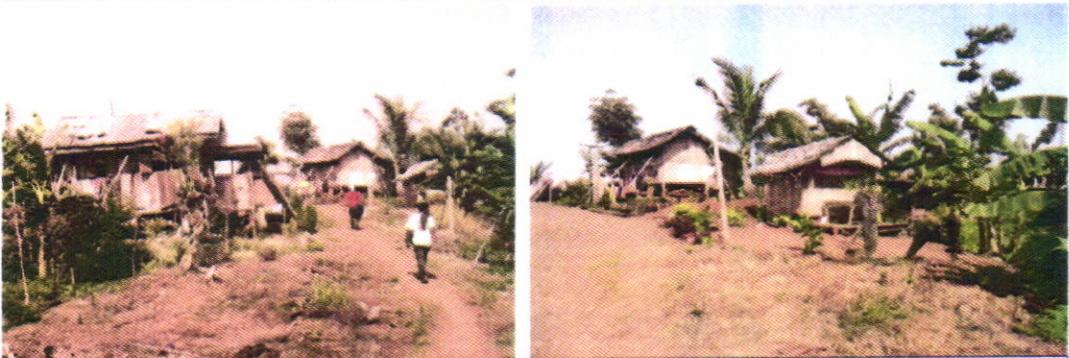
Photos are Purok 9 Sitio Agda which is located at the ridge with steep slopes. Observe for presence of mass movements and prohibit future settlement at the ridge edges and foot of slopes. Also develop an early warning system regarding landslide and pre-emptive evacuation during inclement weather conditions is recommended. Relocating the residents located at very steep slopes is also recommended.

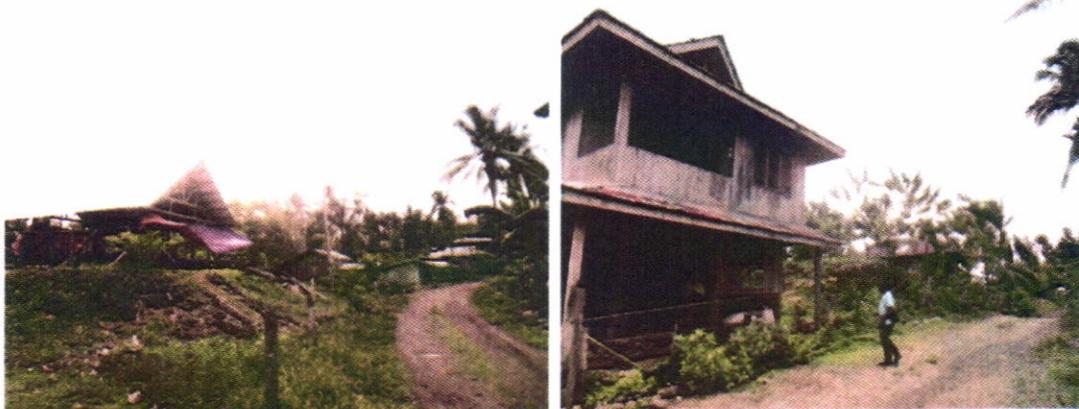
Photos show houses of Purok 11 Sitio Mahayahay which is rated moderate to landslide. The purok is underlain with limestone and is susceptible to sinkhole. Observe for presence of mass movements and prohibit future settlement at the ridge edges and foot of slopes. Also observe for ground depressions possibly indicating a presence of sinkholes.

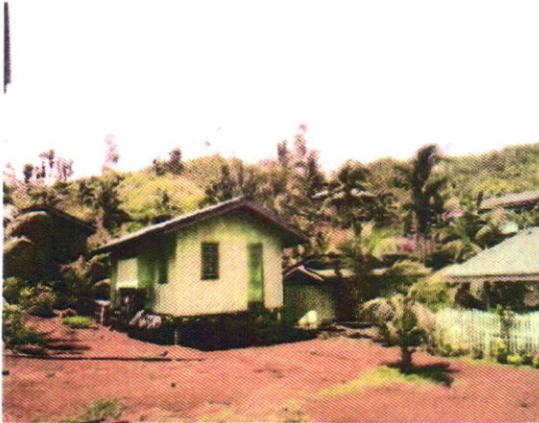
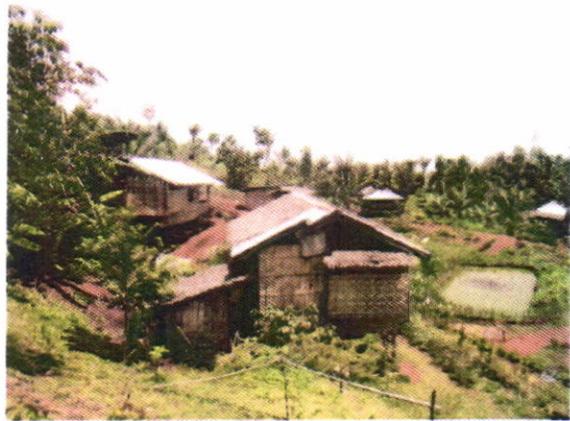
Houses of Purok 13 Sitio Tagbayog are rated moderate to high to landslide due to moderate to steep slopes where the purok is located. Observe for presence of mass movements and pre-emptive evacuation is recommended during extreme weather events. Also develop an early warning system regarding landslide and prohibit settlement directly located at the foot of slopes.

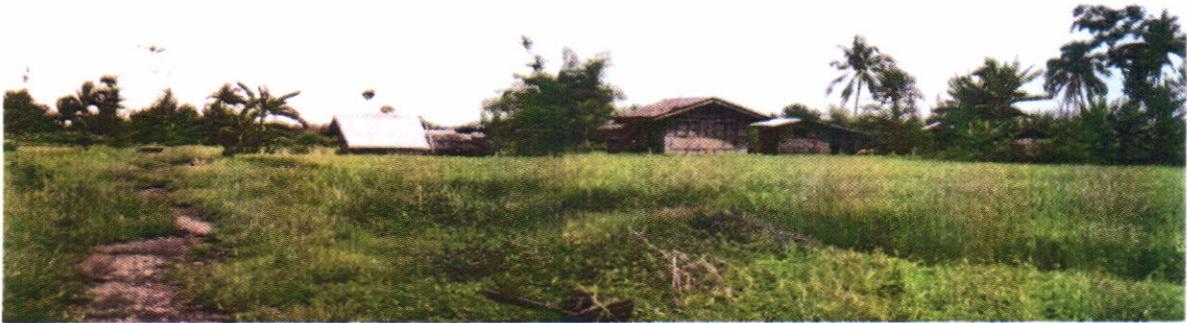
Photos are Purok 1 which is moderate to flooding due to the Awao River overflow. Pre-emptive evacuation is recommended if abnormalities in the water level in the river are observed or if unusual flooding is experienced. For long term solution, relocating the purok to a much safer site is recommended

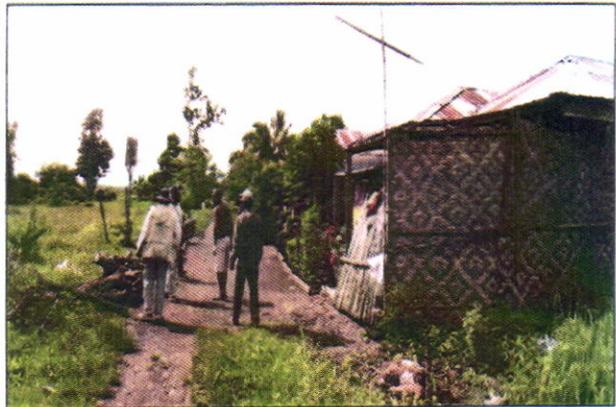
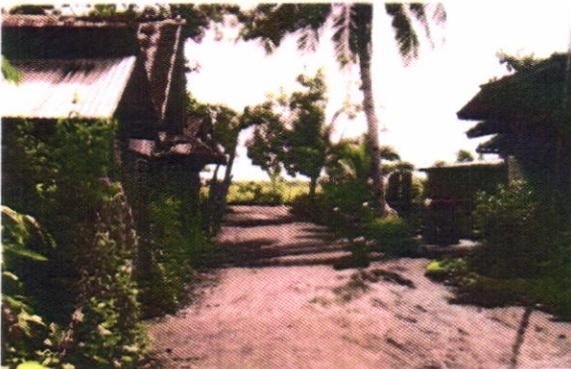
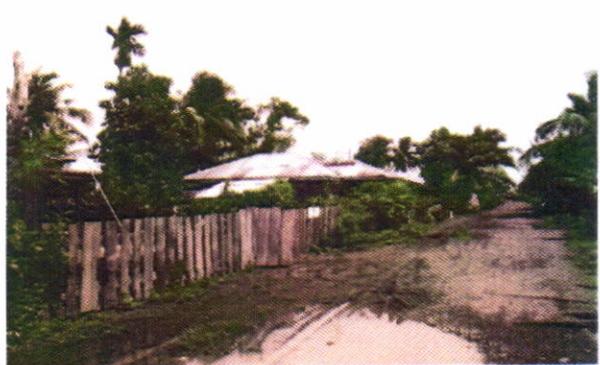
Photos are portions of Purok 2 which is affected by moderate to high flooding due to Awao River overflow. Pre-emptive evacuation is recommended if abnormalities in the water level in the river are observed or if unusual flooding is experienced. For long term solution, relocating the purok to a much safer site is recommended.

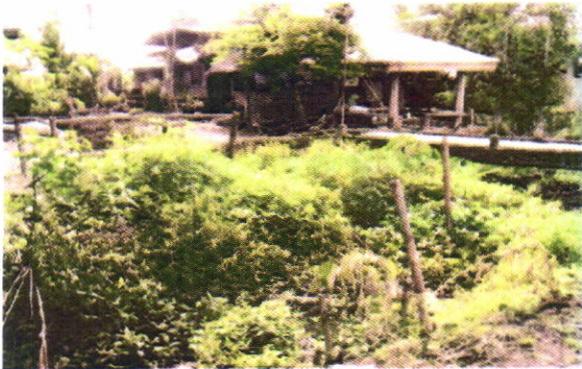
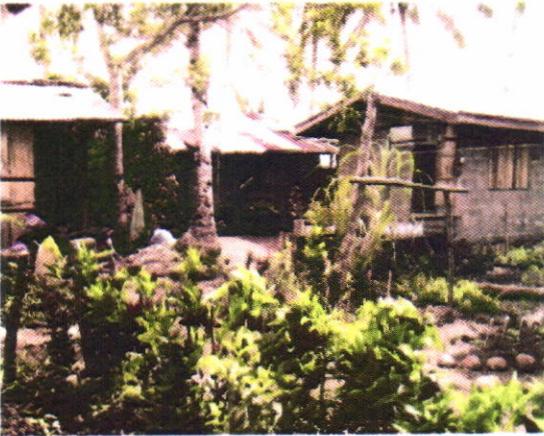
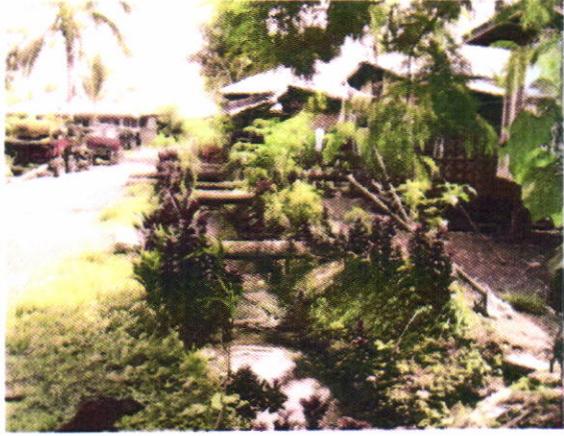
The photos are Purok 4 which experiences moderate to high flooding. Observe for rapid increase/decrease of water level at the Awao River and pre-emptive evacuation is advised during inclement weather conditions. For long term solution, relocating the entire purok is recommended.

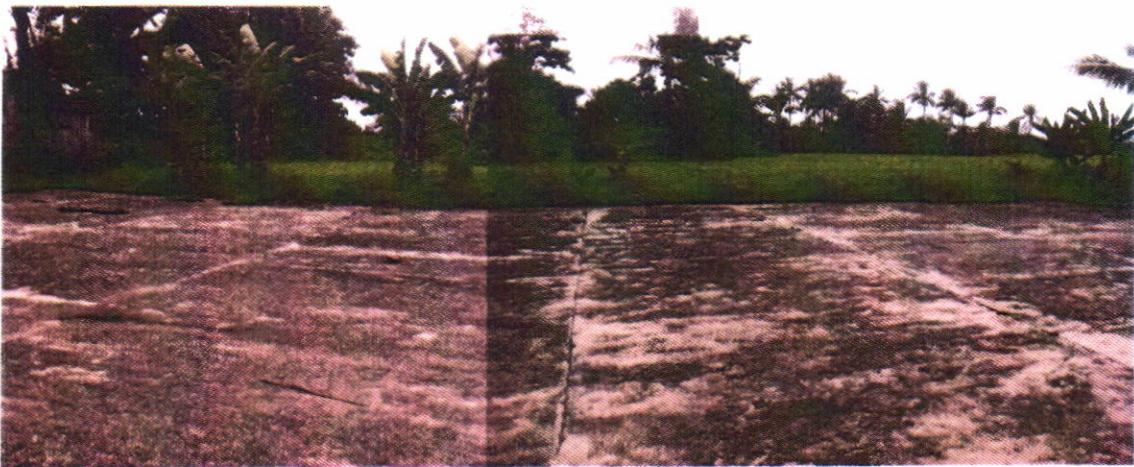
Fig. 11 Geographic location of Purok 5 situated along NIA Irrigation drainage canal or within the flood-prone section. GPS reading is 8°05'26.1"-N/126°00'00.3"-E.

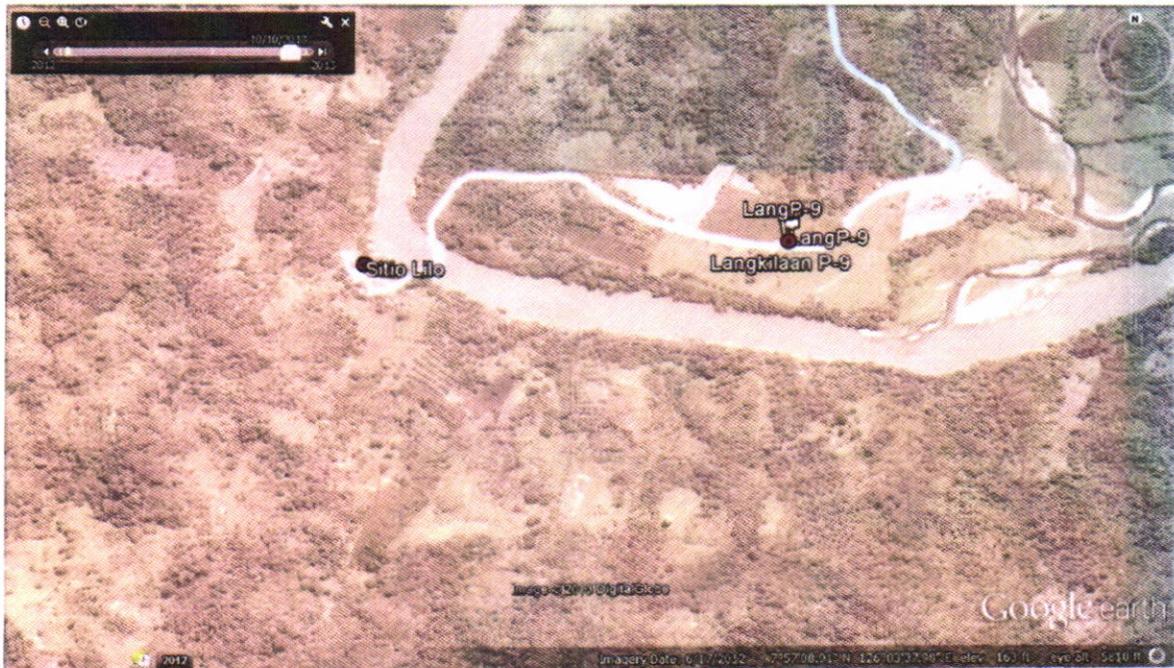
Fig. 1 Geographic location of Sitio Lilo, Brgy. Patrocinio, Sta. Josefa, ADS. It is situated along Agusan River embankment which is prone to river-flooding, flash-flood and river-scouring. Total relocation is highly recommended. GPS reading is  $7^{\circ}57'17''\text{-N}/126^{\circ}03'20.7''\text{-}$

Fig. 1 Geographic location of Sitio Lilo, Brgy. Patrocinio, Sta. Josefa, ADS. It is situated along Agusan River embankment which is prone to river-flooding, flash-flood and river-scouring. Total relocation is highly recommended. GPS reading is 7°57'17"-N/126°03'20.7"-E.

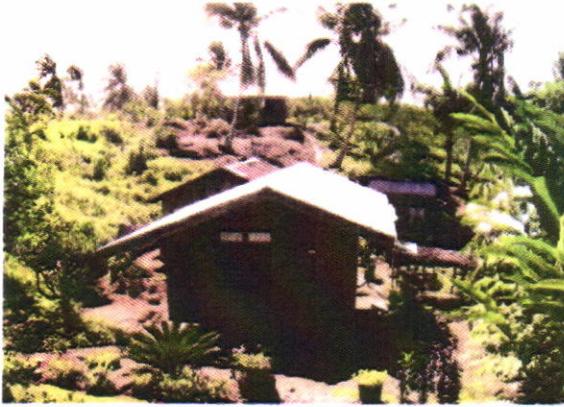
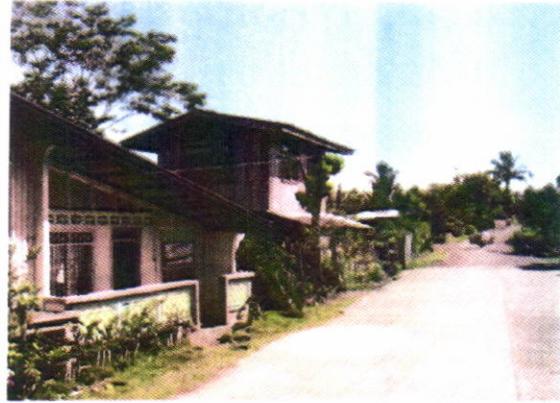
Photos are portions of Purok 1 which is characterized with gentle to moderately steep slopes and is rated moderate to landslide. Observe for presence of mass movements and prohibit future settlement at the foot of slopes. Proper concrete drainage canals are also recommended to facilitate surface run-off during heavy precipitation.

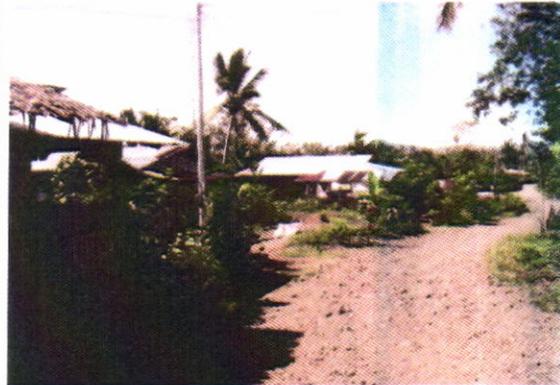
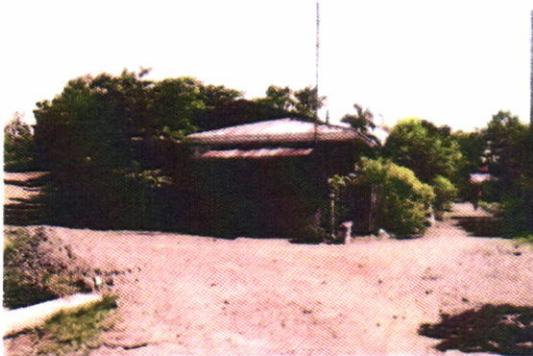
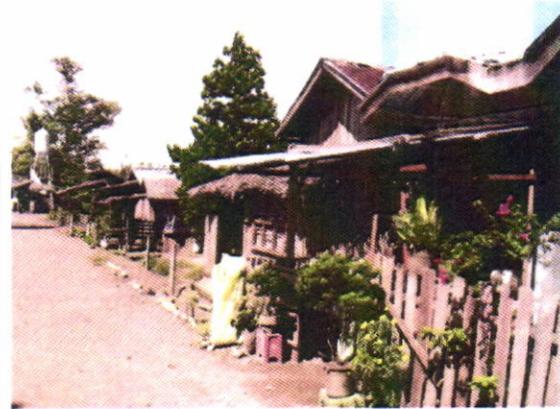
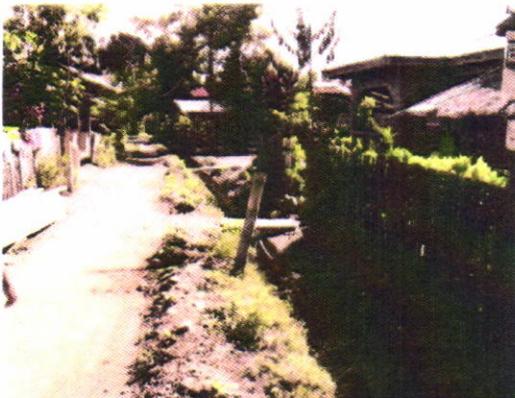
Photos are Purok 2 which is located near the Agusan River. Observe for the water level along Agusan River especially during inclement weather conditions. Pre-emptive evacuation is advised if unusual water level along the river is observed. Also, prohibit future settlement at the river embankments. Conduct regular maintenance on existing canals and installation of drainage canals to the other portions of the purok is recommended.

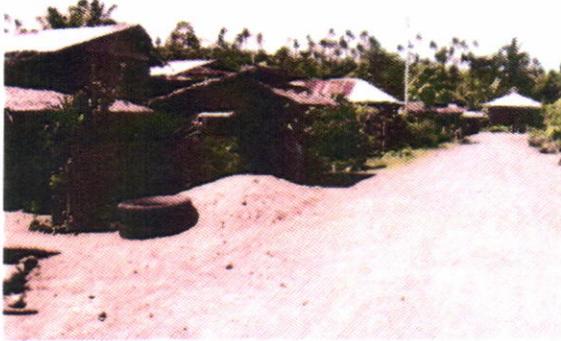
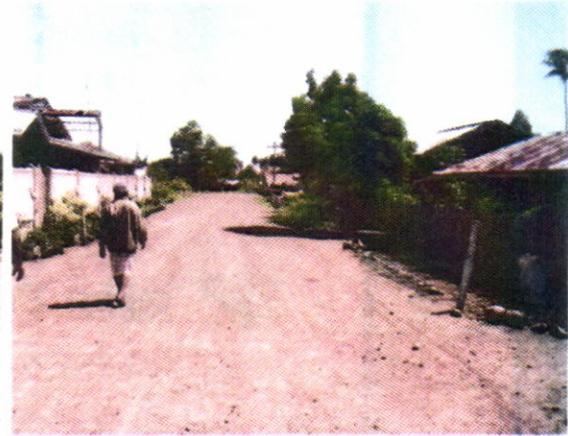
Proper concrete drainage canals are recommended to be installed at Purok 3 to facilitate surface run-off especially during heavy rainfall.

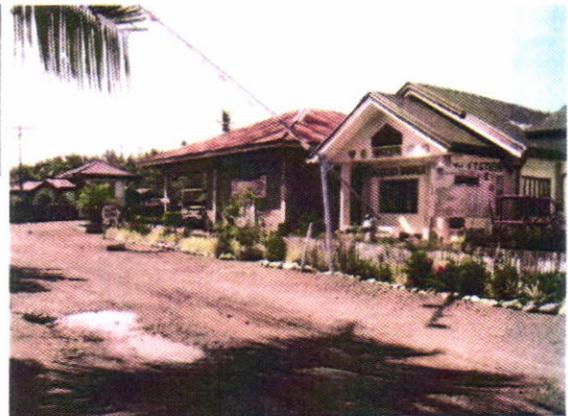
Photo above shows the proximity of some houses at Purok 3 to the Agusan River. According to the residents, Agusan River overflow does not reach the purok but only levels at its embankments. Prohibit future settlement towards and along the Agusan River embankments. Vigilance of residents closest to the river is recommended especially during extreme weather

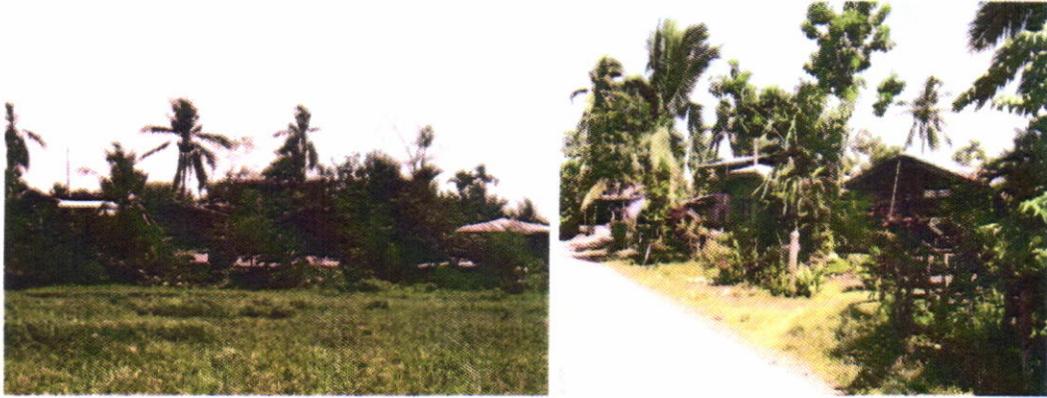
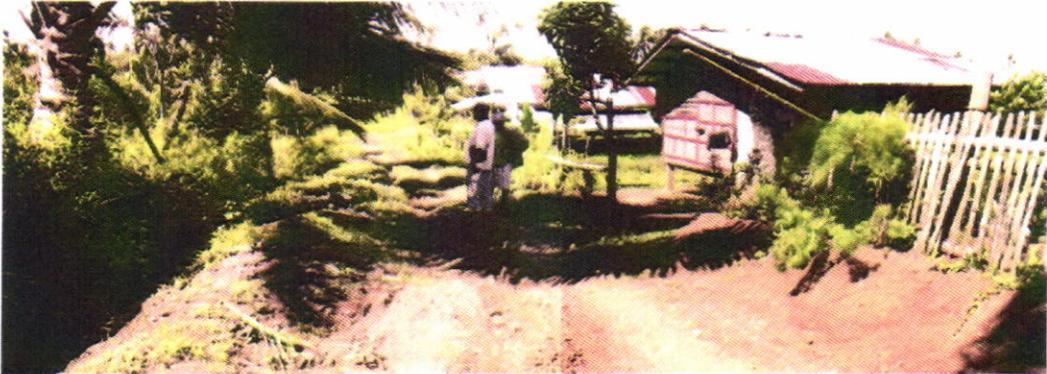
Photos above are houses of Purok 4 which are low to moderate to landslide. Provision of concrete drainage canals at the purok is recommended to facilitate surface run-off.
