Republic of the Philippines  
Department of Environment and Natural Resources  
**MINES AND GEOSCIENCES BUREAU**  
Regional Office No. XIII

Respectfully furnishing your end the document entitled "Results of the MGB Landslide and Flood Assessment and Mapping (1:10,000 scale) of the Municipality of Sta. Josefa Agusan del Sur". The assessment is in line with the government's effort aimed at reducing, if not totally mitigating the destructive effects and impacts of natural hazards to the populace.

## RESULTS OF THE MGB LANDSLIDE AND FLOOD ASSESSMENT AND MAPPING (1:10,000 SCALE) OF THE MUNICIPALITY OF STA. JOSEFA, PROVINCE OF AGUSAN DEL SUR

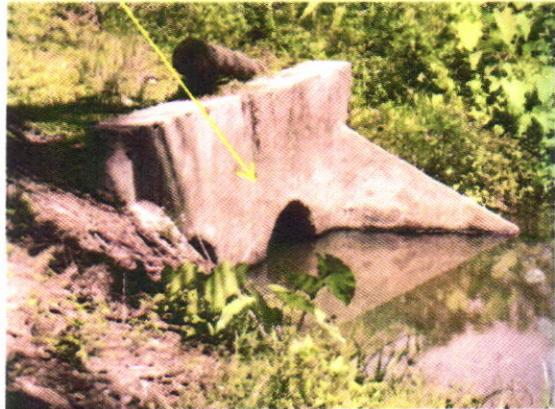
The creek on the above photo is the Mahaba Creek which traverses at Purok 6 Magalibobo and causes flooding up to waist-level at the purok since the existing culvert (close-up at right photo) could not cater too much volume of water during heavy rainfall. Replacing the existing culvert into box-type culvert is recommended to address the problem. GPS coordinates 07°59'48.9"N/126°03'42.3"E

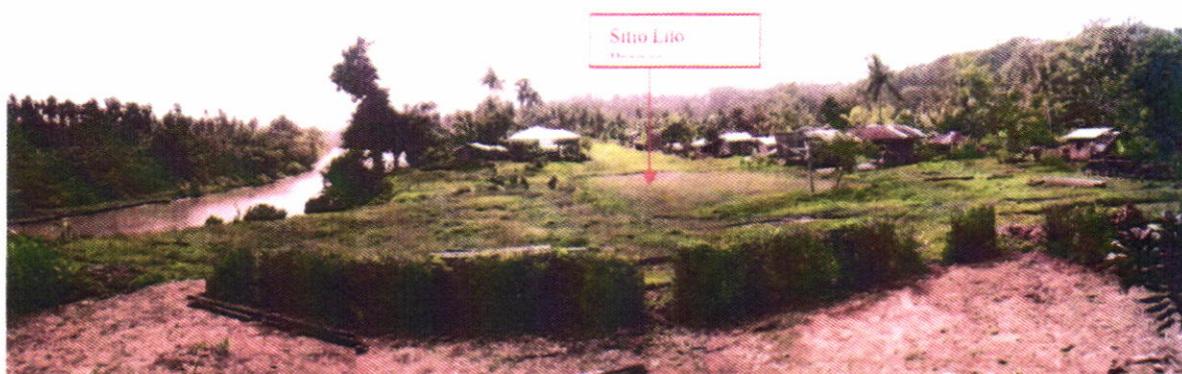
Closer panoramic-view of Sitio Lilo proper situated along Agusan River embankment.

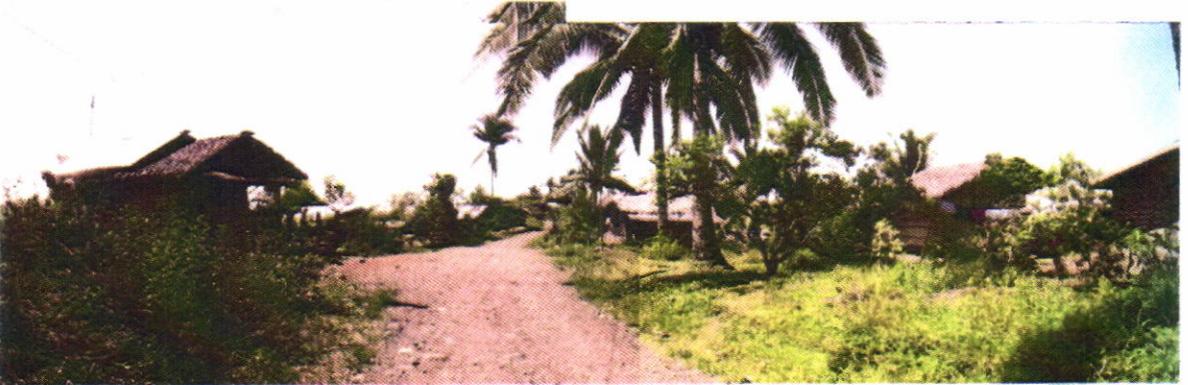
Photo is Purok 9 Sitio Marang which is rated moderate to landslide. Observe for presence of mass movements and prohibit future settlement at the ridge edges and at the foot of slopes.

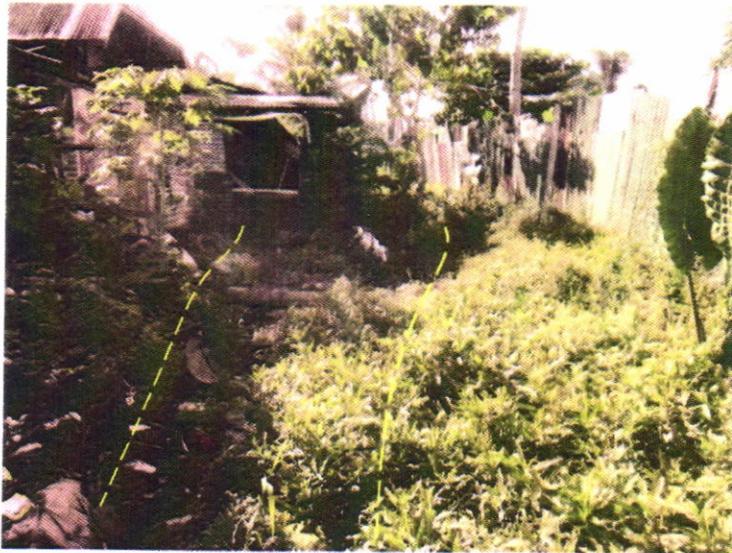
A view of drainage canal located at the back of Sta. Josefa Nat'l High School at Purok 7B that is recommended to be defined, conducted with regular maintenance and concretized so as to properly facilitate surface run-off at the area.

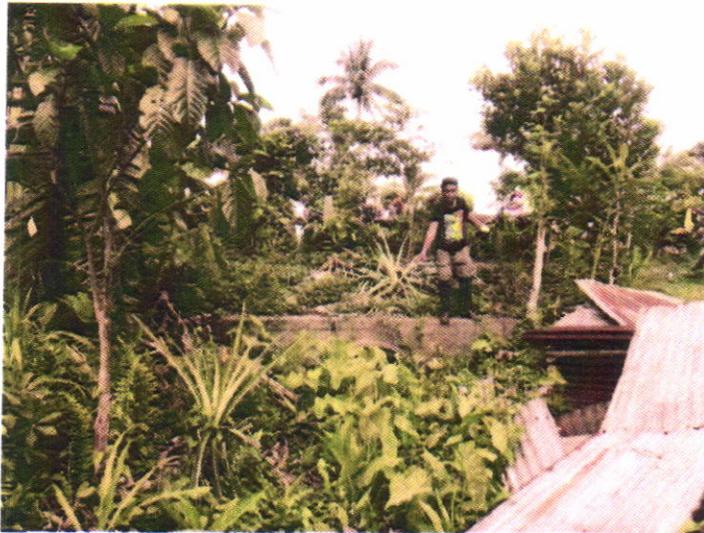
RCP culvert located at Purok 7A that needs to be conducted with regular maintenance to properly drain-out floodwaters from the area.

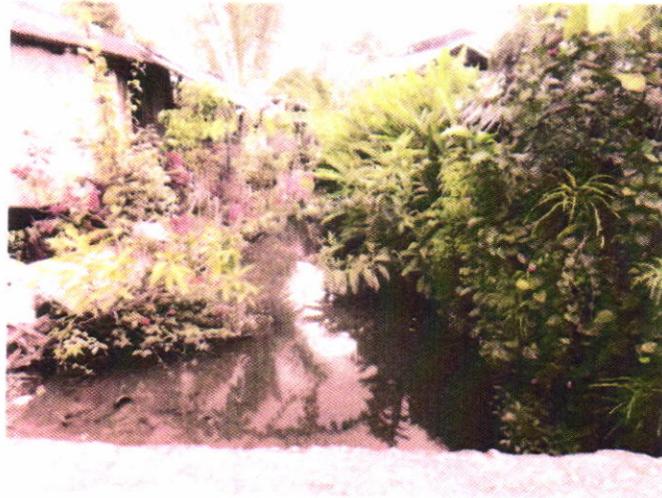
A view o of RCP culvert located at Purok 4 that seems to be inadequate in draining the water from the area. Replacing the existing culvert into a sufficient culvert and defining its outlet is recommended.

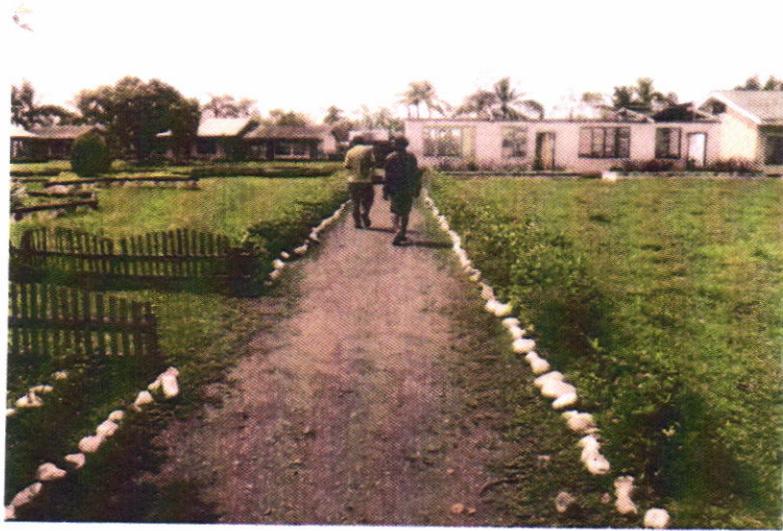
A view of the school grounds of San Jose Elem. School that is recommended to be provided with concrete line canal. Also being shown is the damaged school building due to Typhoon Pablo.

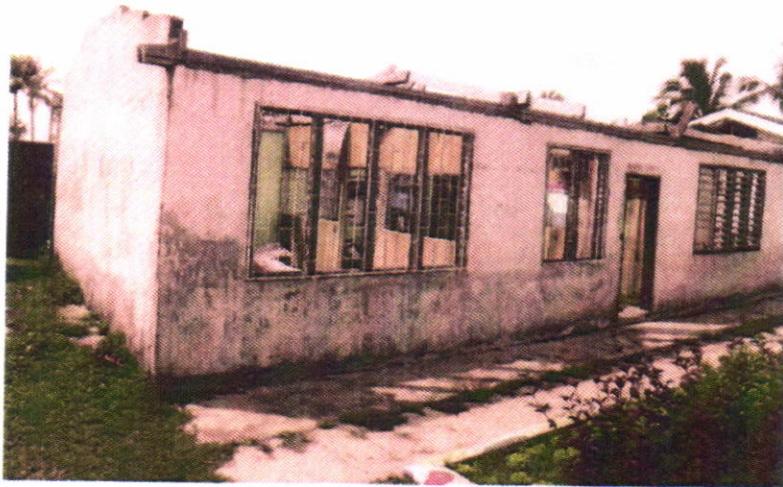
Closer view of the damaged school building of San Jose Elem. School located at Purok 3.

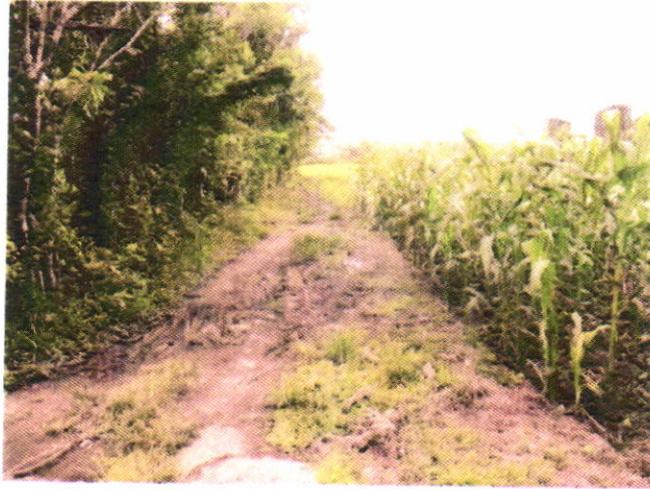
Barangay road located at Purok 5 that is recommended to be improved for evacuation and quick response.

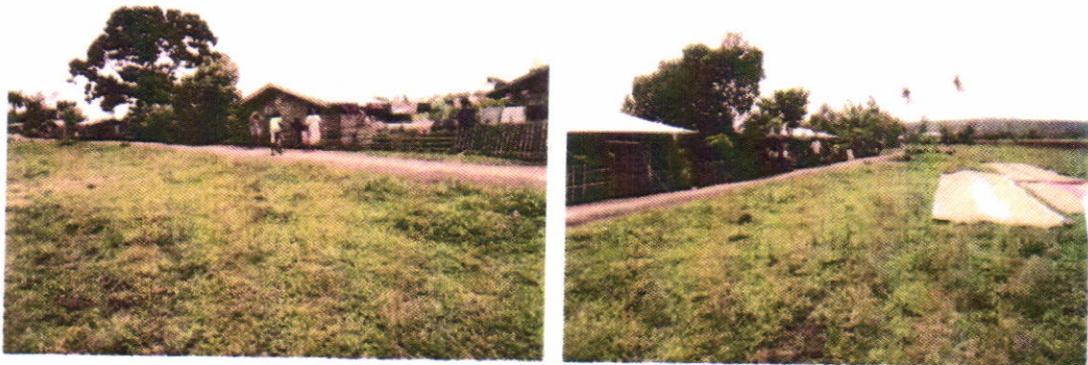
Houses located along the Agusan riverbank at Purok 4 that are subject for relocation since they are directly vulnerable to flashflood and river scouring.

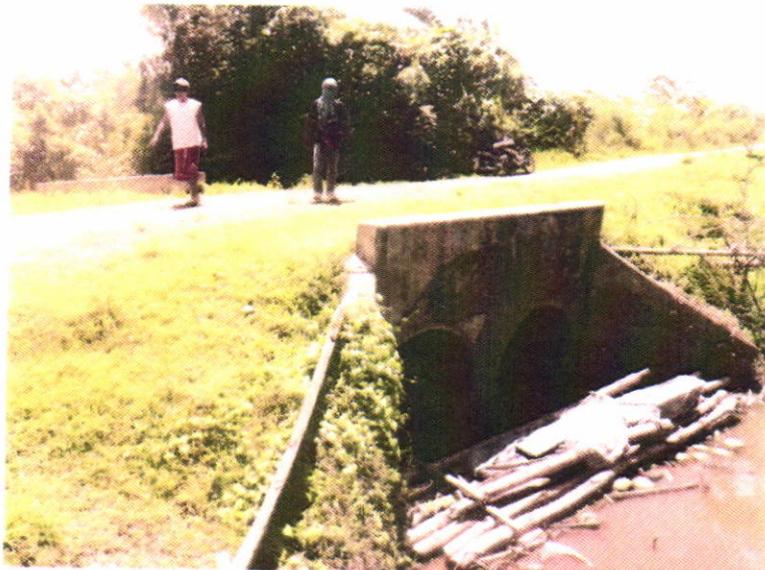
A double-barrel RCP located at Purok 8 that is recommended to be replaced into box-type culvert so as to sufficiently facilitate surface run-off at the area.

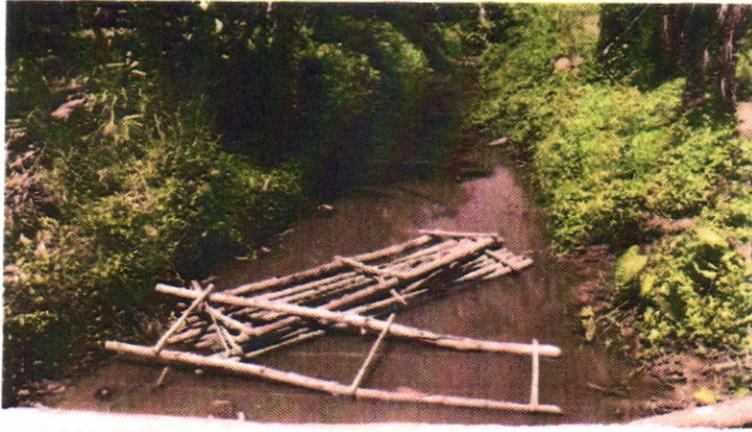
A view showing the Tadeco canal located downstream of the double barrel RCP at Purok 8. Defining and clearing the obstructions at the canal as well as conducting regular maintenance are recommended so as to prevent its overflow.

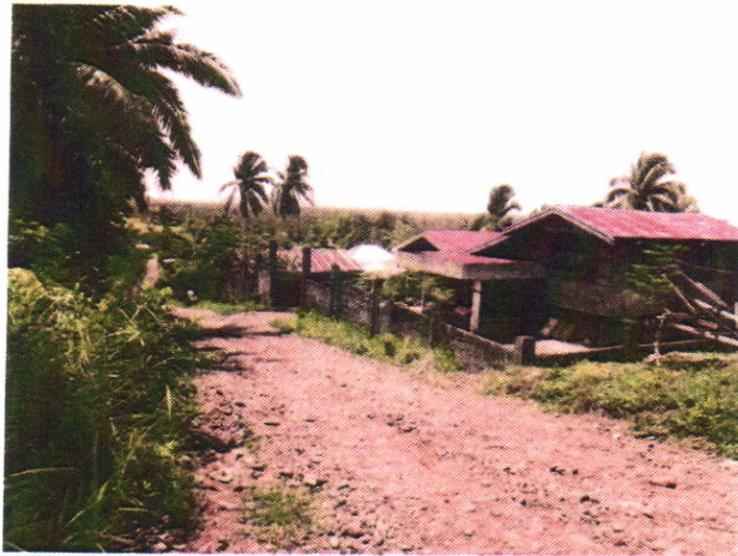
Houses located at Purok 7 that has a high landslide susceptibility rating.

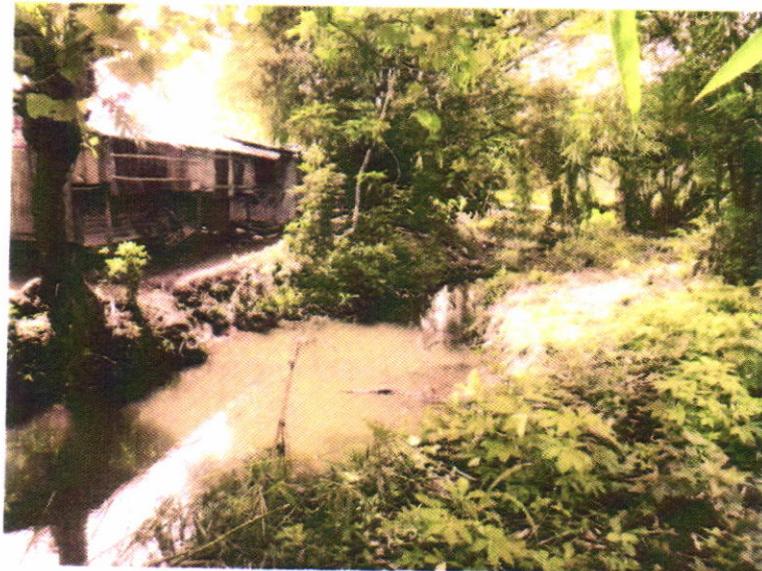
A creek located at Purok 7 that floods nearby houses when it overflows. Rechanneling the creek is also recommended.

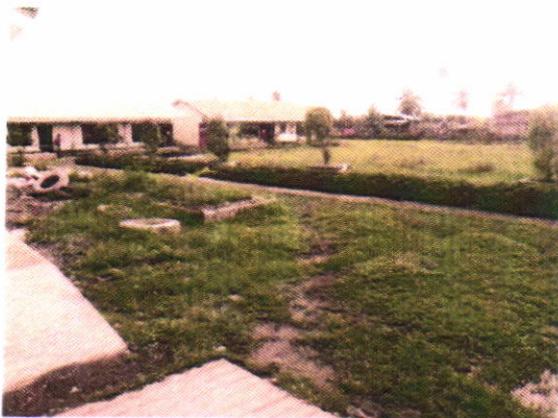
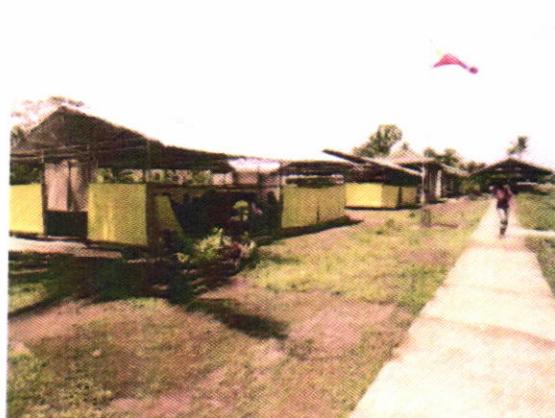
School grounds of Sayon Elem. School (left photo) and Sta. Josefa Nat'l High School (Annex) (right photo) that are recommended to be provided with proper drainage system to prevent ponding of water at the area and to properly facilitate surface run-off.

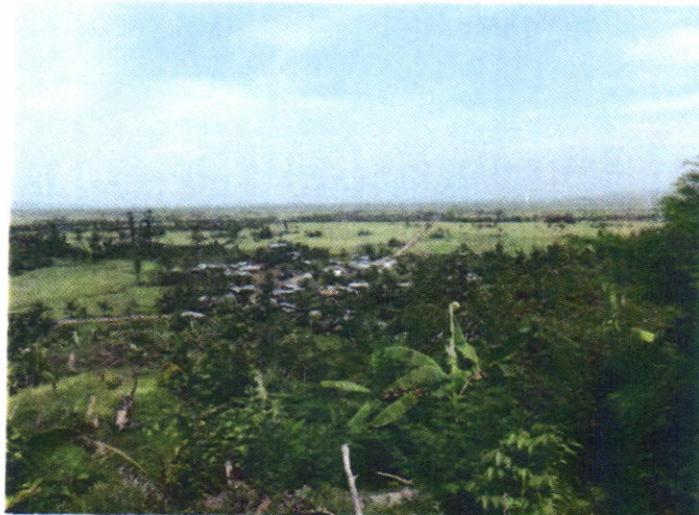
Top view of the houses at Purok 8 Tagmanuro located at the foot slope which is rated to be moderately susceptible to landslide.

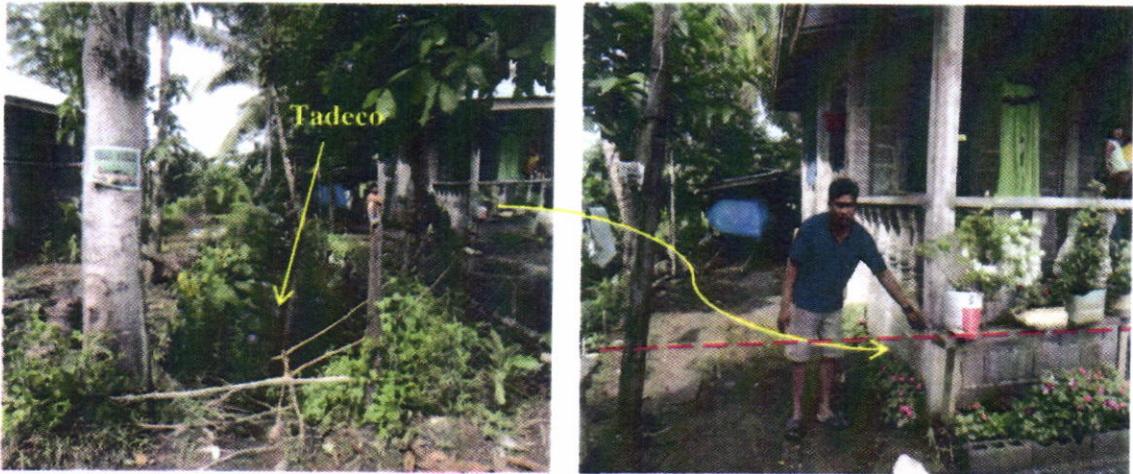
Photos showing the Tadeco canal (left photo) that sometimes overflow and flood nearby houses. Flood height that approximately reached 0.5 meter was experienced at the area as shown by a resident (right photo).

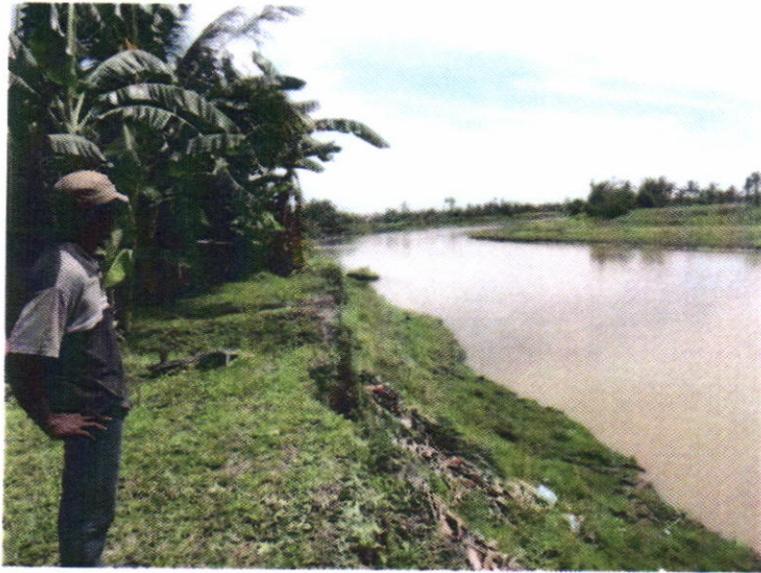
A view of Agusan River located at the barangay proper which is the main cause of flooding at the barangay.

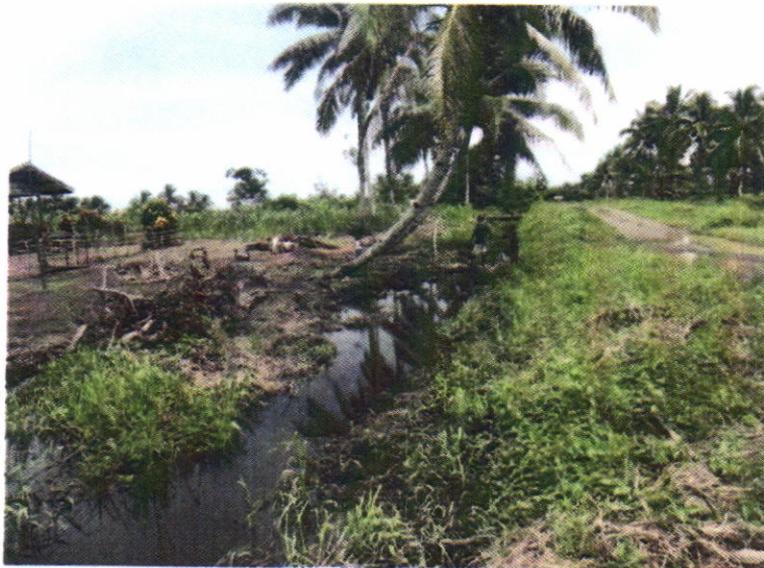
Drainage canal located at Purok 7 Paraiso Nangka which needs to be conducted with regular maintenance.

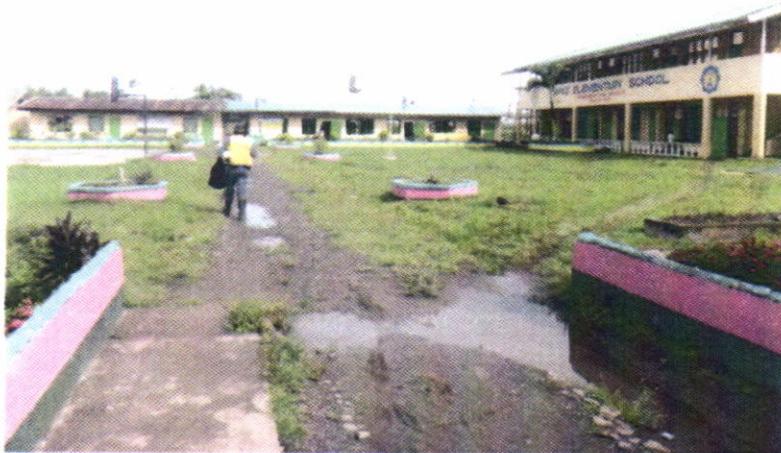
Tapaz Elem. School located at Purok 3 that needs to be provided with proper drainage system to prevent localized flooding at the area.

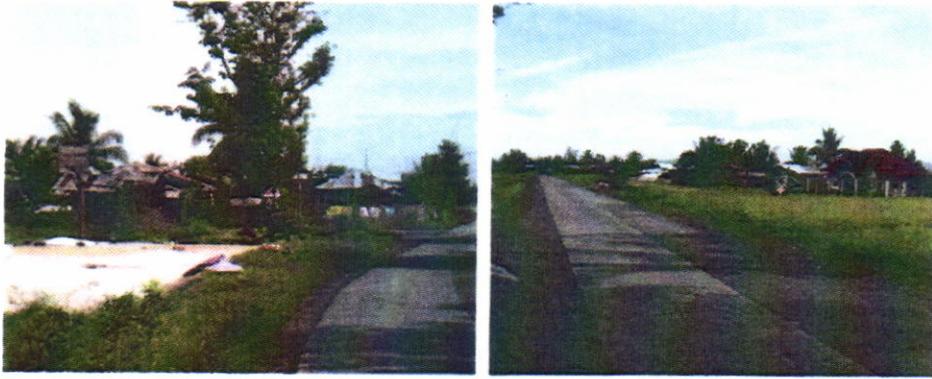
Photos are Purok 1 which is recommended to install proper concrete drainage canals to facilitate surface run-off especially

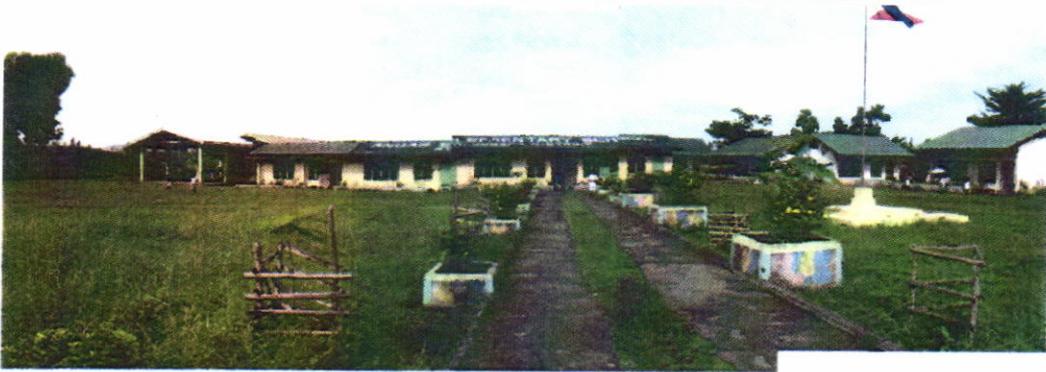
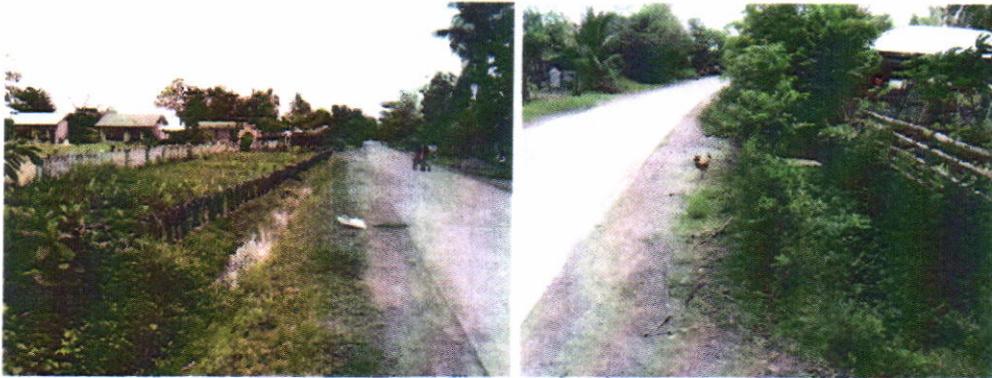
Photos above are areas at Purok 2 including Angas Elementary School. Installation of proper concrete drainage canals at the purok and at the school is recommended.

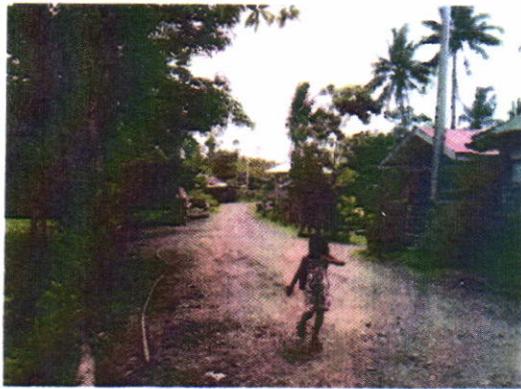
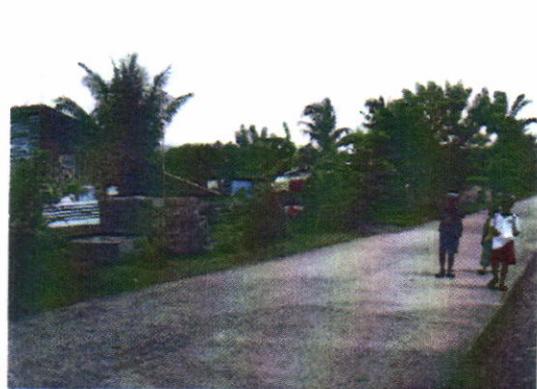
Photos are Purok 3 which is recommended to install proper concrete drainage canals to facilitate surface run-off.

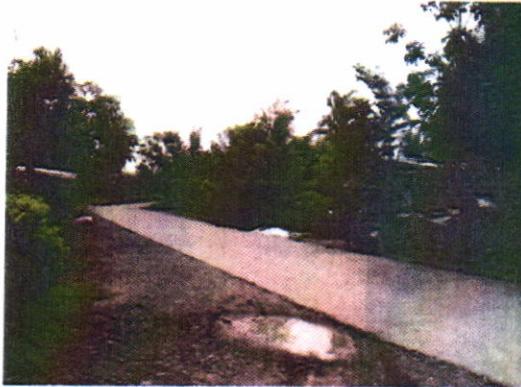
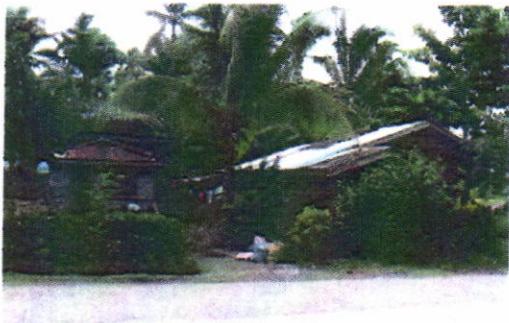
Photos are Purok 4 Lower Angas. Installation of proper concrete drainage canals to facilitate surface run-off is recommended.

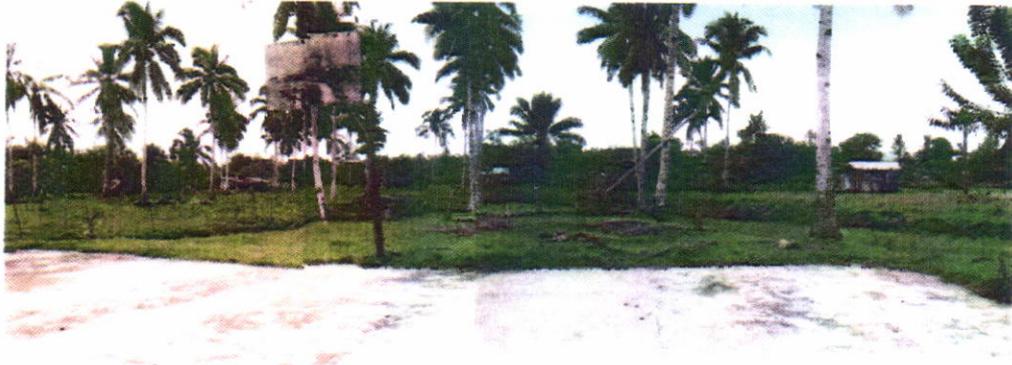
Photo above is a panoramic view of Purok 11 Sitio Cebuli which is rated low to landslide and flooding.

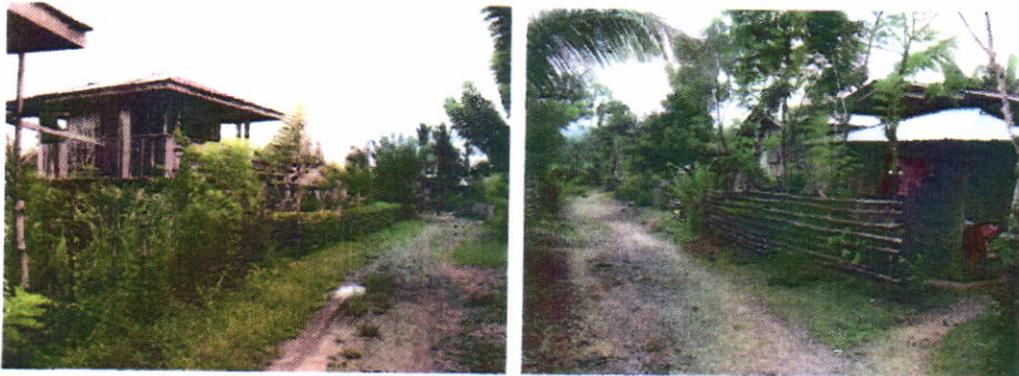
Photos above are houses of Purok 12 which are located at the ridge and rated moderate to landslide. Observe for presence of mass movements and prohibit future settlement along ridge edges and footslopes.

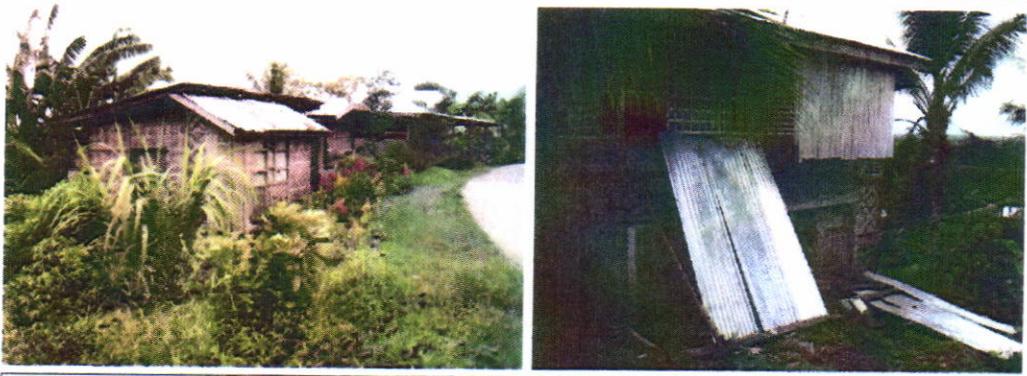
Photos are some of the houses of Purok 13 which are on the ridge edges and highly susceptible to landslide. Prohibit future settlement along ridge edges and footslopes. For long term solution, relocating the residents located at the ridge with very steep slopes is highly recommended.

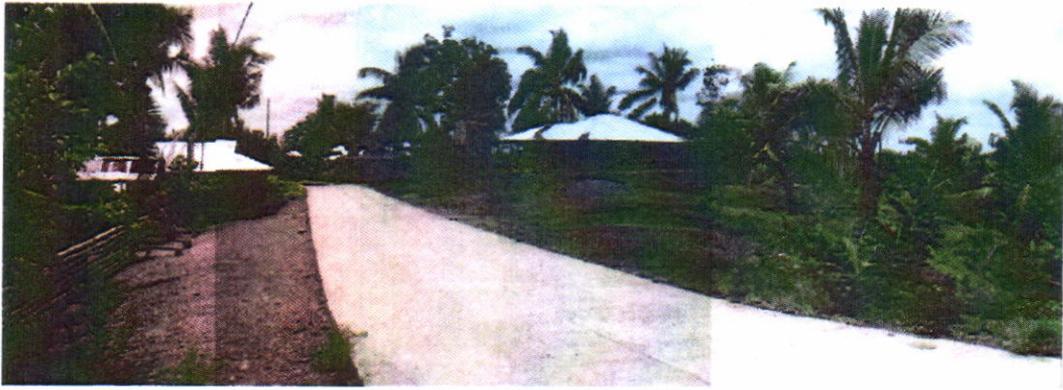
Photo is Purok 14 which is moderate to landslide. Observe for presence of mass movements and prohibit future settlement along ridge edges and footslopes.

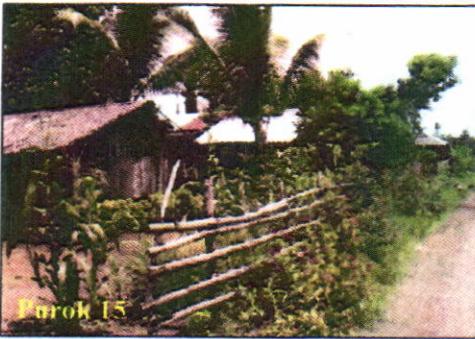
Purok 15

Photos are Puroks 15, 16, 17, and 26 located at Sitio Durian. The puroks are elevated from its surrounding ricefields and are rated low to landslide and flooding. Proper drainage canals are recommended to be installed to facilitate surface run-off especially during heavy precipitation.

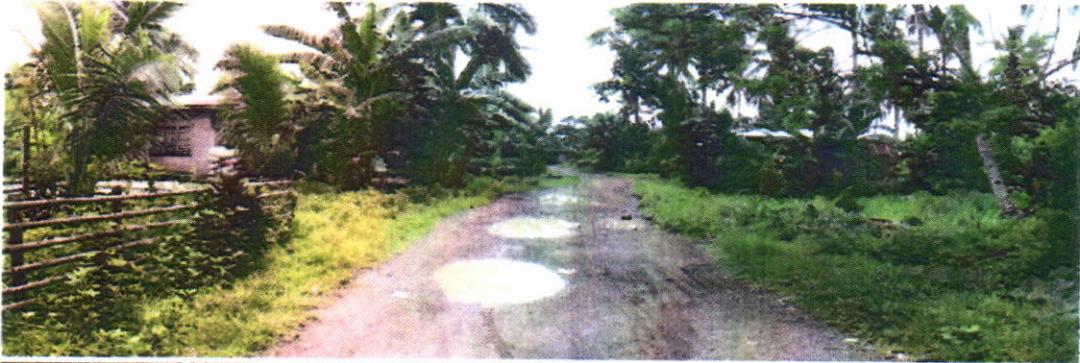
Photos are Purok 18 Sitio Dao which is rated low to moderate to flooding. Right photo is a resident showing the flood height the purok experienced during typhoon Pablo. Recommend to develop an early warning system regarding flooding, and pre-emptive evacuation is advised during typhoons or if unusual flooding is experienced. Also prohibit future settlement on the creeks embankments.

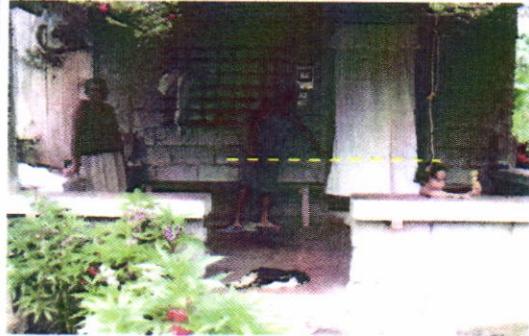
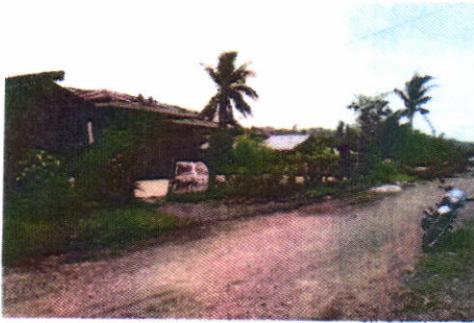
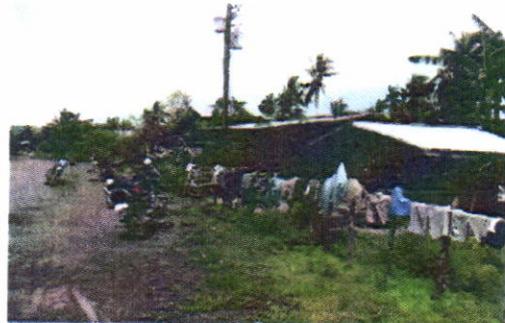
Photos are Purok 19 Sitio Dao which is rated low to moderate to flooding. Right photo is a resident showing the flood height the purok experienced during typhoon Pablo. Recommend to develop an early warning system regarding flooding, and pre-emptive evacuation is advised during typhoons or if unusual flooding is experienced. Proper concrete drainage canals are also recommended to install.

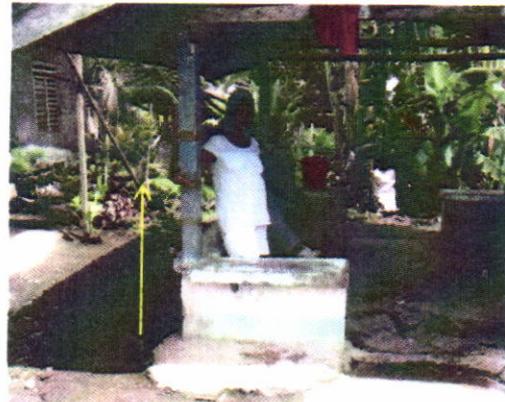
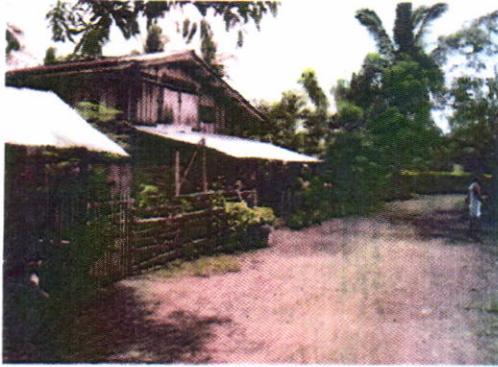
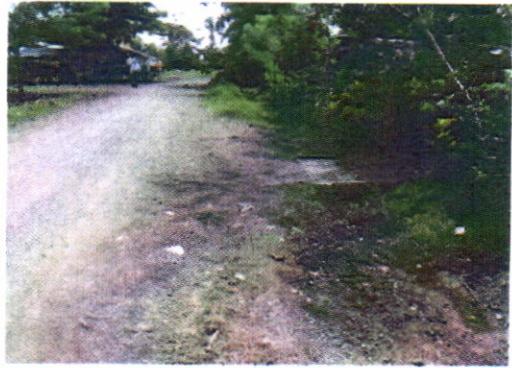
Photos are Purok 20 Sitio Dao and some of its existing drainage canals. The purok had experienced a moderate flooding during the typhoon Pablo. Recommend to develop an early warning system regarding flooding, and pre-emptive evacuation is advised during typhoons or if unusual flooding is experienced. Proper concrete drainage canals are also recommended to install.

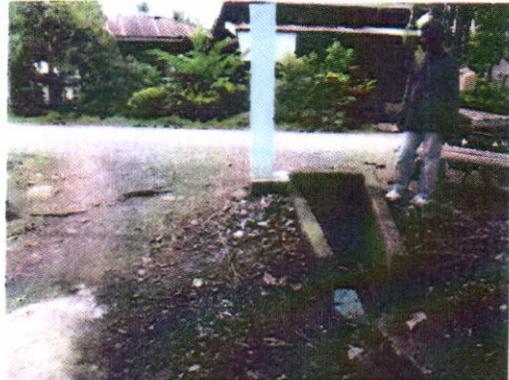
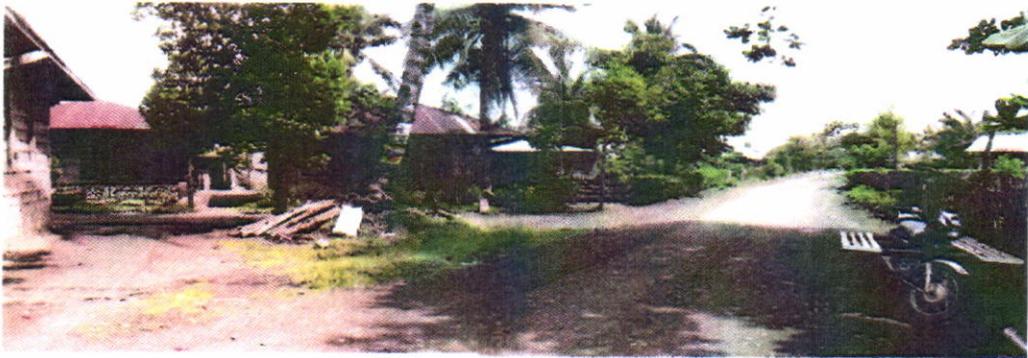
Photos are Purok 21 Sitio Dao which also experienced moderate flooding during typhoon Pablo. Recommend to develop an early warning system regarding flooding, and pre-emptive evacuation is advised during typhoons or if unusual flooding is experienced. Proper concrete drainage canals are also recommended to install.

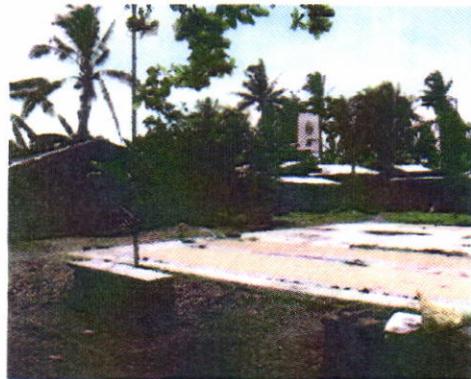
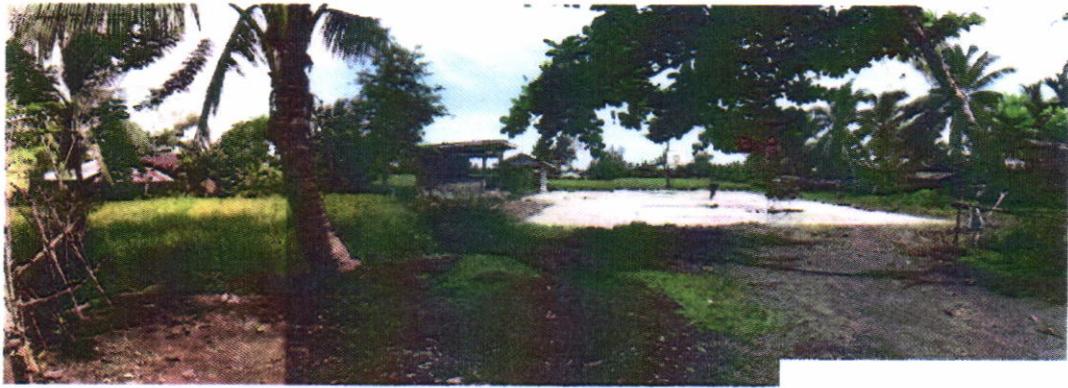
Photo above is the Purok 22 which experiences moderate to high flooding every time the Hinalinan Creek overflows. Recommend to observe for water level at the creek during inclement weather conditions and pre-emptive evacuation is advised. Also prohibit future settlement at the creeks embankments. For long term solution, relocating the entire purok is recommended.

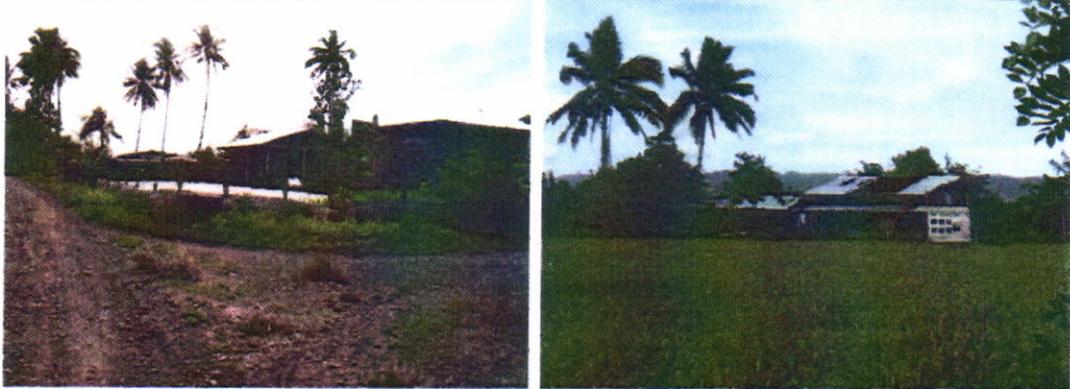
Photos are Purok 23 which is low to flooding.

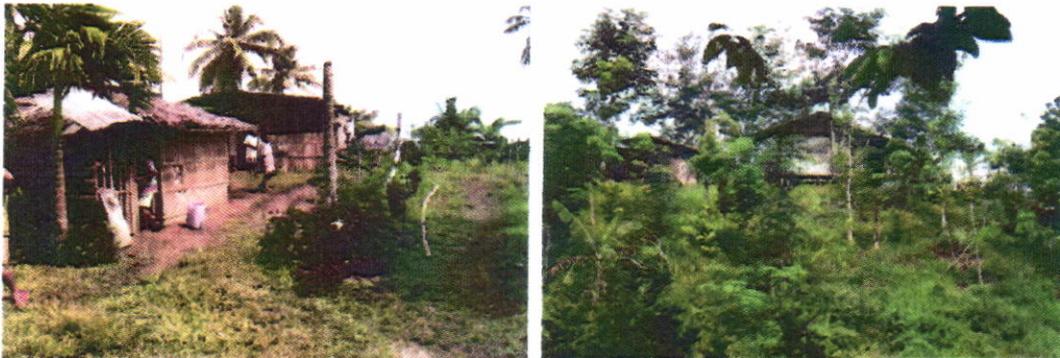
Photos above are houses of Purok 24 which are elevated from the surrounding ricefields. The purok is both low to landslide and flooding.

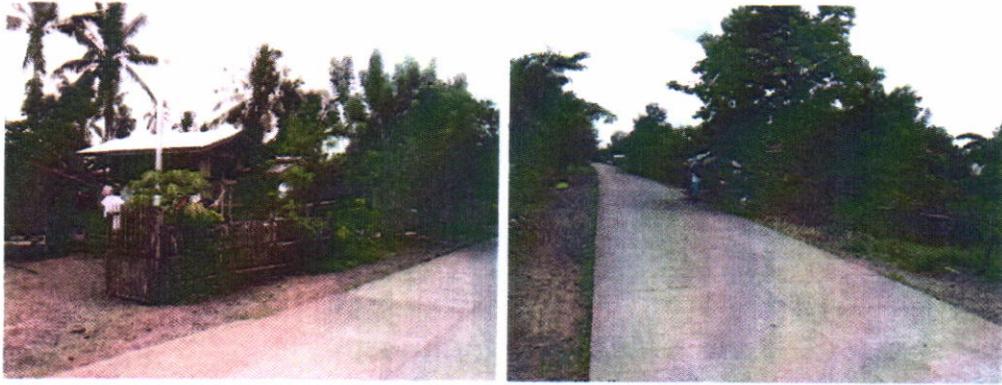
Photos are areas of Purok 25 which are recommended to install proper concrete drainage canals to facilitate surface run-off.

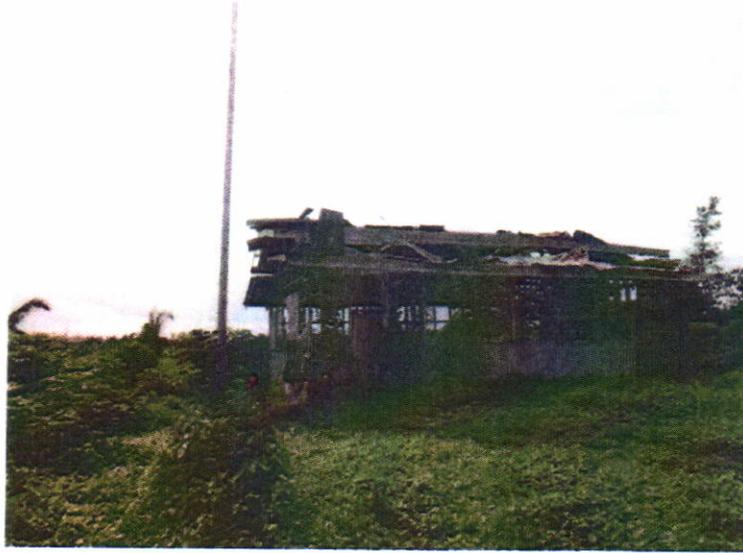
Photo showing the damaged Sitio Hall of Kaangayan 1 due to the strong winds brought by Typhoon Pablo.

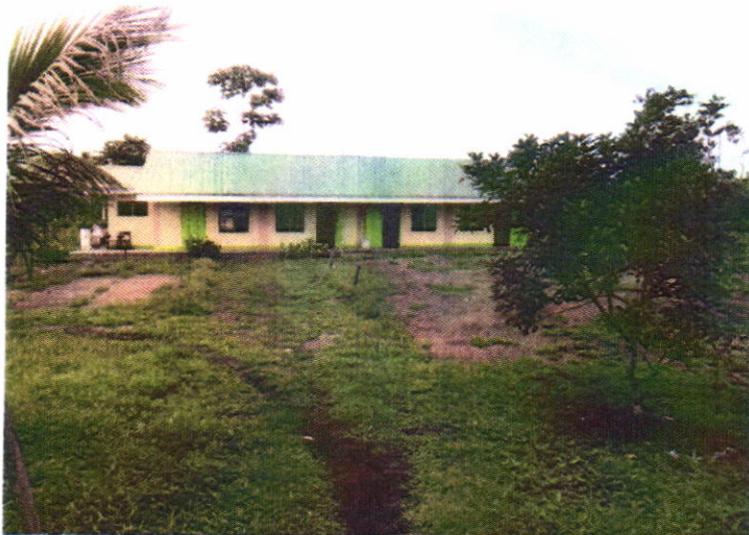
A view of Kaangayan Primary School located at Purok 10 which needs proper drainage system.

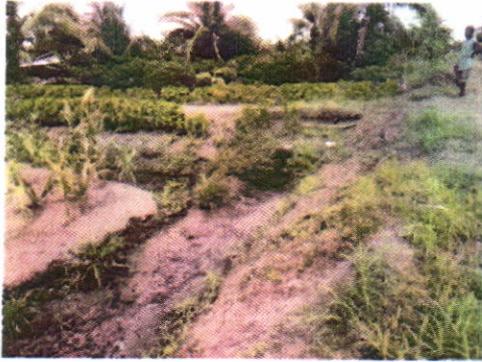
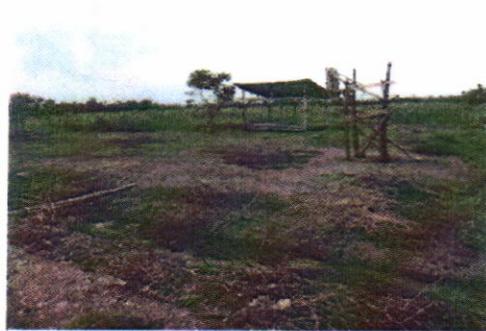
Drainage canals at Sitio Kaangayan 1 that needs to be defined and deepened so as to prevent its overflow.

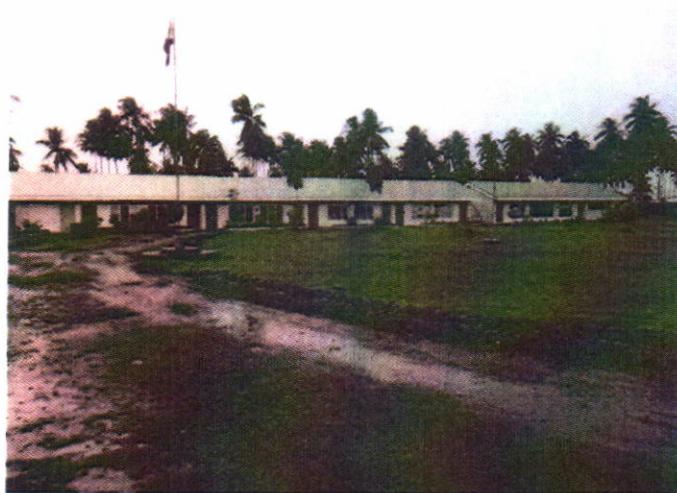
Photo showing the school ground located at Aurora Nat'l High School that needs to be provided with concrete line canals.

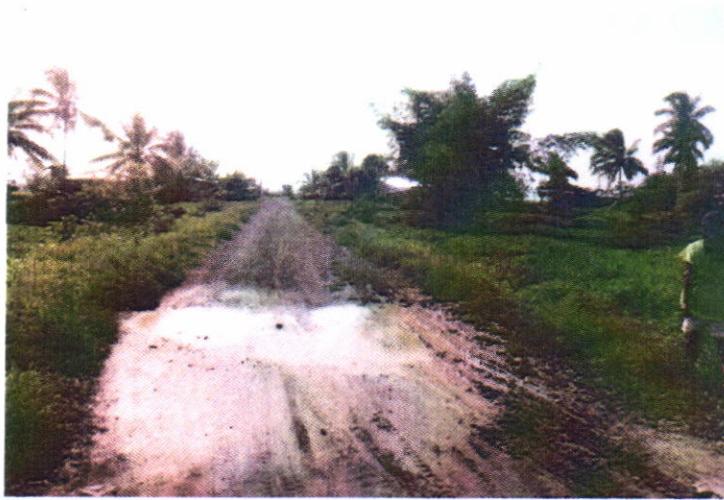
Barangay road located at Sitio Kaangayan 2 that is recommended to be elevated and to be provided with drainage canals to lessen the effects of flooding at the area.

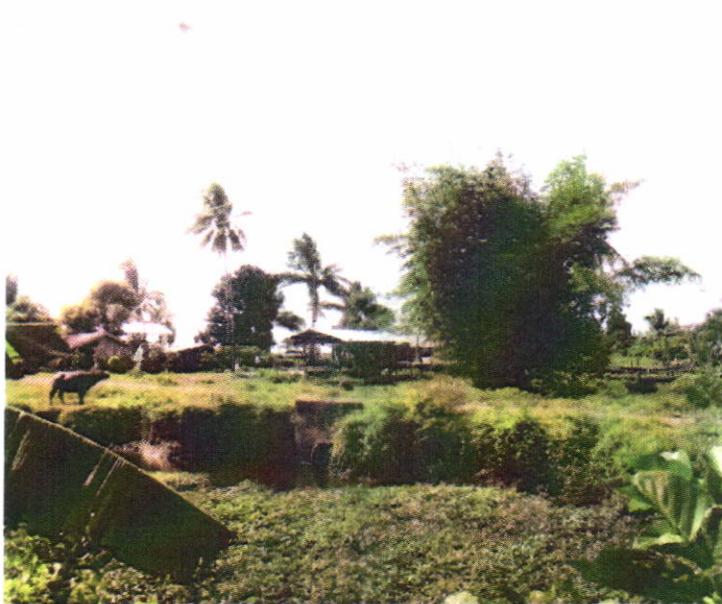
Area at Purok 13 located at Sitio Kaangayan 2 that is recommended to be provided with additional box-type culvert to aid in draining out water from the area.

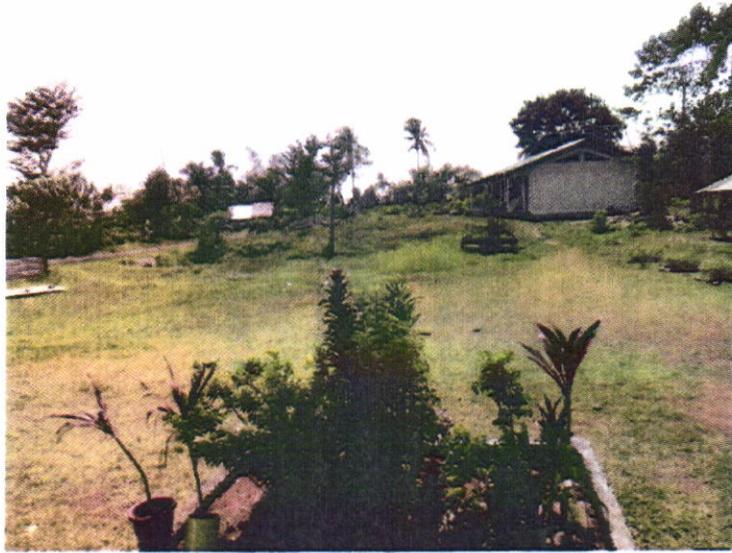
School grounds of Pag-asa Elem. School at Purok 15 located at Sitio Kaangayan 2 that is recommended to be elevated and to be provided with proper drainage system.

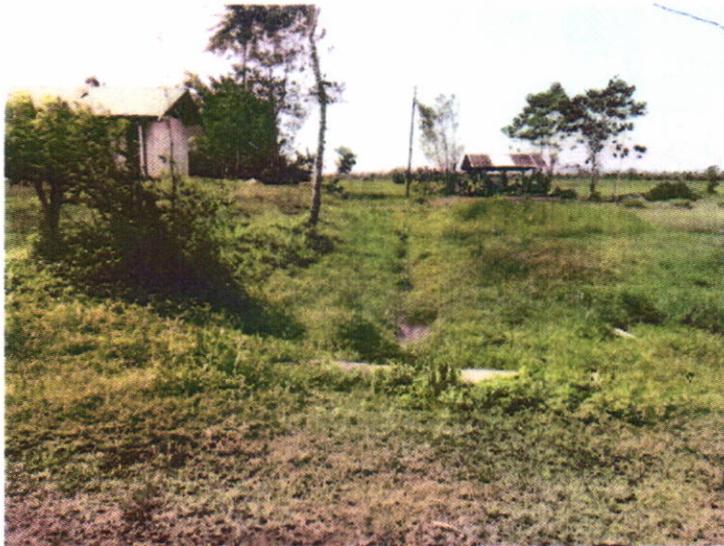
Photo showing the drainage canal at Pag-asa Elem. School that is recommended to be concretized and have its outlet defined to properly drain run-off and prevent further erosion at the school grounds.

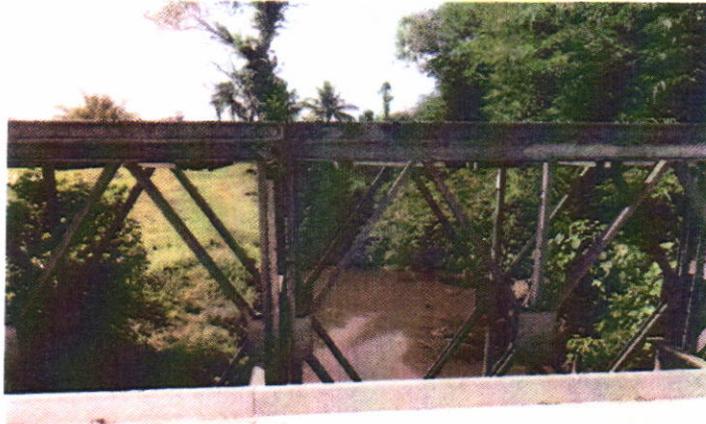
A view of Lucad creek flowing under the steel bridge located at Purok 15 which is the main cause of the major flooding at Sitio Kaangayan 2. Rechanneling the creek is recommended.

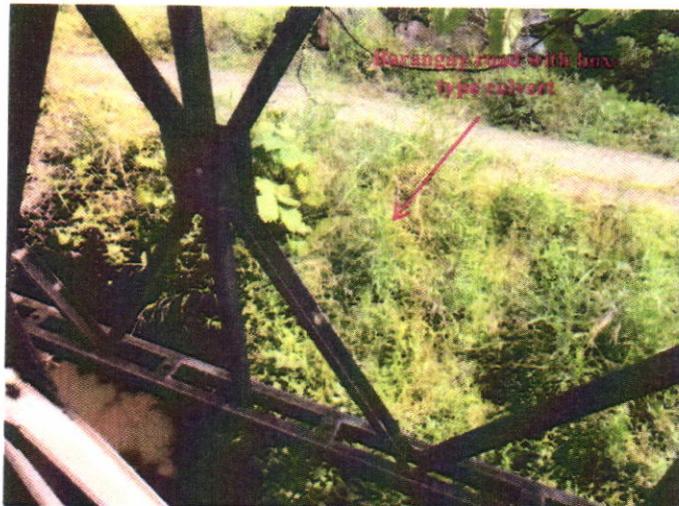
Also under the Lucad steel bridge is a part of barangay road (above photo) installed with box-type culvert which obstructs the flow of the Lucad creek during inclement weather condition causing it to overflow. Removing such obstructions as well as realigning the barangay road directly to the steel bridge is recommended.

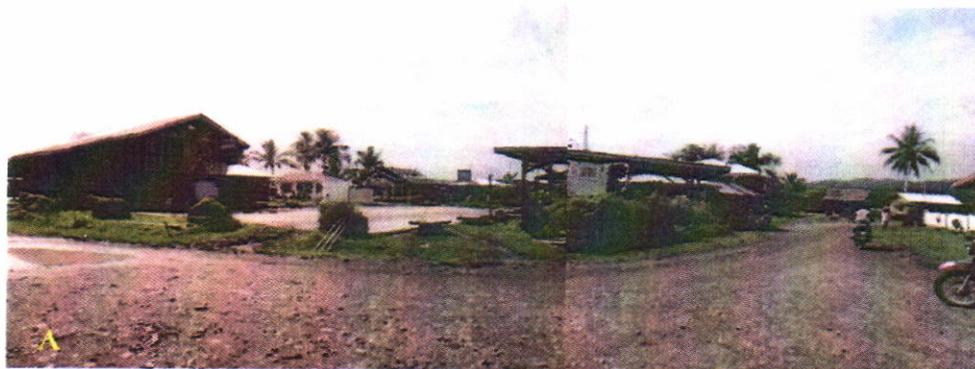
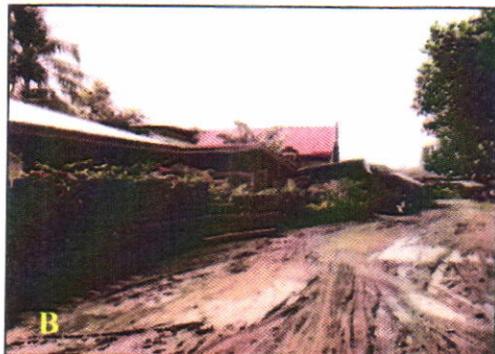
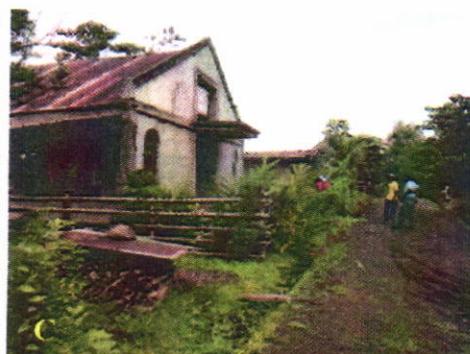
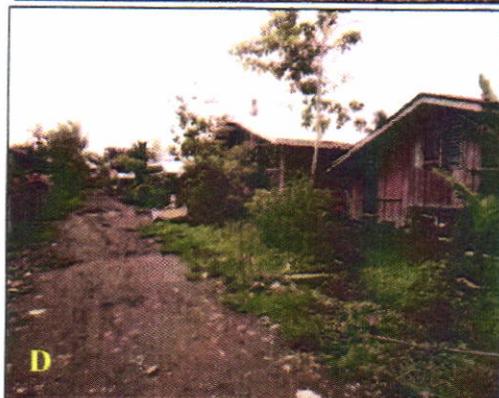
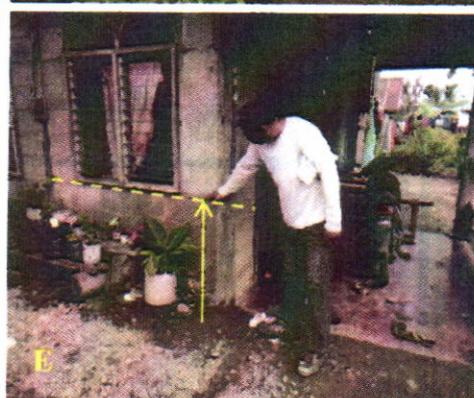
Photos above are areas of Purok 1 and Purok 2 which are experiencing high flooding due to Awao River overflow during extreme weather events. Photo E shows the flood height the houses experienced during flooding. Observe for increase/decrease of water level along the river. Develop an early warning system and pre-emptive evacuation is recommended during inclement weather conditions. Proper drainage canals are also recommended.
