Republic of the Philippines  
Department of Environment and Natural Resources  
**MINES AND GEOSCIENCES BUREAU**  
Regional Office No. XIII

Respectfully furnishing your end the document entitled "Results of the MGB Landslide and Flood Assessment and Mapping (1:10,000 scale) of the Municipality of Sta. Josefa Agusan del Sur". The assessment is in line with the government's effort aimed at reducing, if not totally mitigating the destructive effects and impacts of natural hazards to the populace.

## RESULTS OF THE MGB LANDSLIDE AND FLOOD ASSESSMENT AND MAPPING (1:10,000 SCALE) OF THE MUNICIPALITY OF STA. JOSEFA, PROVINCE OF AGUSAN DEL SUR

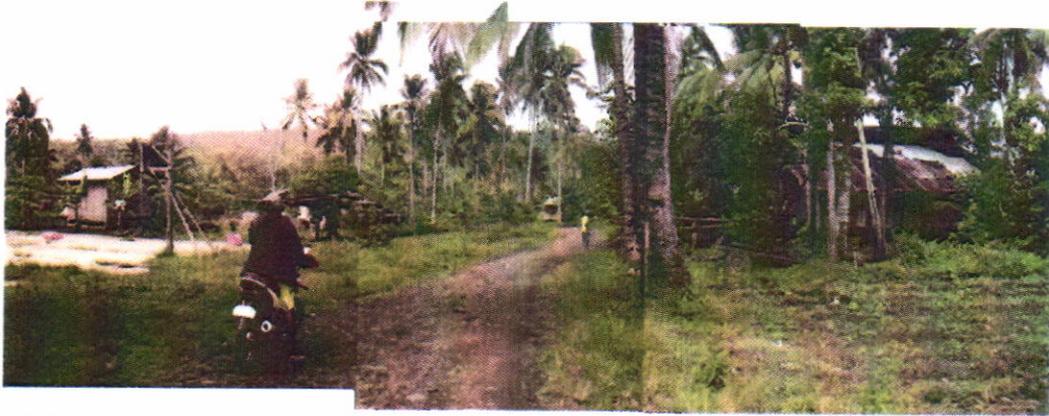
Photo above is an area ok Purok 3 which is moderate to flooding due to the Awao River overflow. Observe for increase/decrease of water level along the river. Develop an early warning system and pre-emptive evacuation is recommended during inclement weather

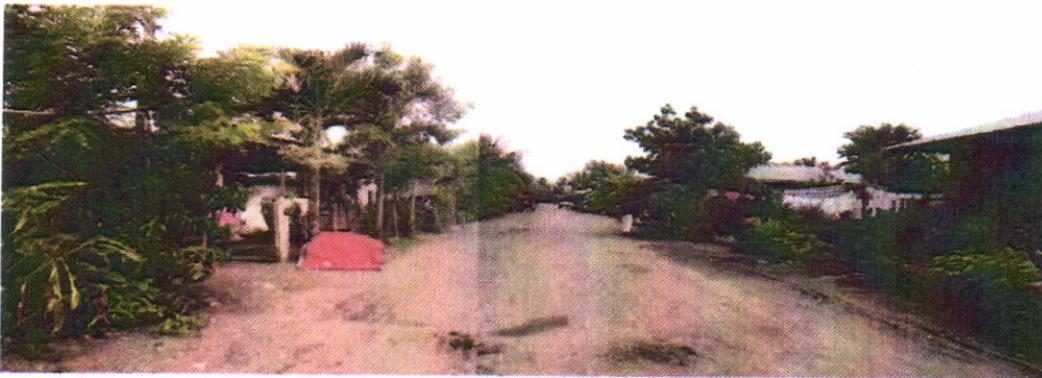
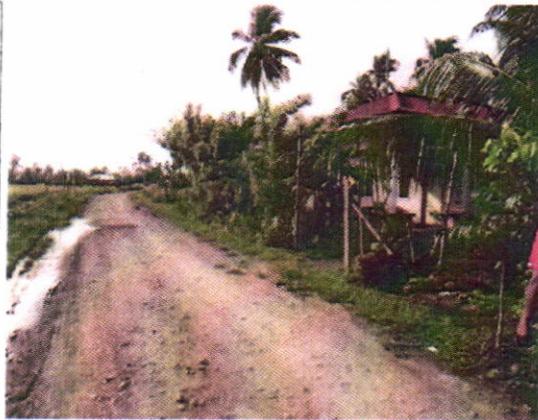
Photos are Purok 4 which is rated moderate to flooding. Develop an early warning system and pre-emptive evacuation is recommended during inclement weather conditions. Proper drainage canals are also recommended to install

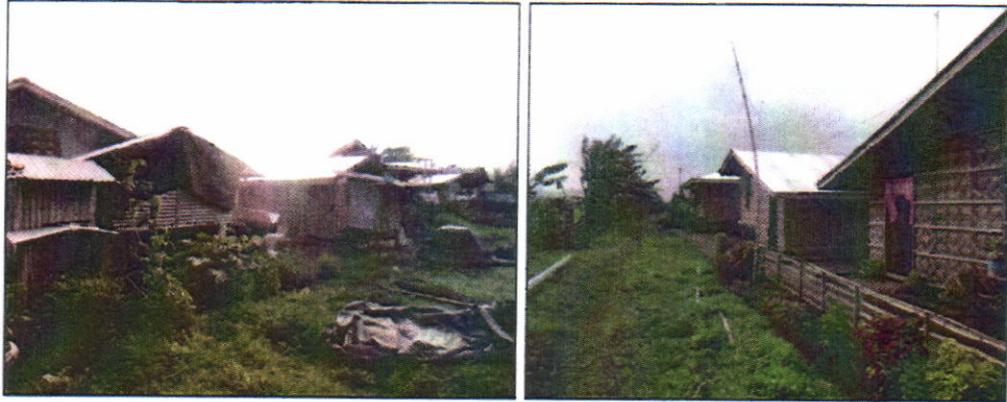
Photos are houses of Purok 5. The purok is rated low to flooding. According to the residents, Awao River overflow do not reach up to

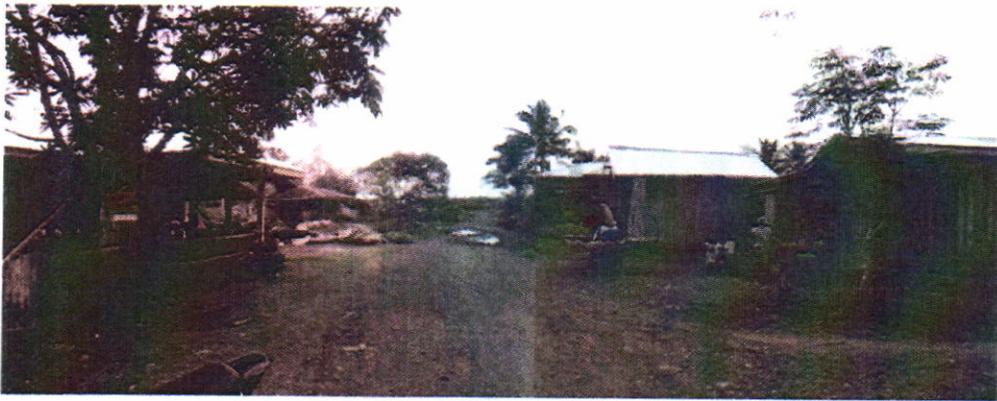
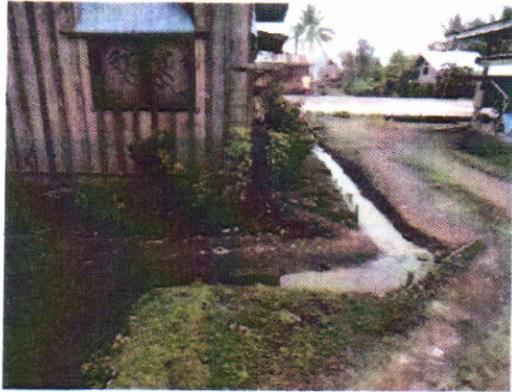
Photos are Purok 6 which is moderate to flooding. Develop an early warning system and pre-emptive evacuation is recommended during inclement weather conditions. Proper drainage canals are also recommended to install.

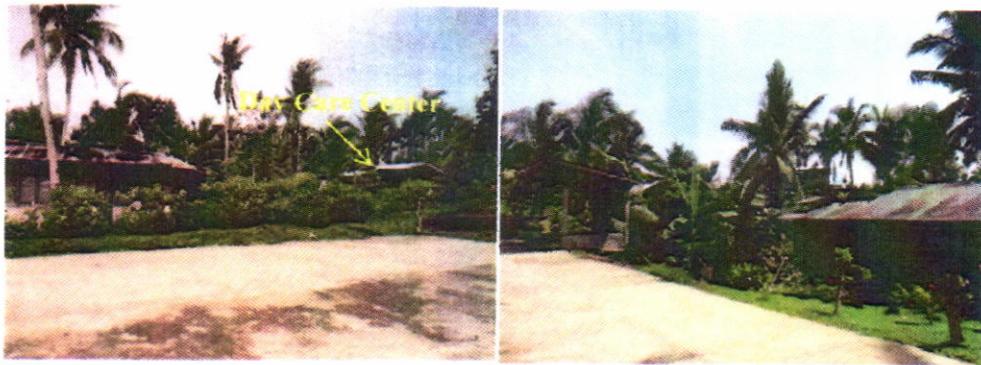
Photos are areas at Purok 7 which are located at the ridge characterized with moderately steep slopes. Observe for presence of mass movements and prohibit future settlement at the ridge edges and foot of slopes.

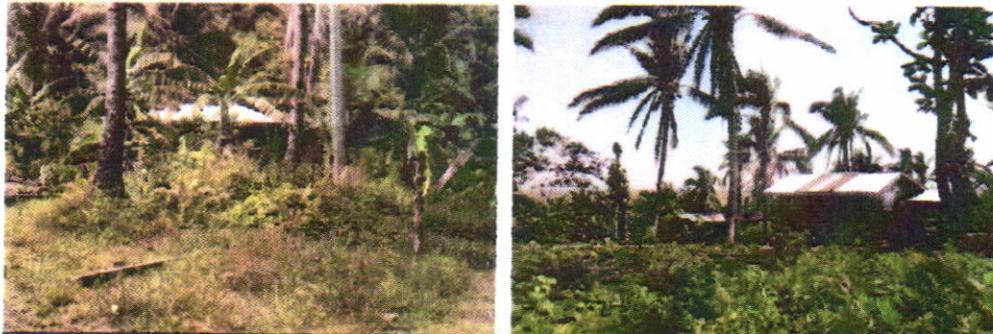
Photos are some houses of Purok 8 which are located at the ridge and are rated moderate to high to landslide. Observe for presence of mass movements and prohibit future settlement at the ridge edges and foot of slopes. Also develop an early warning system regarding landslide and pre-emptive evacuation during inclement weather conditions is recommended.

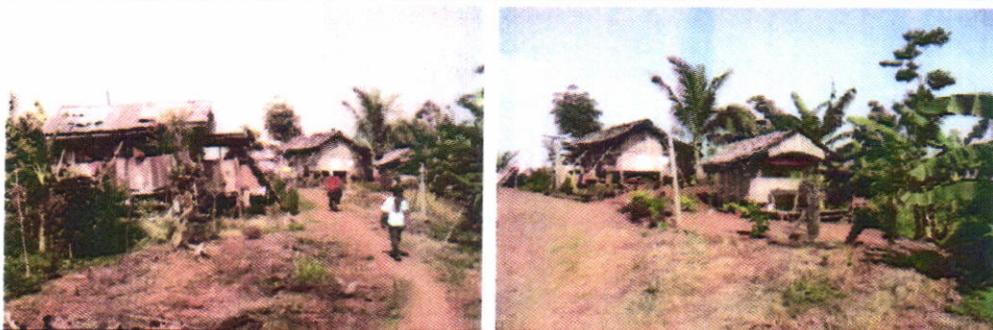
Photos are Purok 9 Sitio Agda which is located at the ridge with steep slopes. Observe for presence of mass movements and prohibit future settlement at the ridge edges and foot of slopes. Also develop an early warning system regarding landslide and pre-emptive evacuation during inclement weather conditions is recommended. Relocating the residents located at very steep slopes is also recommended.

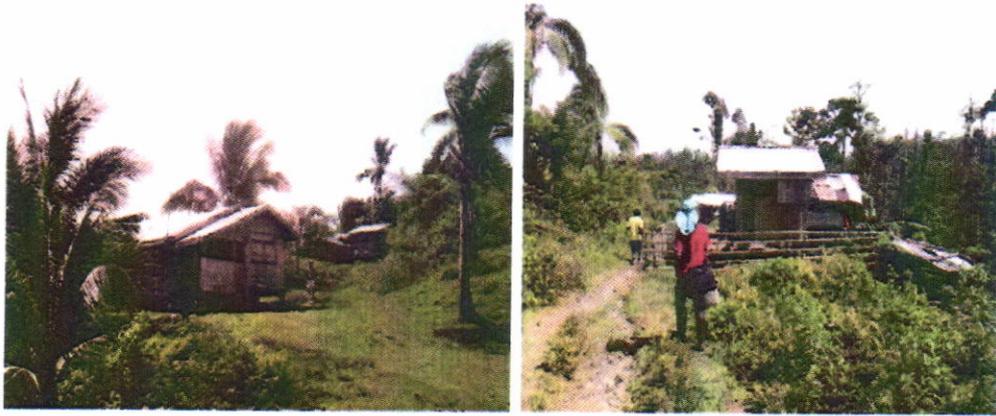
Houses of Purok 10 Sitio Kayakalan are located at the ridge with steep to very steep slopes and are highly susceptible to landslide. Observe for presence of mass movements and prohibit future settlement at the ridge edges and foot of slopes. Also develop an early warning system regarding landslide and pre-emptive evacuation during inclement weather conditions is recommended. Relocating the entire purok is also recommended.

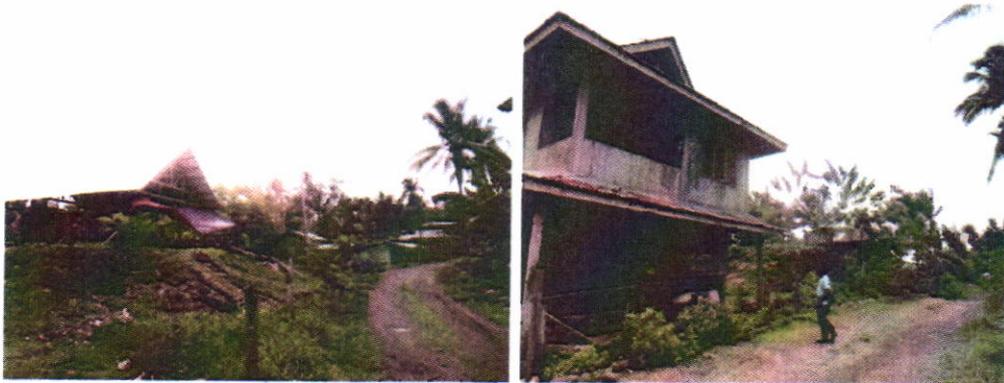
Photos show houses of Purok 11 Sitio Mahayahay which is rated moderate to landslide. The purok is underlain with limestone and is susceptible to sinkhole. Observe for presence of mass movements and prohibit future settlement at the ridge edges and foot of slopes. Also observe for ground depressions possibly indicating a presence of sinkholes.

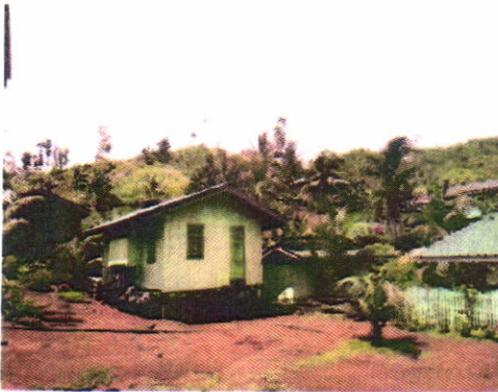
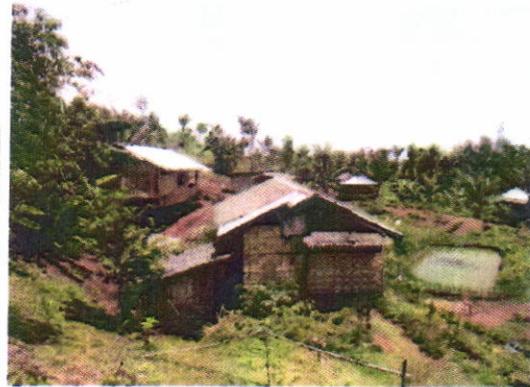
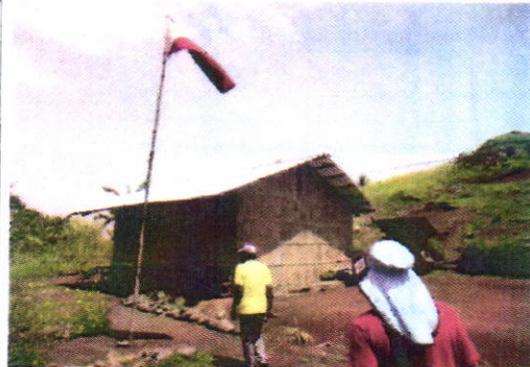
Houses of Purok 13 Sitio Tagbayog are rated moderate to high to landslide due to moderate to steep slopes where the purok is located. Observe for presence of mass movements and pre-emptive evacuation is recommended during extreme weather events. Also develop an early warning system regarding landslide and prohibit settlement directly located at the foot of slopes.

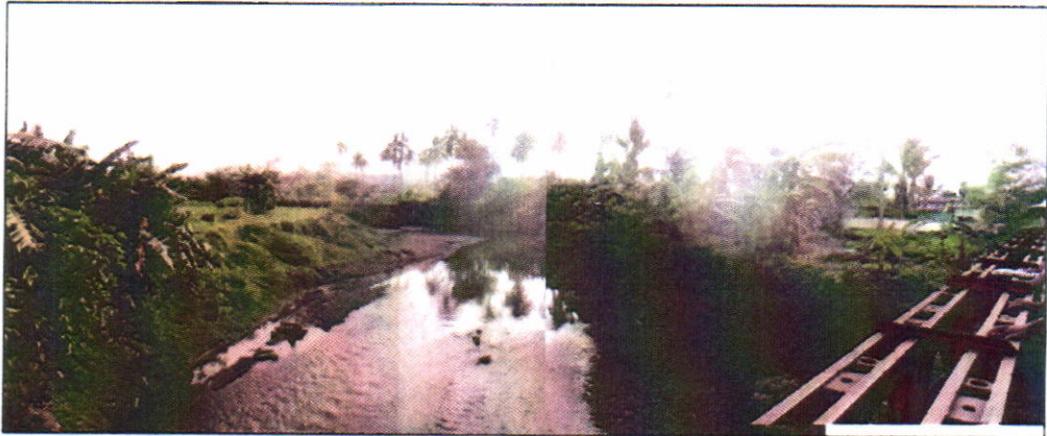
Photo above is a portion of the Awao River near the steel bridge which flooding to the most of the puroks of the barangay usually starts. Recommend a flood protective structure to mitigate or if not lessen the impact of flooding in the barangay. GPS coordinates 07°58' 02.4"N/ 126°00'11.5"E

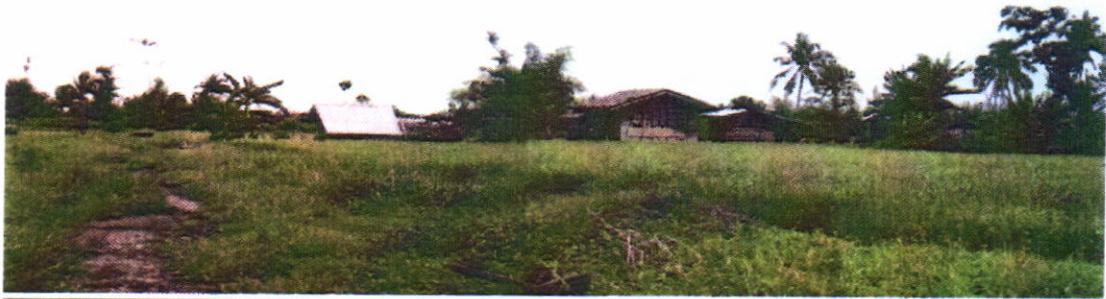
Photos are Purok 1 which is moderate to flooding due to the Awao River overflow. Pre-emptive evacuation is recommended if abnormalities in the water level in the river are observed or if unusual flooding is experienced. For long term solution, relocating the purok to a much safer site is recommended

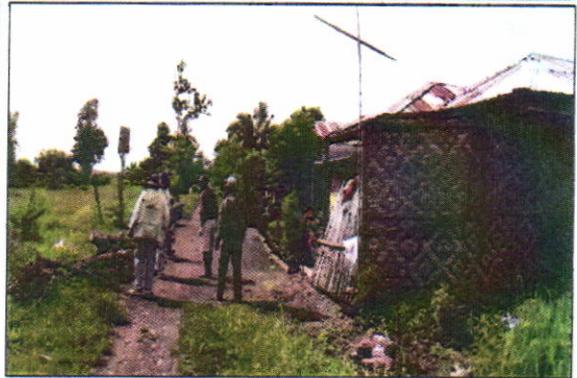
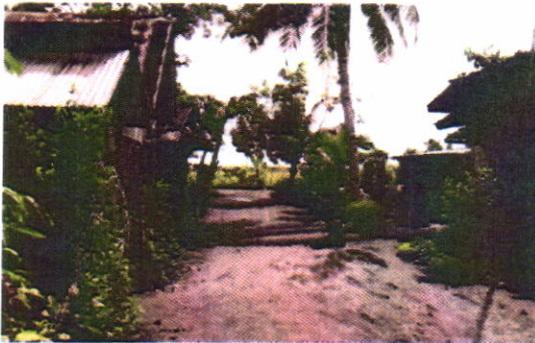
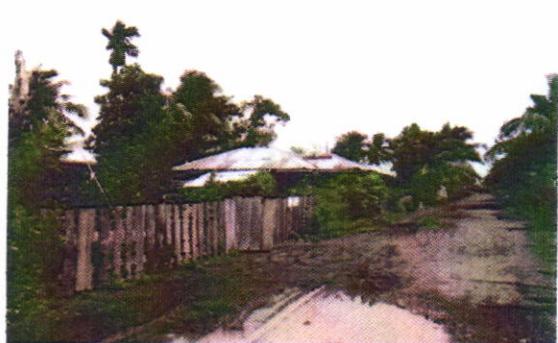
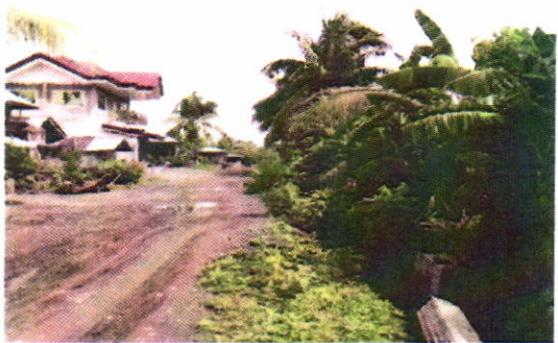
Photos are portions of Purok 2 which is affected by moderate to high flooding due to Awao River overflow. Pre-emptive evacuation is recommended if abnormalities in the water level in the river are observed or if unusual flooding is experienced. For long term solution, relocating the purok to a much safer site is recommended.

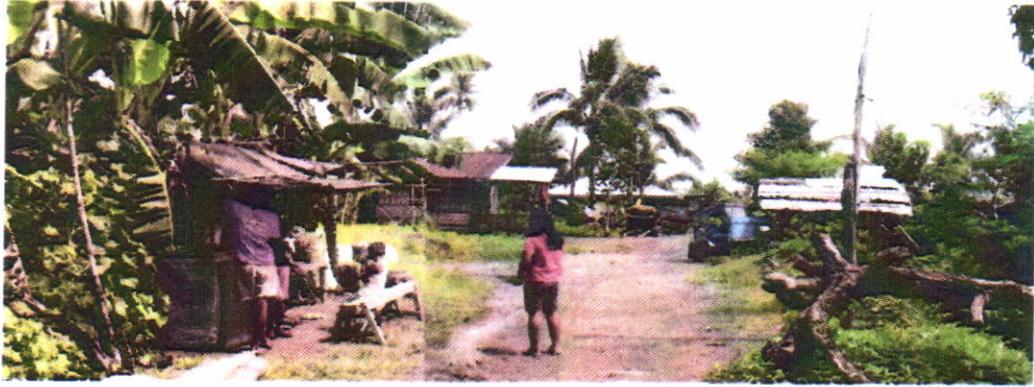
Photos are areas in Purok 3. The purok is rated moderate to high to flooding. Flooding is caused by the Awao river overflow during extreme weather events. Recommend pre-emptive evacuation if abnormalities in the water level at the river is observed. For long term solutions, relocating the entire purok is recommended.

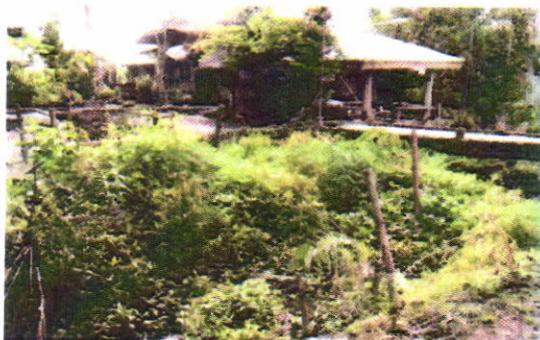
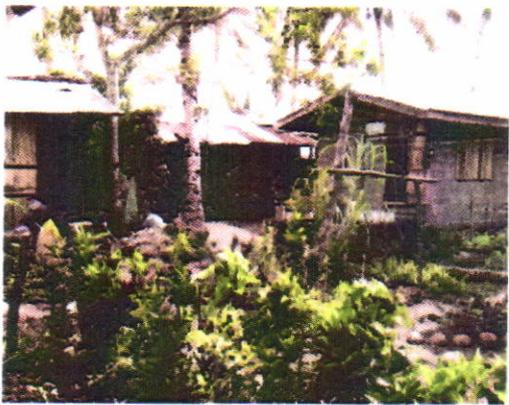
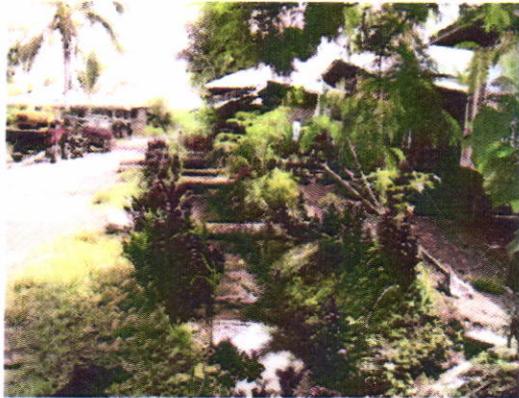
The photos are Purok 4 which experiences moderate to high flooding. Observe for rapid increase/decrease of water level at the Awao River and pre-emptive evacuation is advised during inclement weather conditions. For long term solution, relocating the entire purok is recommended.

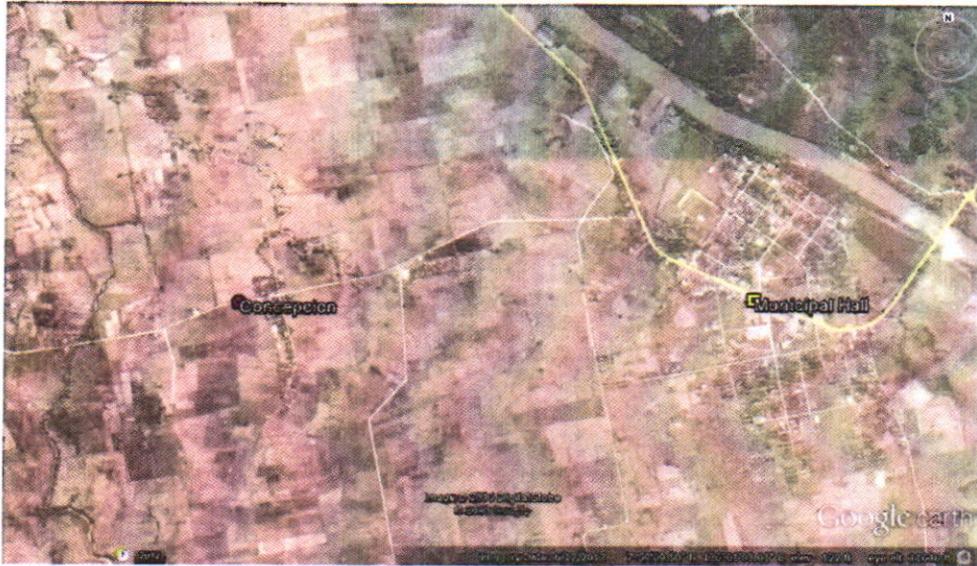
Location of Barangay Concepcion via Google Earth Satellite Imagery. GPS coordinates 07°59'07.1"N/126°00'28.5"E

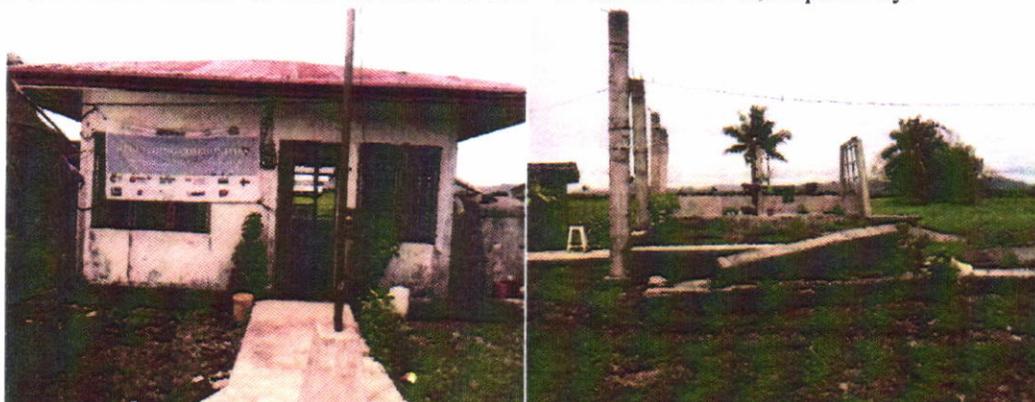
Fig. 2 The Barangay Hall is moderately damaged and completely damaged building of Barangay Multi-purpose by typhoon "Pablo" were observed at Purok 1. GPS reading is  $8^{\circ}04'37.2''\text{-N}/126^{\circ}00'01.4''\text{-E}$  and  $8^{\circ}04'36.8''\text{-N}/126^{\circ}00'01.9''\text{-E}$ , respectively. Flood rating is moderate.

Fig. 2 The Barangay Hall is moderately damaged and completely damaged building of Barangay Multi-purpose by typhoon "Pablo" were observed at Purok 1. GPS reading is 8°04'37.2"-N/ 126°00'01.4"-E and 8°04'36.8"-N/126°00'01.9"-E, respectively. Flood rating is moderate.

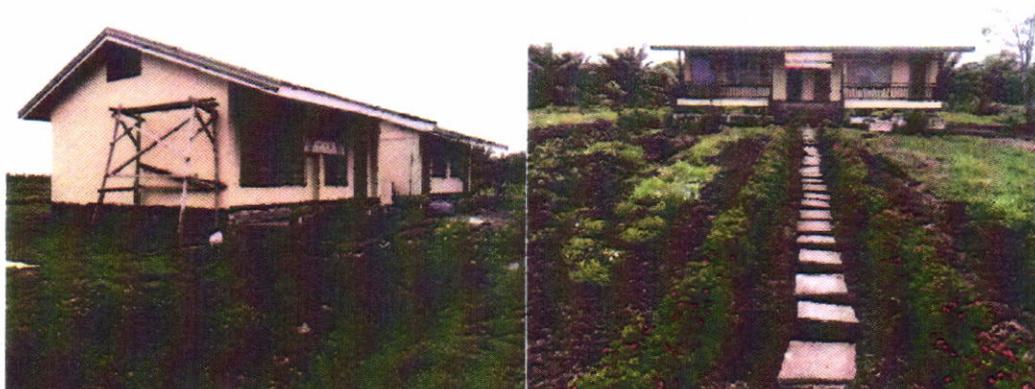
Fig. 3 Construction of concrete drainage canals are highly recommended at San Vicente Elementary School of Purok 1. GPS reading is  $8^{\circ}04'34.7''\text{-N}/126^{\circ}00'02.2''\text{-E}$ .

Fig. 3 Construction of concrete drainage canals are highly recommended at San Vicente Elementary School of Purok 1. GPS reading is 8°04'34.7"-N/126°00'02.2"-E.

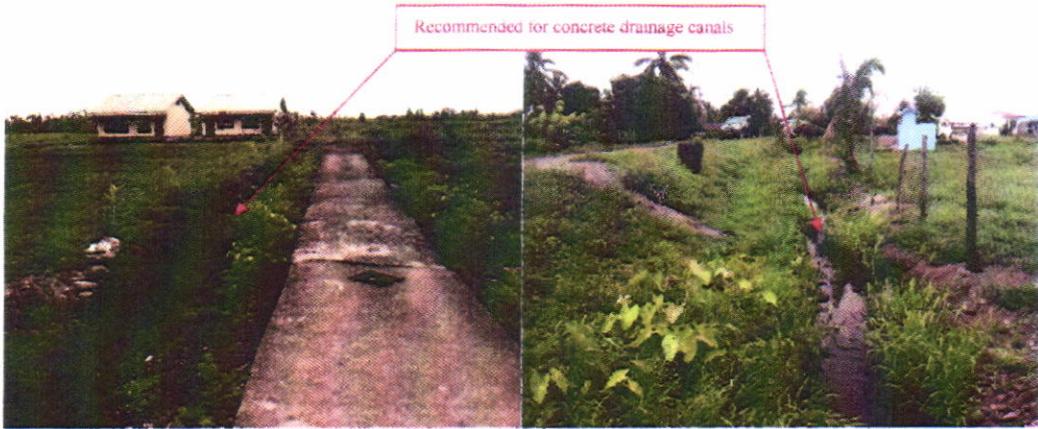
Fig. 4 These sections of Purok 1 are highly recommended for concreting drainage canals.

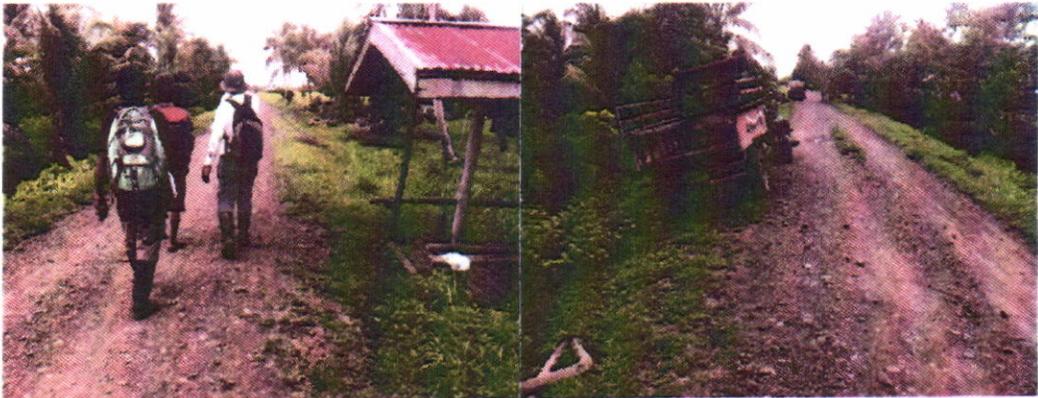
Fig. 5 Concreting of road and drainages are highly recommended at Purok 2. GPS reading is 8°04'45.5"-N/126°00'00"-E.

Fig. 5 Concreting of road and drainages are highly recommended at Purok 2. GPS reading is  $8^{\circ}04'45.5''\text{-N}/126^{\circ}00'00''\text{-E}$ .

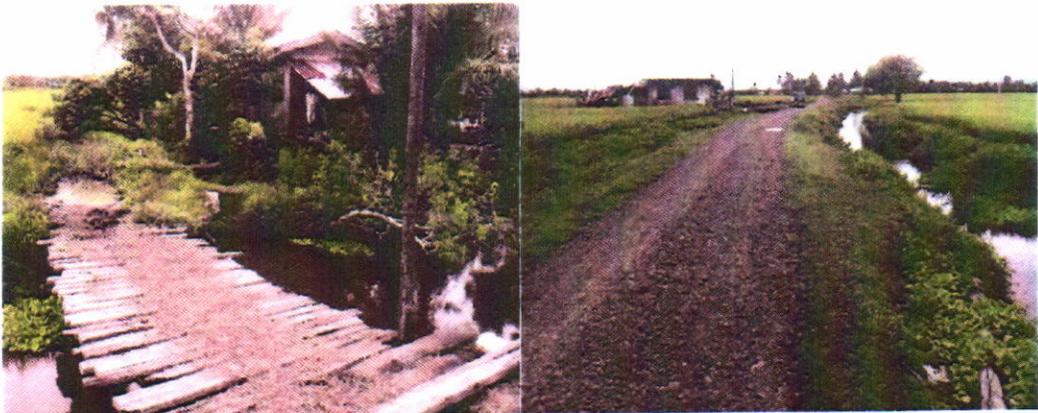
Fig. 6 Local residents are resided along NIA Irrigation canal at Purok 2. Road and NIA Irrigation canals are highly for concreting.

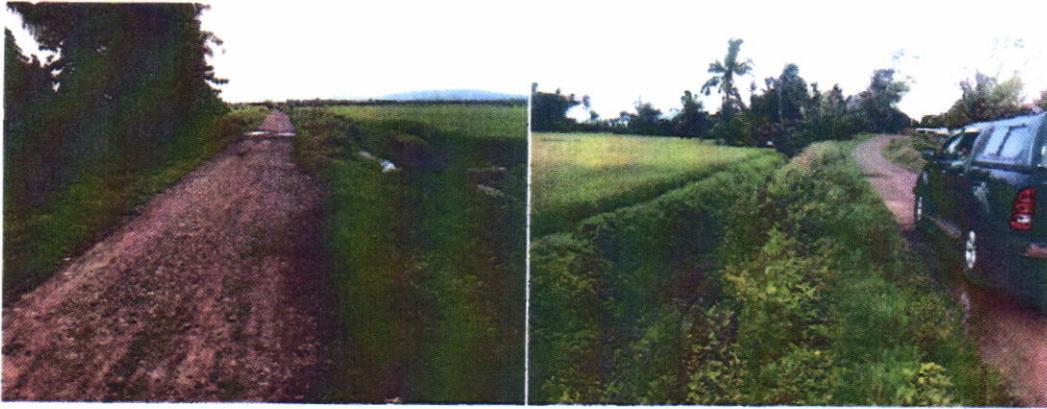
Fig. 7 No concrete road and no concrete drainage canal were noted at Purok 3. GPS reading is 8°04'59.3"-N/125°59'59.9"-E.

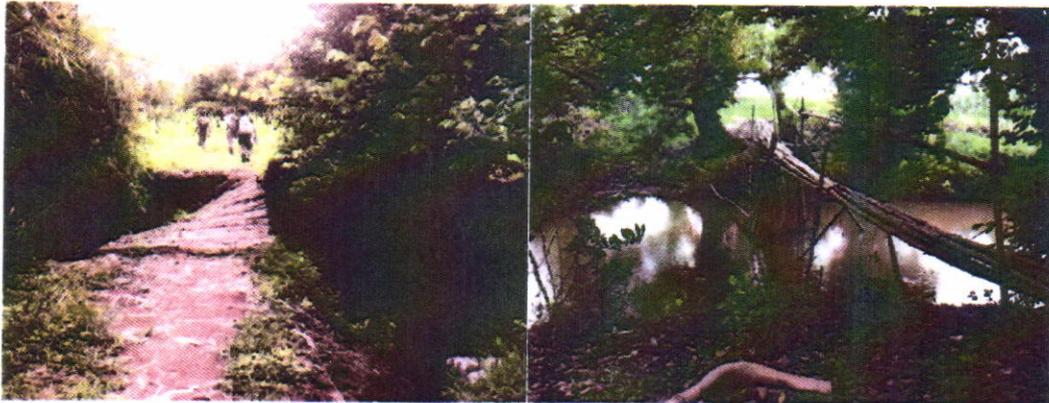
Fig. 8 Wooded bridges are main access across Lukad River. Construction of proper concrete bridge across Lukad River is highly recommended. GPS reading is 8°05'11.8"-N/126°00'17"-E.

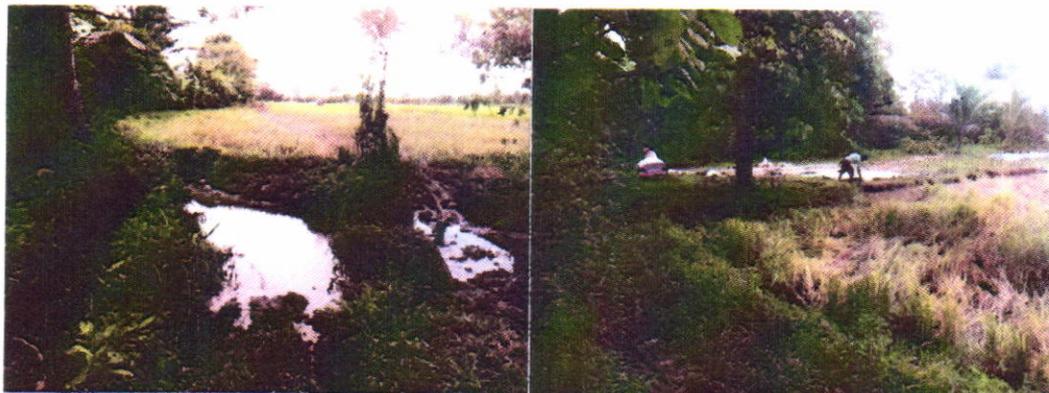
Fig. 9 Trail is main access toward Purok 4 from the barangay road which is parallel to the Lukad River. Proper road-piloting is highly recommended.

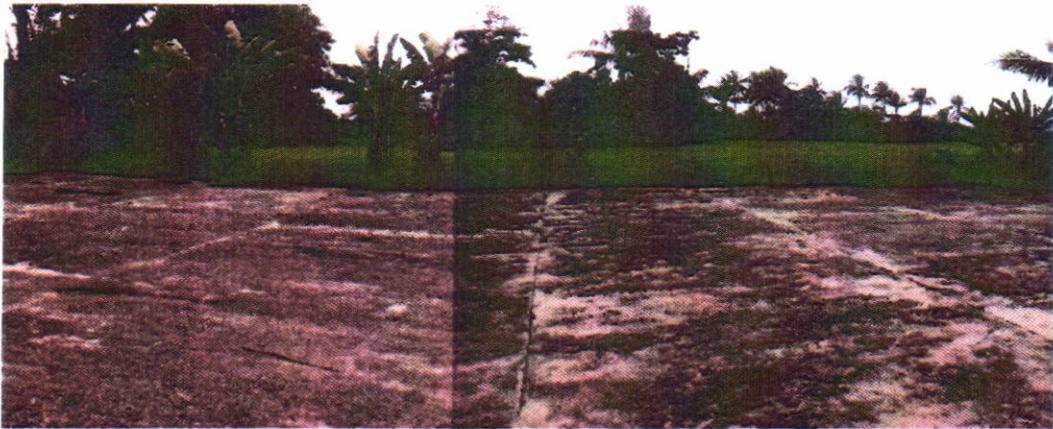
Fig. 11 Geographic location of Purok 5 situated along NIA Irrigation drainage canal or within the flood-prone section. GPS reading is 8°05'26.1"-N/126°00'00.3"-E.

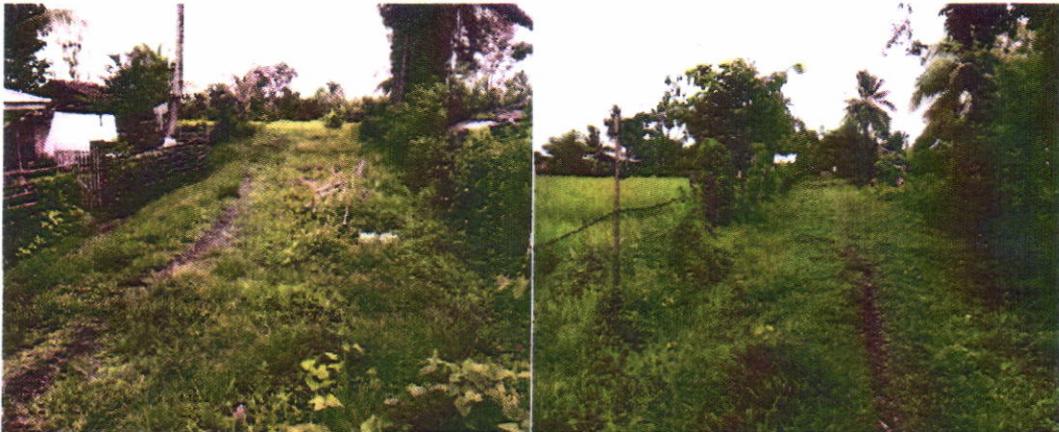
Fig. 12 No proper drainage canals and no concrete road were observed at Purok 6. Construction of concrete drainage canals and concrete roads are highly recommended. GPS reading is 8°04'10.1"-N/126°00'48.5"-E.

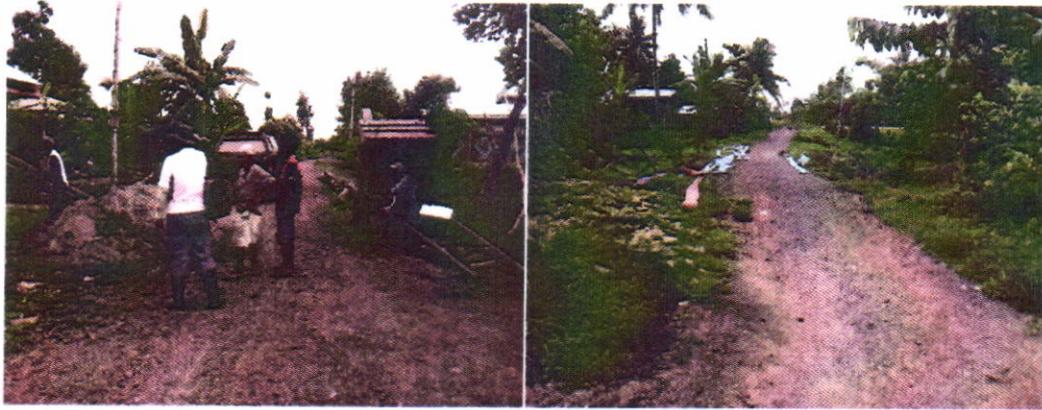
Fig. 16 No concrete drainage road and no drainage canal at Purok 7. GPS reading is 8°04'03.6"-N/126°00'48.3"-E.

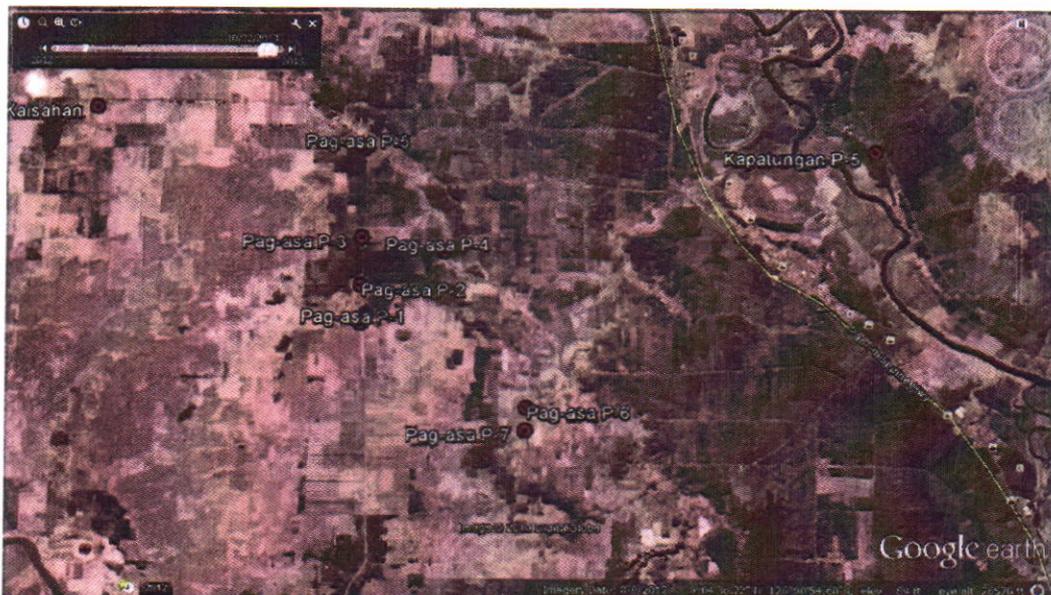
Fig. 17 Geographic location of Brgy. Pag-asa, Sta. Josefa, ADS with their puroks/sitios based on Google Earth 2013. General geohazard on the area is flooding and liquefaction.

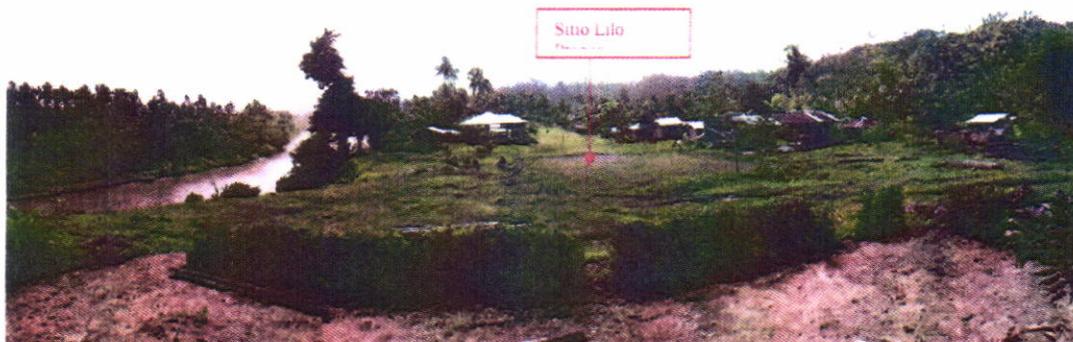
Fig. 4 Closer panoramic-view of Sitio Lilo proper situated along Agusan River embankment.

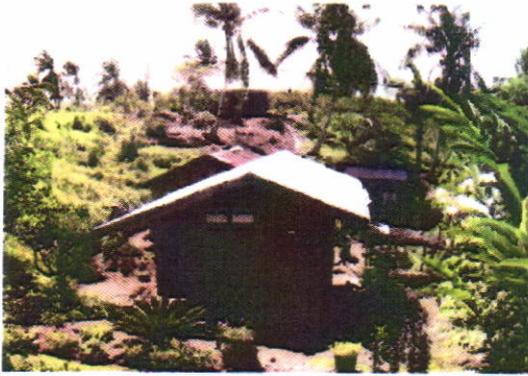
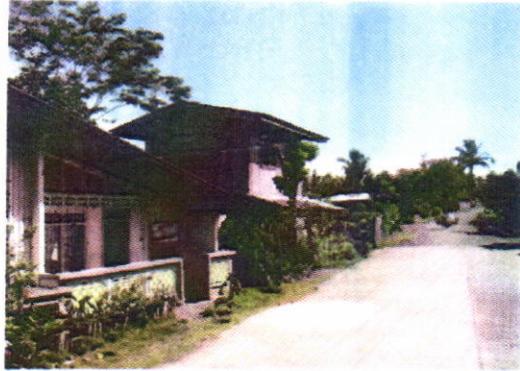
Photos are portions of Purok 1 which is characterized with gentle to moderately steep slopes and is rated moderate to landslide. Observe for presence of mass movements and prohibit future settlement at the foot of slopes. Proper concrete drainage canals are also recommended to facilitate surface run-off during heavy precipitation.

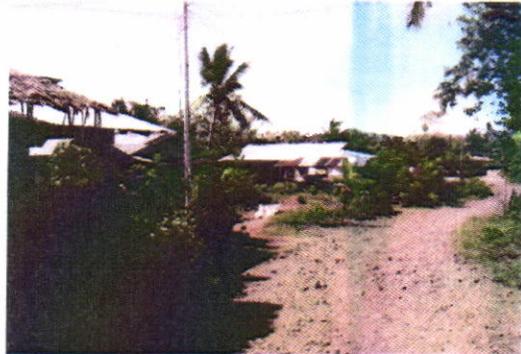
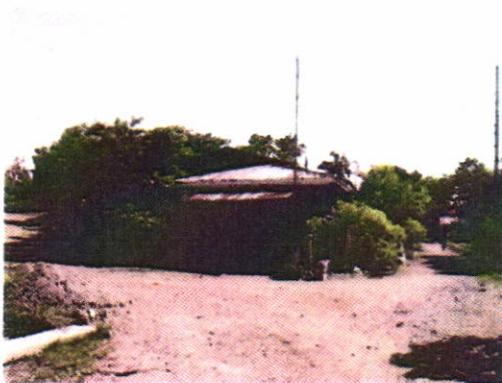
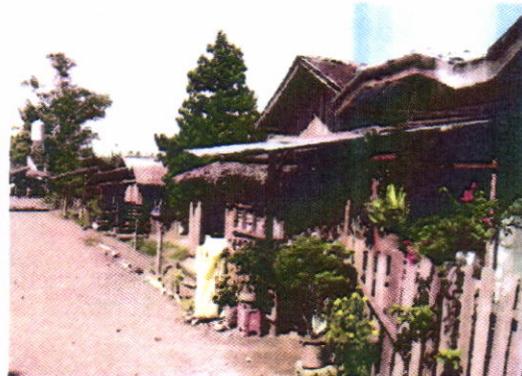
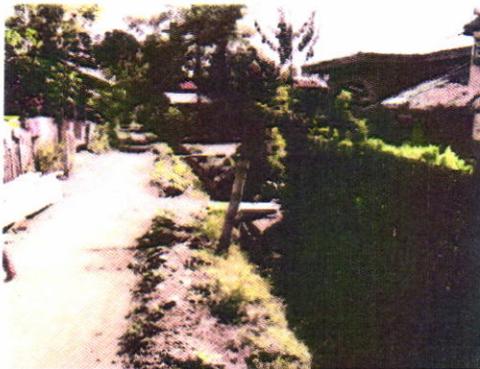
Photos are Purok 2 which is located near the Agusan River. Observe for the water level along Agusan River especially during inclement weather conditions. Pre-emptive evacuation is advised if unusual water level along the river is observed. Also, prohibit future settlement at the river embankments. Conduct regular maintenance on existing canals and installation of drainage canals to the other portions of the purok is recommended.

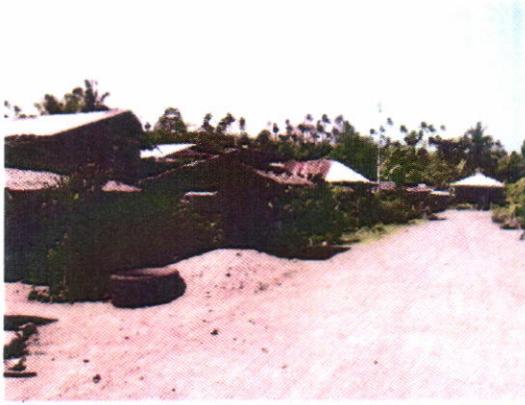
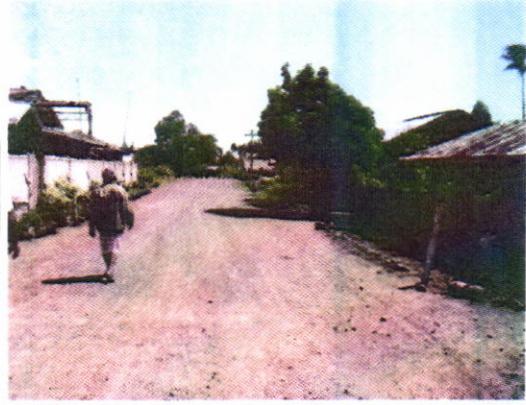
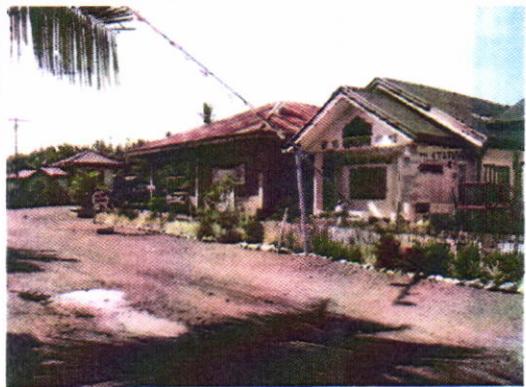
Proper concrete drainage canals are recommended to be installed at Purok 3 to facilitate surface run-off especially during heavy rainfall.

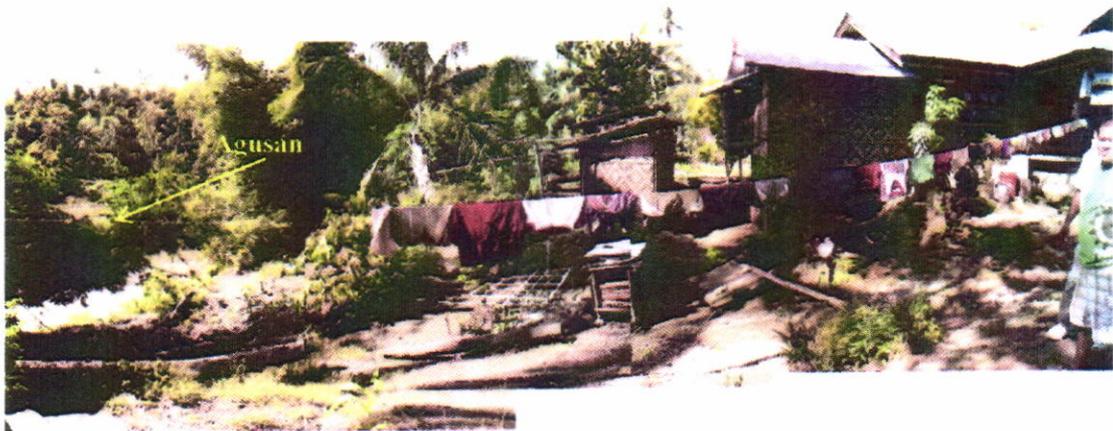
Photo above shows the proximity of some houses at Purok 3 to the Agusan River. According to the residents, Agusan River overflow does not reach the purok but only levels at its embankments. Prohibit future settlement towards and along the Agusan River embankments. Vigilance of residents closest to the river is recommended especially during extreme weather

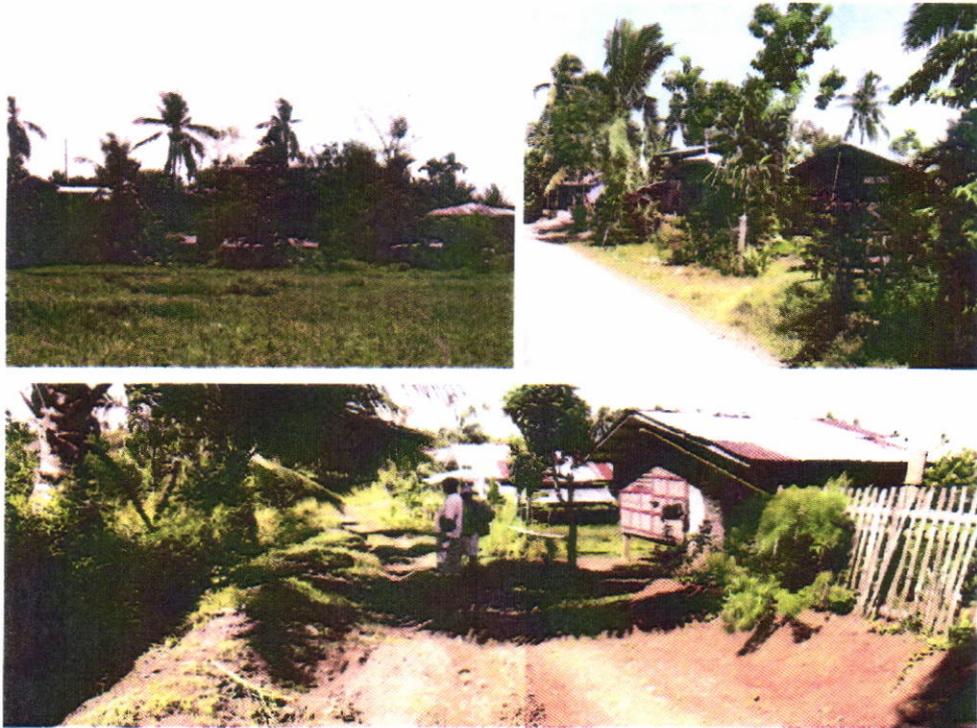
Photos above are houses of Purok 4 which are low to moderate to landslide. Provision of concrete drainage canals at the purok is recommended to facilitate surface run-off.

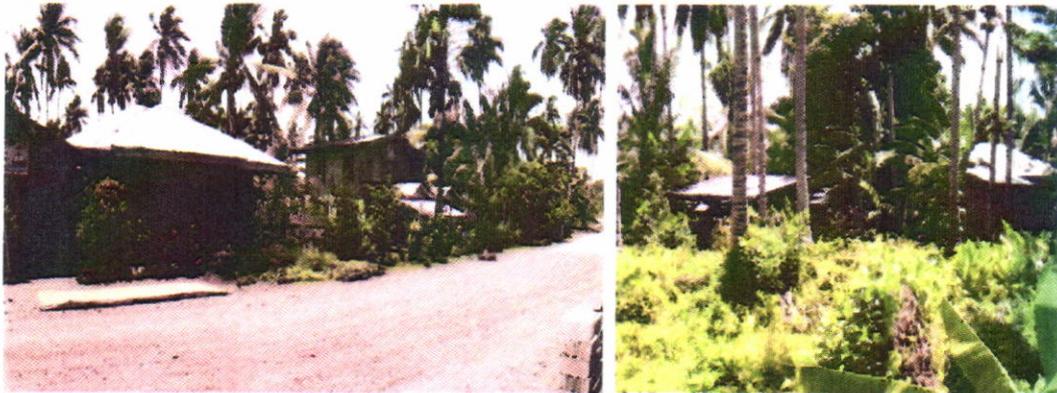
Photos are Purok 5. Installation of concrete drainage canals at the purok is recommended to facilitate surface run-off.

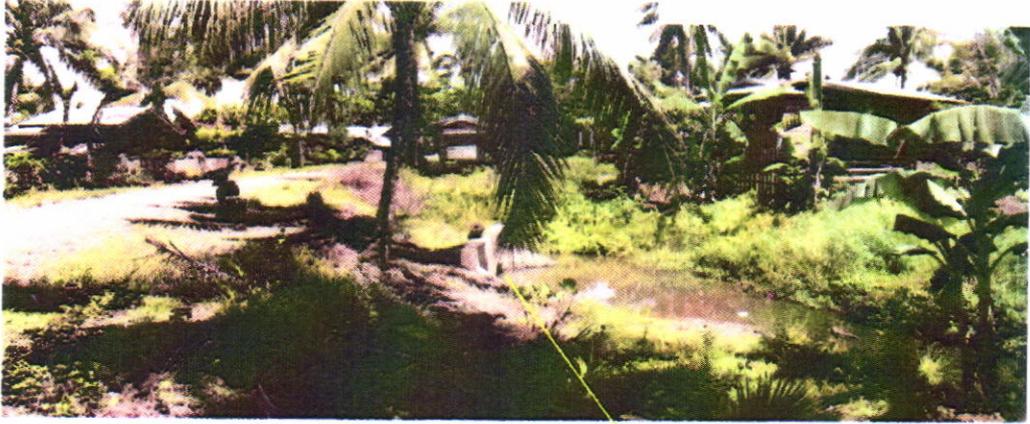
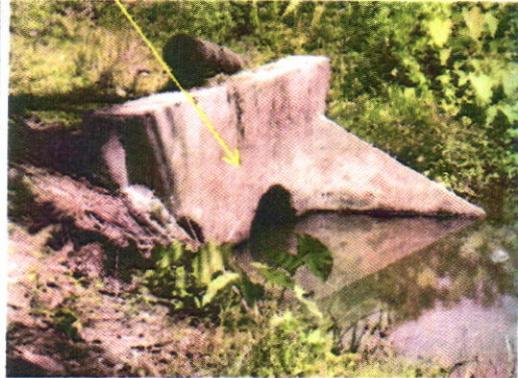
The creek on the above photo is the Mahaba Creek which traverses at Purok 6 Magalibobo and causes flooding up to waist-level at the purok since the existing culvert (close-up at right photo) could not cater too much volume of water during heavy rainfall. Replacing the existing culvert into box-type culvert is recommended to address the problem. GPS coordinates 07°59'48.9"N/126°03'42.3"E

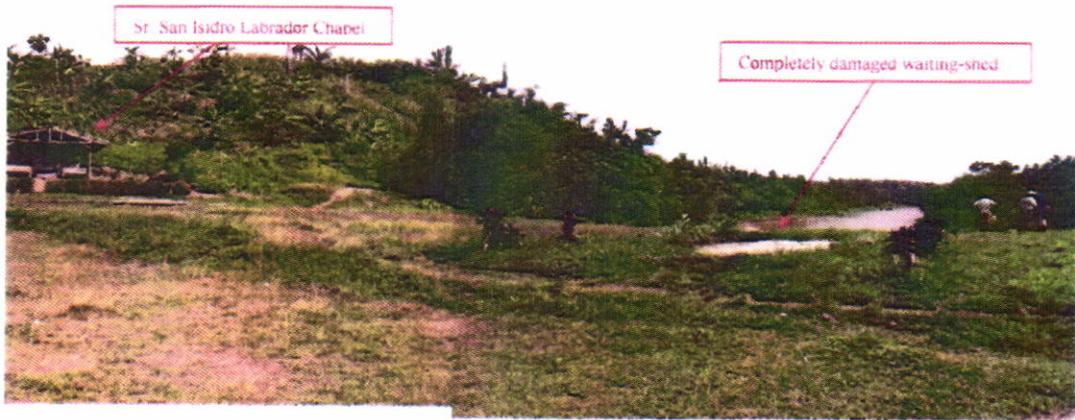
Sitio Lilo waiting-shed is completely damaged by typhoon "Pablo" and Sr. San Isidro Labrador Chapel is prone to landslide.

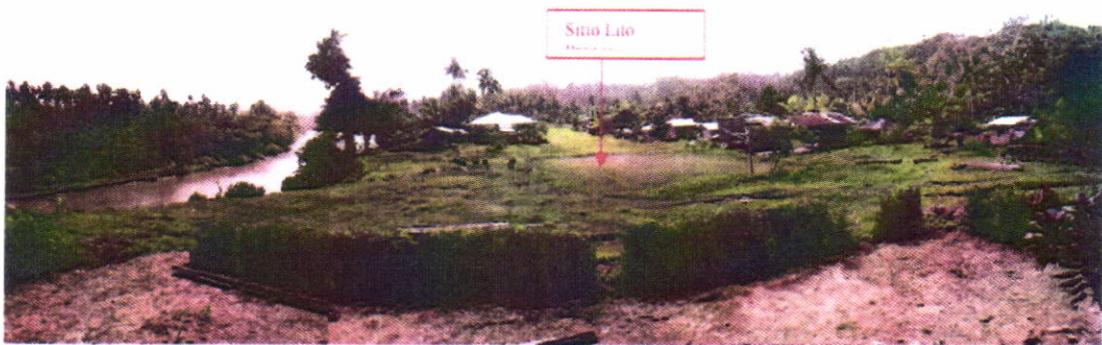
Closer panoramic-view of Sitio Lilo proper situated along Agusan River embankment.

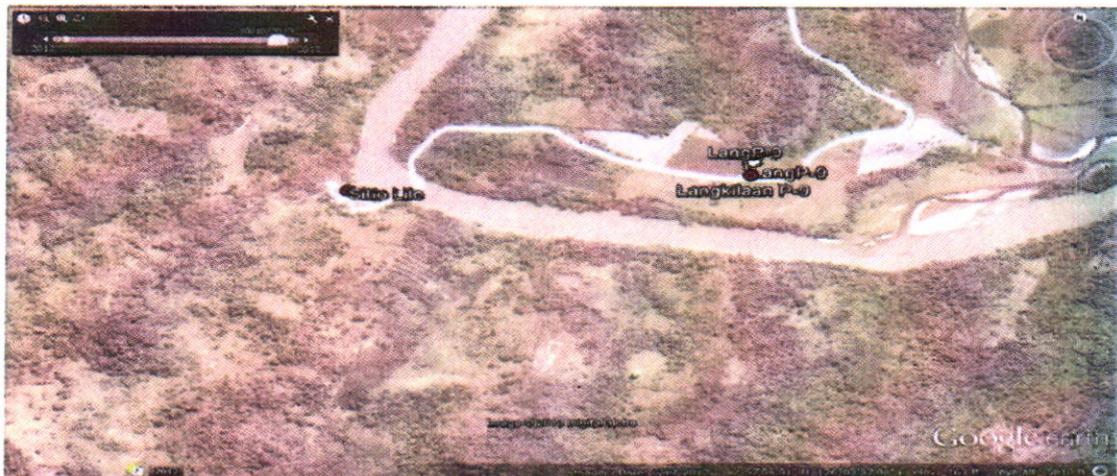
Fig. 1 Geographic location of Sitio Lilo, Brgy. Patrocinio, Sta. Josefa, ADS. It is situated along Agusan River embankment which is prone to river-flooding, flash-flood and river-scouring. Total relocation is highly recommended. GPS reading is 7°57'17"-N/126°03'20.7"-E.

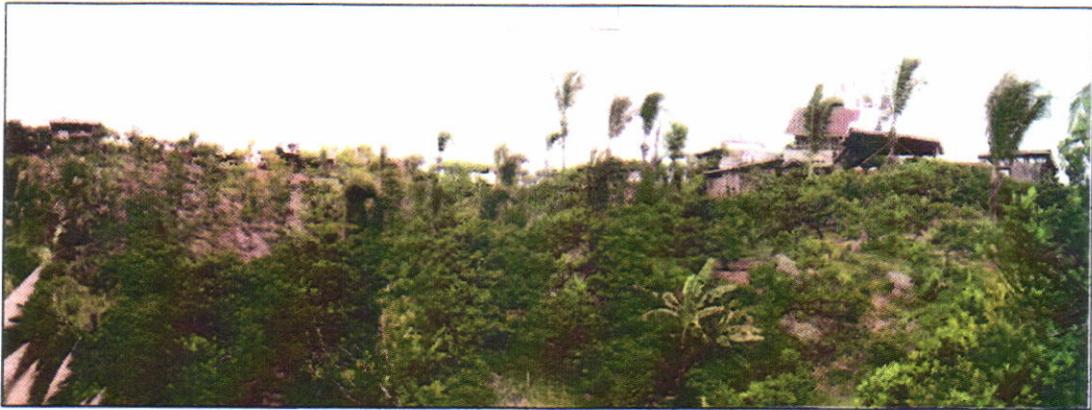
Photo above is Purok 8 Sitio Lemon which houses are located at the top ridge along the calamansi farmland and are moderate to landslide. Recommend to observe for presence of mass movements and prohibit future settlement at the ridge edges and at the foot of slopes.

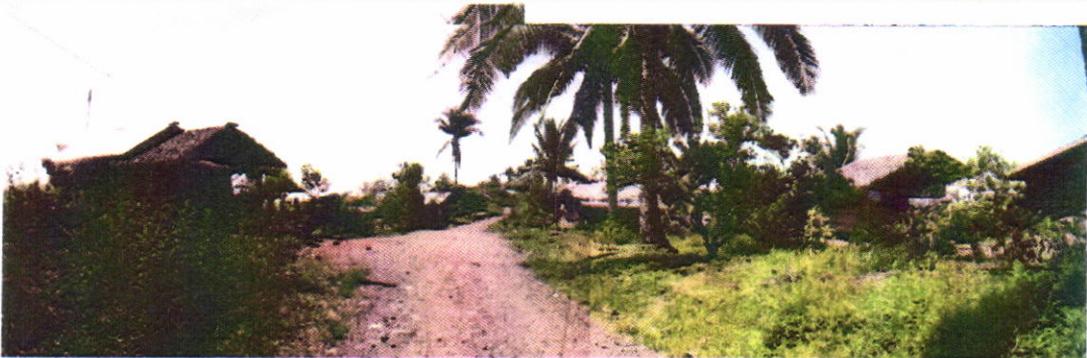
Photo is Purok 9 Sitio Marang which is rated moderate to landslide. Observe for presence of mass movements and prohibit future settlement at the ridge edges and at the foot of slopes.

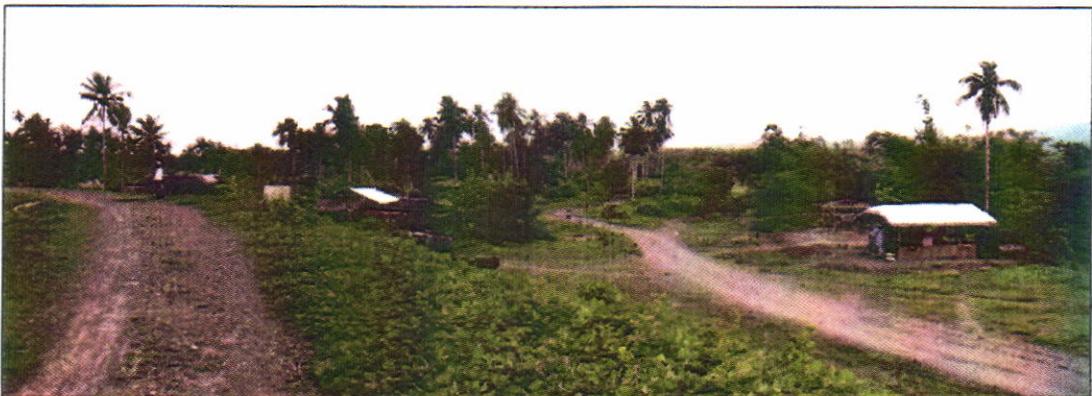
Photo is Purok 10 Sitio Bacilisi which is close to the Agusan River. Recommend to observe for rapid increase/decrease of water level along the river. Pre-emptive evacuation is recommended if abnormalities in the water level of the river are observed.
