Republic of the Philippines  
Department of Environment and Natural Resources  
**MINES AND GEOSCIENCES BUREAU**  
Regional Office No. XIII

Respectfully furnishing your end the document entitled "Results of the MGB Landslide and Flood Assessment and Mapping (1:10,000 scale) of the Municipality of Sta. Josefa Agusan del Sur". The assessment is in line with the government's effort aimed at reducing, if not totally mitigating the destructive effects and impacts of natural hazards to the populace.

## RESULTS OF THE MGB LANDSLIDE AND FLOOD ASSESSMENT AND MAPPING (1:10,000 SCALE) OF THE MUNICIPALITY OF STA. JOSEFA, PROVINCE OF AGUSAN DEL SUR

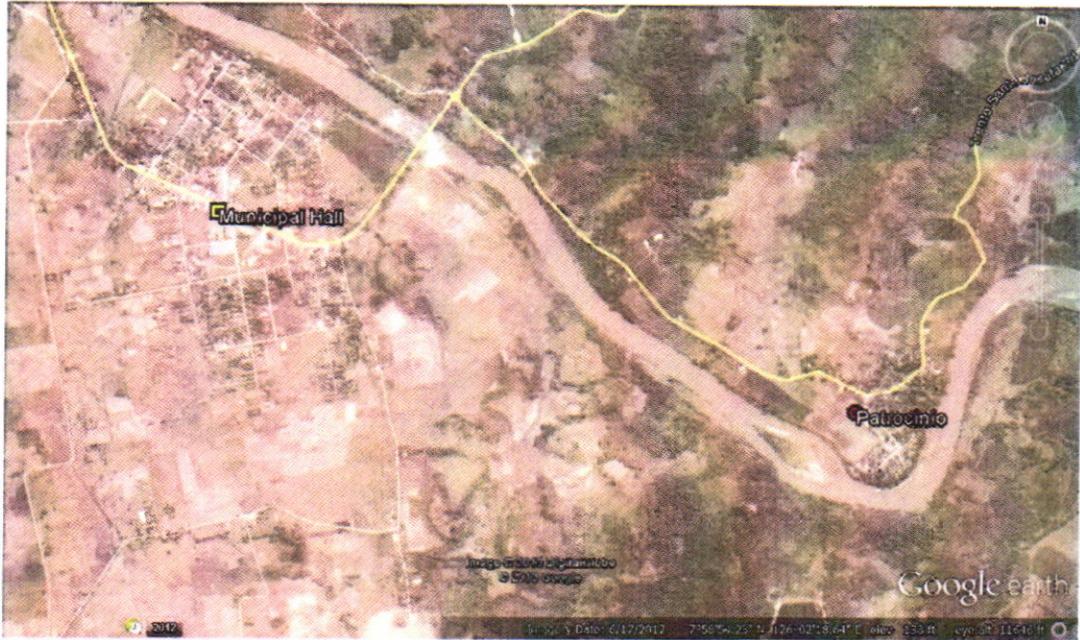
Location of Barangay Patrocinio via Google Earth Satellite Imagery. GPS coordinates 07°58'43.4"N/126°02'57.2"E

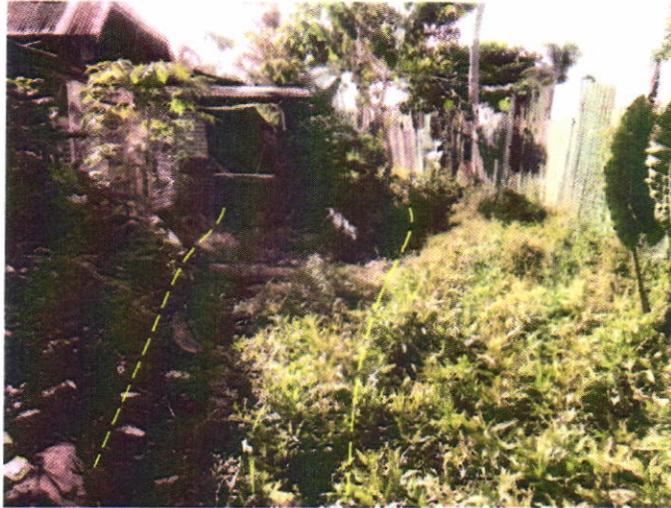
A view of drainage canal located at the back of Sta. Josefa Nat'l High School at Purok 7B that is recommended to be defined, conducted with regular maintenance and concretized so as to properly facilitate surface run-off at the area.

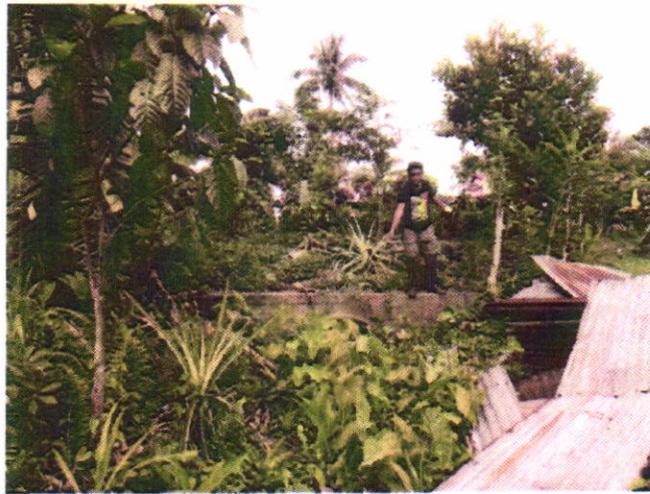
RCP culvert located at Purok 7A that needs to be conducted with regular maintenance to properly drain-out floodwaters from the area.

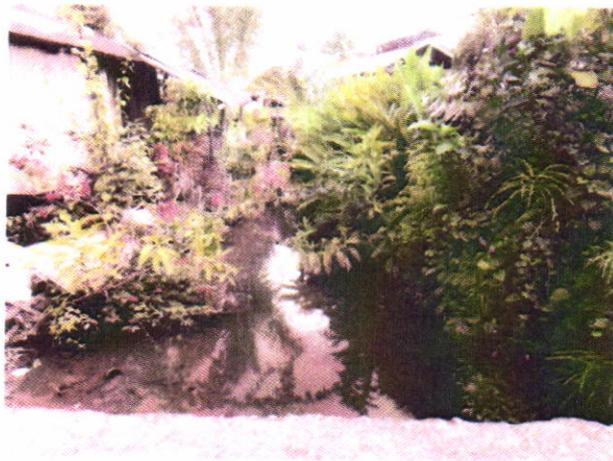
A view o of RCP culvert located at Purok 4 that seems to be inadequate in draining the water from the area. Replacing the existing culvert into a sufficient culvert and defining its outlet is recommended.

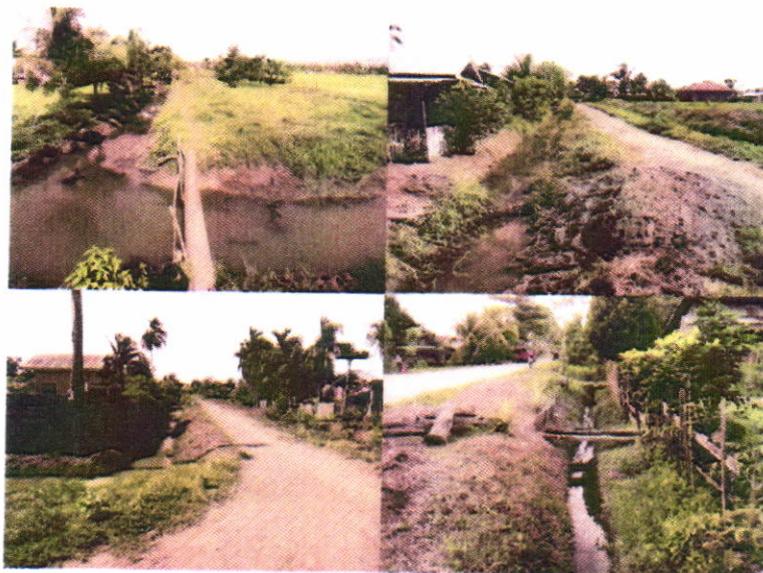
Some examples of existing drainage canals of Brgy. Poblacion located at Purok 9, 9A, 7B and 6(photos in clockwise direction) that need to be improved.

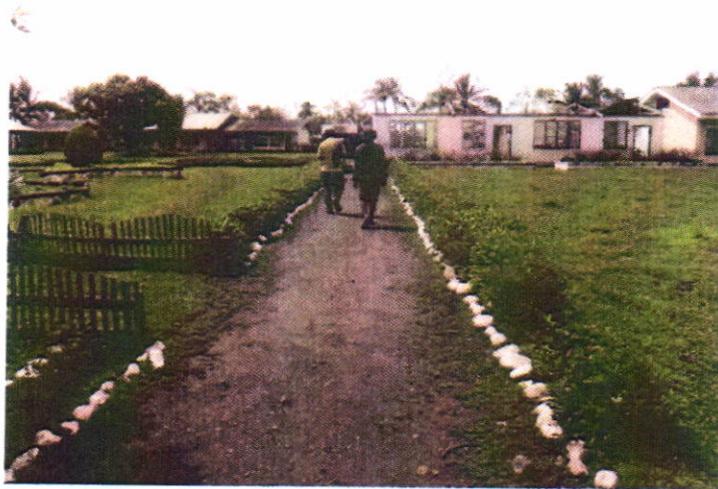
A view of the school grounds of San Jose Elem. School that is recommended to be provided with concrete line canal. Also being shown is the damaged school building due to Typhoon Pablo.

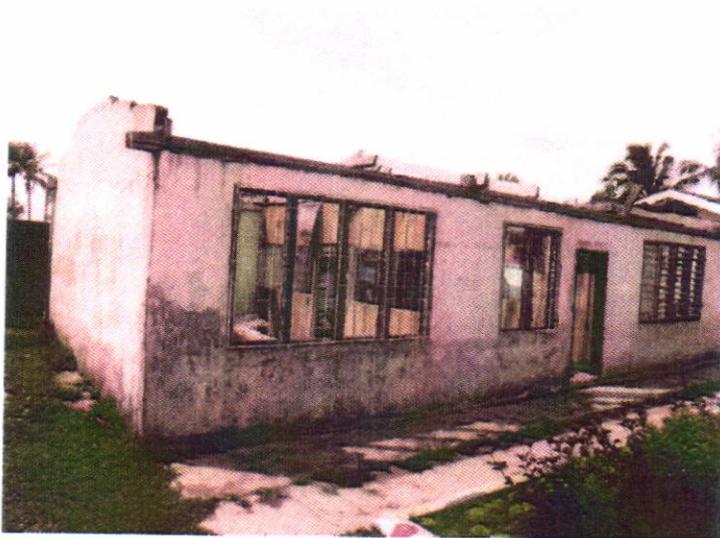
Closer view of the damaged school building of San Jose Elem. School located at Purok 3.

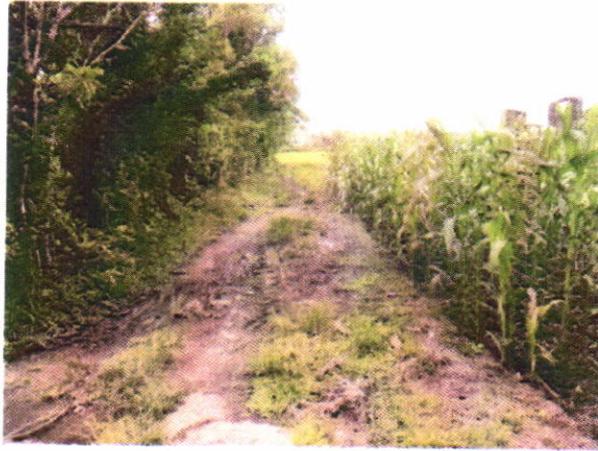
Barangay road located at Purok 5 that is recommended to be improved for evacuation and quick response.

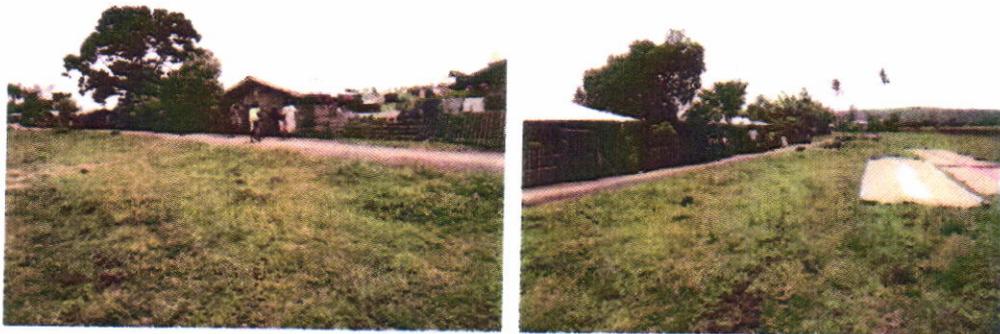
Houses located along the Agusan riverbank at Purok 4 that are subject for relocation since they are directly vulnerable to flashflood and river scouring.

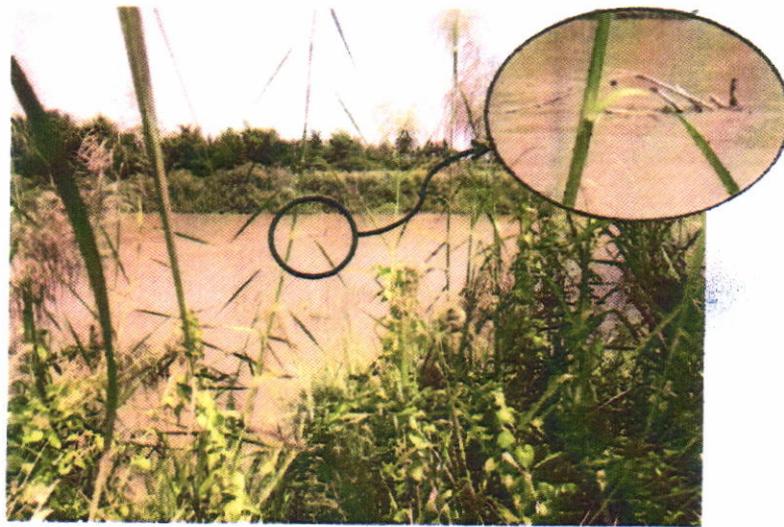
Photo showing the remaining part of an old and damaged bridge that obstructs the flow of Agusan River, causing river scouring on a riverbank located at Purok 1. Removing the obstruction is recommended.

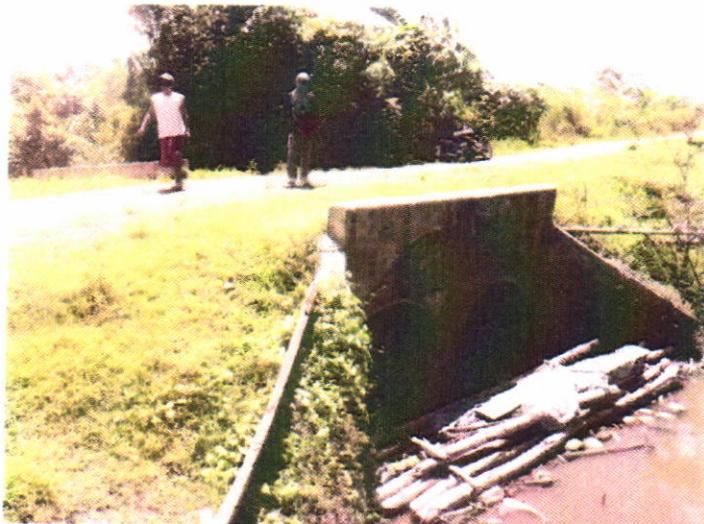
A double-barrel RCP located at Purok 8 that is recommended to be replaced into box-type culvert so as to sufficiently facilitate surface run-off at the area.

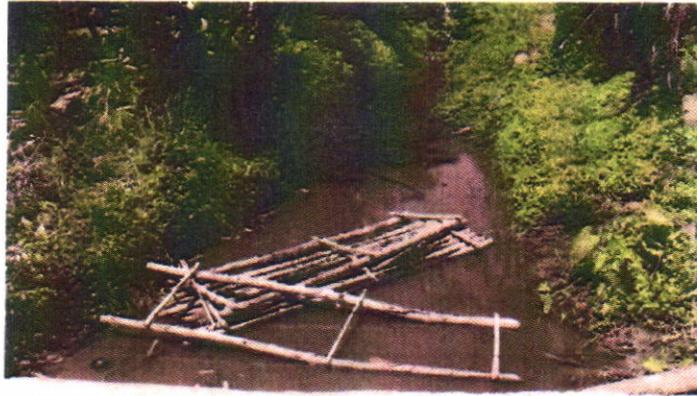
A view showing the Tadeco canal located downstream of the double barrel RCP at Purok 8. Defining and clearing the obstructions at the canal as well as conducting regular maintenance are recommended so as to prevent its overflow.

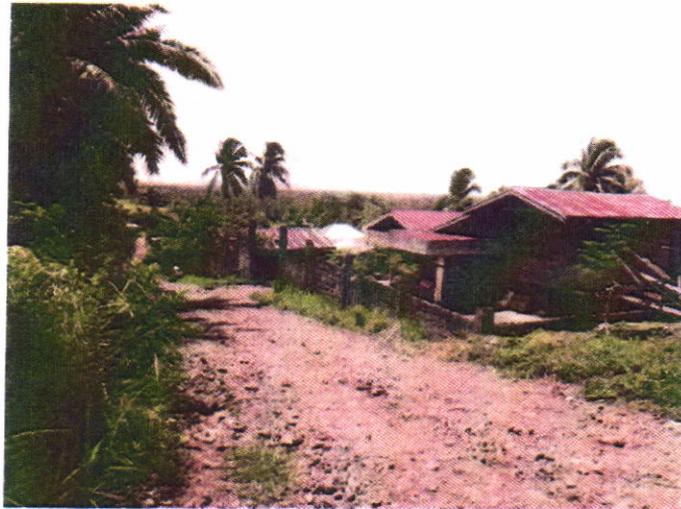
Houses located at Purok 7 that has a high landslide susceptibility rating.

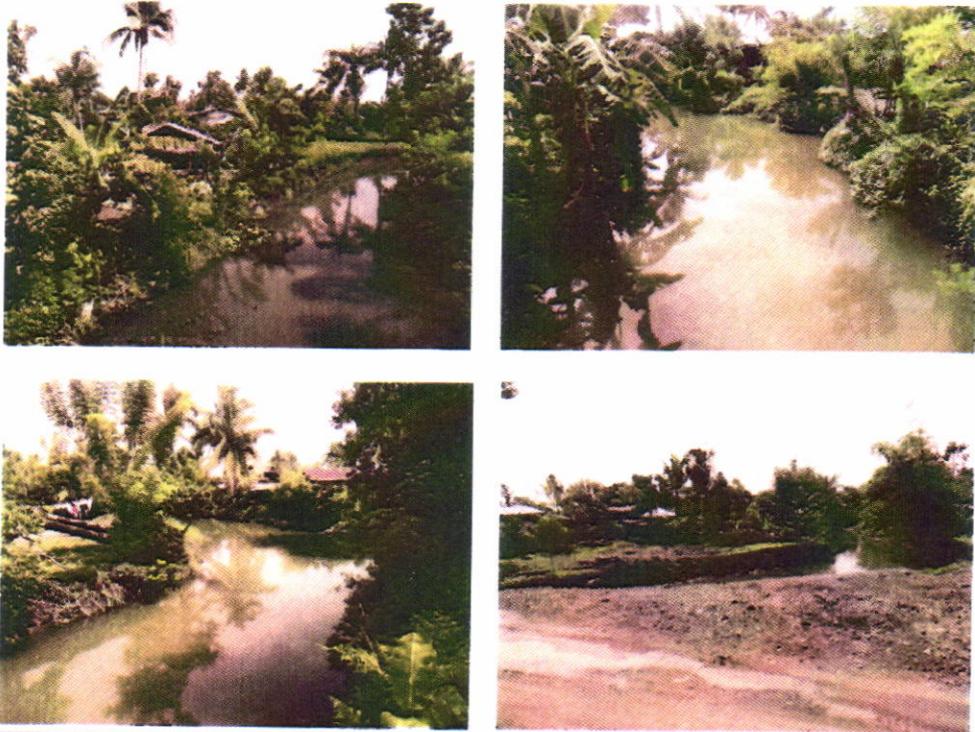
Photos showing the meandering segments of Sayon creek traversing across Puroks 1, 2, 3, 4 and 5 and that also causes major flooding and in the areas. One of the recommendations is to rechannel this creek.

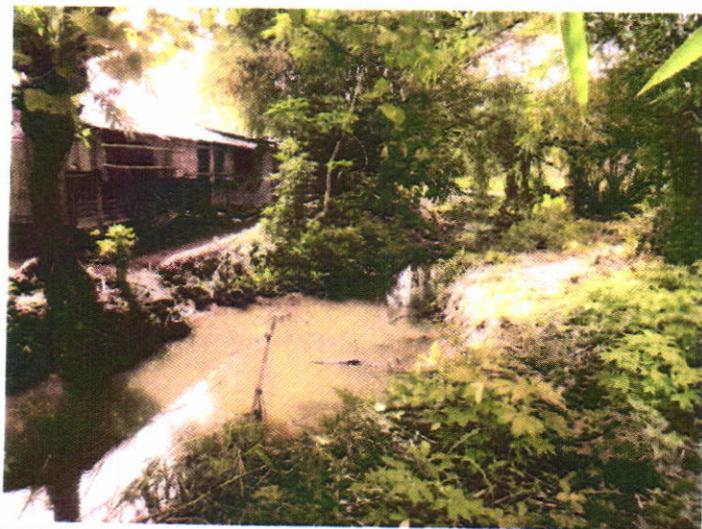
A creek located at Purok 7 that floods nearby houses when it overflows. Rechanneling the creek is also recommended.

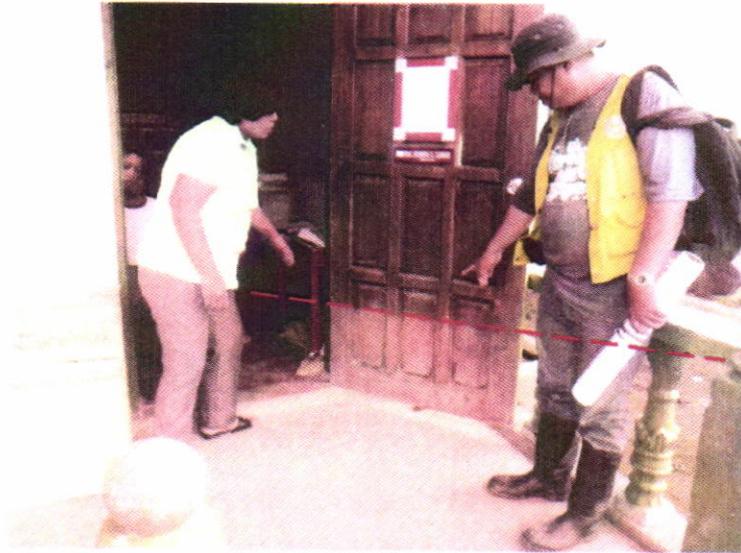
Flood height at Sayon Elem. School located at Purok 2 that approximately reached up to 0.5 meters due to a flashflood event from Sayon creek during Typhoon Pablo.

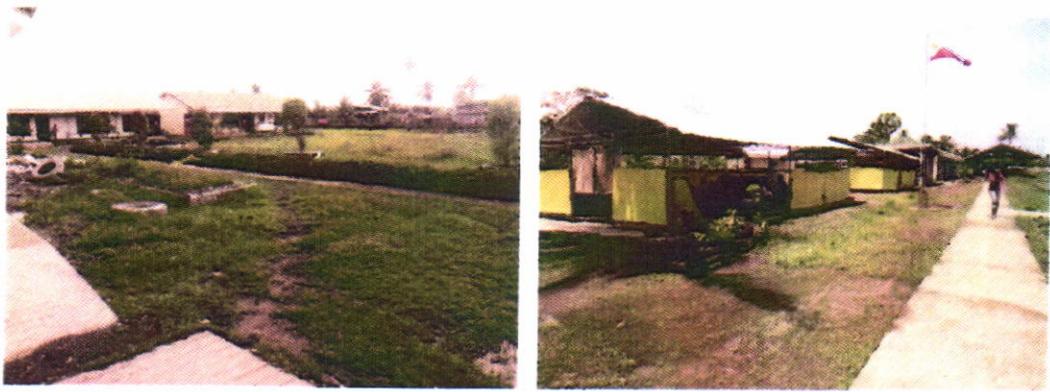
School grounds of Sayon Elem. School (left photo) and Sta. Josefa Nat'l High School (Annex) (right photo) that are recommended to be provided with proper drainage system to prevent ponding of water at the area and to properly facilitate surface run-off.

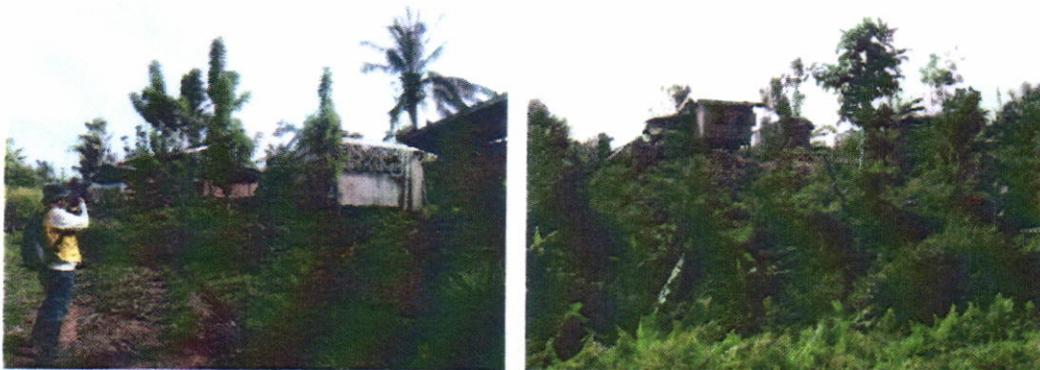
Houses located on the ridge at Purok 9 which is highly susceptible to landslide. For long term solution, relocation of houses on the edge of the ridge is recommended since they are at risk for a possible landslide occurrence.

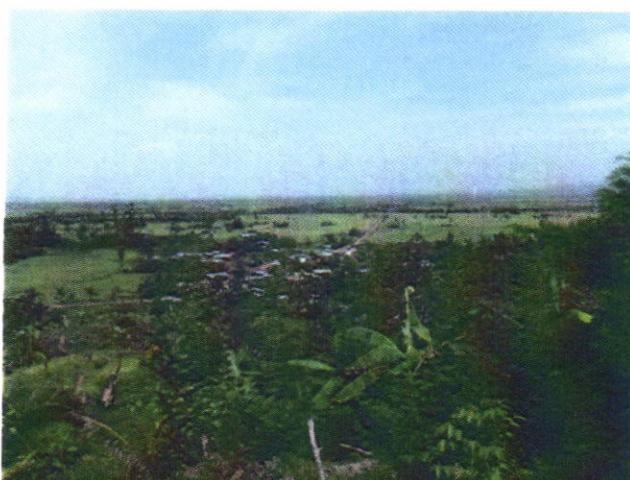
Top view of the houses at Purok 8 Tagmanuro located at the foot slope which is rated to be moderately susceptible to landslide.

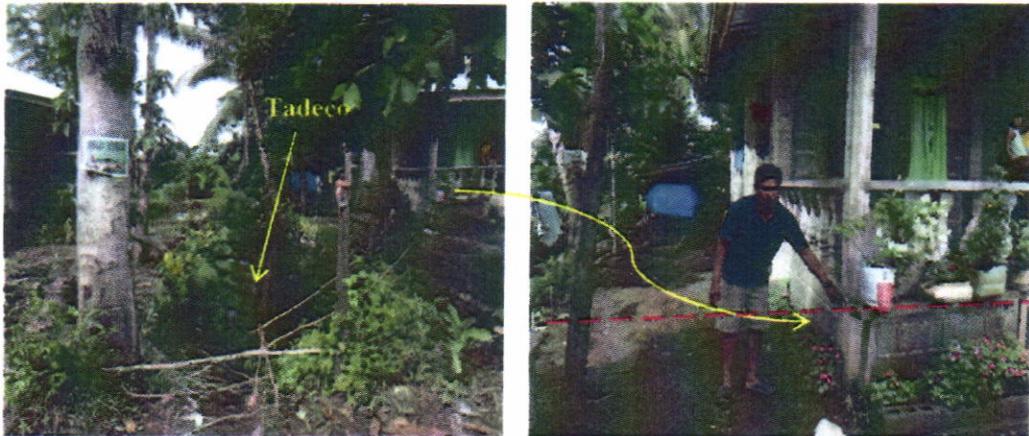
Photos showing the Tadeco canal (left photo) that sometimes overflow and flood nearby houses. Flood height that approximately reached 0.5 meter was experienced at the area as shown by a resident (right photo).

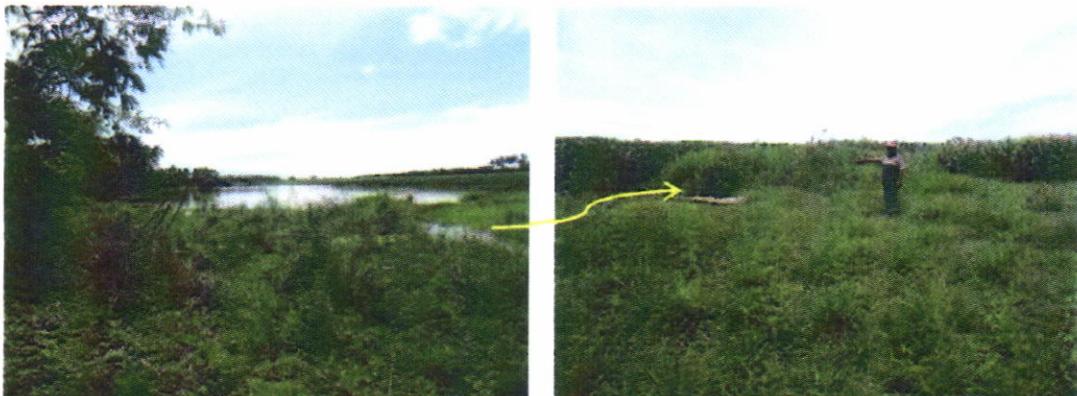
Photos showing the Kanobahan lake (left photo) and its outlet that needs to be widened and that needs to be defined (right photo) located at Purok 1. According to residents, the overflow of Kanobahan Lake is one of the causes of major flooding on the area during heavy rainfall events.

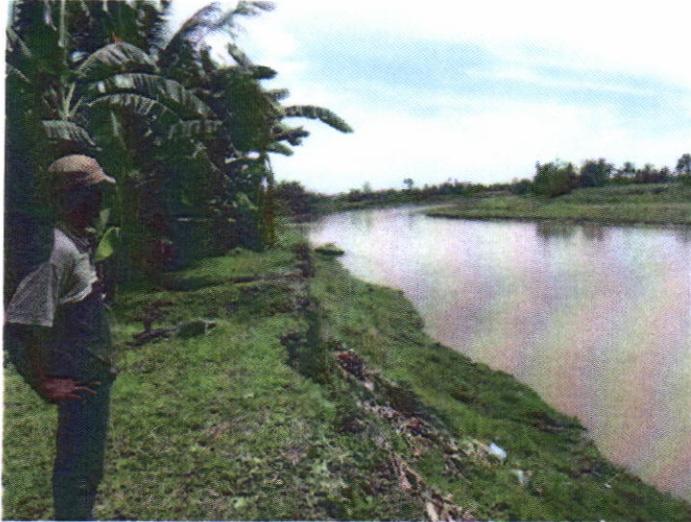
A view of Agusan River located at the barangay proper which is the main cause of flooding at the barangay.

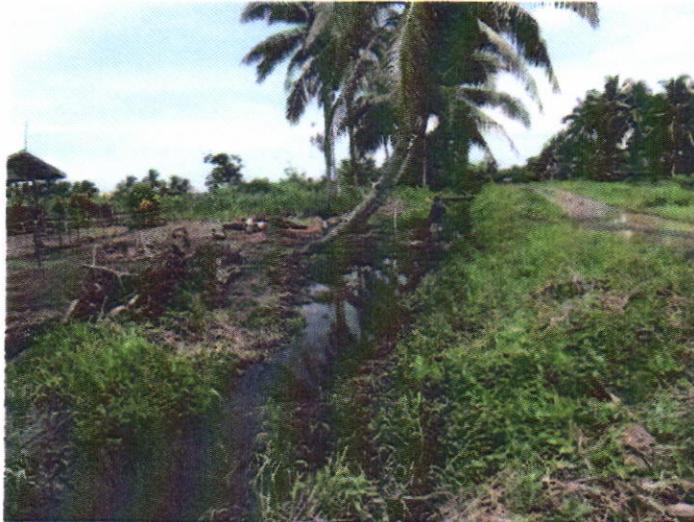
Drainage canal located at Purok 7 Paraiso Nangka which needs to be conducted with regular maintenance.

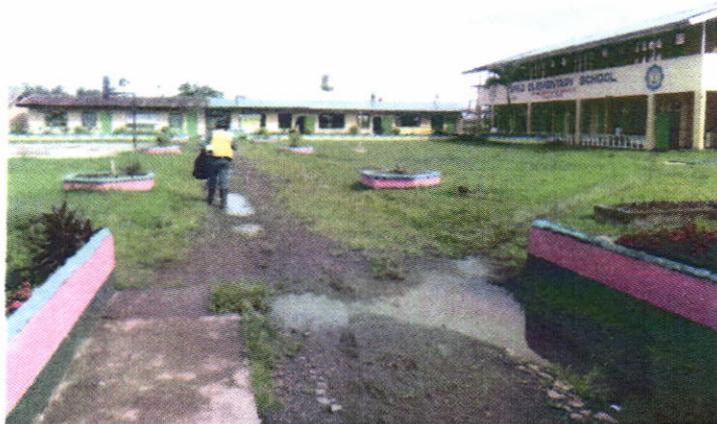
Tapaz Elem. School located at Purok 3 that needs to be provided with proper drainage system to prevent localized flooding at the area.
